August 2006

12 THE PARADE, CARMARTHEN ARCHAEOLOGICAL WATCHING BRIEF

REPORT NUMBER: 2006/95 PROJECT NUMBER: 61993

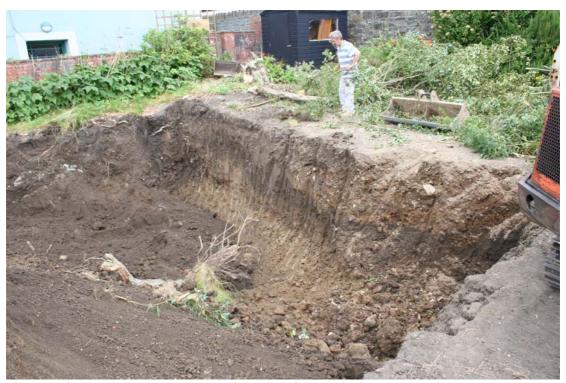
Plate 1: General view across watching brief area during excavation.

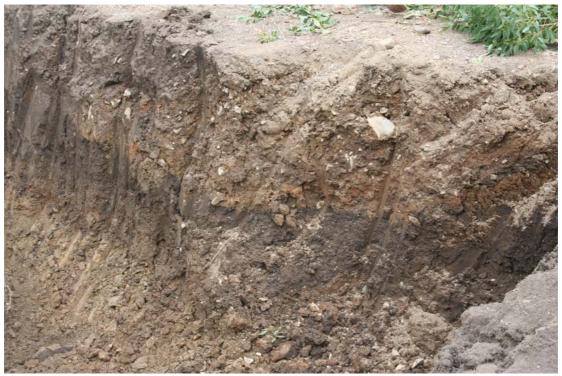
Visits were made during the excavation to reduce the level of the garden. The method of excavation meant that little was observable except in the sides of the excavated area. This showed a buried soil horizon, c.1m below the present garden surface (Plate 2), that may have been a former garden soil buried by what appears to have been fairly recent build up. A lighter clay material (visible in the bottom left hand corner of Plate 2) below the buried soil may have been material derived from the Roman rampart, although this is far from certain. If this material was from the rampart it was not clear whether it was in situ or redeposited.

Plate 2: Detail of the buried soil horizon in the northern edge of the excavated area.
