A487 CASTELL CADW, FELINDRE FARCHOG, PEMBROKESHIRE ROAD IMPROVEMENTS ARCHAEOLOGICAL WATCHING BRIEF

Report No 2008/32

RHIF YR ADRODDIAD / REPORT NO. 2008/32
RHIF Y PROSIECT / PROJECT RECORD NO. 61998

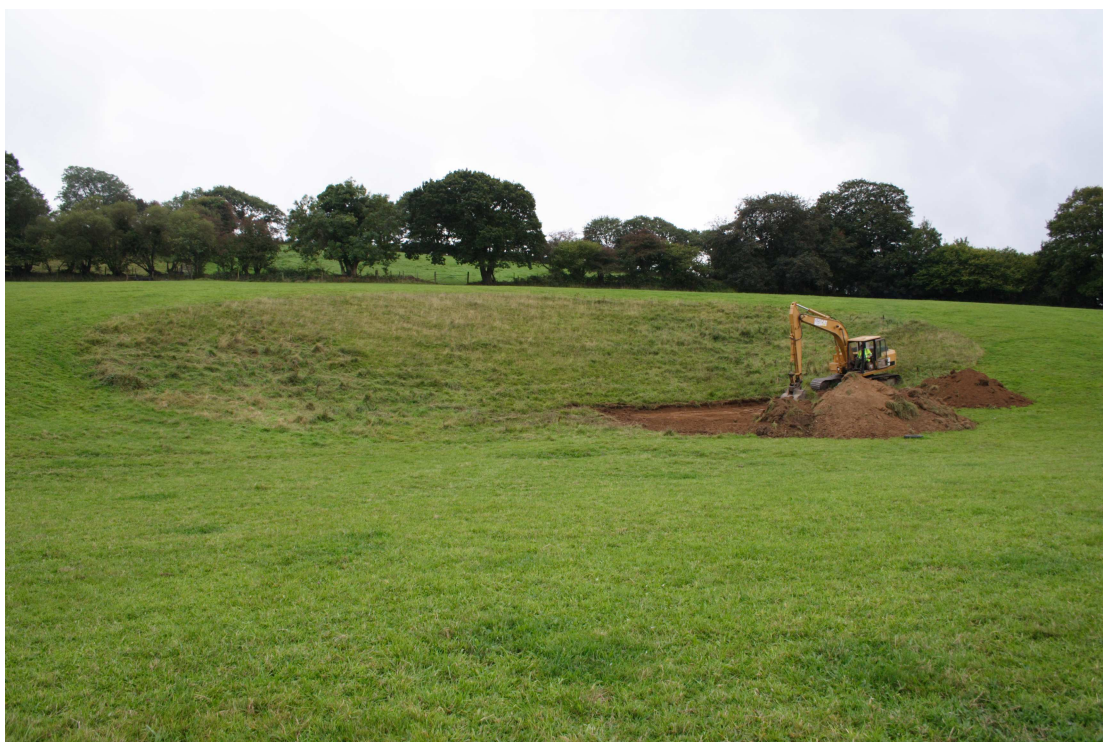
Photo 1: Old Quarry at SN 0922038835. View SW

The first phase of the watching brief was begun on 18th September 2006 with a site visit after removal of trees, but before any groundworks were started. The topsoil was removed from the lower part of the possible old quarry (Photo. 1), as this was to be used as an area to deposit excess material. The quarry measured c.40m east west and was cut back by possibly 25m to 30m south into the hillslope. There was a slight hump c.20m to the north, which was probably the result of quarry tailings. The machine did not reach bedrock and there was up to 0.6m of silty topsoil in the base of the quarry.

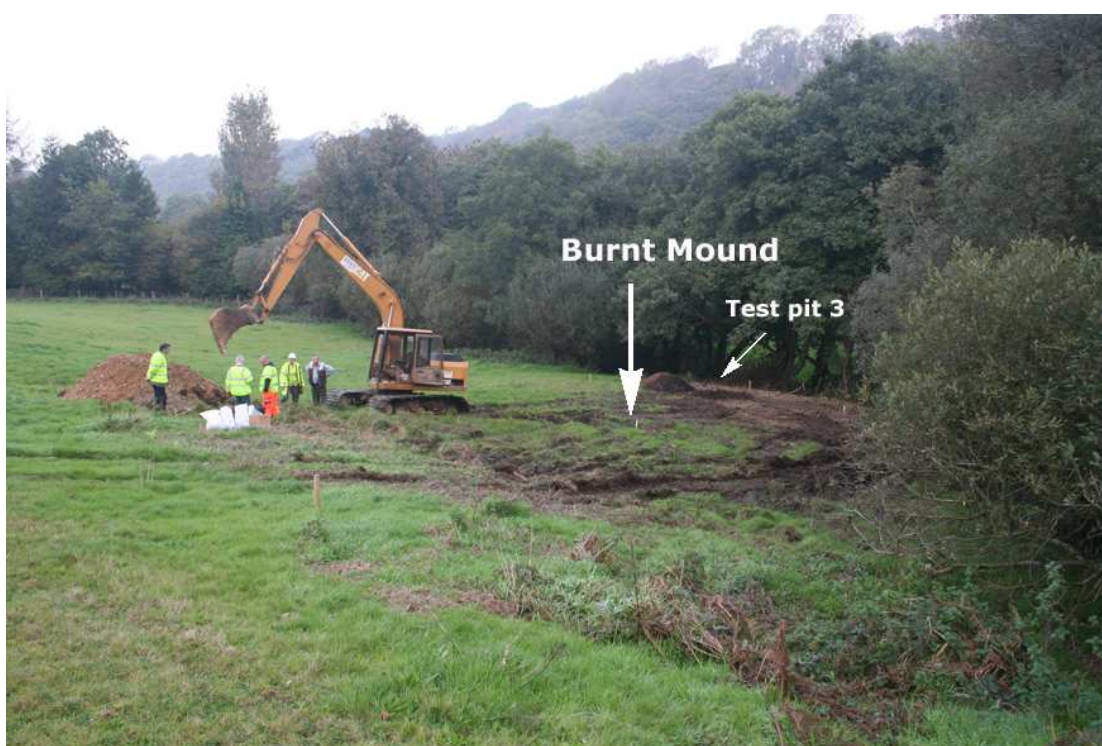
Photo. 2: Burnt mound and test pit 3. View NW

Six test pits were excavated, but only test pit 3 produced archaeological deposits. This Test Pit was in the outer part of a slight mound 0.3m high by approximately 12.5m diameter (Photo. 2) which initially appeared to be a natural feature but some very dark soil and small quartz stone could be seen in the surface (Photo. 3). Immediately on starting the test pit fire-cracked stone and very dark charcoal rich soil was encountered, material typical of burnt-mounds. Machine excavation was therefore halted and the trench was hand cleaned, revealing the possibility of part of a shallow pit in the southeast corner of the test pit (Photos 4 and 5). The fill of this pit, like the soil above, was very dark, with fire-cracked stone, but also contained a few small lumps and flecks of charcoal. A sample of this charcoal was sent for radiocarbon dating and this produced a determination of Cal BC 2340 to 2030 (Beta-224477) at 95% probability (Appendix 1*).

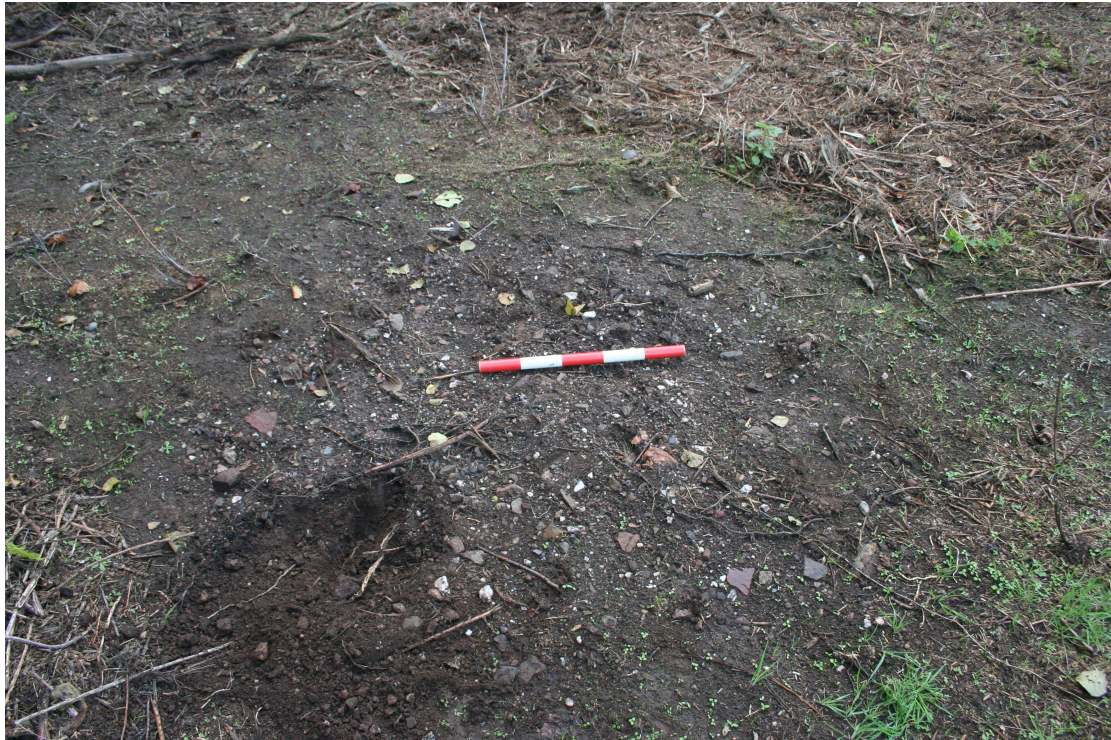
Photo. 3: Surface of burnt mound. Scale 0.5m

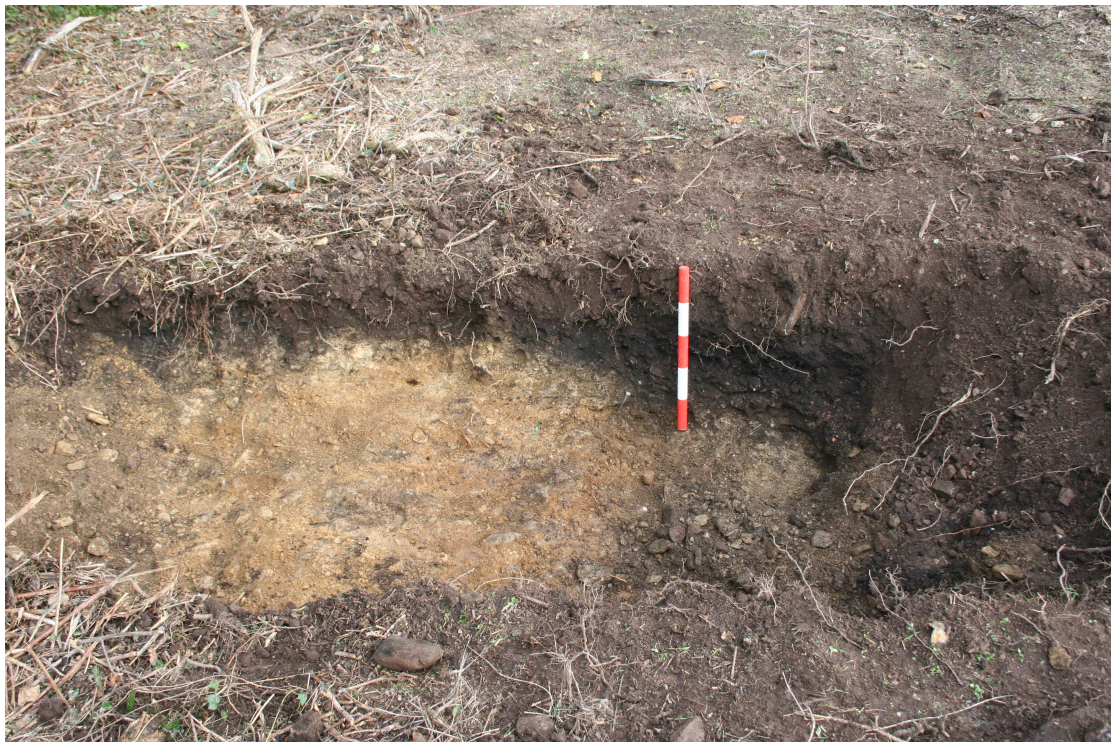
Photo. 4: Test pit 3, pit 104. View NE. Scale 0.5

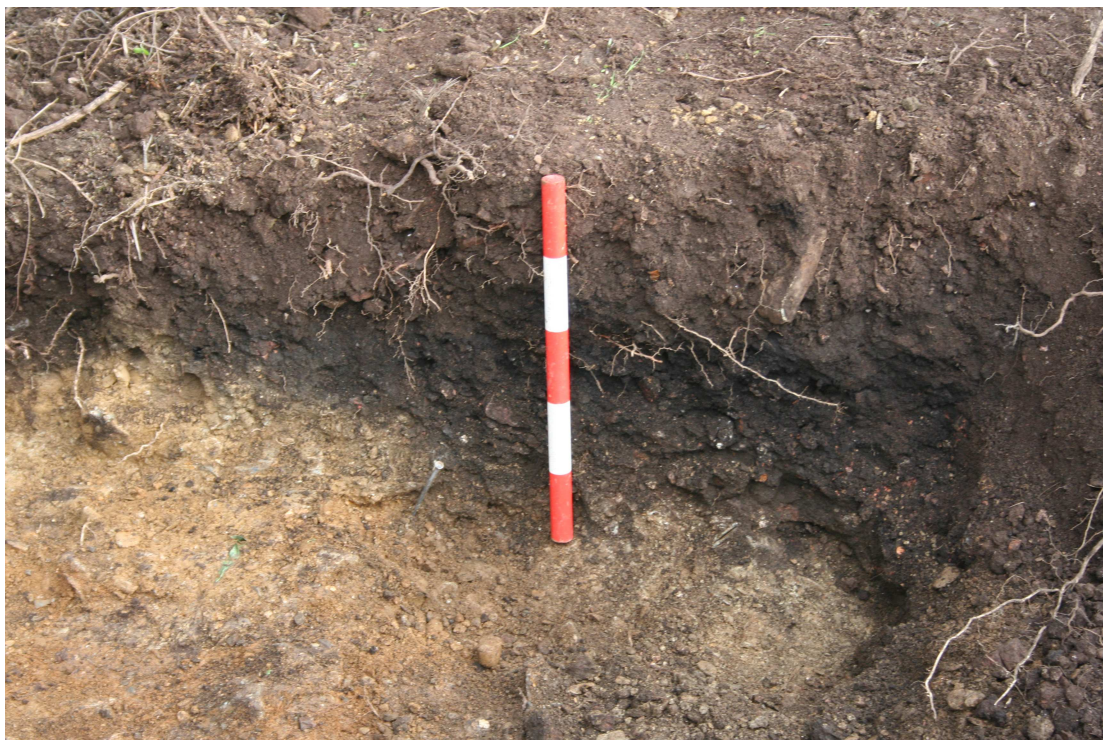
Photo. 5: Test pit 3, pit 104 detail. View NE. Scale 0.5

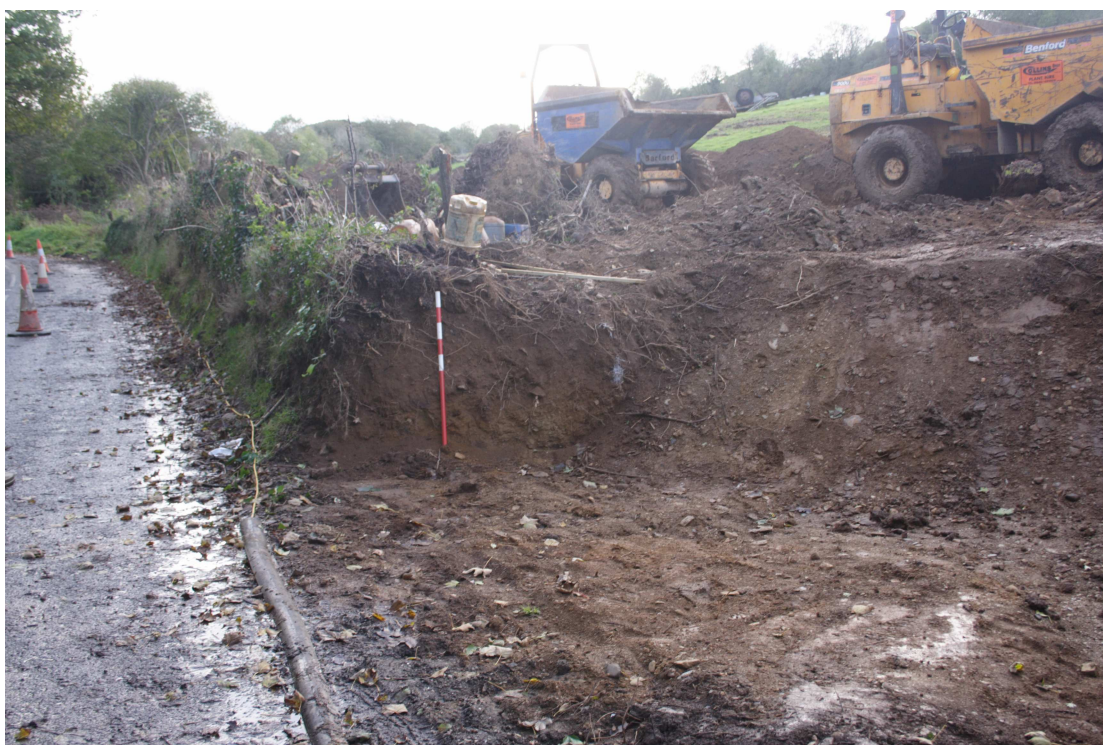
Photo. 6: Boundary 001. View E. Scale 1m

Only the new western entrance opposite Look-about cottage was observed, with nothing noted of archaeological interest other than the hedge bank (001)(Fig.1), grid ref. SN 0915538940, on the south side of the road (Photo. 6). This boundary appeared to have a buried soil layer below bank material of light mid brown silty soil with 5% angular shaley stone. On the top of the bank there was darker more humic topsoil on which there were the remains of the mature trees and scrub already cut down. These trees were of sycamore, hazel, thorn and holly and some rosehip. This bank was about 1.2m above the level of the old road with around 0.75m of make up above the buried soil. On the south side there was a considerable amount of hill-wash that was almost up to the top of the bank.

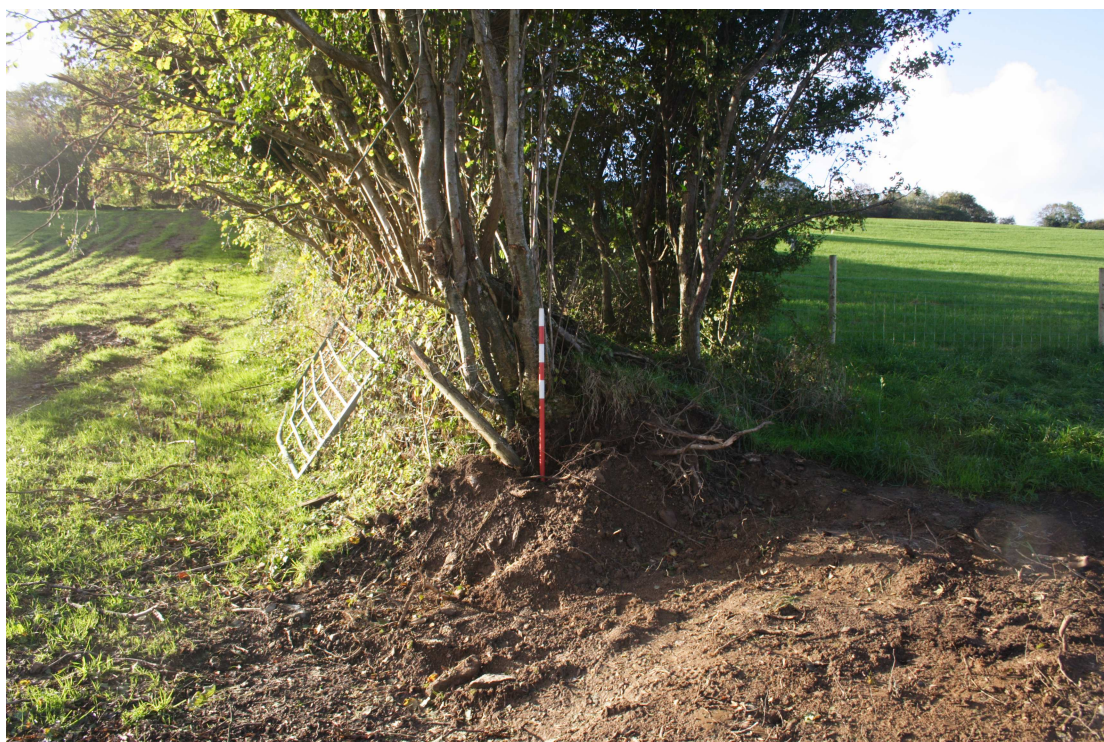
Photo. 7: Boundary 002. View S. Scale 1m

Further to the west of Look-about Cottage there was a north-south boundary (002)(Photo. 7), grid ref. SN 0909538935. This was an earth and stone bank c. 1m high with trees and scrub (sycamore, hazel and thorn) but no hedge. There was a post and wire fence on its east side and some barbed wire on its west side. There was no indication that this boundary ever had a deep ditch.

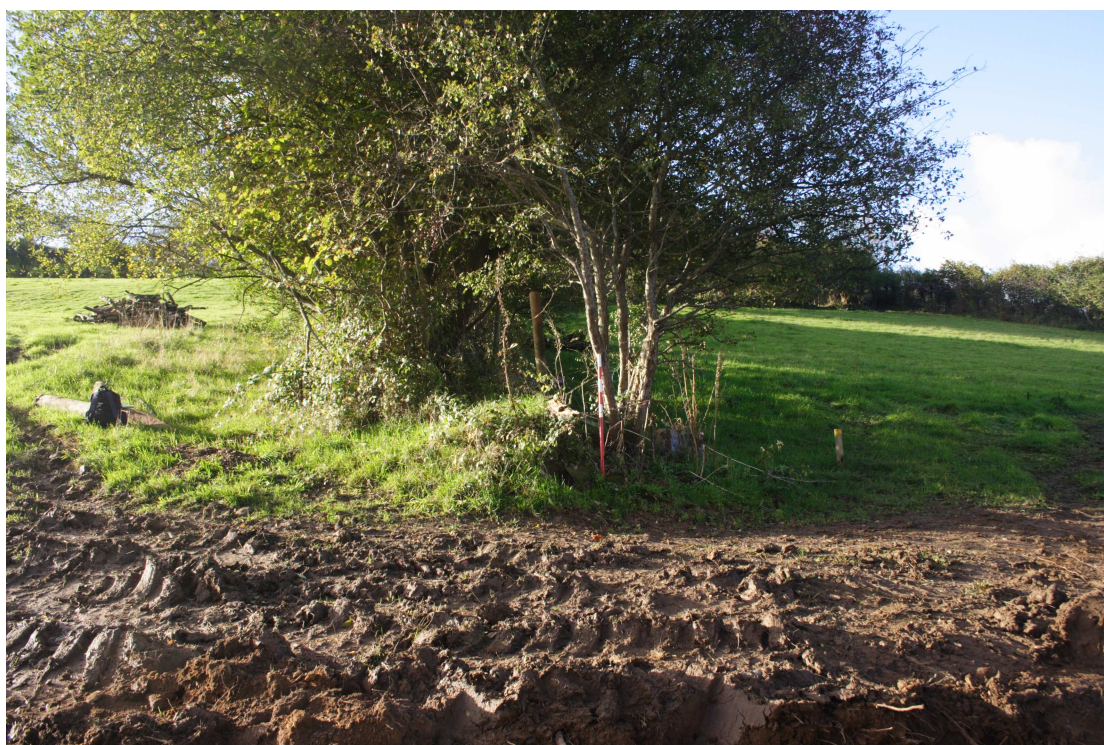
Photo. 8: Boundary 003. View S. Scale 1m

Almost opposite Look-about Cottage there was another north-south boundary (003)(Photo. 8), grid ref. SN 09163038920. This bank was smaller than the one to the west, only being c. 0.6m high, covered with similar scrub and trees, but with a post and wire fence on top. All three of these field boundaries are shown on the 1843 Nevern Tithe Map (Fig. 2).

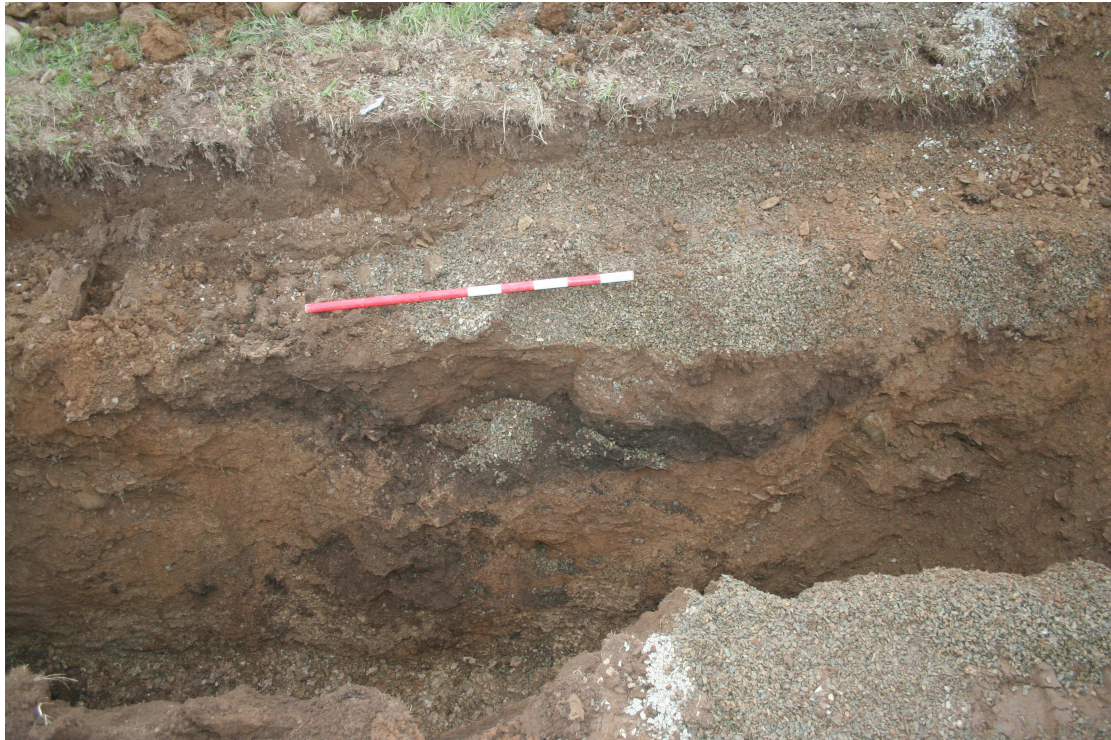
Photo. 9 Deep ditch sectioned by pipe trench from road to balance pond. View E.
Scale 1m

(Figs. 1 and 2). This appeared to be a substantial ditch possibly up to 2m deep, but close access was inadvisable (Photo. 9). There were no finds in the trench topsoil except a couple of fragments of recent china.

The pipe-trench was excavated later on 24 September 2007; the cut for the ditch was about 2m deep and not quite fully reached by the bottom of the pipe trench.

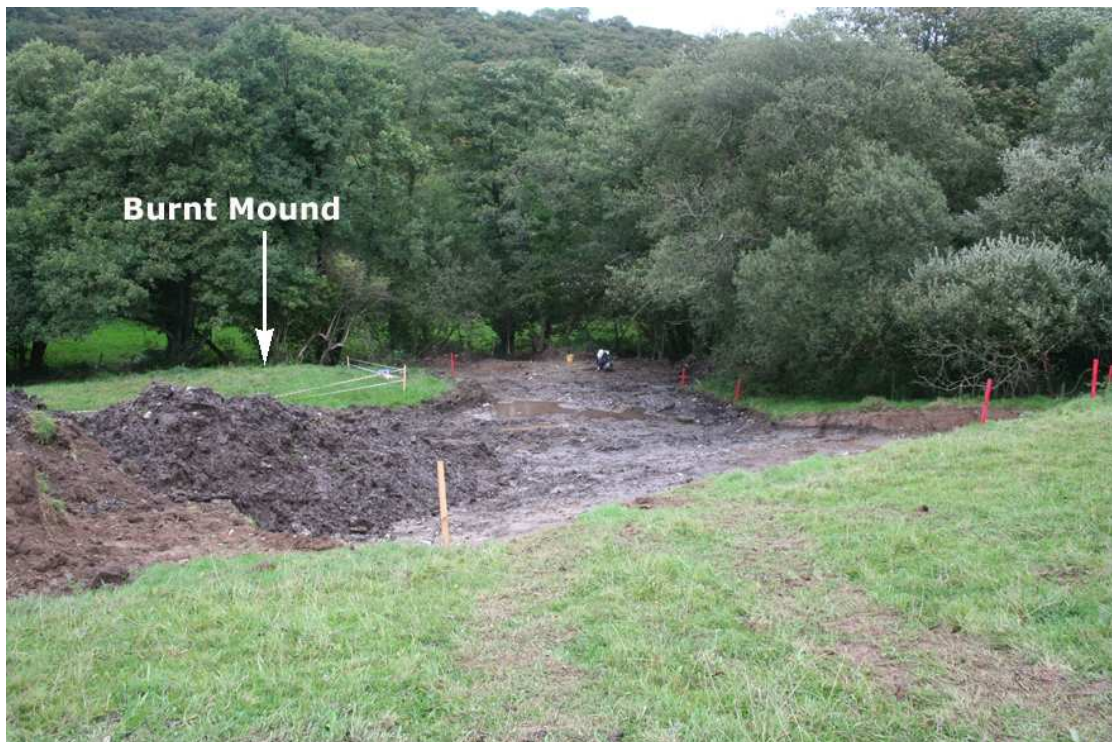
Photo. 10: Area for balance pond. View N

Machine clearance of the topsoil started in the northwest corner or the excavation against the fence line, and to the east of the burnt mound found earlier (Photo. 10). Almost immediately heat-affected shattered stone and very dark soil was found around the edges of the excavation and a number of small features filled with dark soil were observed within this corner of the site. Machining was therefore stopped at the top of the subsoil, which was then hand-shovelled and trowelled clean.

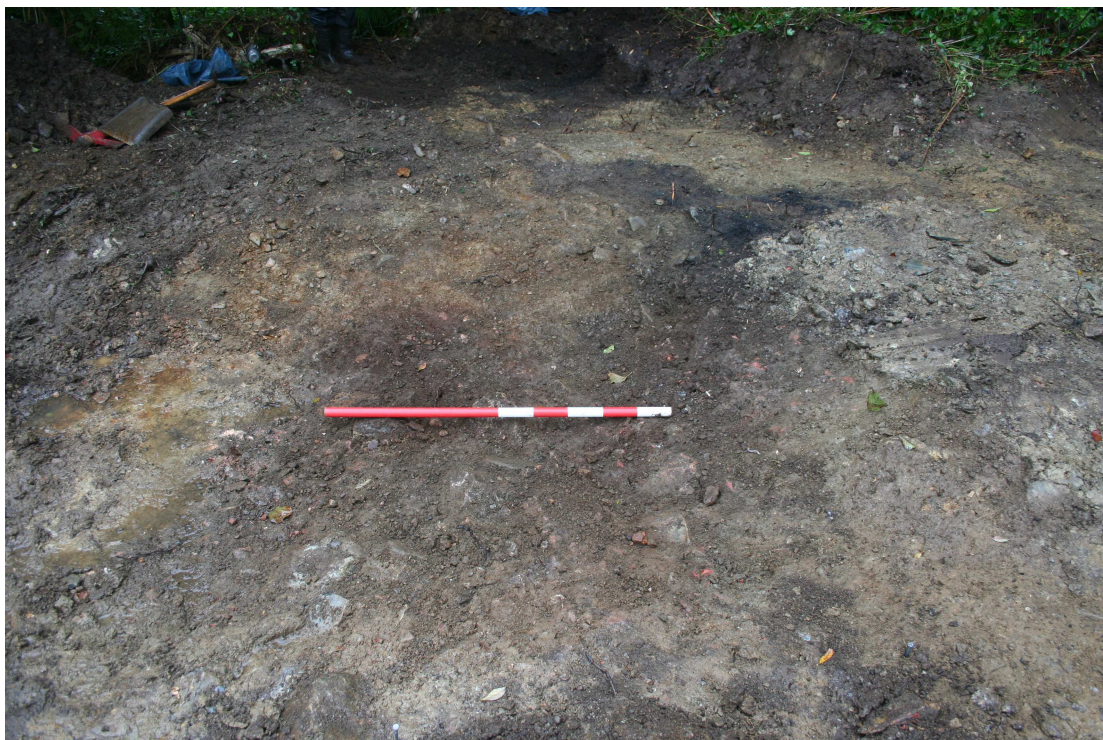
Photo. 11 Possible heat reddened area, around scale. View NNE. Scale 1m

This area was quite wet and animal hooves had obviously poached it in the past. There were root disturbances, not just from the adjacent trees but also from trees long felled. There was one quite large apparent root hole or tree bowl 105 (Fig. 4), although this area may have been reddened by heat (Photo 11)

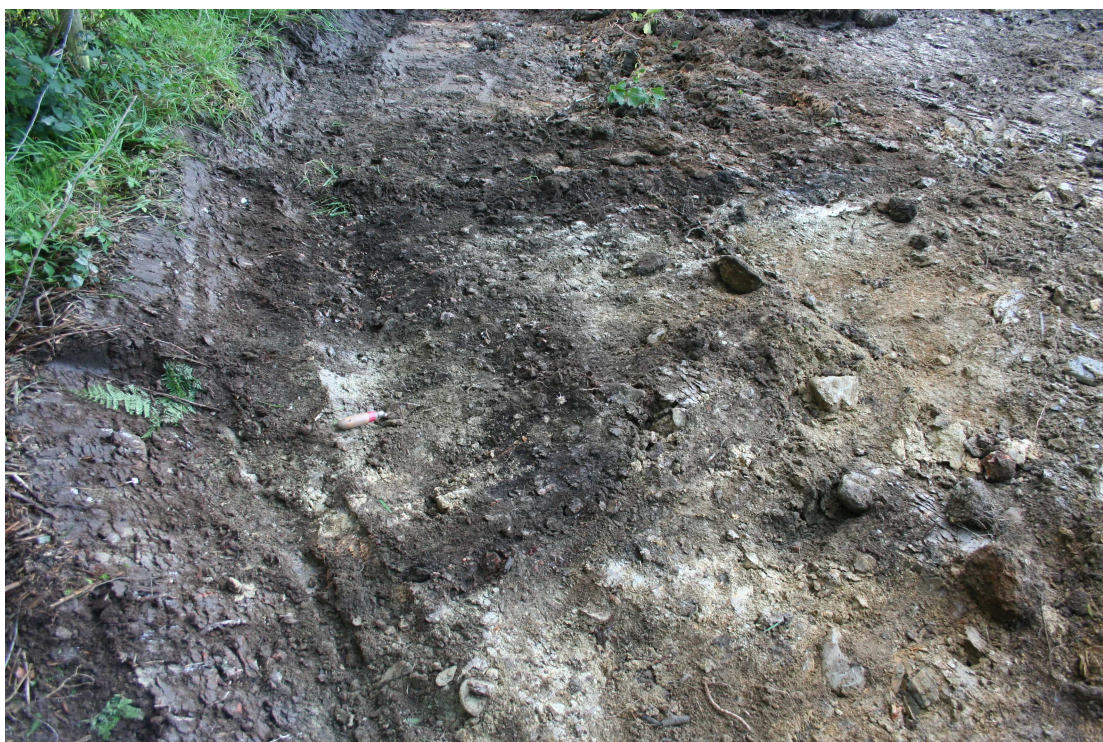
Photo. 12: Zigzag feature with dark fill as observed after machining. View E

After machining, a short zigzag feature or features with a dark soil fill was observed (Photo. 12). However, after further cleaning these became less continuous (Photo. 13) and resolved into a few small shallow features, possibly shallow postholes (107, 109, 111, and 113), cut up to 0.17m into the subsoil, and possibly linked by root disturbances (115, and 117) (Figs. 4 and 5 sections 203-6). It was considered that one of these features (111) could be modern, possibly machine infill from when the trial trenches were dug. Another feature (107) may be a root hole or a cattle poach due to its shape and its grey brown fill (106), whereas the fills of the other two features (109 and 113) had very dark grey brown fills, but differing amounts of fire-cracked stone in them. All of these features were half excavated and soil samples taken from the latter two features (109 and 113) as these appeared to be more archeologically significant (Appendix 4).

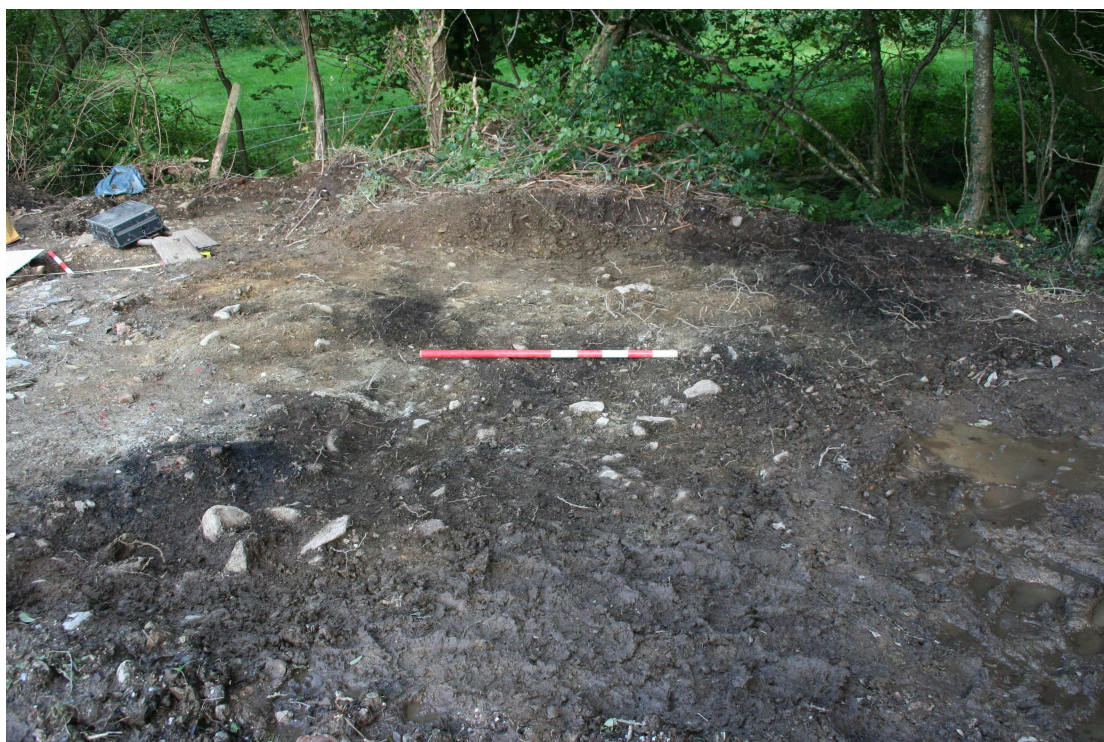
Photo. 13: Area of Zigzag feature after hand cleaning. View N. Scale 1m

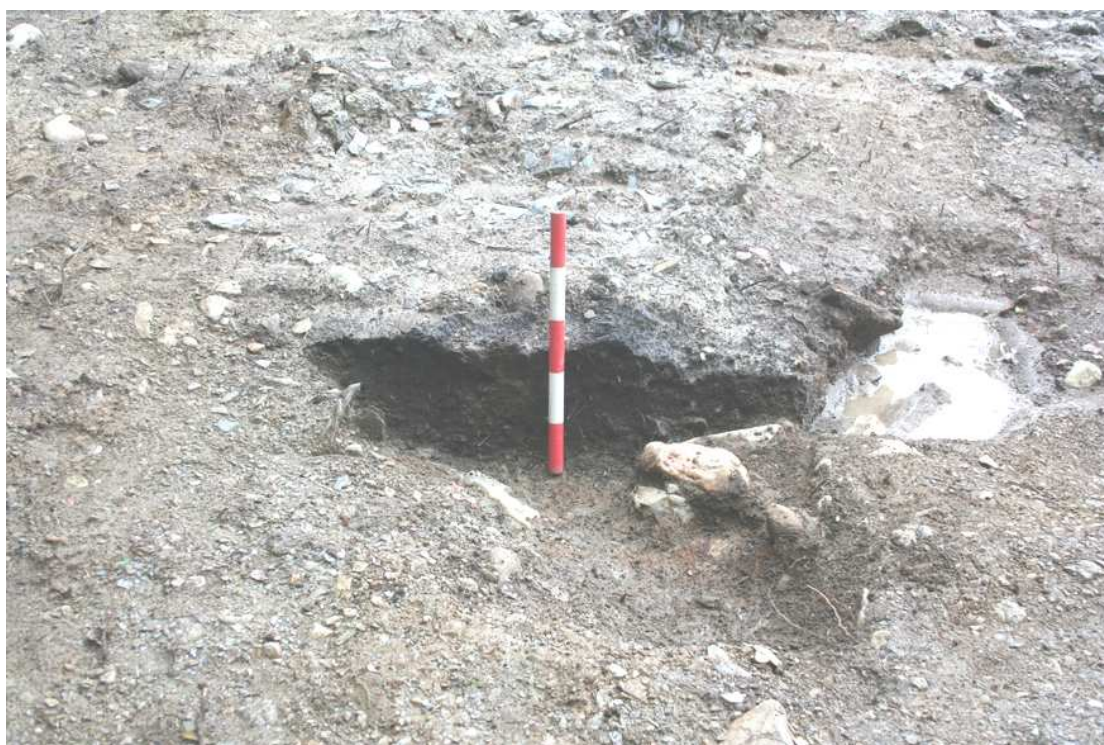
Photo. 14: Pit 102 as sectioned (202). View S. Scale 0.5m

At the north end of the Test Pit there was the remains of a shallow pit (102)(Figure 5 section 202, Photo. 14) with some root-disturbed edges. This pit was dug 0.25m deep into the subsoil, some 0.70m wide and at least 1m long, but as it was truncated by the Test Pit it can only have been a little longer otherwise it would have been noted previously.

The lower fill (103) of this pit (102) was grey silty clay with occasional flecks of charcoal. The upper fill (101) was also root disturbed (Fig. 5 section 202). Where undisturbed, this fill (101) was very dark grey/black silt, however there was far less heat-affected and shattered stone than in the burnt mound and in the material at the edge of this area. Some charcoal fragments were hand collected (Sample 301) from this upper fill (101) and were sent later for identification and
