PRINCE CHARLES QUAY CARDIGAN

ARCHAEOLOGICAL WATCHING BRIEF

RHIF YR ADRODDIAD / REPORT NO. 2006/130
RHIF Y PROSIECT / PROJECT RECORD NO. 62349

PRINCE CHARLES QUAY, CARDIGAN ARCHAEOLOGICAL WATCHING BRIEF

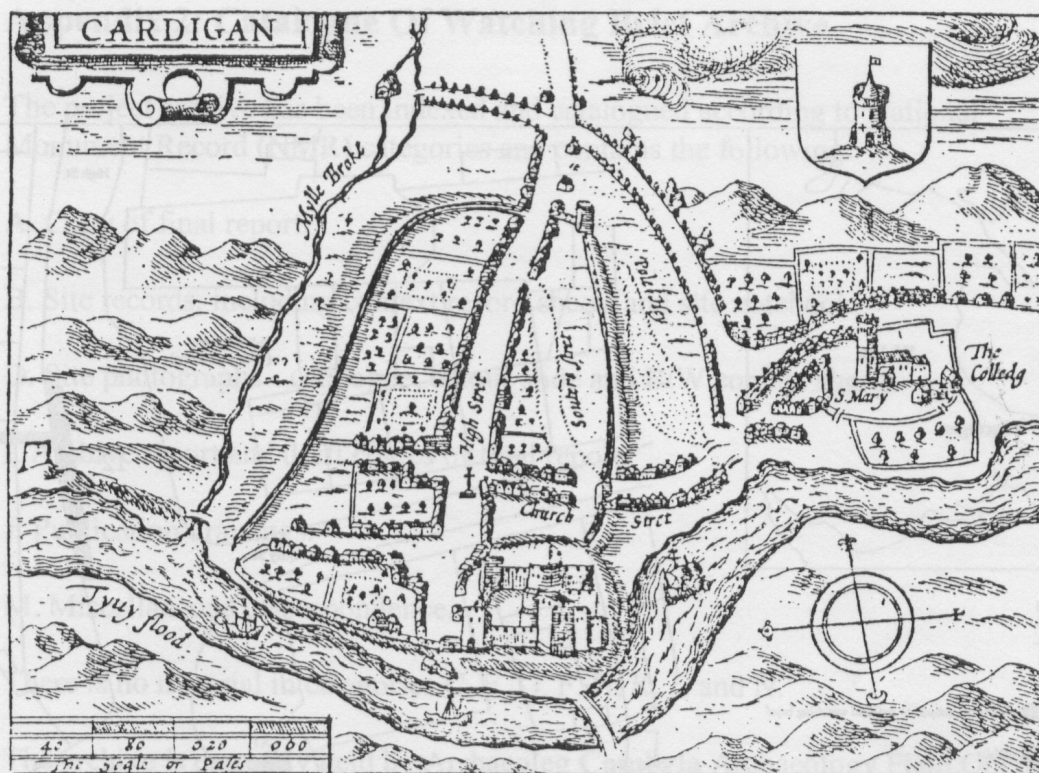
Figure 3: Print of Cardigan Castle 1748

The remains of the former building on the quay may have its origins in the two houses recorded outside of the town wall in c. 1507, becoming the single building illustrated in 1748 (Fig. 3). The illustration of this frontage appears to correlate with that of the left hand side of the remaining ground floor (Photo. 5).

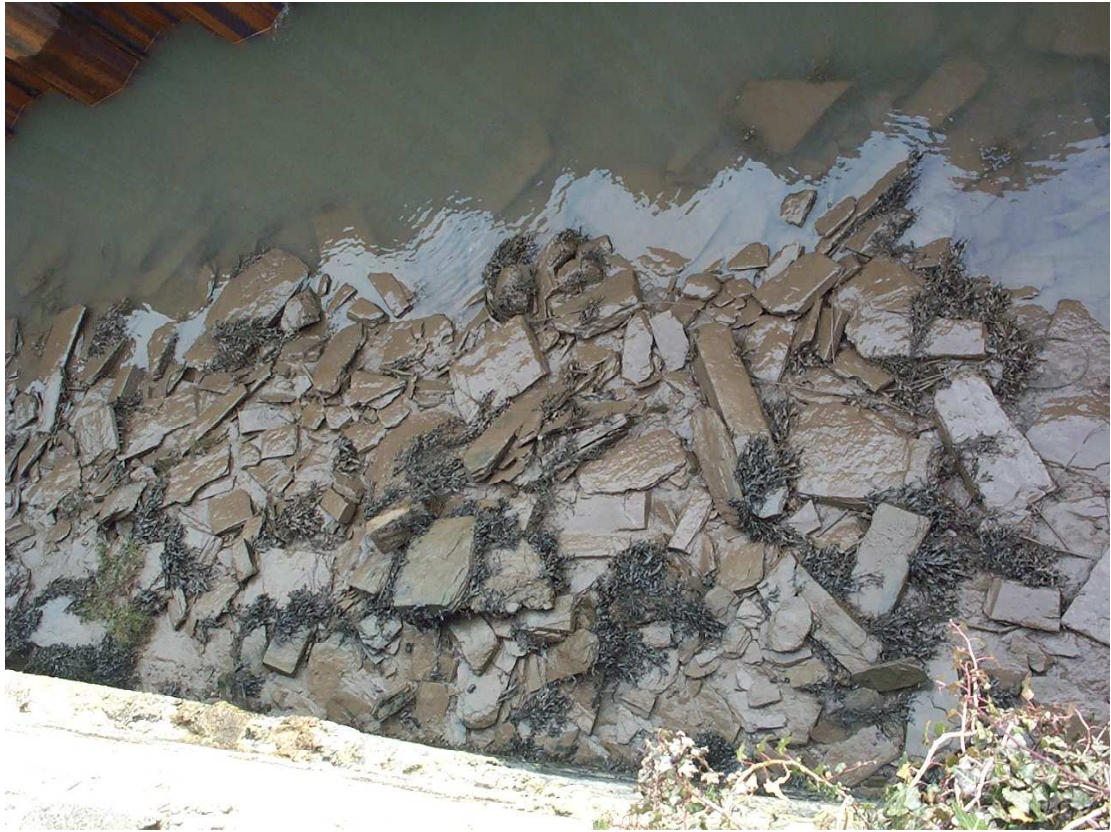
Photo. 1: Slate deposit at base of quay

On the riverbed at the base of the quay wall there was a deposit of large, medium and small-sized fragments of thick slate which appeared to be the result of building demolition debris that had been dumped into the river (Photo 1). Some of the larger slate fragments had large holes drilled into them. The remaining visible deposits consisted of red brick fragments and assorted rubbish along with some *in situ* seaweed and soft grey brown silty mud.

The slates slabs at the bottom of the quay are probably recent and may come from the partial demolition of the former Warehouses on what is now Prince Charles Quay. It is possible that the five timbers recovered (Photo. 3) may also come from this demolition. It cannot be ascertained what the original function of

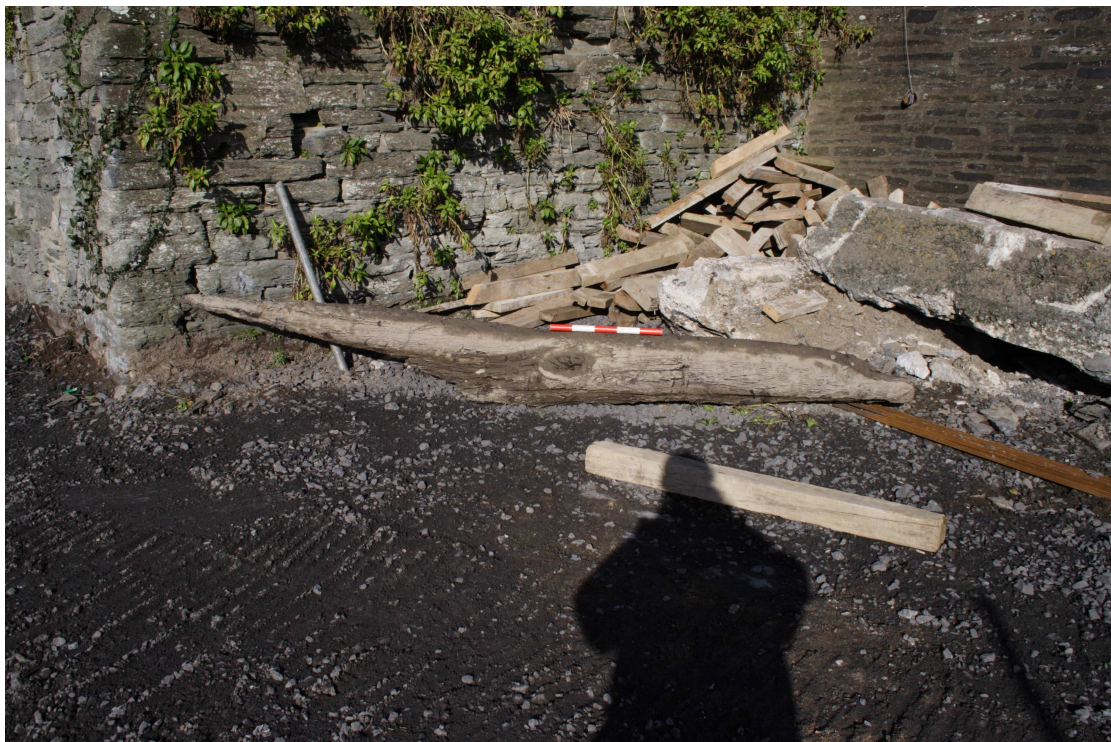
Photo. 2: Probable large pile

A few large pieces of timber were recovered during the works. One large timber was possibly a pile as it appeared to have been deliberately pointed (Photo. 2). Five other pieces were found at the same time and all are probably of oak (Photo. 3).

these timbers might have been. There was no indication of the date of the probable timber pile but it too is likely to be relatively recent.

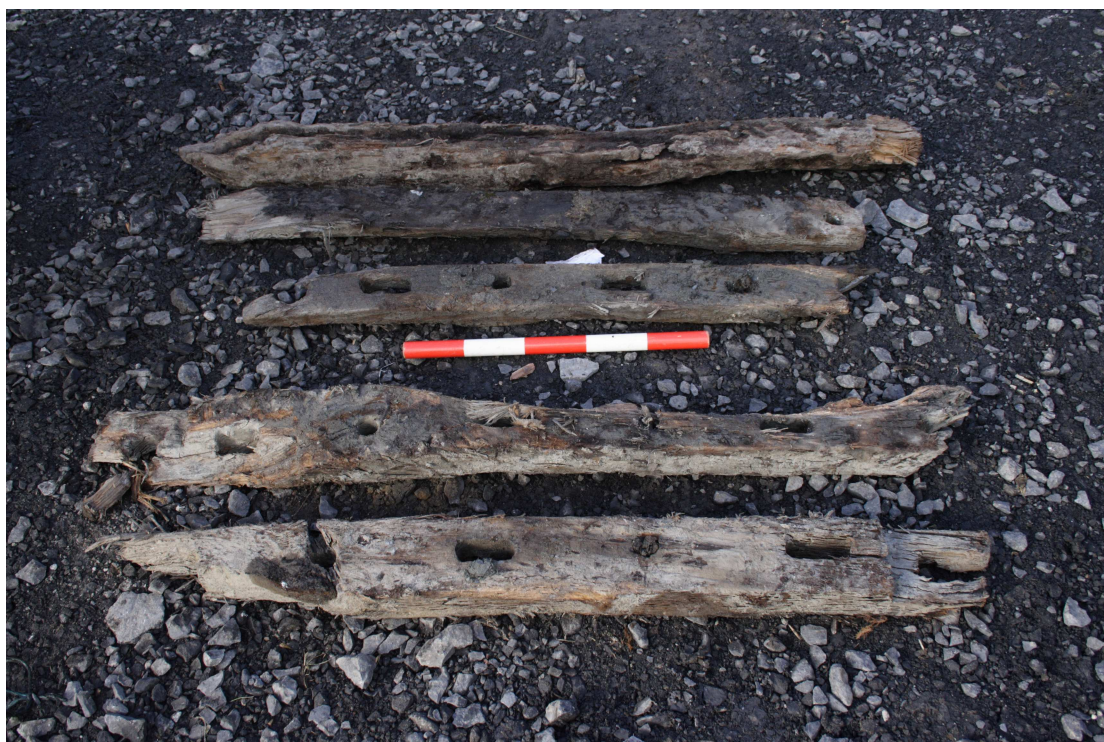
Photo. 3: Timbers with joints. Scale 0.5m

- The furthest away on the photograph had no visible joints (80mm x 140mm x 1400mm).
- The next had one bored hole 30mm dia. near a finished end, the other end appeared to be broken (40mm x 110mm x 1200mm)

- The next had similar features to the two nearest, of alternating bore holes, 30-35mm dia. with sub-rectangular through-mortises, 35mm wide and 85mm long. It was an incomplete length, but may have been very nearly complete as it had larger, c. 50mm holes at each end, one of which was a possible half joint (40mm x 100mm x 1070mm long)

- Same bore holes and mortises as above. One end finished with half joint with 45mm dia. bored hole, the other end was broken. This timber was not square and partly rounded on one corner, possibly natural edge. (70mm x 140mm x 1350mm)

- Similar bore holes and mortises to the two above. Also had one half joint with remains of 45mm dia. bored hole, other end broken. Timber rectangular (65mm x 120mm x 1230mm)

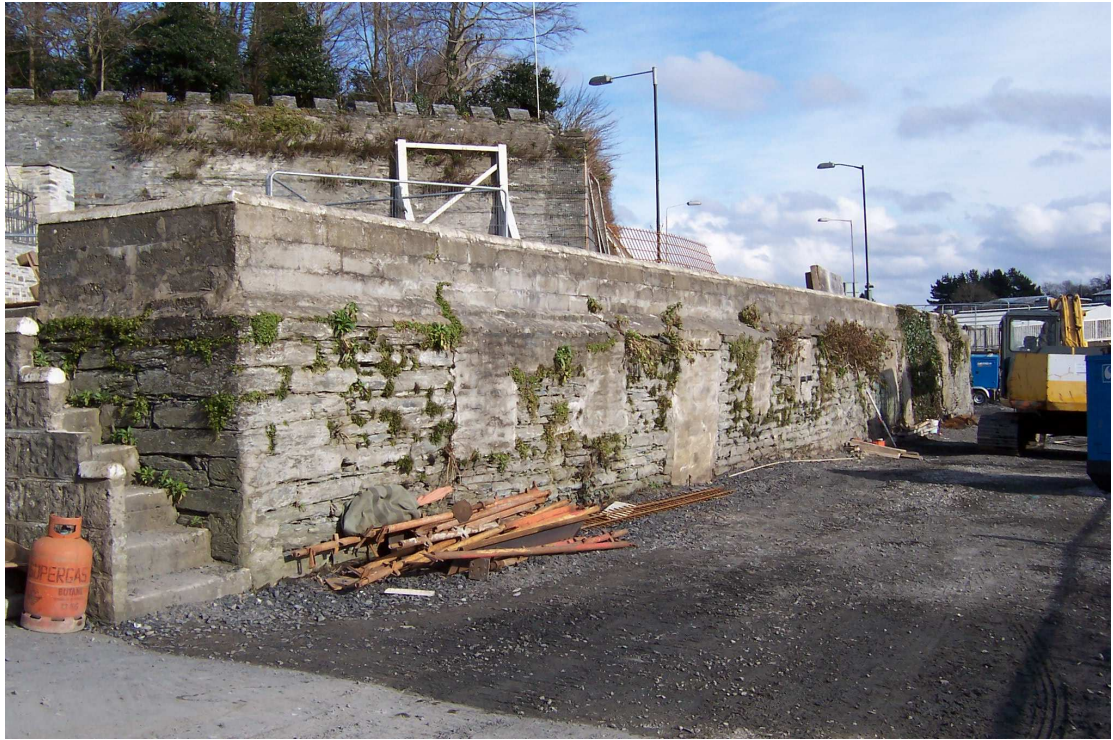
Photo. 5: Remains of building on Prince Charles Quay before demolition. View E

The remains of the building, probably on the quay, were landscaped in the 1960's when the quay gained its present name (Photo. 4) leaving part of the ground floor south elevation showing (Photo. 5). This area was rapidly excavated using a large tracked digger using a toothed bucket and it was not therefore practical to undertake any recording.

Unfortunately the methods being employed on this project were not conducive to recording the past elements of the site. Although there were obvious engineering and costs priorities, it is considered that some of these problems could have been addressed, especially in recording the remains of the former warehouse. These recording problems were exacerbated, to some extent, by Cambria not having a detailed description of the works and not being updated on the work timetable. It is hoped that these discrepancies will be addressed in any similar project. Furthermore the landscaping has removed all above-ground trace of the former warehouse on this site (Figs. 5 and 6). It is therefore hoped that an interpretation panel will be included in the near future to balance the visual loss.

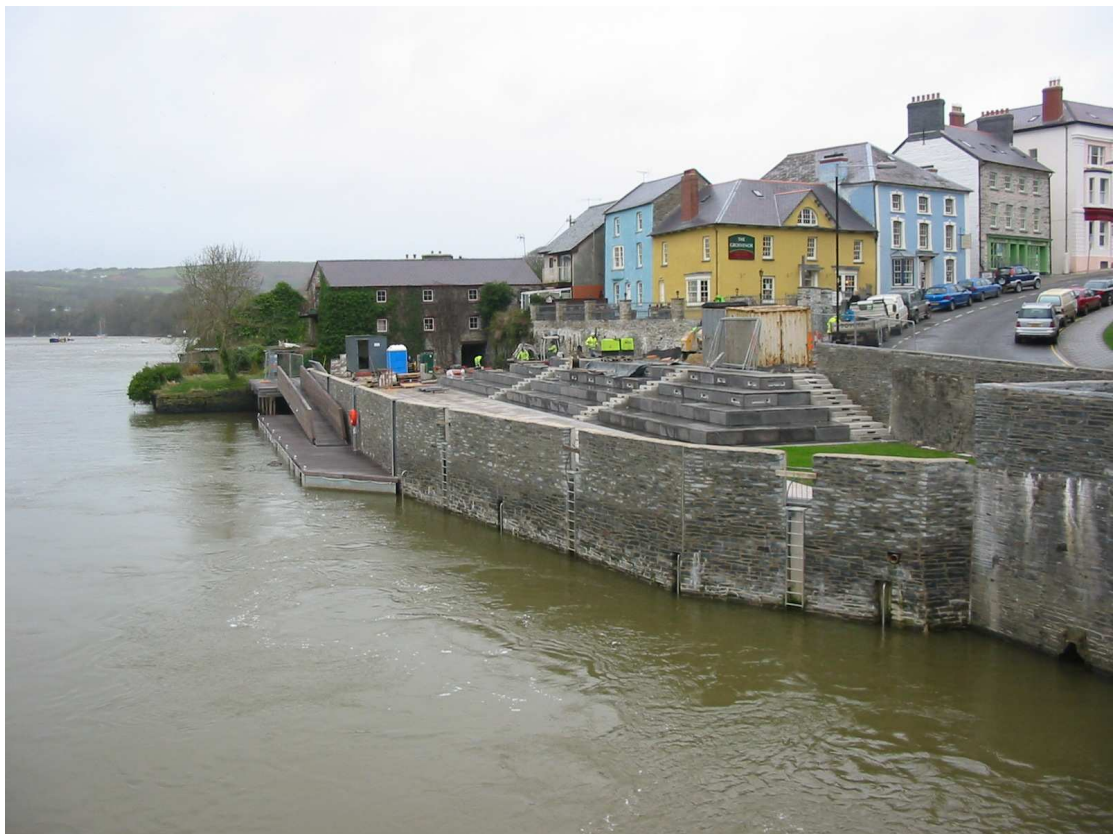
Photo. 6: The newly built quay wall and landscaping. View NW

The work being carried out at Prince Charles Quay aims to strengthen the quay wall in order to allow, amongst other land-based quayside developments, the construction of a pontoon, a new access ladder, and mooring ring.

In order to effect the strengthening of the quay wall a number of steel sheet piles were first to be inserted into the river bed some 3 to 4 metres in front of the existing quay wall and then new foundations and a retaining wall of reinforced concrete constructed and faced with stone. The space between the existing quay structure and the new retaining wall will then be backfilled.
