MORFA BERWIG, LLANELLI ARCHAEOLOGICAL DESK-BASED ASSESSMENT

REPORT NO. 2007/7
PROJECT RECORD No.62550

February 2007

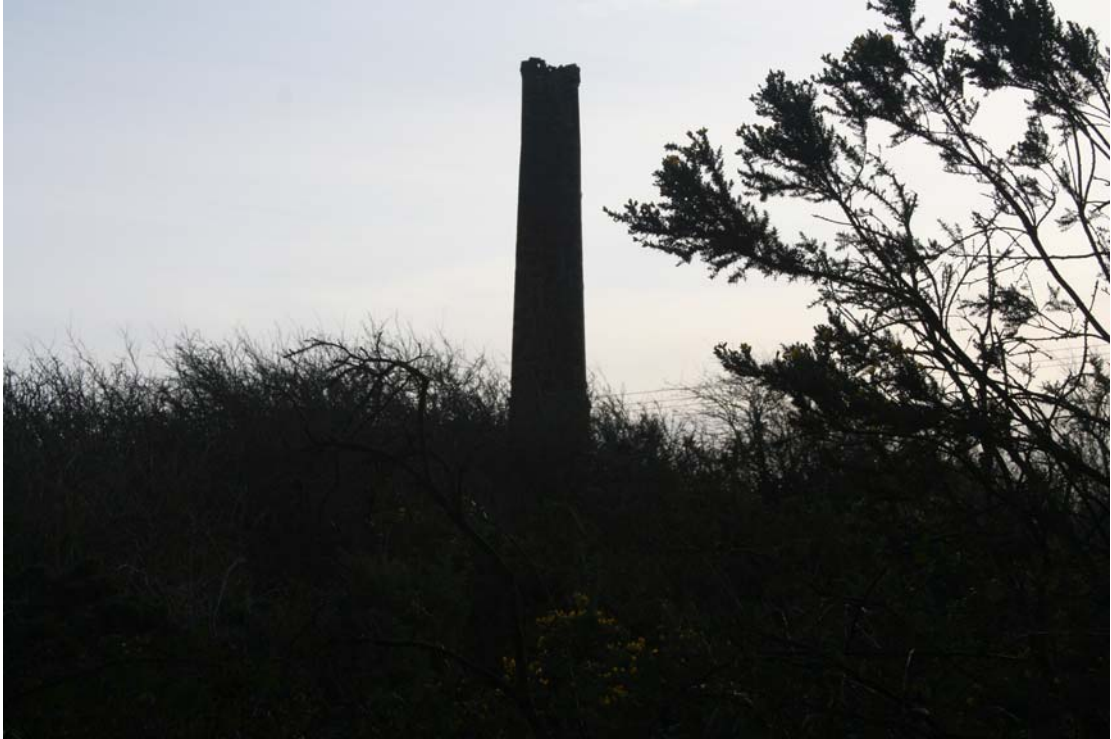
Today only the chimney from the engine house is visible (Plate 1). The site is very overgrown and the chimney itself is vegetation covered. There may be other structures or features, such as shafts and spoil tips, surviving on the site beneath the vegetation, which is currently too dense to allow access to the site.

Plate 1: The overgrown remains of Carnarfon Colliery PRN 4657.

The remains of Carnarfon Colliery would be more difficult to reintegrate because of the significant engineering and health and safety implications of clearing and consolidating standing buildings. A programme of archaeological recording might also be required if the colliery site was cleared to record the surviving buildings, including the chimney, and any other features, such as spoil tips or shafts that may survive below the vegetation cover. This would also allow for on-site interpretation of the history and development of the area, possibly through the installation of information panels.

The other option for the colliery site is the 'do nothing option', although this excludes the, not inconsiderable, costs of clearance, recording and consolidation, it inevitably means that the surviving structures will continue to deteriorate and ultimately collapse. As well as the deterioration of the remains, this option carries a higher risk of personal injury to anyone that gains access to the colliery site.

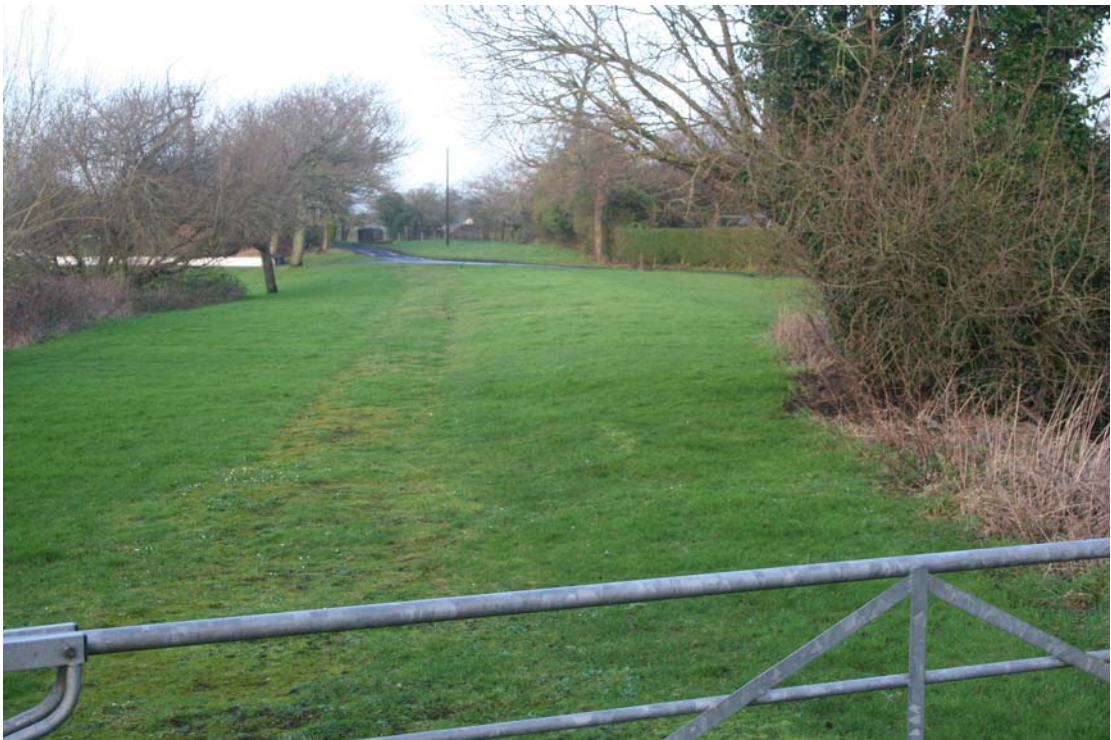
The tramway survives as a low very overgrown earthwork. Only the northwest end is clear of vegetation where it survives as a low grass bank (Plate 2).

Plate 2: the grassed earthwork remains of the northwest end of the former Carnarfon Colliery tramway PRN 31637.

Both flood defence banks (PRNs 31652 and 31658) and the tramway (PRN 31637) could be cleared of some of their vegetation to make them more visible and to reintegrate them into the present landscape. A programme of archaeological monitoring and recording might be required for those features that were cleared.

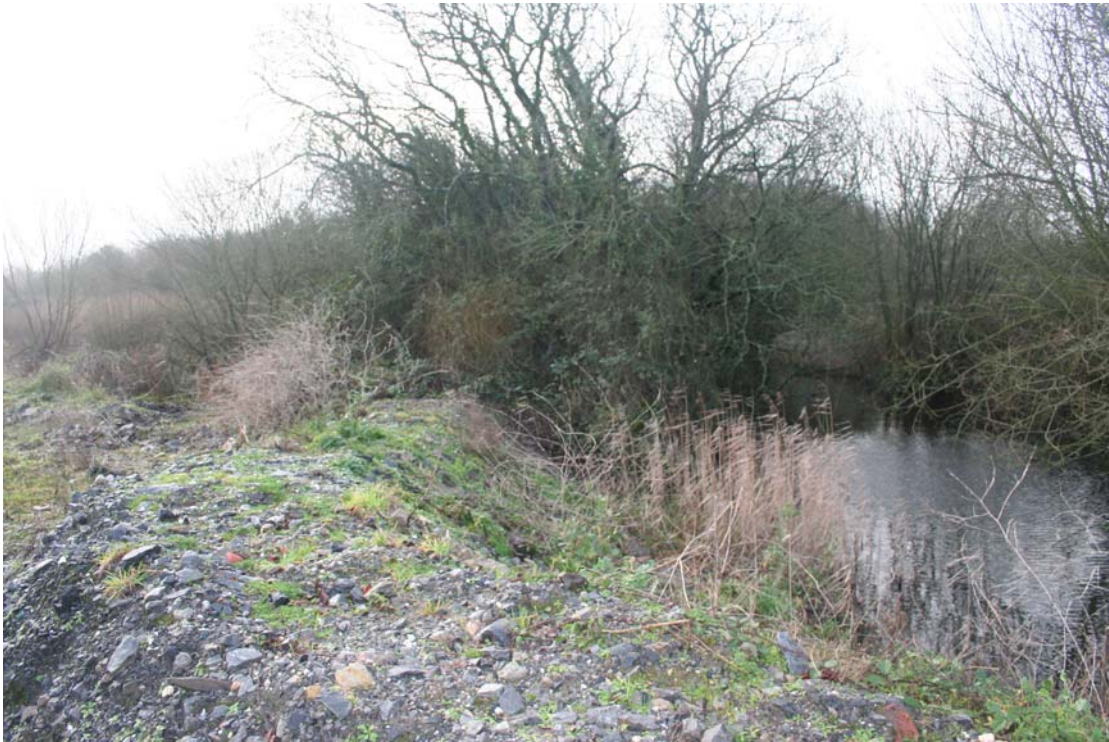
The bank survives in very degraded form. It has been partially destroyed by modern clearance works that has removed the central section of the bank resulting in two short lengths of bank. Where it survives on the south side of the site it is a low stone and earth bank, which – although virtually covered by vegetation – is in fairly good condition (Plate 3). The north section is less well preserved.

A modern flood defence bank constructed from industrial waste and demolition debris now extends northwest from the surviving southern section of the original bank.

Plate 3: The overgrown flood defence bank PRN 31652 with the new defence bank in the foreground.

The standing remains are in fairly discrete areas of the site and could be avoided by intrusive processes that would directly affect them. Flood defence bank PRN 31652 still protects part of the site from flooding so presumably could be left intact and not replaced with a modern bank.

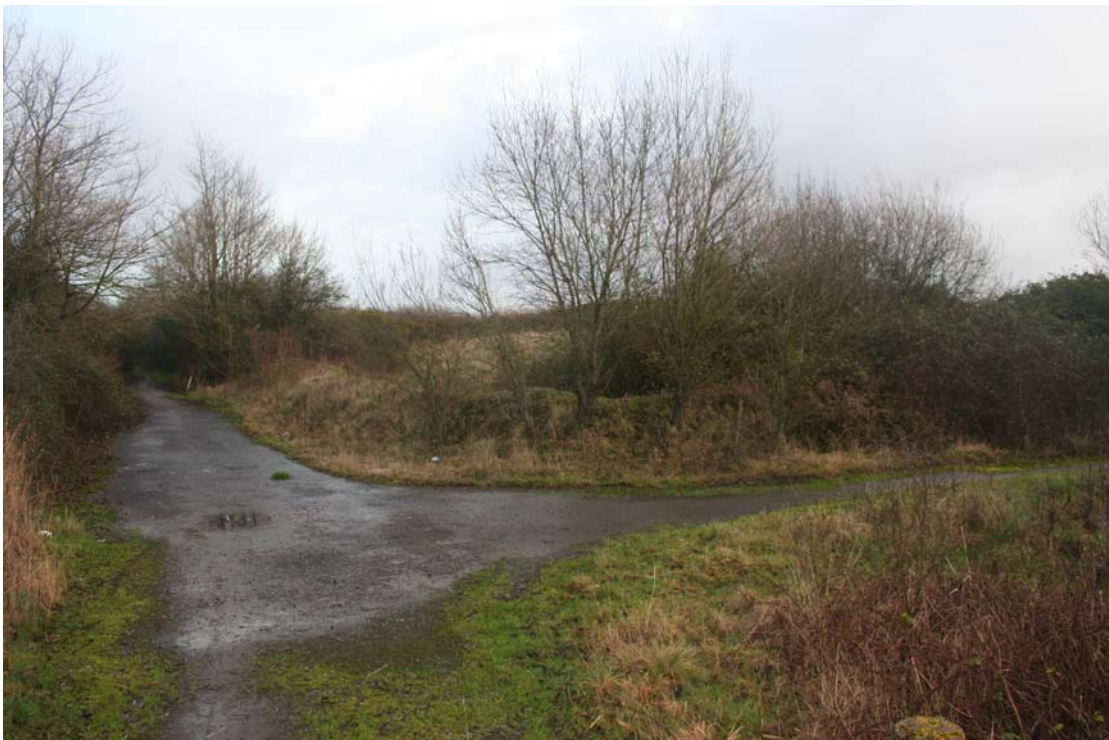
This area has been heavily disturbed and there are no above ground remains of this building (Plate 4). It is possible that some below ground remains survive.

Plate 4: The site of the former building PRN 31653 that was shown on the Ordnance Survey 1st and 2nd edition maps of the area.

The site of demolished building PRN 31653 is also vulnerable to groundworks and any below ground remains that may survive could be affected by construction works.
