BETTER WOODLANDS FOR WALES MANAGEMENT PLAN HERITAGE MANAGEMENT INFORMATION (WHE2)

Prepared for: Ty Rhyg Coed Preseli

BWW Reference No 2567

Project Record No. 62604

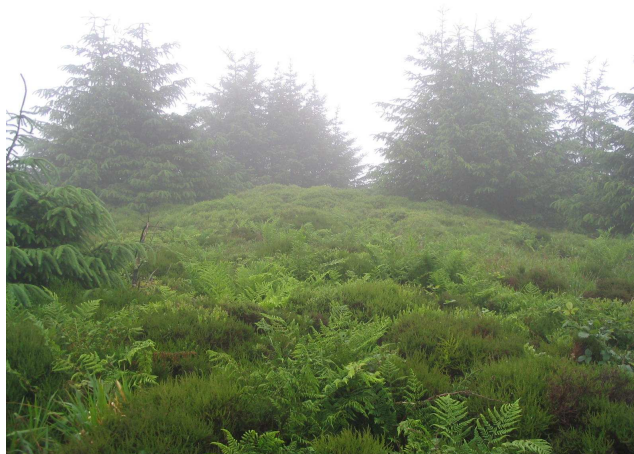
PRN 1583 CNWC II Bronze Age round barrow SN0856930288

Scheduled Ancient Monument. This site is a Scheduled Ancient Monument. A round barrow, circa 25m in diameter and 1.8m high. It has previously been dug into, the hole is 0.6m deep.

The vegetation on and around the barrow is predominantly heather, grass and bilberry, with some natural regeneration of sitka spruce. Sitka growth is beginning to mask the cairns profile, whilst being potentially damaging to buried archaeological remains through root action.

The round barrow, seen from the north-east.

The condition of the barrow would be improved by removing trees from within the scheduled area. Tree roots damage underground archaeological features. The presence of trees/ scrub/ wind-blow obscures the monuments and increases the likelihood of damage to the sites during timber extraction operations, track construction etc.

The sitka growing on the mound should be felled and removed. Work should be undertaken when conditions are dry to minimise damage to the ground surface. Stumps should be left to rot *in situ*. Felled trees should be removed from the scheduled area then dispersed. An area of 20m around the cairn should be kept clear of trees; regenerating trees and scrub should be cut, removed from the scheduled area and then dispersed; replanting should avoid this area.

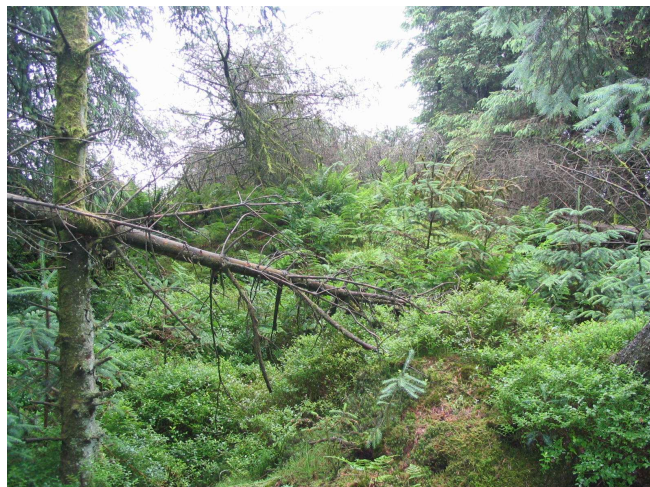
PRN 1584 CNWC III

Scheduled Ancient Monument. This site is a Scheduled Ancient Monument. A round barrow, circa 25m in diameter and 1.8m high. Fallen trees lie across the cairn which has some sitka regeneration on it. Deep forest ploughing has disturbed the ground surface to within 5m of the base of the cairn in the past.

The round barrow is obscured by scrub and forest debris. View from south.

The wind blown trees should be cut and removed. Work should be undertaken when conditions are dry to minimise damage to the ground surface. Stumps should be left to rot *in situ*. An area of 20m around the cairn should be kept clear of trees; regenerating scrub and trees should be cut, removed from the scheduled area and then dispersed; replanting should avoid this area.

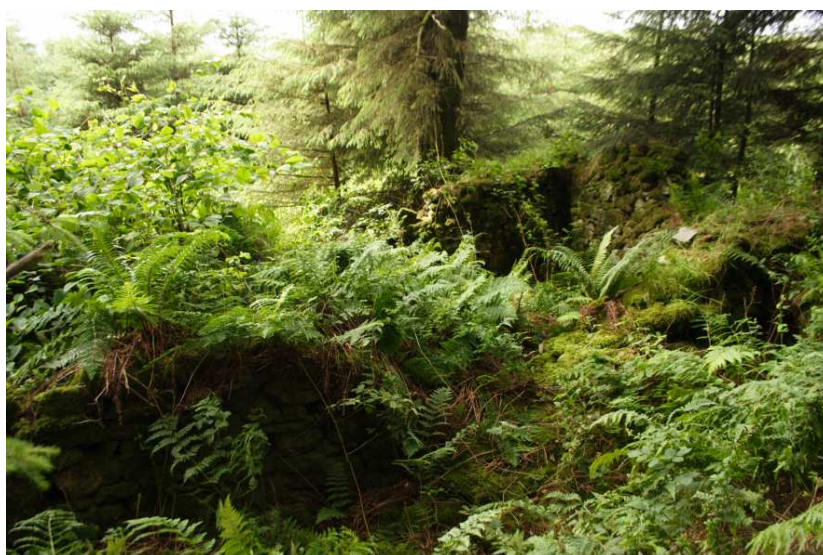
PRN 30267 CWM-SLADE**Post Medieval farmstead****SN04362989**

Abandoned farmstead in a conifer plantation. The buildings survive in a very ruinous condition, situated on a made up terrace cut into the natural slope. They are now largely obscured by regeneration scrub and it is difficult to ascribe function to either with any confidence. A series of redundant stony banks marking old fields and enclosures are visible in forestry to the south, where dense tree cover has suppressed vegetation growth.

Dense regeneration growth now obscures the ruinous farmstead. View north towards the eastern building.

The natural regeneration growth at Cwm-slade is potentially damaging to standing and buried archaeological remains whilst also having a detrimental effect on the visibility of the farmstead. Management should consider how best to protect the site in the long term whilst enhancing its visibility.

- Monitor mature trees growing on or close to the buildings. Consider felling mature trees which are at risk of damaging standing or buried archaeological remains by windthrow.
- Cut or spray back young trees on the standing remains leaving the roots in situ. Consider spot treating to prevent re-growth.

- The long term aim should be to establish a continuous broadleaved canopy over the farmstead site in order to shade out the forest floor and suppress natural regeneration.

Tree planting should not take place within 5m of any archaeological remains (ie. buildings, boundary banks). A map showing sensitive areas has been provided to the agent planner.

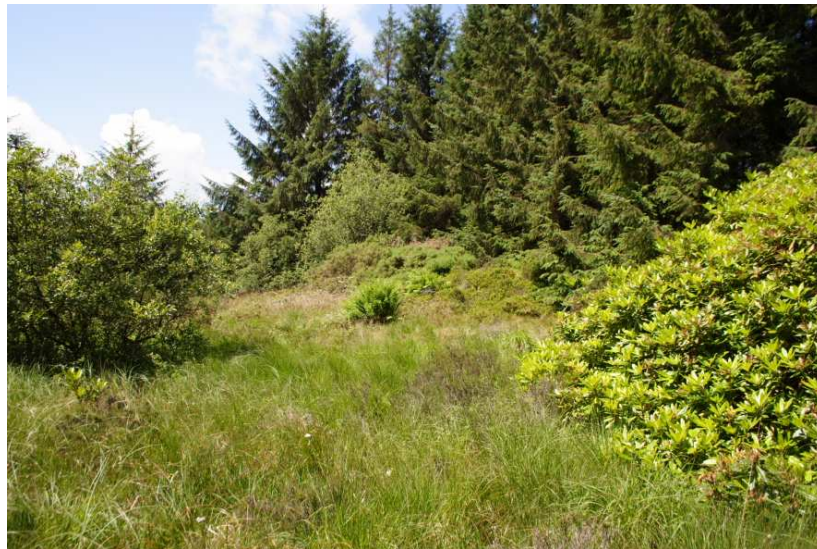
PRN 62616

This site is very difficult to locate. It is situated on the edge of a small forest clearing and is now almost completely obscured by trees and vegetation. The long hut measures approximately 5m north-east x 9m south-west with drystone walls approximately 0.6m wide standing up to 1 metre. The original entrance is hard to identify but is probably central on the north-west side.

The long hut is situated on a natural knoll which overlooks an area of low lying, boggy ground. The banks of an enclosure boundary can be seen running to the north-west but are difficult to follow due to extremely dense vegetation.

The long hut, seen from the east.

The natural regeneration is potentially damaging to standing and buried archaeological remains whilst also having a detrimental effect on the visibility of the long hut. Management should consider how best to protect the site in the long term whilst enhancing visibility.

- The long term aim should be to establish a continuous broadleaved canopy over the site in order to shade out the forest floor and suppress natural regeneration.

Tree planting should not take place within 5m of the long hut. A map showing the sensitive area has been provided to the agent planner.

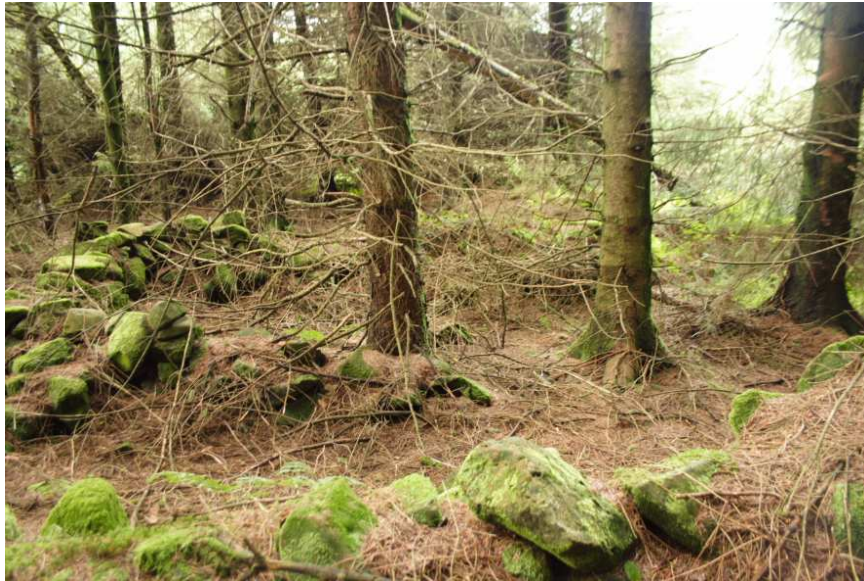
PRN 62620

The farmstead includes the ruinous remains of two buildings, situated facing opposite each other. The largest, probably the dwelling is approximately 10m x 6m with walls standing to approximately 1m high. Parallel opposite is a second range, consisting of two adjacent units measuring approximately 6m x 4m and 5m x 3m but more fragmentary in nature and difficult to interpret with any confidence. Surviving banks surrounding the complex indicate a system of enclosures and paddocks.

The farmstead now lies within a forestry plantation. The forest floor is relatively clear where the dense trees have shaded out scrub growth.

Facing south towards one of the ruinous farmstead buildings.

The farmstead is currently in a stable condition with no obvious management threats identified.

- Beneficial management would see this site maintained under a continuous canopy in order to suppress natural regeneration.
- Consider felling derelict trees on the structure which pose a threat to standing archaeological remains through falling limbs or root bowl damage.
