HISTORICAL ANALYSIS OF THE EAST WING, INNER COURTYARD, NEWTON HOUSE

Prepared by Cambria Archaeology
For the National Trust

REPORT NO. 2007/20
PROJECT RECORD NO. 62759

March 2007

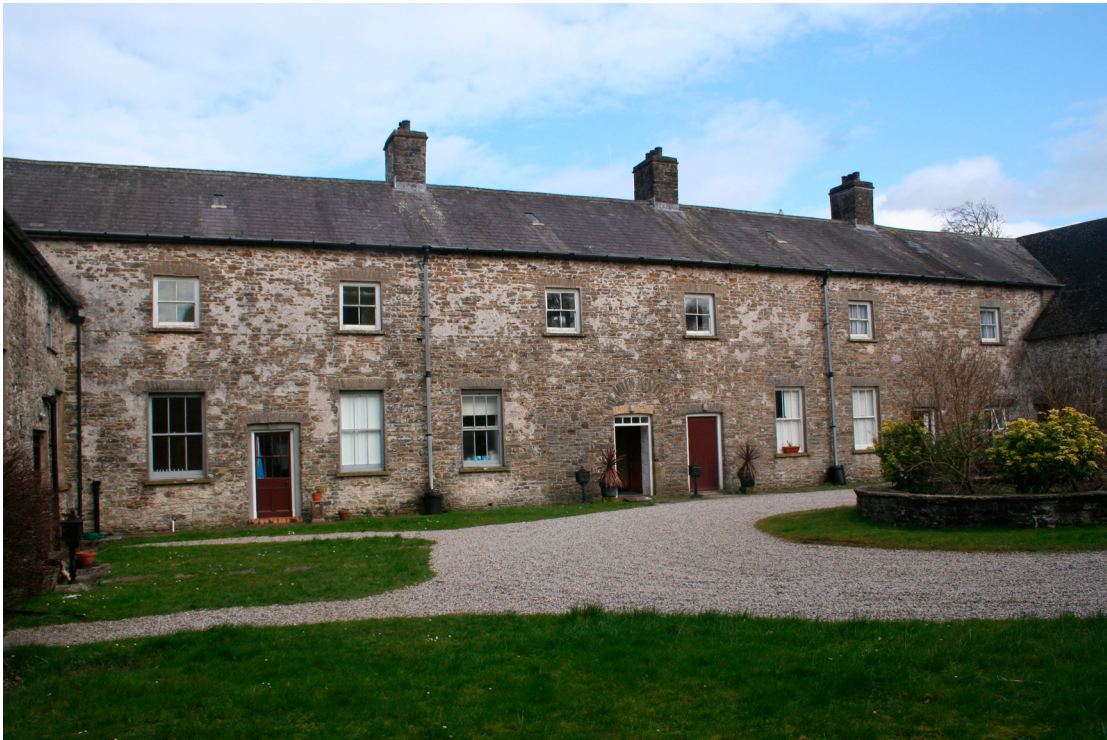
West Facing Elevation (Plate 1)

The west facing elevation of the East Wing of the Inner Courtyard is constructed from roughly squared rubble stone almost brought to courses. Evidence of a

roughcast lime render survives in patches. Each of the window openings are constructed with flat stone arches and sawn stone sills and appear to be integral to the construction of this elevation, no evidence has been observed of window enlargement or other modification.

The openings in this elevation demonstrate an almost symmetrical arrangement. In the centre of the ground floor is a high stone arch forming a through passageway to the exterior of the courtyard. This entrance is now partially blocked with stone and a doorway leading into a central vestibule. The late insertion of this blocking is indicated by the yellow brick arch forming the doorhead.

To the north of this central passage is a former doorway now blocked with stone, one of two which flank the central arch, its pair still surviving to the south of the former passage.

The only other modification noted on this elevation is the ground floor window at the north end which was formerly a doorway, now partially blocked. This is the only window which does not conform in this elevation and is of later twentieth century origin.

Otherwise the windows in this elevation follow the same pattern; the ground floor windows are all six paned (three over three) sliding sash windows with horns, above in the first floor, the windows are four paned (two over two) sliding sash also with horns.

Plate 1: The west elevation of the East Wing of the Inner Courtyard

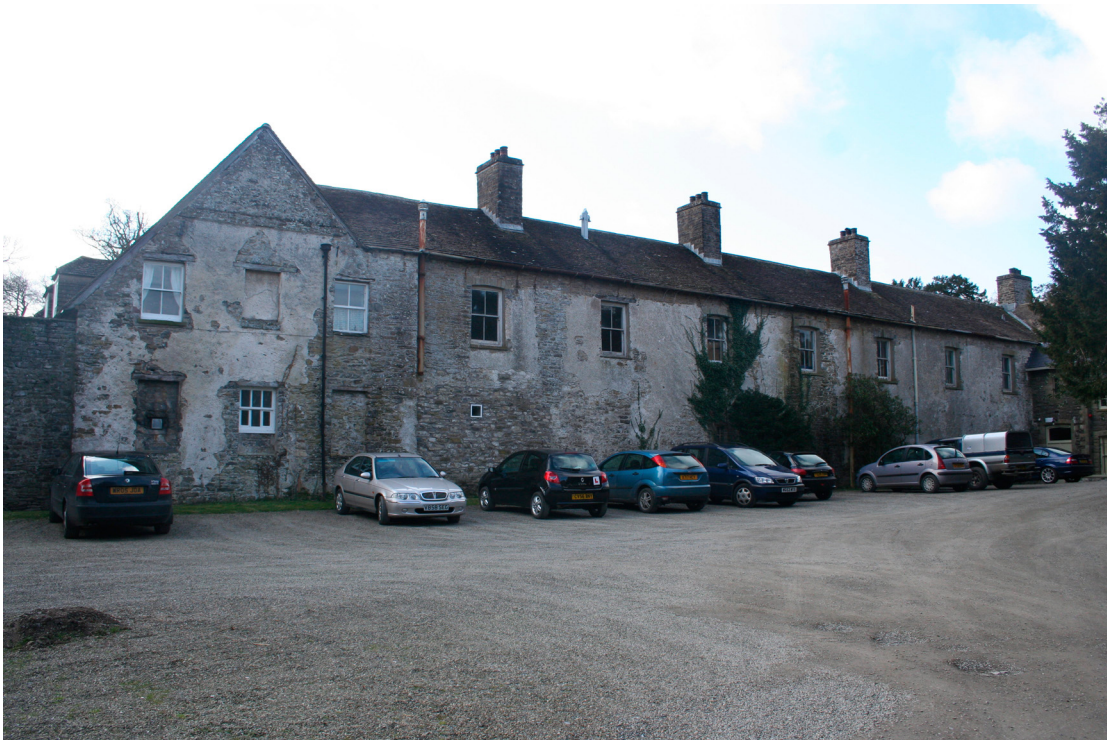
East Facing Elevation (Plate 2)

The east facing elevation of the East Wing of the Inner Courtyard is also constructed out of rubble stone, however less of the masonry fabric is visible due to a greater proportion of this elevation being obscured by roughcast lime render and ivy.

The central passage opening is visible and fully blocked with stone.

To the north of the elevation is a single low blocked doorway (probably an insertion) with a flat stone arch. A twentieth century window has been inserted into the fabric to the left of this doorway.

The dressings of the window openings on this elevation are different to those of the west facing elevation; the stone arches include more substantial voussoirs and there maybe some suggestion that the openings have been modified - one has a timber lintel (First Floor room 7). Many of the window jambs are obscured by vegetation and render so observation is difficult and the evidence is inconclusive at this stage.

Plate 2: The east elevation of the East Wing of the Inner Courtyard

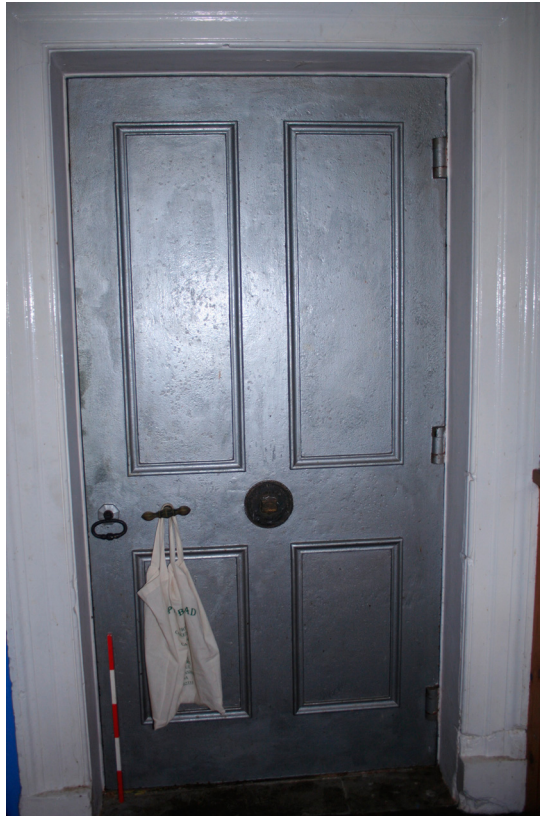
On the east side of the room, is a large metal door set within a masonry architrave (see drawing 18; Plate 3), which leads to the strong room. This is a stone vaulted room with quarry tile floor, one small barred opening in the external wall and an arched ceiling. The door is an immense metal door, four panelled with the crest 'IMPREGNABLE FIRE-PROOF CHEST' and 'Frederic Whitfields Patent Lock' embellished with banners 'Safe Bind Safe Find' above and 'Whitfield Maker Birmingham' below. (Agents for Whitfield's fire proof safes are recorded in Slaters' Commercial Directory, 1858-1859 for Merthyr Tydfil). The doorway is constructed with crisp ashlar jambs with a plain chamfer and pyramidal chamfer stop. It is curious that this room is omitted entirely from the

pre 1896 plan, when the evidence strongly suggests that it is an integral part of the construction of the building. It seems likely that this room, which was evidently an important repository, was purposely omitted from the plan for security reasons.

Plate 3: The metal door and architrave to the strong room

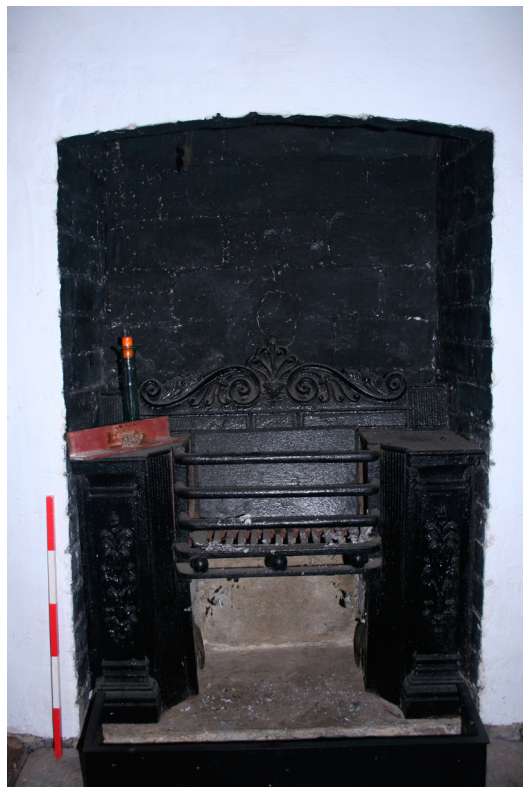
Room 6 is accessed by steps which return the floor level in this room to ground level. There is no doorway, but a panel has been removed from what is assumed, due to its thickness, to be a timber and brick partition. In the east wall of this room is a small decorated hob firegrate with a decorated back, probably of early nineteenth century date, set into the thickness of the wall (Plate 4). This room is recorded on the pre 1896 plan as the **Saddle** room.

Plate 4: An ornate hobgrate in Ground Floor room 6

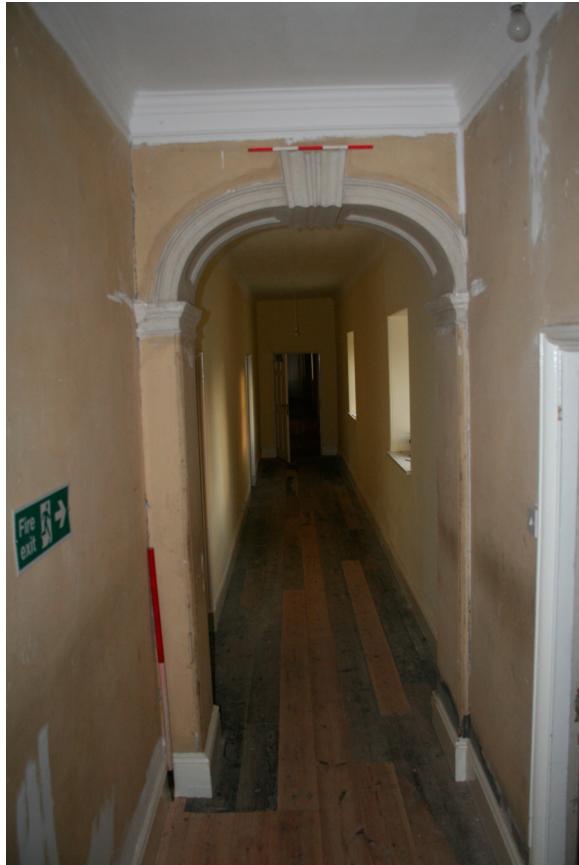
Passageway (Plate 5)

The passageway runs from the connecting corridor to Newton House, through the former gable wall of the north wing, marked by a decorative plaster arch (Arch A). As the passage turns the corner into the East Wing, it is punctuated by four more arches along the length of the corridor (Arches B to E). Further examination of the corridor has shown that a further two more arches were constructed in the passageway and that these have been removed. The scars relating to these arches lie either side of Arch C, in line with the party wall between rooms 3 / 4 and the party wall between rooms 5 / 6. The present passage opening adjacent to room 4 is clearly a later twentieth century insertion.

Plate 5: Looking south down the passageway at Arch C

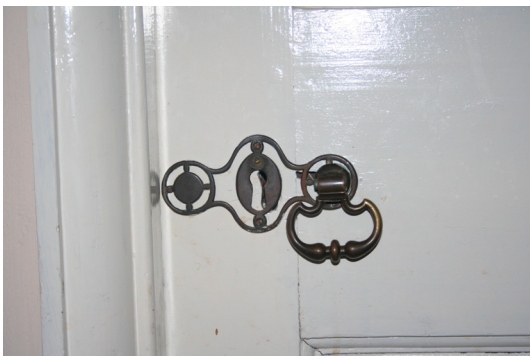
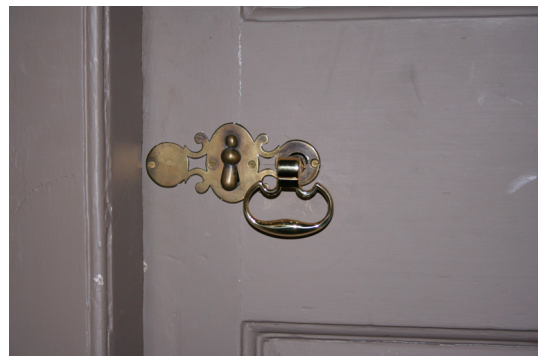
The doors on the first floor are six panelled, raised and fielded type. All but one (Room 8), have looped door handles, similar to those seen in the upper floors of Newton House (Plate 6 & 7).

Plate 6: East Wing door handle

Plate 7: Newton House door handle

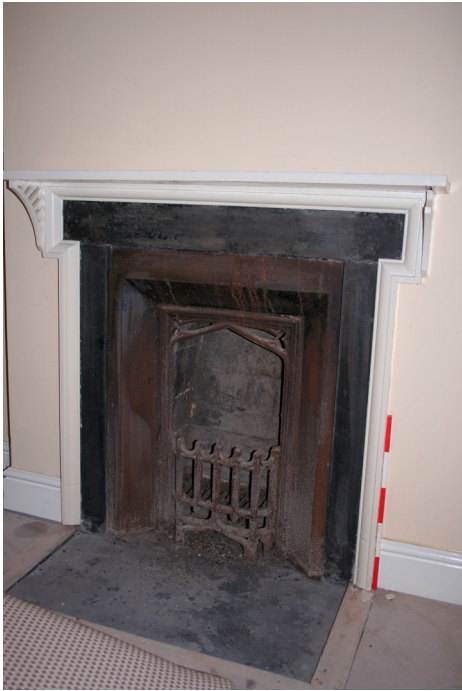
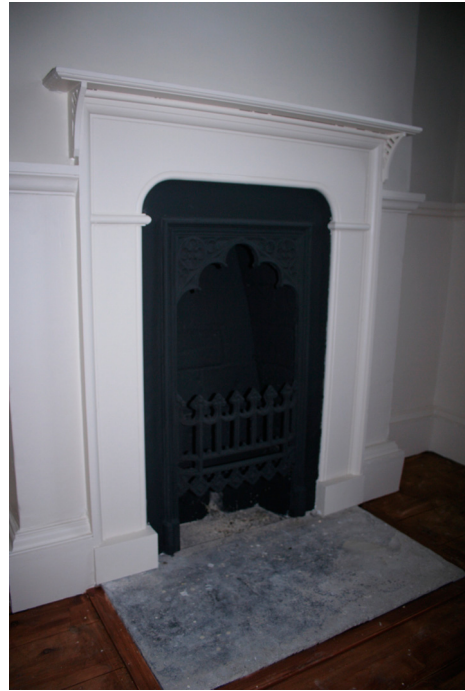
The fireplaces within the upper floor, with the exception of room 7, conform to a Gothick type with trefoil detailing. There is a slight variation in the surrounds and mantelshelves. The brackets to the mantelshelf are usually perforated with diagonal slots. These distinctive firegrates are strikingly similar to those found in the turret rooms of Newton House (Plates 8 & 9).

Plate 8: Firegrate in the East Wing

Plate 9: Firegrate in Newton House turret room

There are a number of points of comparison with Newton house itself; the Gothick fireplaces with quatrefoil details found in the turret rooms of Newton House are ostensibly from the same pattern book as those which predominate the upper floor of the East Wing. The turret rooms and the fittings therein are attributed to Penson's refurbishments of 1856. The doors and door furniture are also very closely related, indicating that Penson had a hand in fitting out the East Wing.

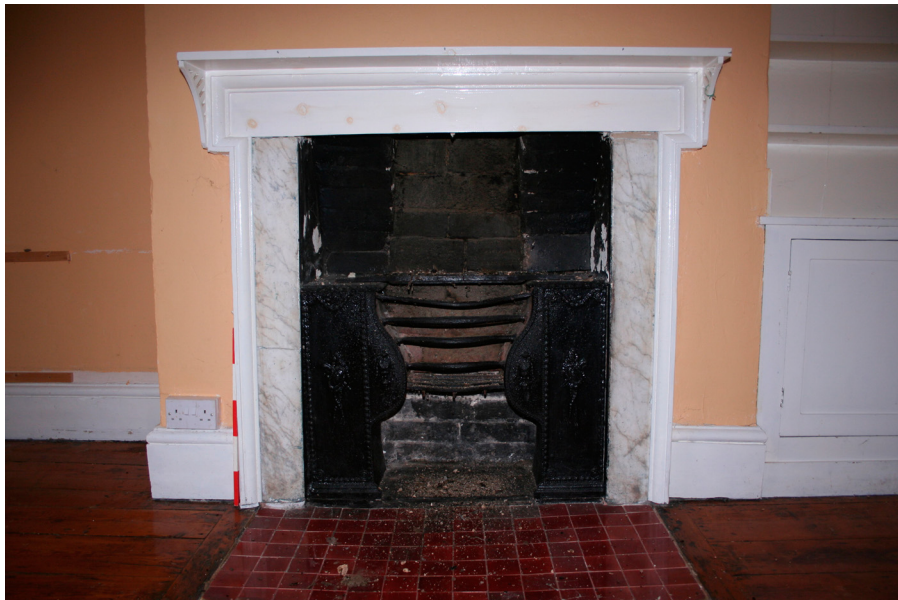
The same cornice profile as seen in the passageway extends around room 7 (type 01). The fireplace is significantly different from the others in that the fireplace is of a late Georgian/early Victorian style of a waisted hobgrate with decorative motifs and garlands to either side. The surround and mantelshelf are similar however to those seen elsewhere in the upper floors (Plate 10). In the centre of the ceiling is an ornate metal ventilation grille.

Plate 10: A hobgrate fireplace in First Floor room 7.
