HISTORIC TOWN SURVEYS OF CARDIGAN AND TREGARON

PART 2 CARDIGAN TOWN

Paratowyd gan Archaeoleg Cambria
Ar gyfer Cadw ac Cyngor Sir
Ceredigion
Prepared by Cambria Archaeology
For Cadw and Ceredigion County
Council

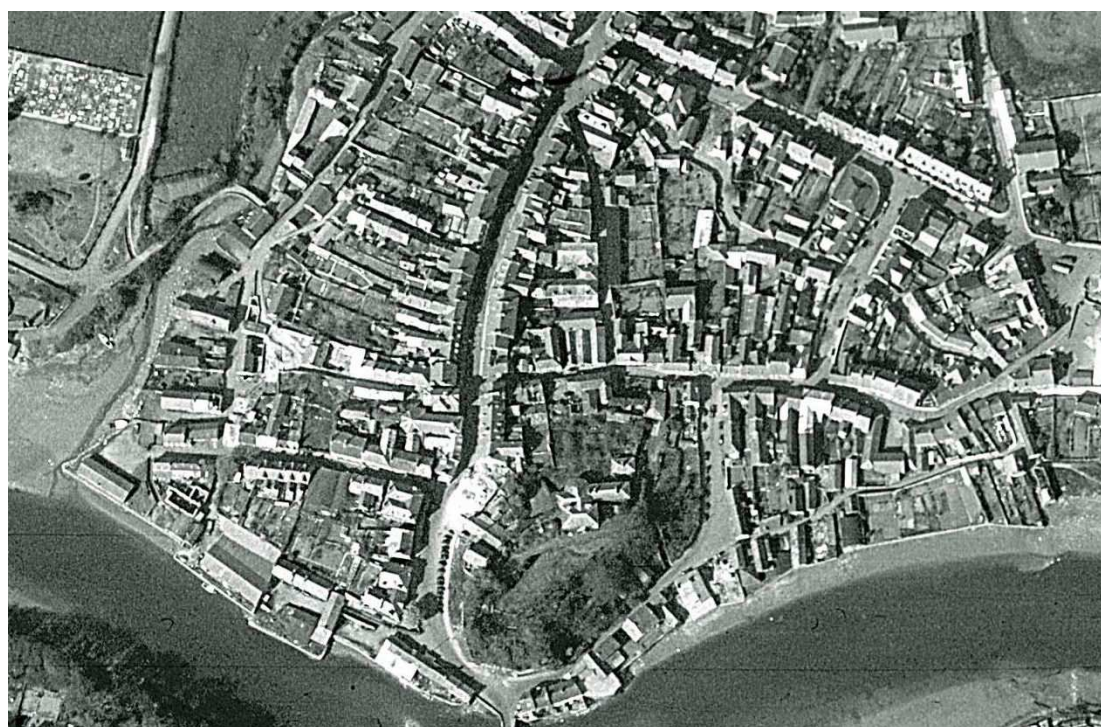
Figure 1. 1946 Vertical RAF Aerial Photograph showing layout of Cardigan's historic core

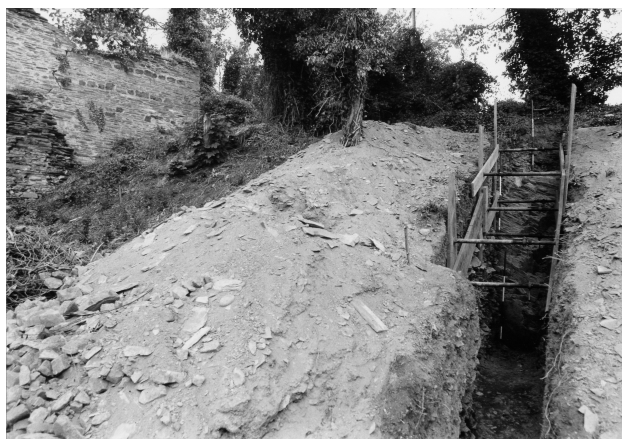
Figure 11a. Photograph of trench from 1984 excavations

Within the castle small-scale excavations were undertaken by Cambria Archaeology (Murphy & O'Mahoney 1985) primarily to assess the depth and condition of archaeological deposits as well as attempt to gain a better understanding of the castle layout. Sixteen small trenches were opened up revealing the depth of archaeological deposits within the castle and positively identifying some features such as the large ditch around the northern edge of the site.

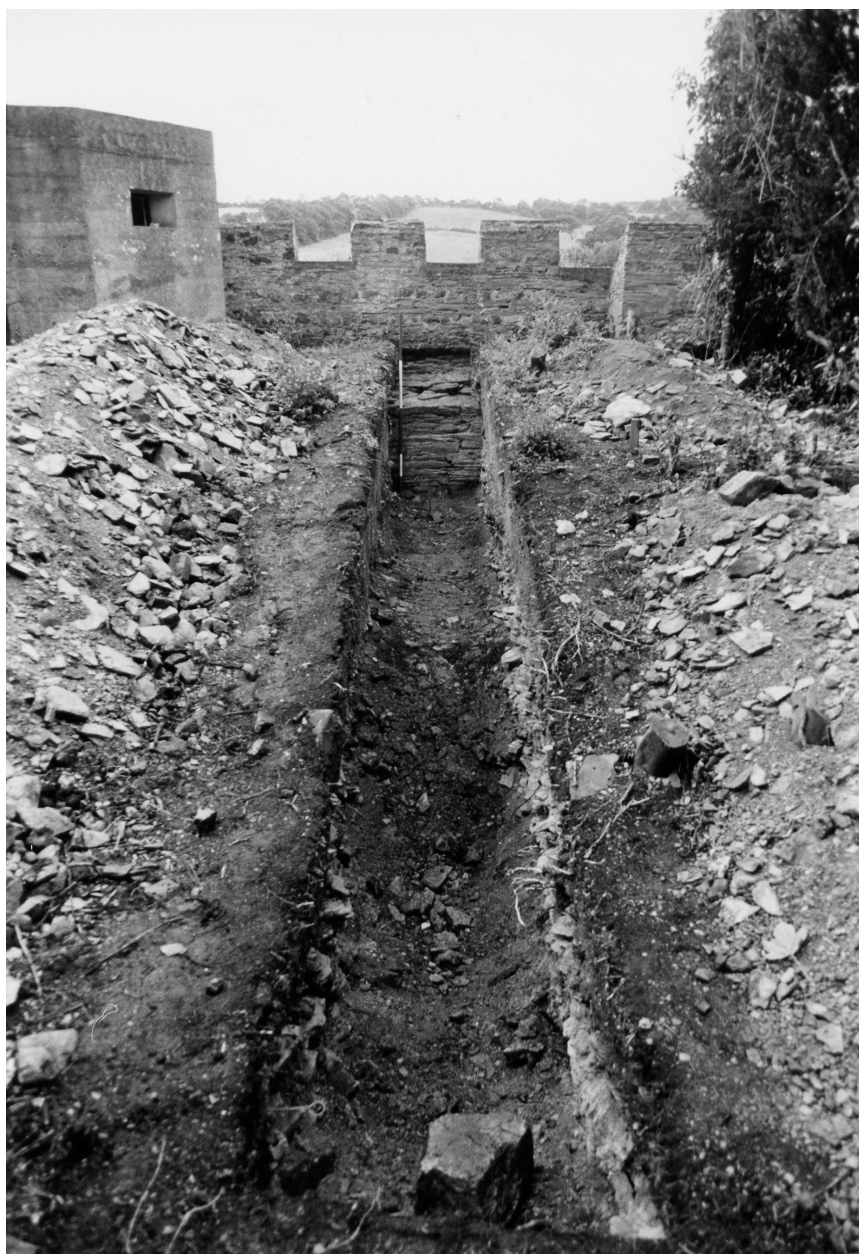
Figure 11b. Photograph of trench from 1984 excavations

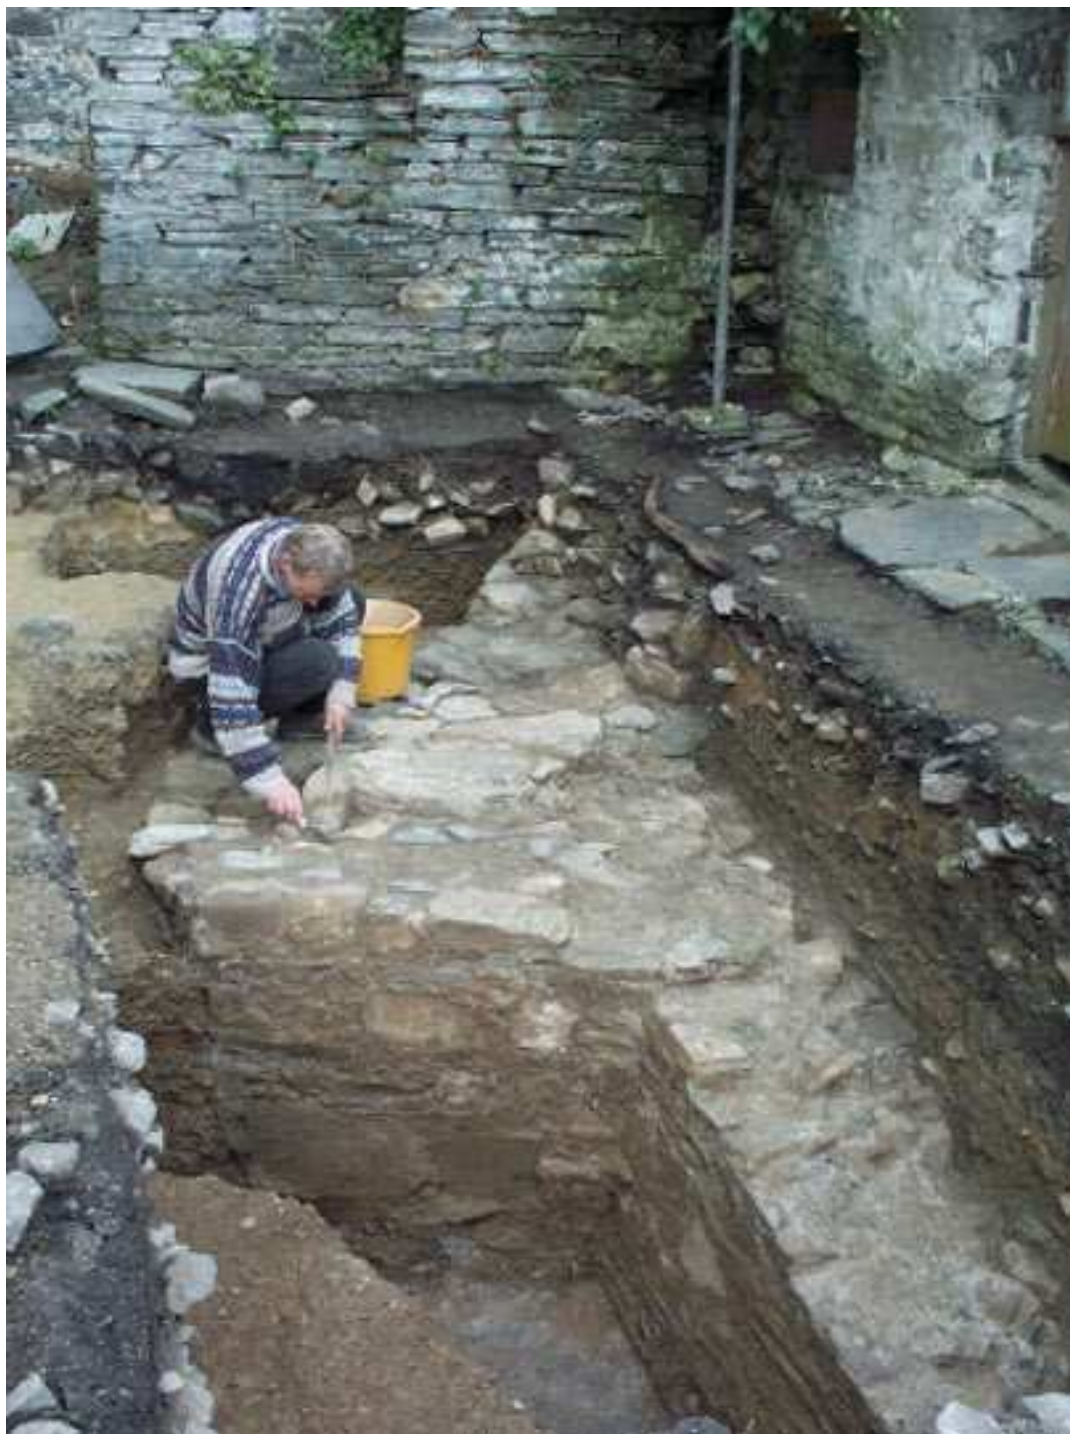
Figure 12. Medieval masonry revealed during excavations at 1 & 2 Green Villas

During restoration work in 2003 on nos. 1 & 2 Green Villas at the entrance to the castle Cambria Archaeology undertook both a building and photographic survey, as well as an excavation in part of the yard area to the rear of the buildings. As well as providing a good record of the development of the buildings themselves, the excavation also revealed an area of substantial Medieval masonry and ditch, filling out the picture of the boundaries of the Medieval castle and possibly indicating the location of the main gateway (Jamieson 2003).

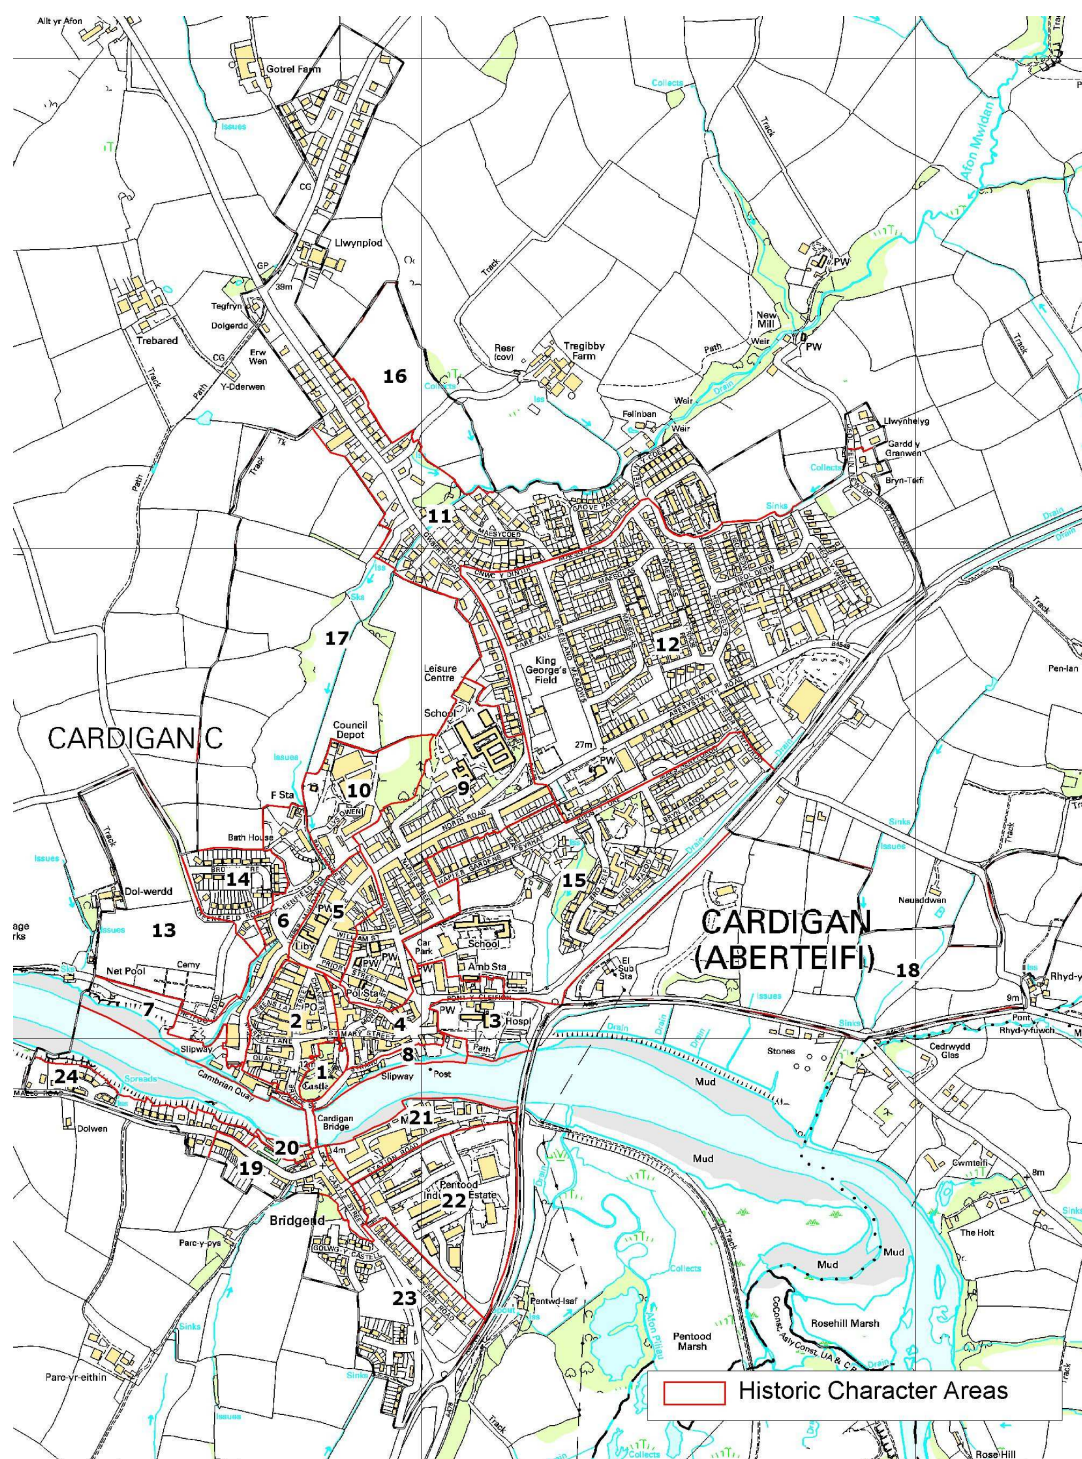
Figure 14. Cardigan Historic Landscape Character Areas

By researching the history of the town it has been possible to gain an understanding not only of the history and development of the urban historic character of Cardigan as a whole, but also to identify specific areas within the town with their own unique historic character. This has enabled the creation of 24 separate 'Character Areas'. This detailed knowledge of the historical development of unique areas within the town, combined with the knowledge of archaeological survival indicated by previous archaeological investigations, highlights specific areas of expected archaeology, of both below-ground remains and possible upstanding remnants.

Detailed descriptions of each of these areas, their specific historical development and archaeological resource is detailed within Appendix 1.

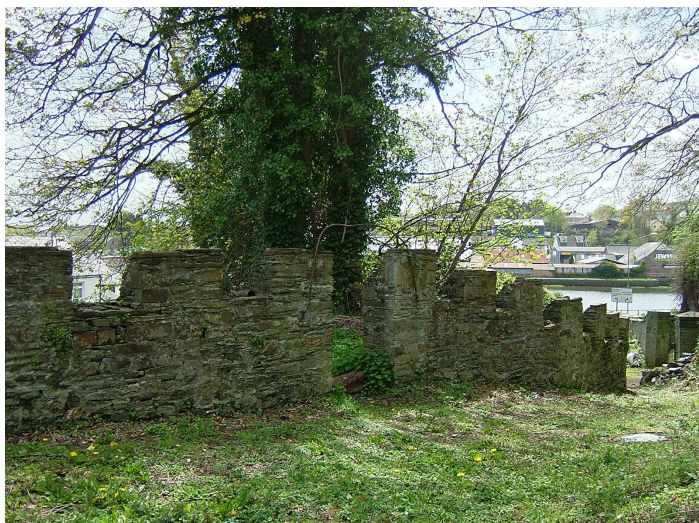
The castellated 19th century boundary wall to the east of Castle Green Mansion.

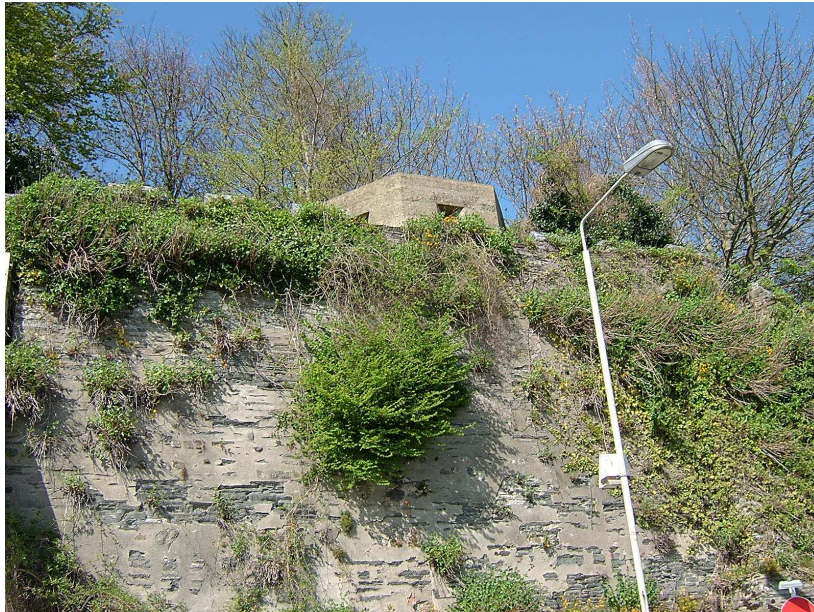
A WWII pill box overlooking Cardigan Bridge, sat on top of the high 19th century castellated walls, which themselves incorporate remains of Medieval castle towers

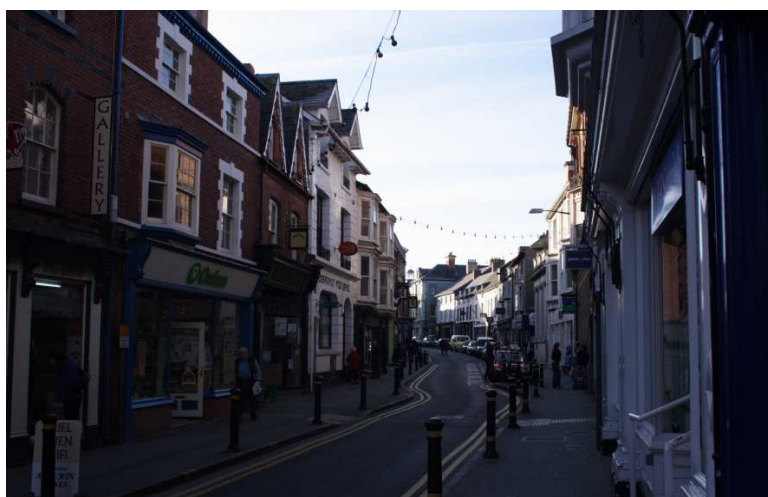
Looking down High Street, showing the densely packed late Post Medieval street frontages, occupying plots possible laid out during the Medieval period.

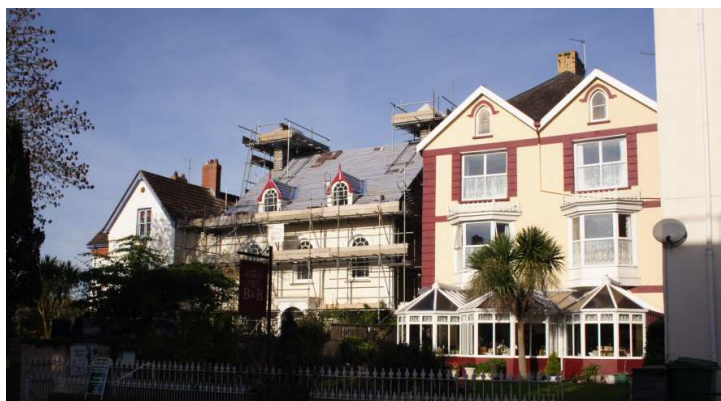
Grade II listed Stanley House and Highbury Hotel, which possibly incorporate the remains of the Nash-designed gaol.

The possibility of pre-19th century archaeology appears relatively slight in this area with the exception of the important Gaol and toll gate sites on North Road but there is a good survival of upstanding traditional buildings, including 12 listed buildings. The Character Area also currently displays a rather complete and undisturbed series of contemporary buildings.

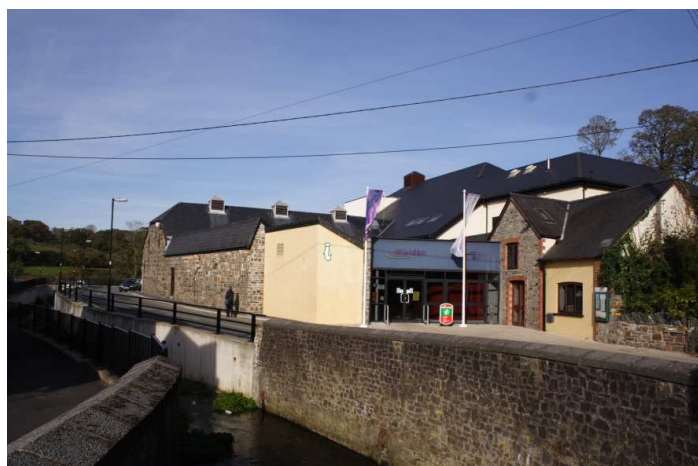
Theatr Mwldan, occupying and possibly incorporating the remains of the former slaughter house and poor house

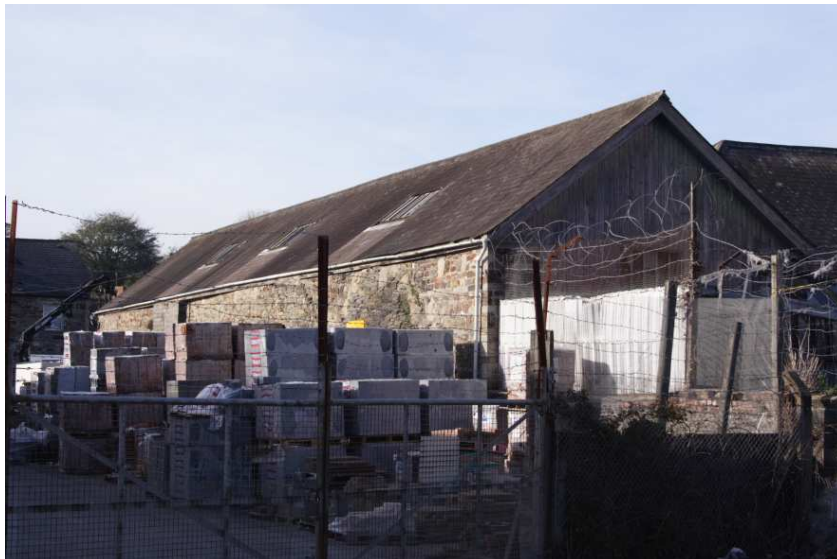
The remains of the former saw mill buildings

Little subsequent history is recorded in this area until the early 19th century. By this time a Saw Mill and Iron Foundry were established close to the current bridge at the western end of this area. Both appear to have been founded by David Davies of Castle Green and survived in various forms until well into the 20th century. At the time of their foundation the remaining area appears to have been mostly farmland, as shown on the tithe map of 1838, although a small cottage is located roughly in the middle of this Area. Interestingly the cottage is located both close to the possible site of the Medieval chapel and 12th century bridge. This cottage however, disappeared underneath the new Cardigan train station that was built at the eastern of this Area in 1885. The 1st edition Ordnance Survey map of 1890 shows an extensive area covered by the railway terminus, including the passenger platform, goods shed, cattle pens and engine house, along with a ferry crossing from Gloster Row.
