QUARRY COTTAGE, HODGESTON, PEMBROKESHIRE

ARCHAEOLOGICAL WATCHING BRIEF APRIL 2007

REPORT NO. 2007/23 PROJECT RECORD NO. 62762

QUARRY COTTAGE, HODGESTON, PEMBROKESHIRE WATCHING BRIEF

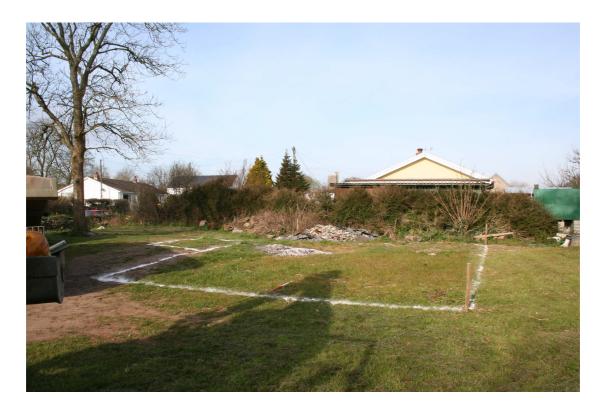
Photo 1: Looking west across the footprint of the house foundation

A JCB excavator using a toothless grading bucket carried out the excavation of the rectangular building footing. The footing measured 10.0m east to west by 7.0m north to south with a porch footing measuring 2.0m by 2.8m projecting centrally from its south side. The maximum depth required for the footing was 0.70m below the present ground surface, although the depth of the excavations in places exceeded this due to the looseness of the underlying ground.

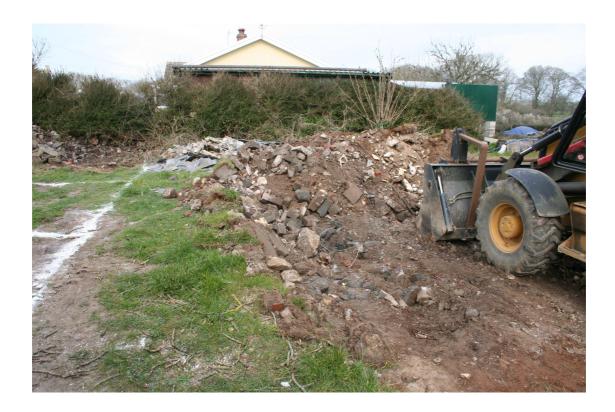
Photo 2: View looking west showing quarry infill during groundworks

There was minimal turf and topsoil cover which gave way to a mass of loosely compacted building demolition debris comprising a mix of stone, roofing slate, shattered mortar, concrete block fragments and assorted rubbish. This dumped material was present to the full depth of the excavations on the eastern side of the footing whilst on the western side limestone bedrock was encountered at depths varying from 0.3m to 0.8m. The exposed limestone was seen to fall away steeply on its eastern side and represented part of the western edge of the former quarry. The demolition debris layers represented dumped material used to infill the former limestone quarry and make up the ground to the west of the quarry edge. Other than the quarry itself no archaeologically significant features were encountered, although a buried soil horizon was exposed to the west of the quarry which represented a former ground surface, but no archaeological features or deposits were noted in that context either.

The footings for the new building were excavated through dumped building demolition rubble which had been used as infill for the disused limestone quarry. Part of the western edge of the quarry was exposed during the excavations and a buried soil horizon was noted which represented a former ground surface some 0.35m below the present ground surface. No significant archaeological features or deposits were identified, either within the former quarry or on its western edge.
