# A SURVEY OF DEFENDED ENCLOSURES IN CARMARTHENSHIRE, 2007-08: GAZETTEER OF ORDNANCE SURVEY GRID SQUARES SN01, SN02, SN10, SN11 & SN12

RHIF YR ADRODDIAD / REPORT NO. 2007/27  
RHIF Y PROSIECT / PROJECT RECORD NO. 62767

## SITE GAZETTEER OF 10KM GRID SQUARES SN01, SN02, SN10, SN11 & SN12

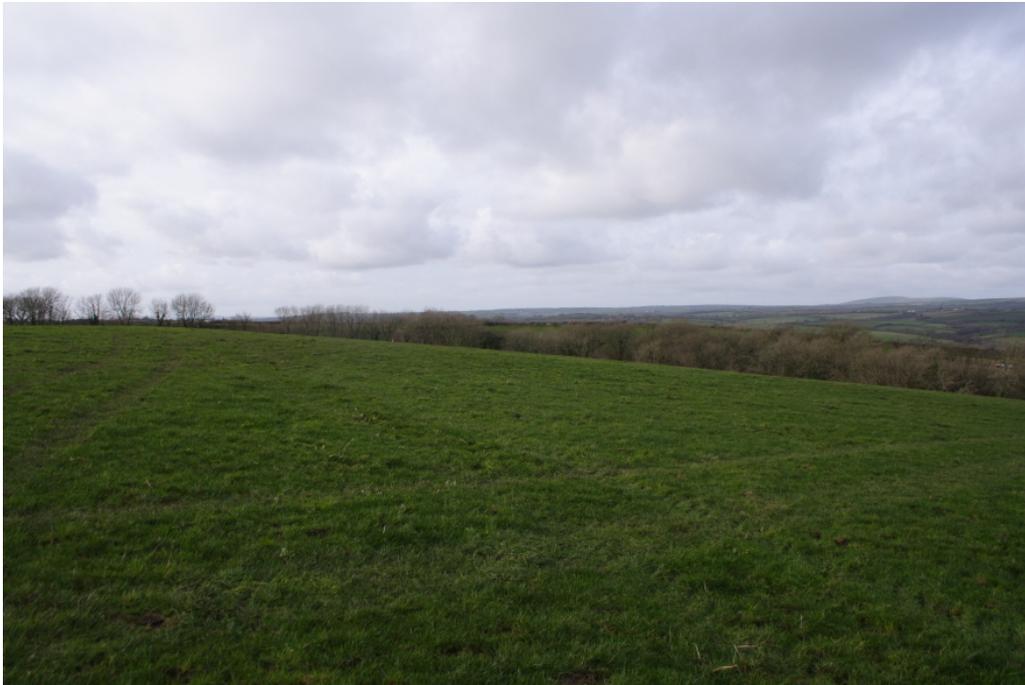
Caeroleu is a sub-rectangular defended enclosure occupying a moderately steep north-facing slope at 90m above sea level. On aerial photographs it shows as a cropmark ditch, with bowed north and south sides and a straight east end. The west end on 1955 photographs is obscured by hedgebanks - these have now been removed. There is an entrance midway along the east side. Internally the enclosure measures c. 80m E-W and 70m N-S. On the ground east and south sides are visible as a low bank up to 0.35m high, and a slight ditch is also visible on the east side. On other sides only very slight traces survive. The interior is slightly dished. In 2008 the site was under improved pasture. A cesspit for Caerolau cottage has been dug into the western edge of the interior.

Looking NW over enclosure.

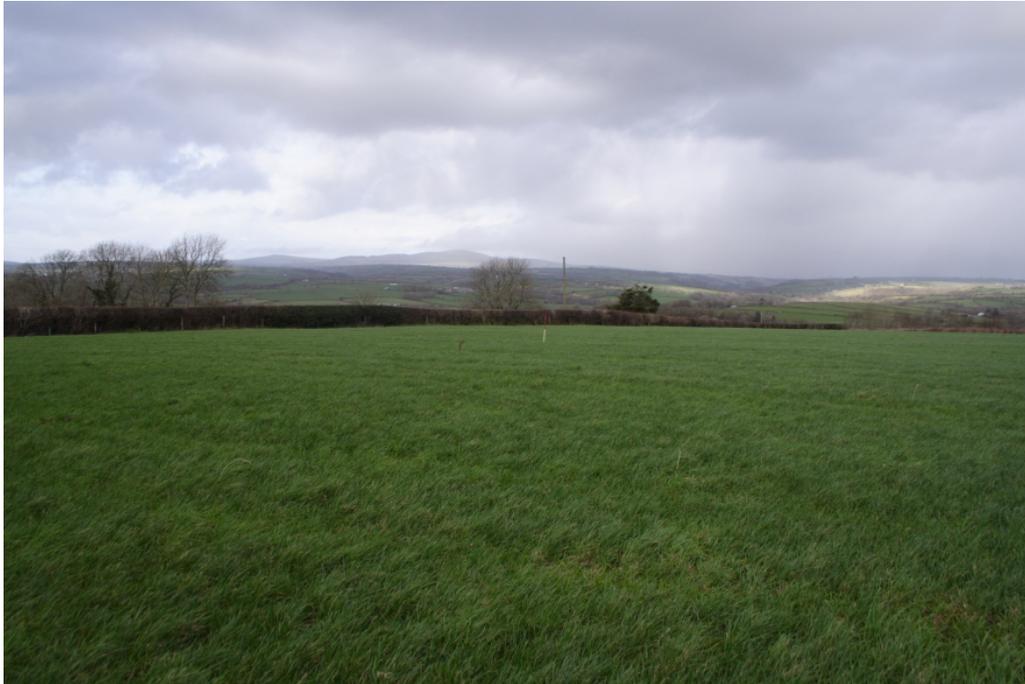
Vertical aerial photographs taken in 1955 seem to show a circular earthwork enclosure defined by a spread parchmark bank with traces of a ditch on the west side. The enclosure measures c.40m diameter internally. Apart from very slight undulations there is no trace of this enclosure on the ground. In 2008 the site was under improved pasture.

Looking N over site of cropmark.

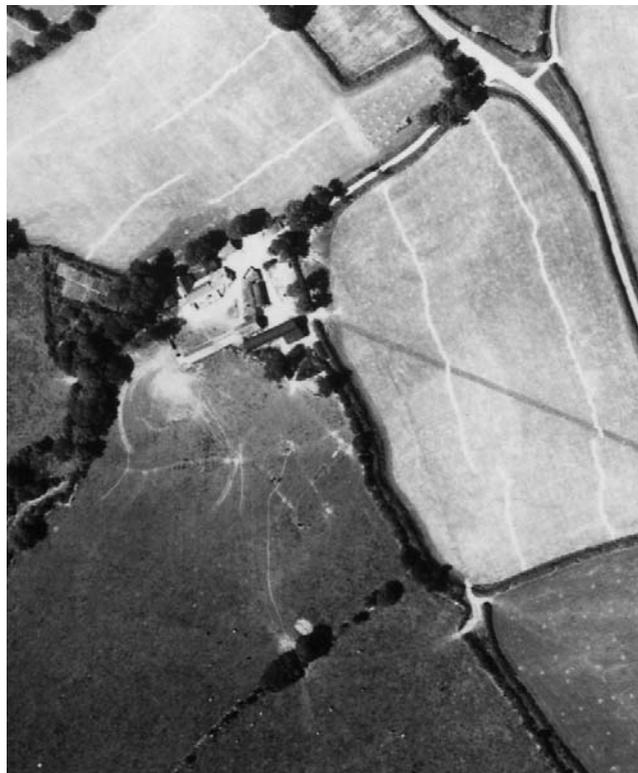
Aerial photograph – Meridian Airmaps 1955 200-210 24372.

As the 1955 photographs are the only evidence, this site must remain a possible enclosure or defended enclosure, not a certainty.

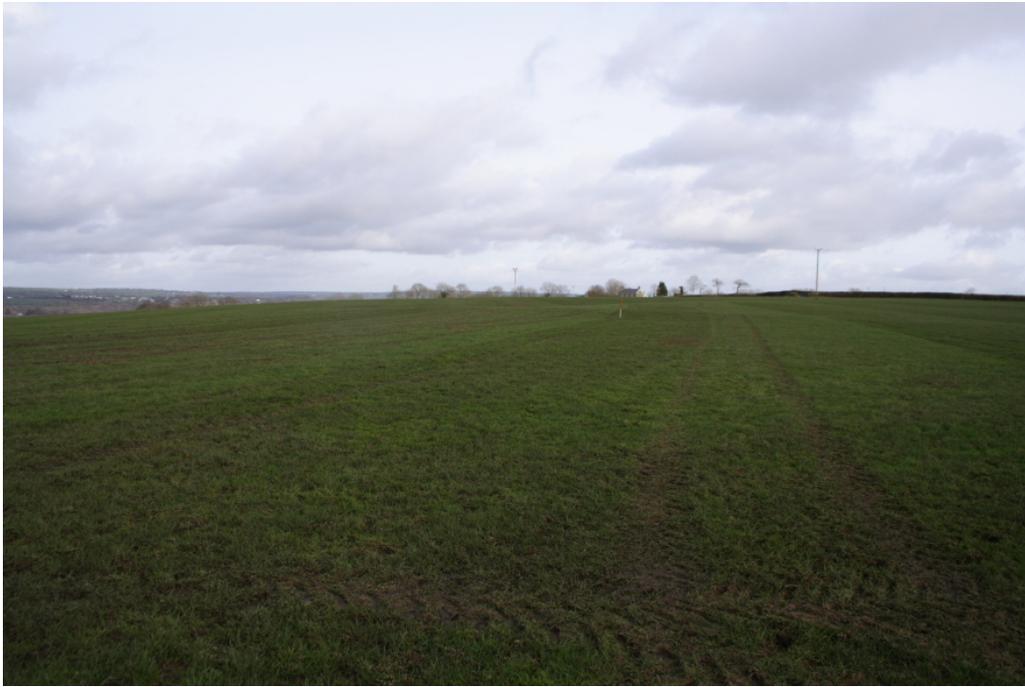
Aerial photographs show what seems to be the parchmark of a curving length of bank c.60m long. On the ground it shows as a curving bank, c. 30m long and up to 0.35m high, perhaps the east side of a roughly circular enclosure. There are hints of low earthworks defining the west side of the enclosure, but these are very vague. In 2008 the site was under improved pasture. It lies on a gentle north-facing slope at 100m above sea level.

Looking NE over site.

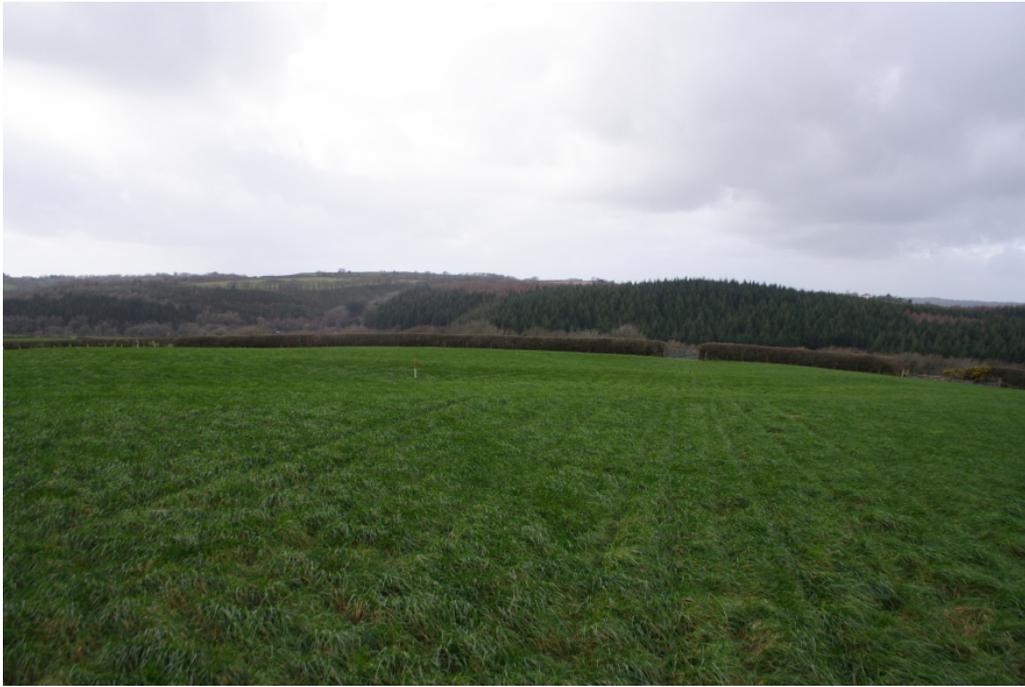
This is a univallate oval enclosure occupying a west-facing slope at 80m above sea level. On the ground it is defined by a bank up to 0.5m with traces of a ditch. These are best preserved on the north side. A north-south hedgebank cuts across the western side of the enclosure. Part of the enclosure lies in a field to the west, and here there is no trace of it. Aerial photographs show the site as a cropmark ditch with parchmarks of a bank and possible counterscarp. The enclosure measures 80m E-W and 40m N-S internally. The position of the entrance is unknown. In 2008 the site was under improved pasture.

Looking SW over enclosure.

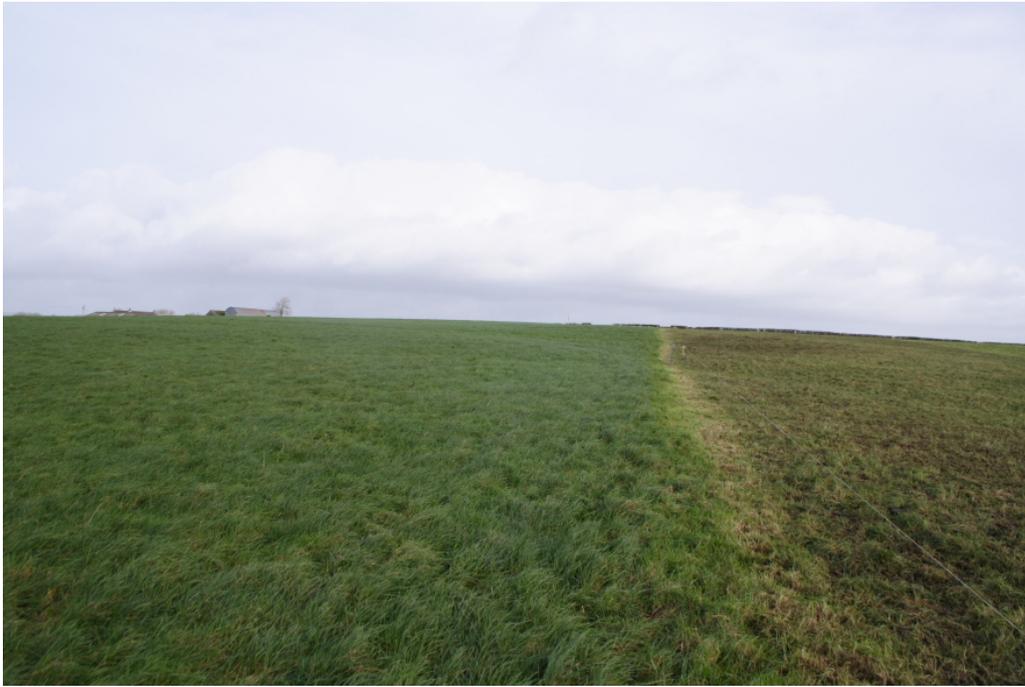
A slight earthwork enclosure, sub-circular in shape, approximately 45m diameter internally, lying on a gentle west-facing slope at a little over 80m above sea level. It is defined by a 0.35m high bank and by a distinct dished interior. The earthwork bank is more complex on the southwest side, probably in the location of the entrance. There are indications of an outer bank to the north and possible other earthworks between this enclosure and enclosure PRN 35771 that lies immediately to the west. The relationship between this enclosure and PRN 35771 is unclear. In 2008 the site was under improved pasture.

Looking N over earthwork enclosure.

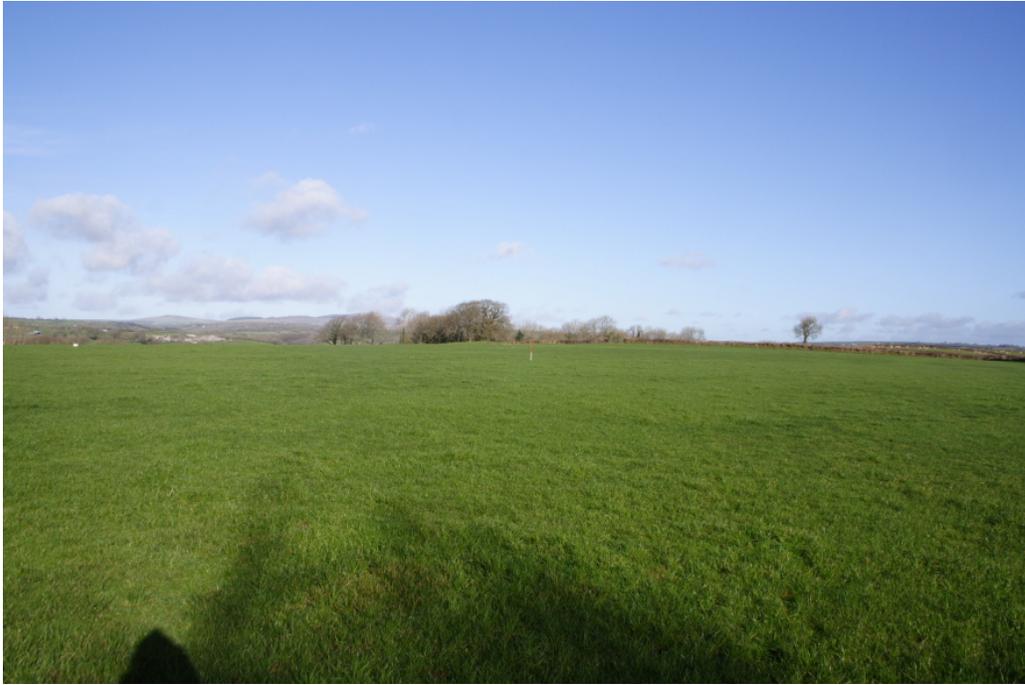
Faint cropmark ditches are visible on aerial photographs possible defining an oval enclosure 100m south of the Llandre moated homestead/ringwork (PRN 1413). The site lies on gentle south-facing slope at c.50m above sea level. The north, northeast and west sides of an enclosure measuring c.130m SW-NE by c.60m NW-SE are visible on photographs. There is no trace of the southeast side. In 2008 the site was under improved pasture. There is no trace of this site on the ground.

Looking N over cropmark site.

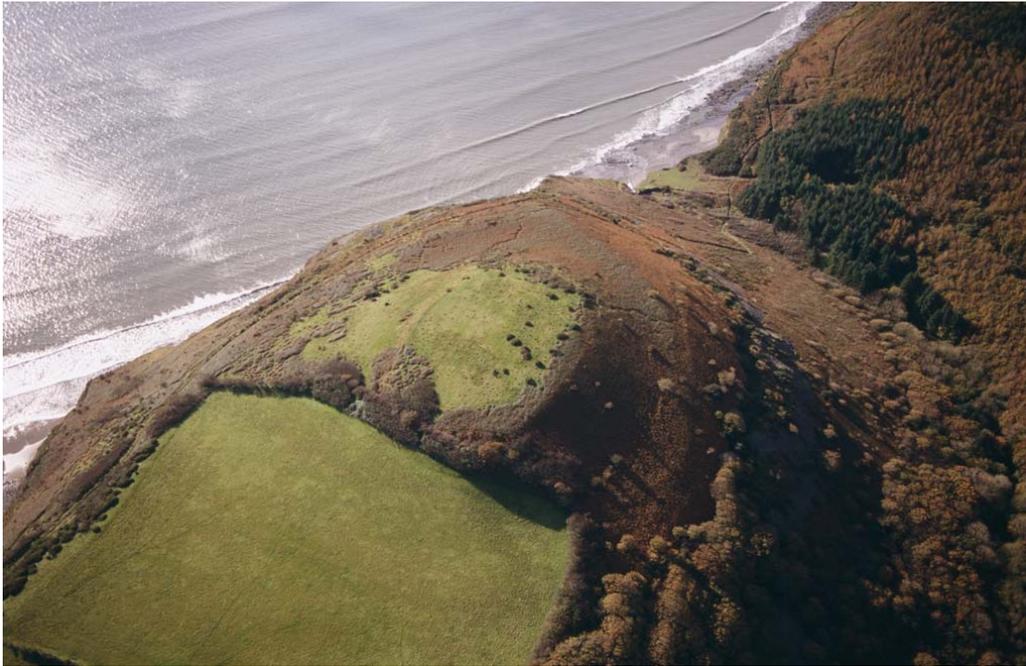
Aerial photograph of 3665. RCAHMW Crown Copyright © reference DI2007\_1669.

The whole site is covered in varying degrees of rough pasture, bracken, bramble and gorse.

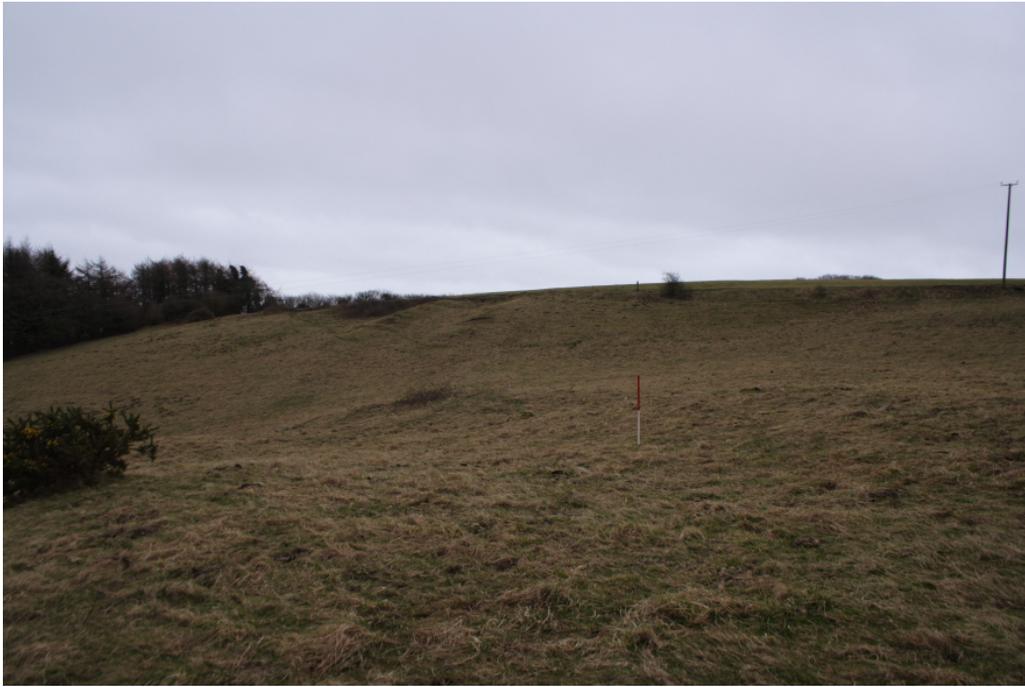
However, the site visit during 2007 identified at least two quite widely spaced defensive banks separated by a ditch on the eastern side of the site. Here the defences have survived because the ground slopes away which makes it much more difficult to plough. Elsewhere the defences, if they existed, have been ploughed away. On the ground the two defensive banks have the appearance of long mounds (described as "giants graves" in folklore) that curve, in discrete lengths, around to the east and southeast. The circular interior measures approximately 65m in diameter, and appears as a concave hollow. The Ordnance Survey reported a possible entrance on the southeast but no evidence of this was visible on the ground in 2007. The field is still ploughed occasionally and large stones have been exposed in the fabric of the outer defensive banks. The site is situated within a field under pasture.

Facing SSW showing outer defences of circular enclosure

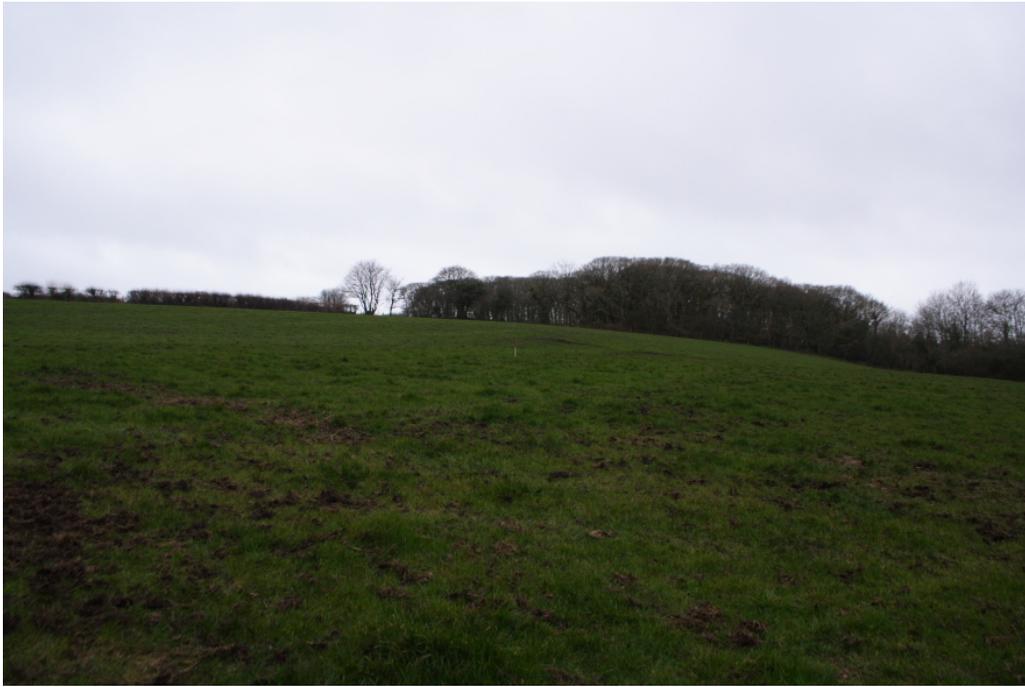
A rectangular enclosure identified from aerial survey, situated on a gentle north facing hillslope at 130m above sea level. The cropmark measures approximately 30m by 20m. No trace of any earthwork was visible on the ground in 2007. The site is located within a field of pasture.

Looking approx. S across field of cropmark enclosure

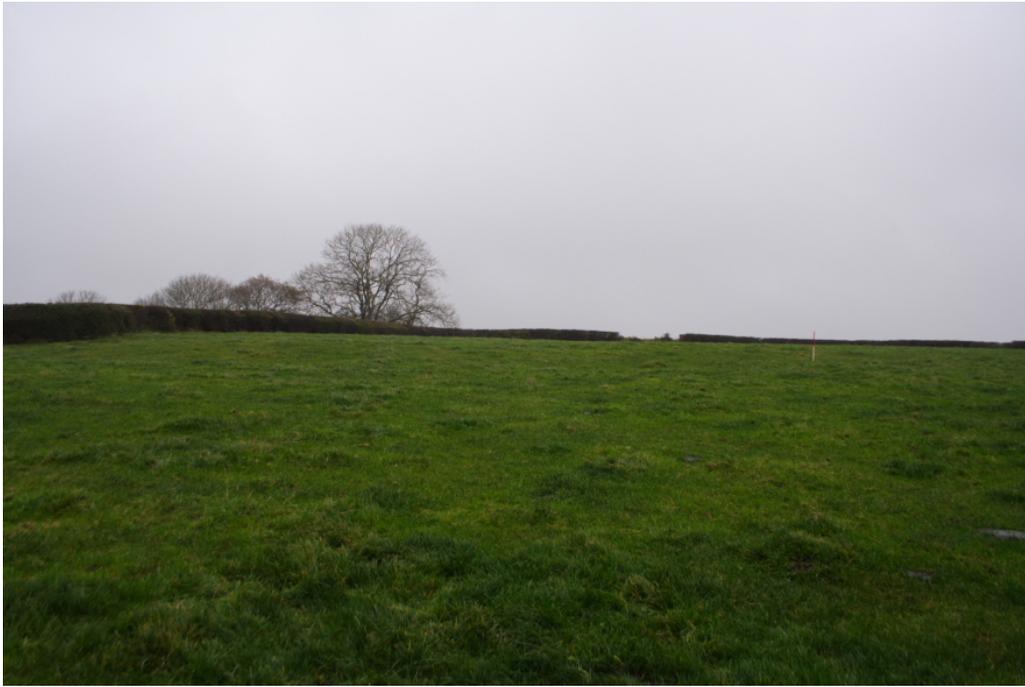
This is a small, oval, univallate, defended enclosure occupying the western side of a rounded hilltop at 120m above sea level. The northern and eastern sides of the enclosure are overlain by hedgebanks, a line of curving shallow ditch, up to 0.4m deep marks the western side of the enclosure. Overall the enclosure measures c. 45m E-W and 40m N-S. There is no evidence for an entrance. In 2007, the site was under improved pasture.

Looking NE across site of enclosure.

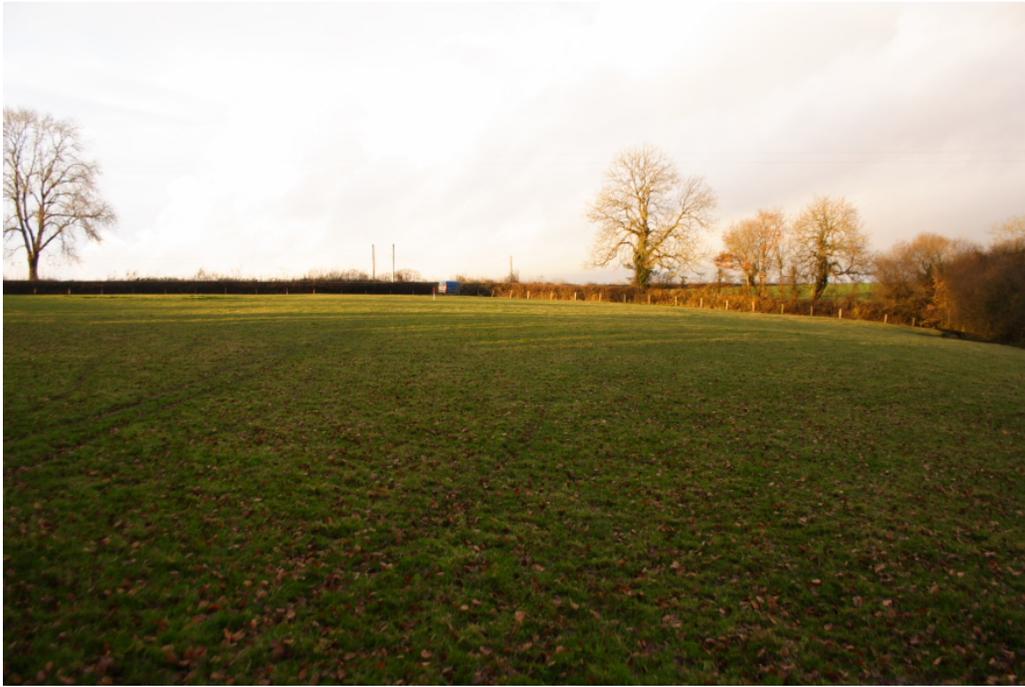
Looking N over site of cropmark

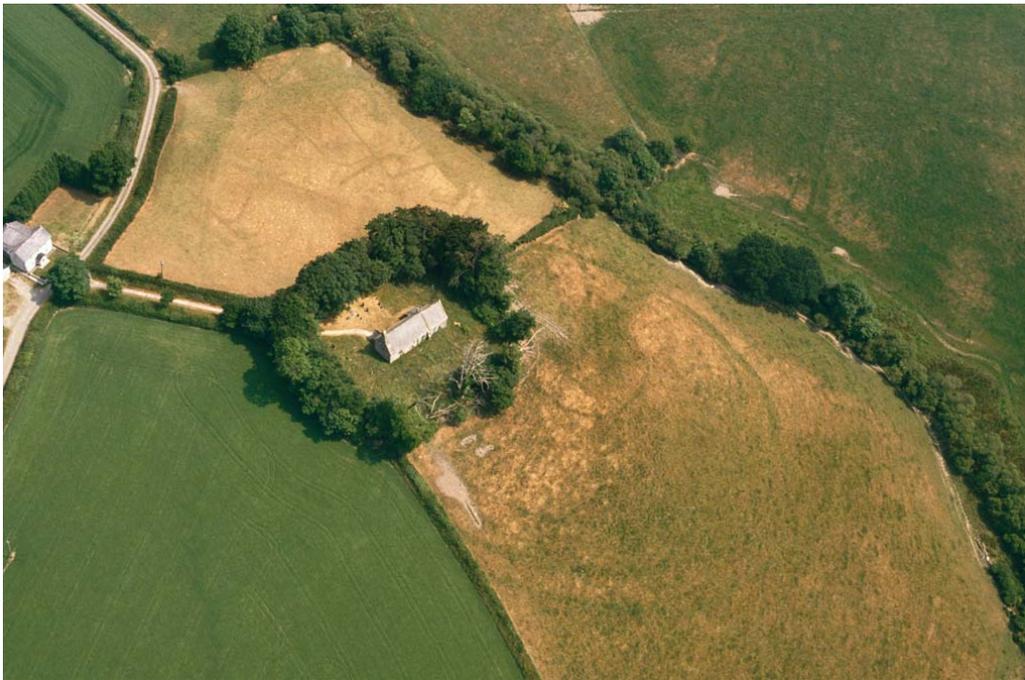
Aerial photograph of 11786. RCAHMW Crown Copyright © reference DI2007\_1674.

Overall this seems to be an Iron Age enclosure reused in the early medieval and medieval periods, both in secular and ecclesiastical terms.

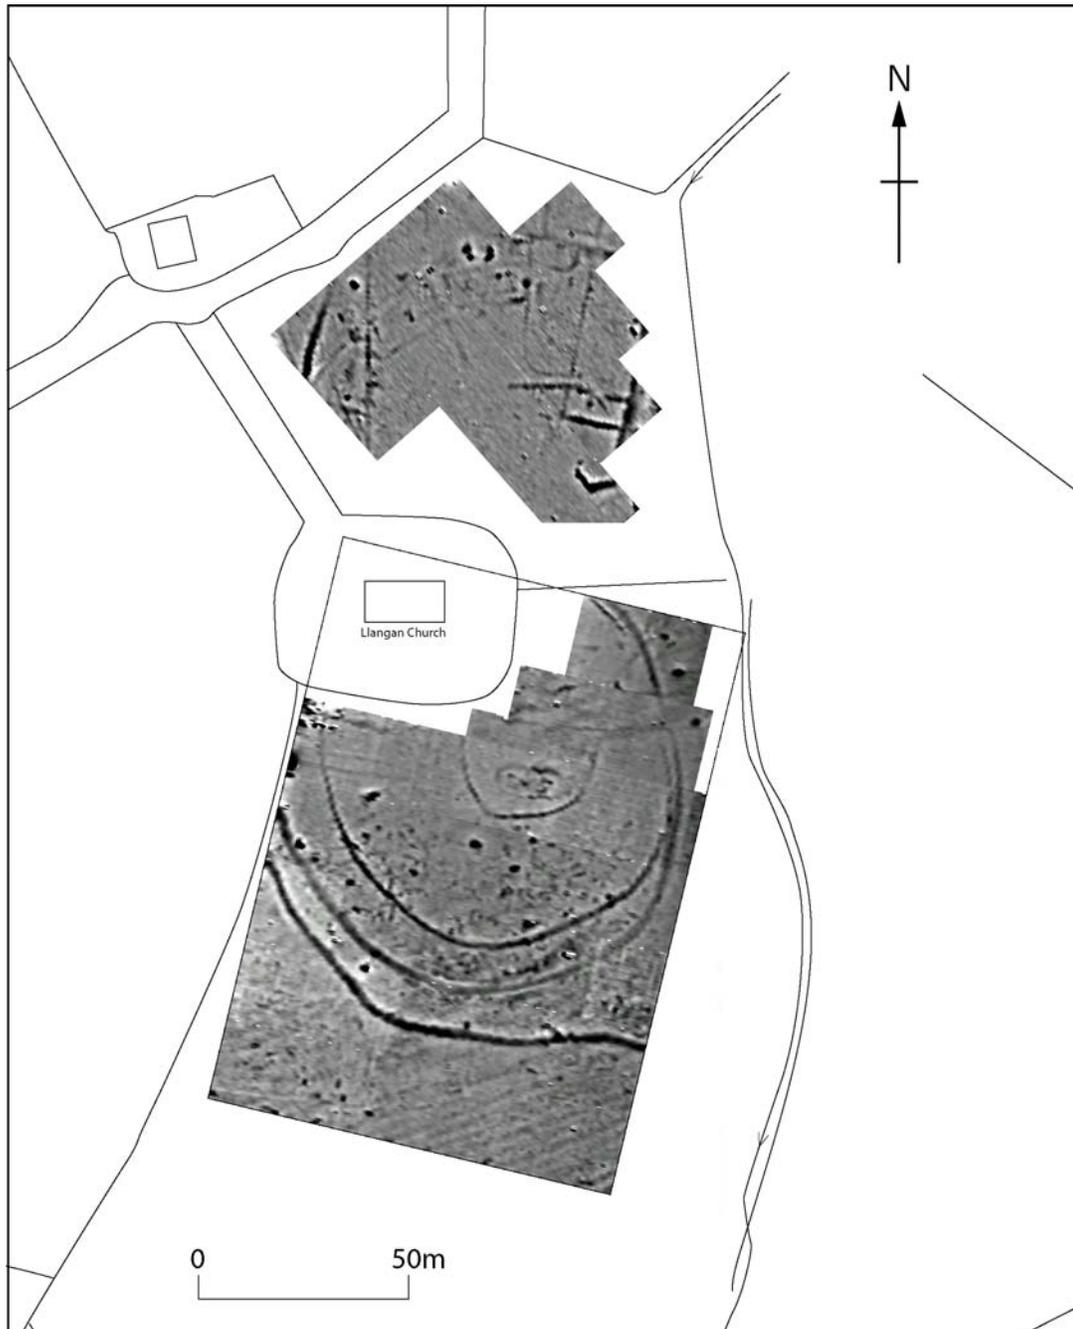
Geophysical Survey of Llangan Church 2007.

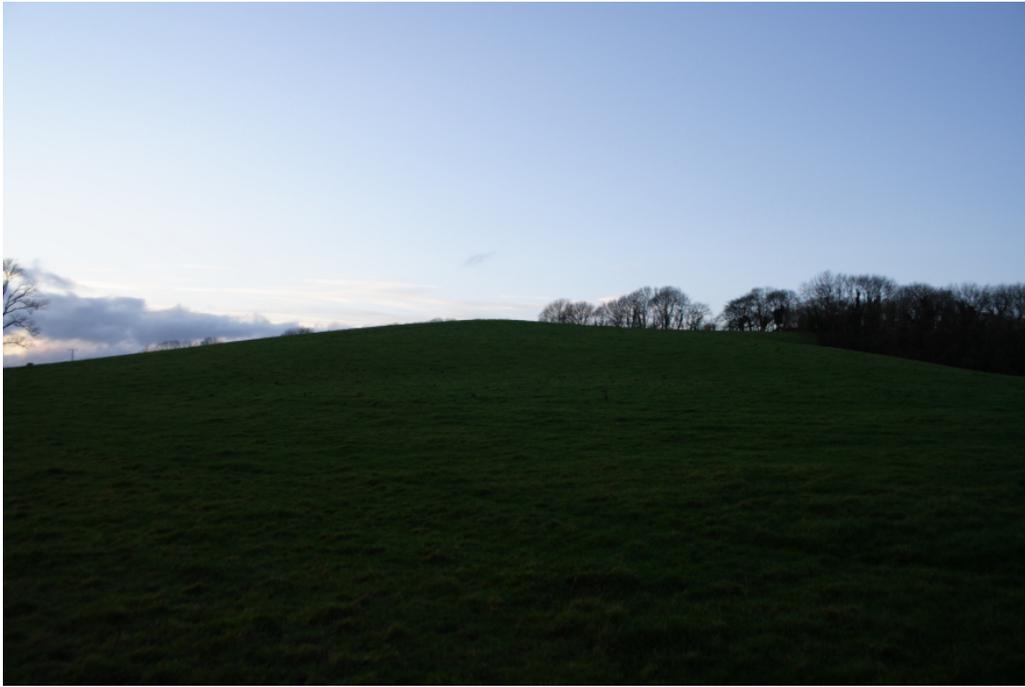
On the ground there is a hint of a bank along the south and west sides of the enclosure. The interior is slightly dished, as though terraced into the slope. The owner, Mrs Hall, stated that the internal splodge is visible in drought conditions. In 2007, the site was under improved pasture.

Looking NW over site of enclosure.

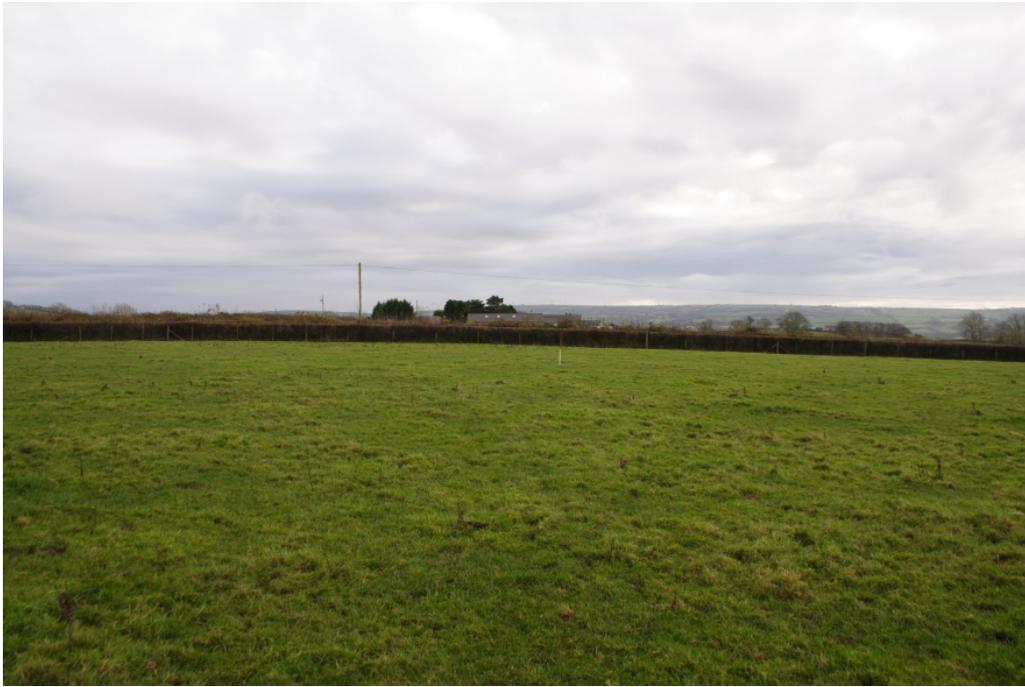
This is an oval or egg-shaped, cropmark, univallate enclosure lying on a very gentle south-facing slope at 65m above sea level. An E-W lane bisects the site. The cropmark ditches defining the enclosure show best on the east and west sides to the north of the lane. The ditches to the south of the lane and on the north side of the enclosure can only just be traced on the ground. There is a possible entrance on the east side. The enclosure measures c.70m N-S and 45m E-W. On the ground the site is marked by a barely perceptible depression. In 2007, the site was under improved pasture.

Looking SW over cropmark enclosure.

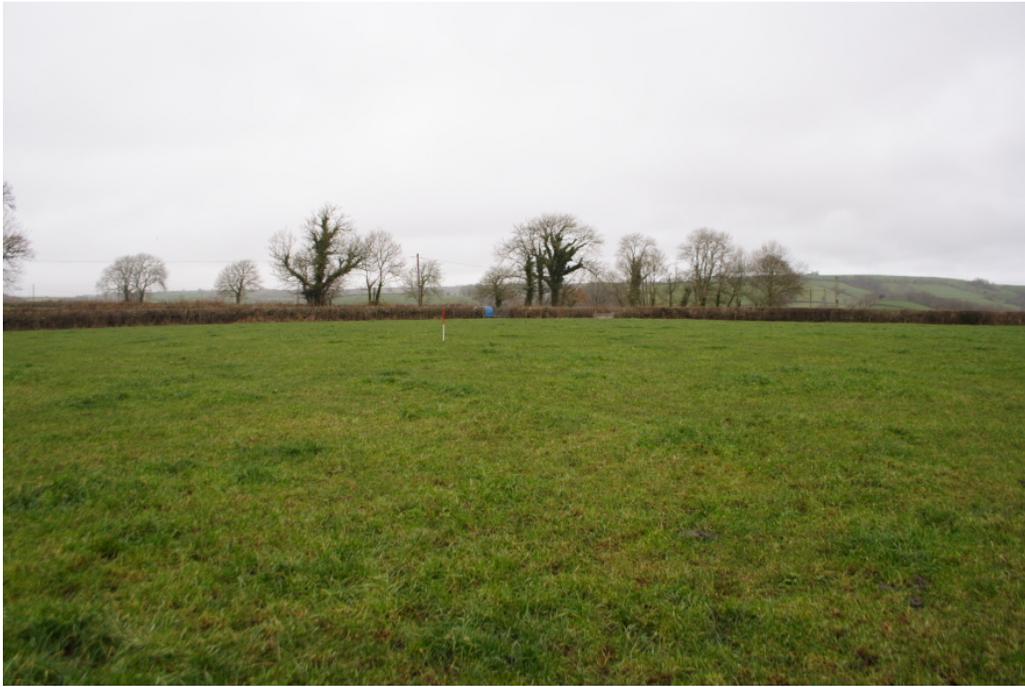
Looking NE over site of cropmark.

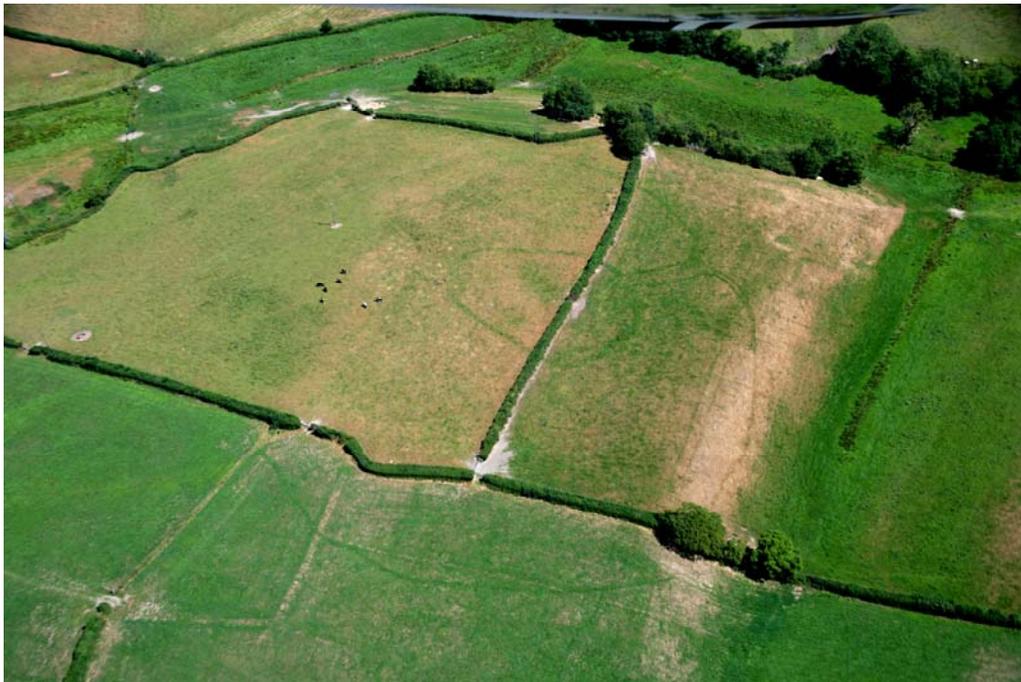
Aerial photograph of 35777. RCAHMW Crown Copyright © reference AP2006\_3020.

Blaen-Lliwe is a fine example of a circular, univallate defended enclosure with a concentric annexe identified from aerial survey. The enclosure straddles an E-W spur of land at 50m above sea level that slopes down to the east. The inner circular enclosure measures c.60m in diameter, and the outer concentric annex has a diameter of c.200m. An approaching ditch/bank track entrance, that is clearly visible on the aerial photograph, is on the southeast side of the site. In 2007 there was no trace of any earthwork on the ground. A hedge bank bisects the inner enclosure, which is discernable on the ground as a circular hollow depression, although this may be a result of the farmer burying sheep here. The site is situated within a field of pasture.

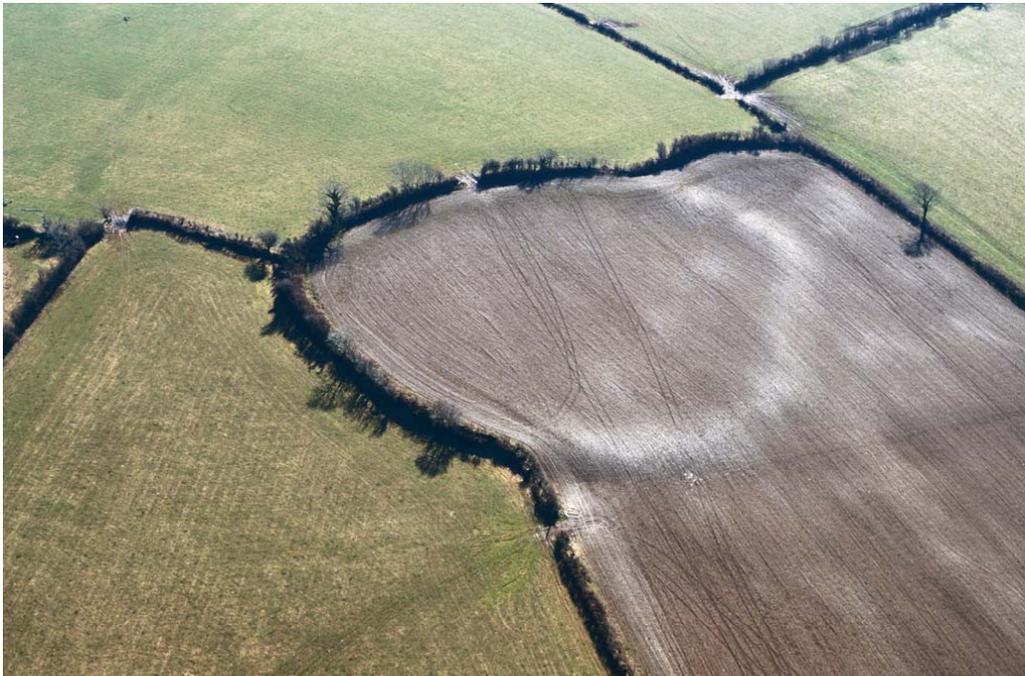
Aerial photograph of 924. RCAHMW Crown Copyright © reference DI2007\_1678.

A large, single banked oval enclosure, with an annexe or elaborate entrance on the south side. It is located on a hillslope at an elevation of 170m above sea level. The defensive bank surrounds an internal area of approximately 0.84 hectare. The whole site has been much reduced by ploughing, and the southern bank of the enclosure stands to an external height of 1.0m, although the bank is better preserved to the north and east, surviving to 2.0m high, where the bank is overlain by a hedge. There are very slight traces of an external ditch evident on the north and southeast. The entrance on the south is approached through an annexed enclosure 30m north-south by 20m east-west, whose banks are slightly lower than those ploughed out elsewhere.

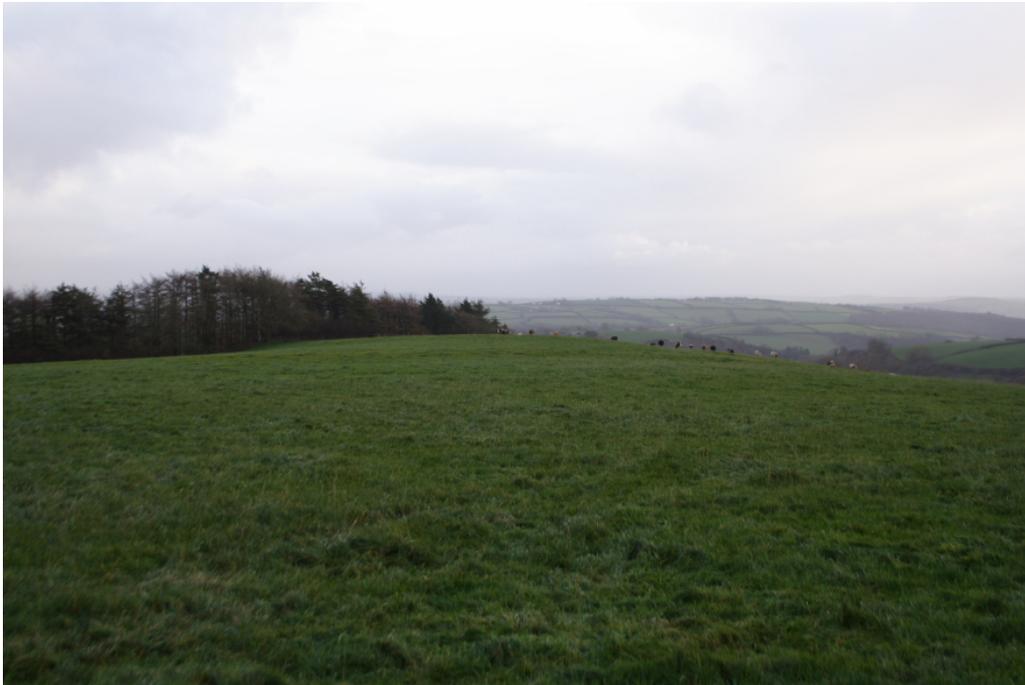
Looking SE up towards area of concentric annex enclosure

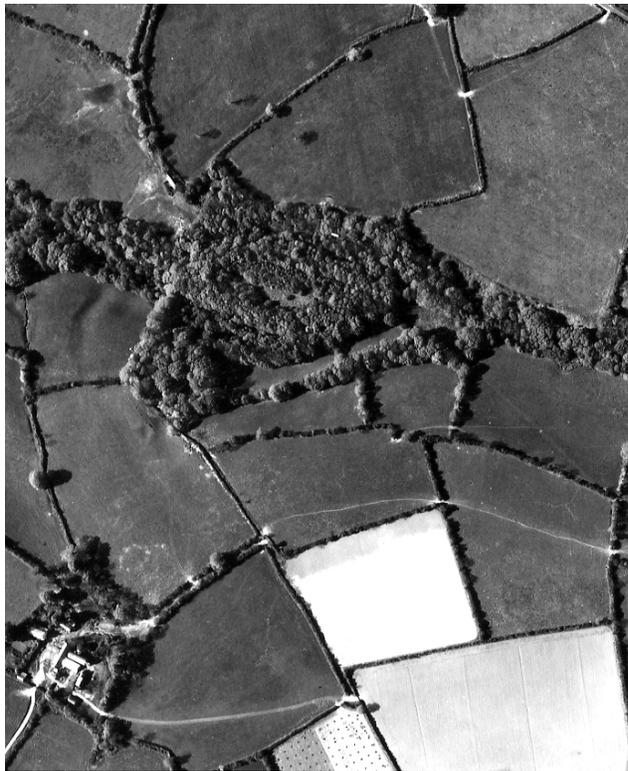
1955 aerial photograph of 941. Meridian 210-220 11350.

In 2007 the site was under deciduous woodland.

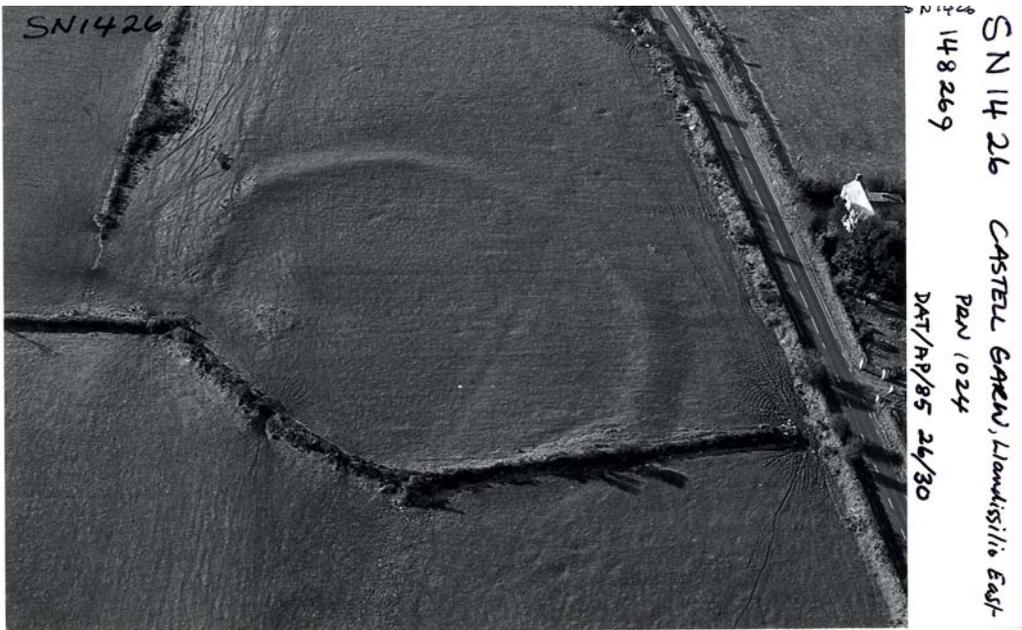
Aerial photograph of 1024. Reference DAT AP85-26.30.

Castell Garw is a large, single-banked enclosure with an outer ditch and an entrance on the south, situated on a southeast facing hillslope at 210m above sea level. Circular in shape, in 1967 the Ordnance Survey reported that the bank had a maximum height of 0.8m, and a counterscarp of 0.5m. An earlier date for the enclosure has been suggested, and the possibility of it being a henge monument. However, the Ordnance Survey states that the supposed recumbent stones within the enclosure are a natural outcrop, and the believed collection of megaliths found northeast of the earthwork are not recognisable as the remains of a burial chamber.

Partial excavation in the 1990's yielded evidence for a series of stake holes and rhyolite artefacts that indicated earlier occupation of the site but may not rule out the case for the present earthworks being an Iron Age enclosure.

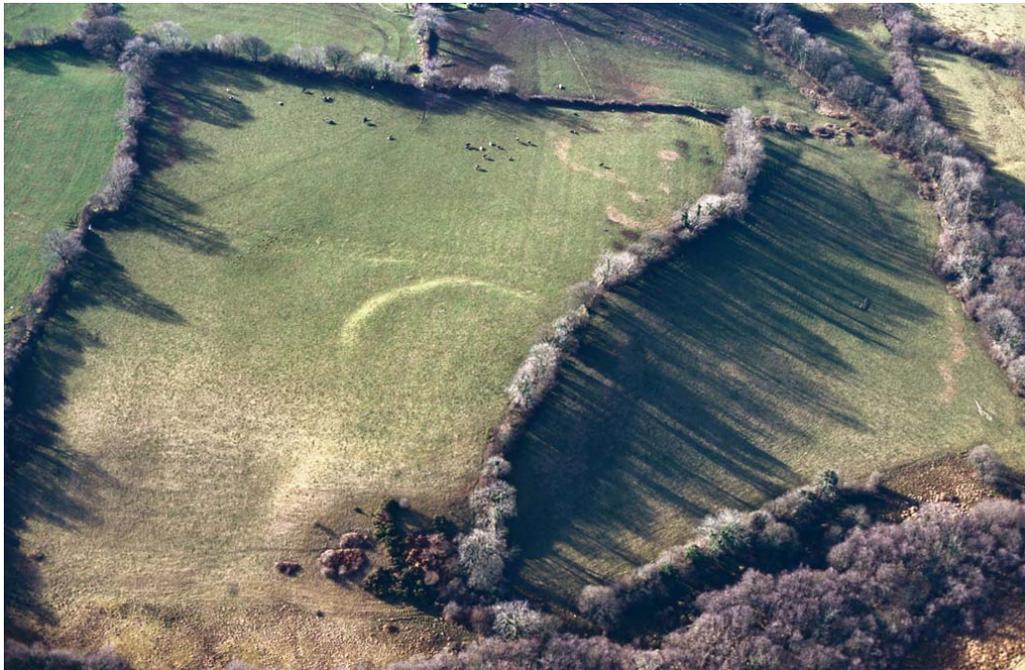
Aerial photograph of 1139. RCAHMW Crown Copyright © reference DI2007\_1675.

The site is under improved pasture. In 2006 the site was ploughed for the first time in 50 years, and it is likely to be ploughed at regular intervals in the future.

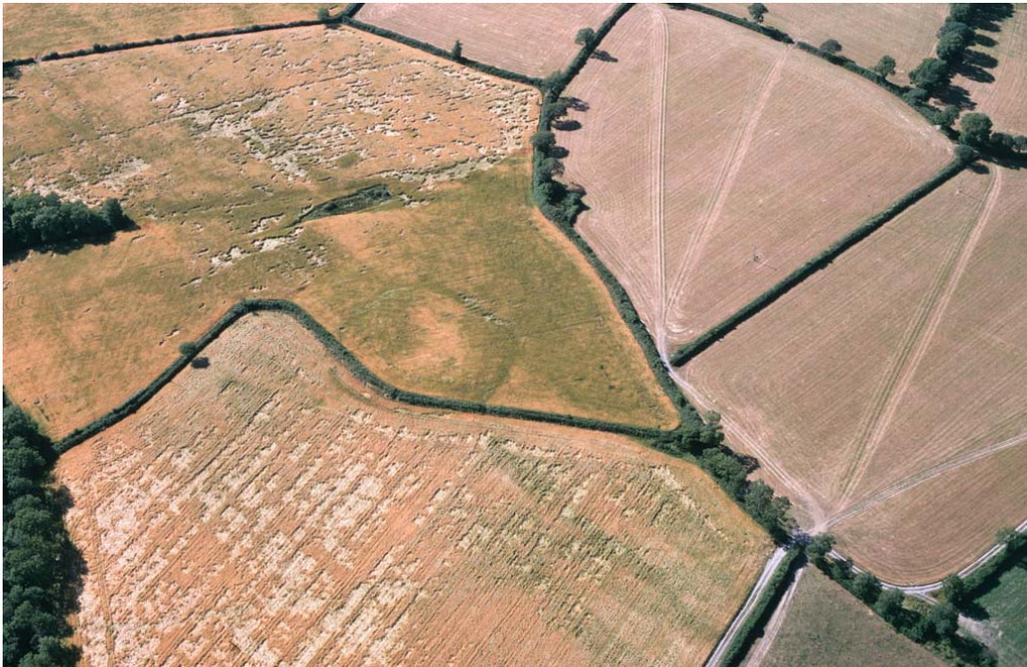
Aerial photograph of 4962. RCAHMW Crown Copyright © reference D12007\_1738.

A sub-circular, univallate defended enclosure situated on a gentle SE facing hillslope at 120m above sea level. The RCAHM record that the site lies within a field called 'Parc yr gaer', but refer to it as having 'no appearance of antiquity about it'. The site was visited in 1984 by Dyfed Archaeological Trust and identified as a univallate enclosure. In 2007 it is obvious that the site has been heavily ploughed over the years and the single rampart is now much spread. The enclosure measures c.60m in diameter and has a dished appearance. The spread rampart is between 14m and 16m in width and stands to a height of less than 0.5m. There appears to be a simple entrance on the N side visible on aerial photographs but not on the ground. On the ground there are traces of an outer ditch in places. The site is situated within a field under pasture.

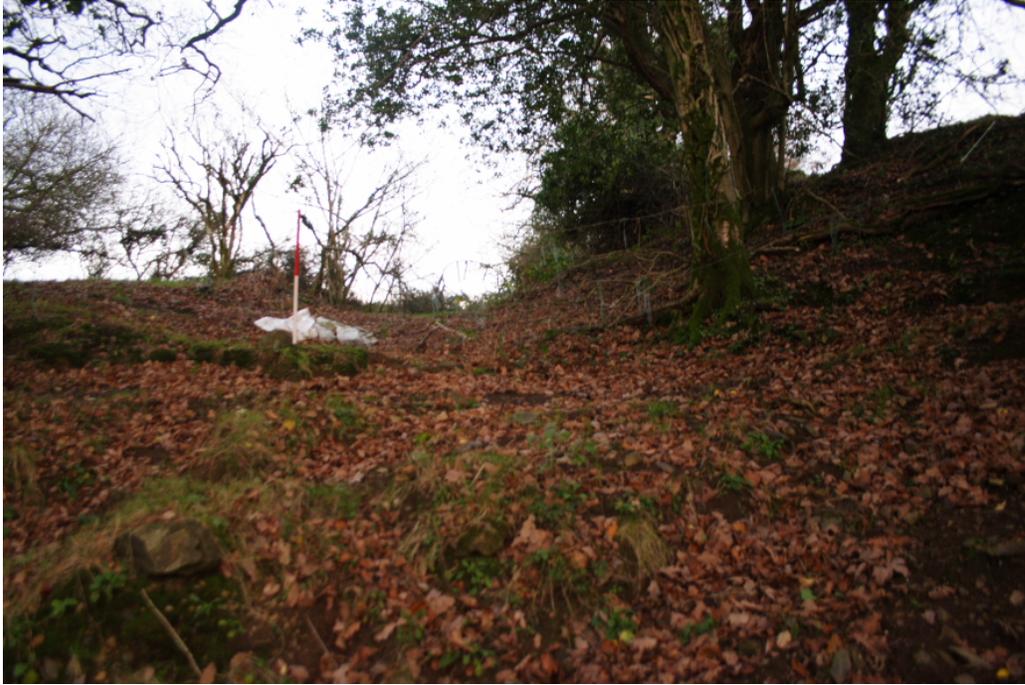
Pen y Gaer is a univallate inland promontory fort lying at c.110m above sea level. It is naturally well defended by steep slopes to the west, south and east, which fall away to streams 50m below. On its easily approachable north side it is defended by a c.100m long length of bank and ditch. The bank rises to 2.5m - 3.5m above the exterior ditch and 0.5m above the interior. The ditch is up to 1.0m deep and 8.0m wide. A hedge runs along the crest of the bank. The location of the entrance is uncertain, but it may be at the western end of the bank and ditch where there is some erosion caused by cattle trampling. The interior is oval in shape, c.95m N-S and 85m E-W. A slight hollow in the northeast corner of the interior may mark the site of a roundhouse. The interior of the fort is under improved pasture, the rampart under trees, bushes and long grass.

Looking E along the fort's defences.

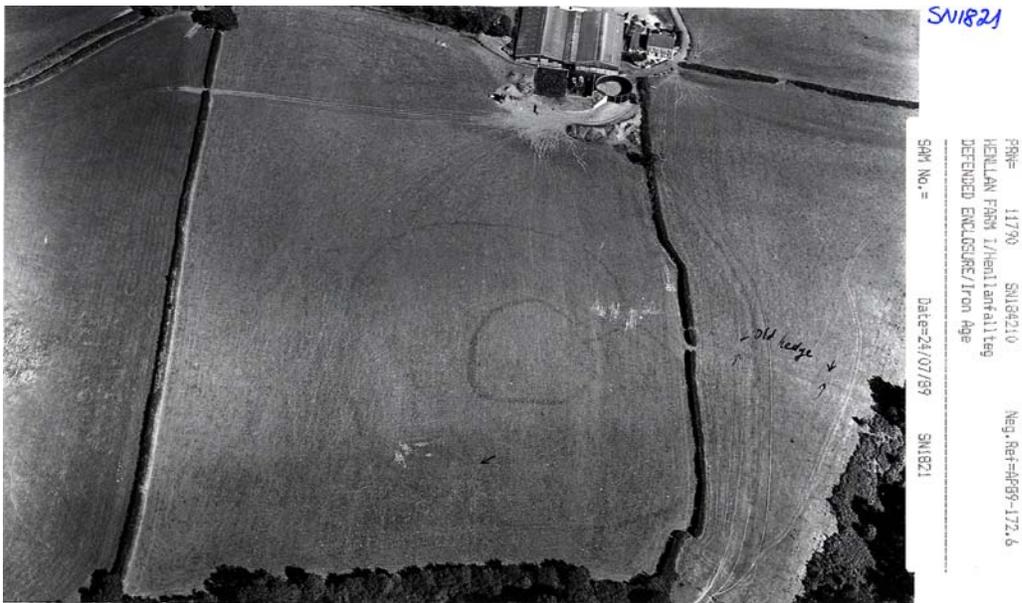
Aerial photograph of 11790. Reference DAT AP89-172.06.

The enclosure lies 100m south of enclosure PRN11791 and 150m south of PRN11792.

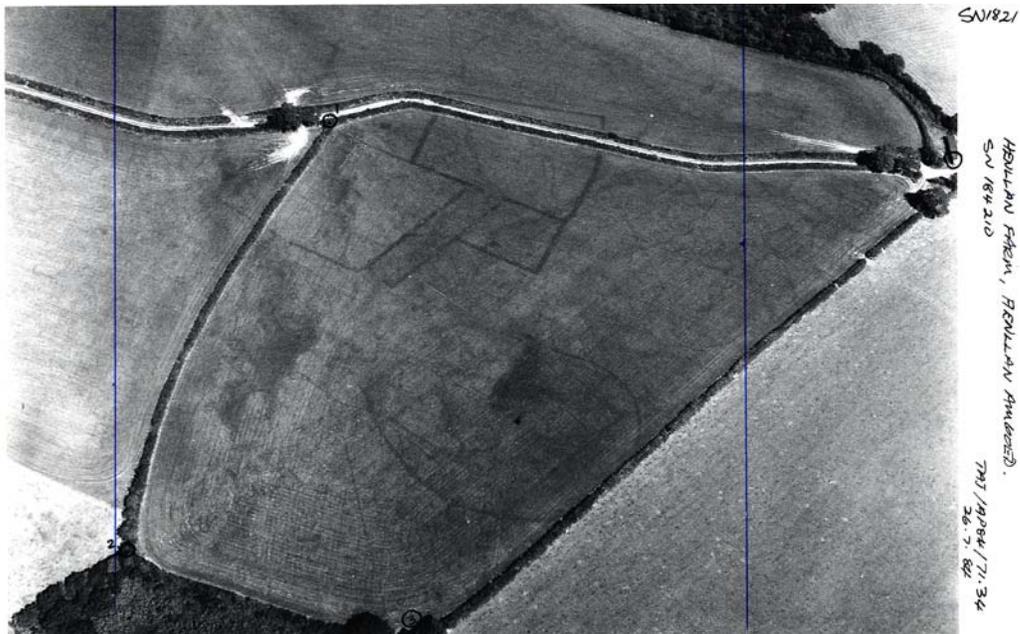
Aerial photograph of 11791. Reference DAT AP84-71.34 .

The site lies in improved pasture. In 2007 the defensive bank was visible as a very low earthwork that reached a maximum height of 0.25m. The interior was slightly dished.
