# A SURVEY OF DEFENDED ENCLOSURES IN CARMARTHENSHIRE, 2007-08: GAZETTEER OF ORDNANCE SURVEY GRID SQUARES SN01, SN02, SN10, SN11 & SN12

RHIF YR ADRODDIAD / REPORT NO. 2007/27  
RHIF Y PROSIECT / PROJECT RECORD NO. 62767

## SITE GAZETTEER OF 10KM GRID SQUARES SN01, SN02, SN10, SN11 & SN12

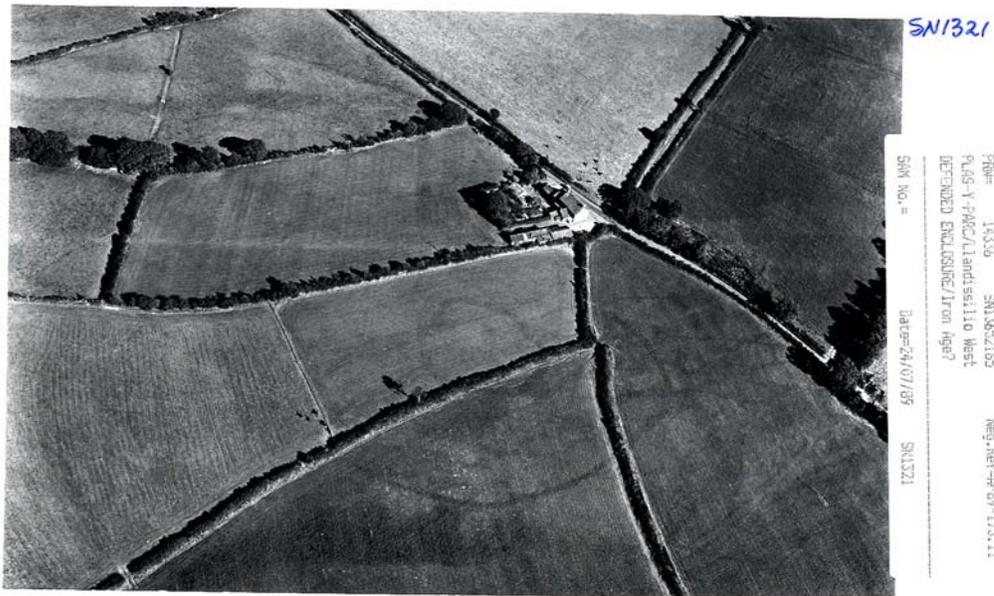
Aerial photograph of 14336. Reference DAT AP89-173.11.

Plas-y-Parc is a univallate, oval-shaped, cropmark defended enclosure with a concentric annexe occupying a low rounded hilltop at c.100m above sea level. The inner enclosure is defined by a cropmark ditch and approximates to a circle c.45m diameter internally, with an entrance on the south side. Aerial photographs show a track with flanking ditches approaching this entrance, but these were not obvious on a geophysical survey undertaken in 2007. A concentric enclosure, defined by a fainter ditch, c.160m across surrounds the inner enclosure. The site is under improved pasture. Since the site was first discovered from the air in 1984 several hedgebanks have been removed.

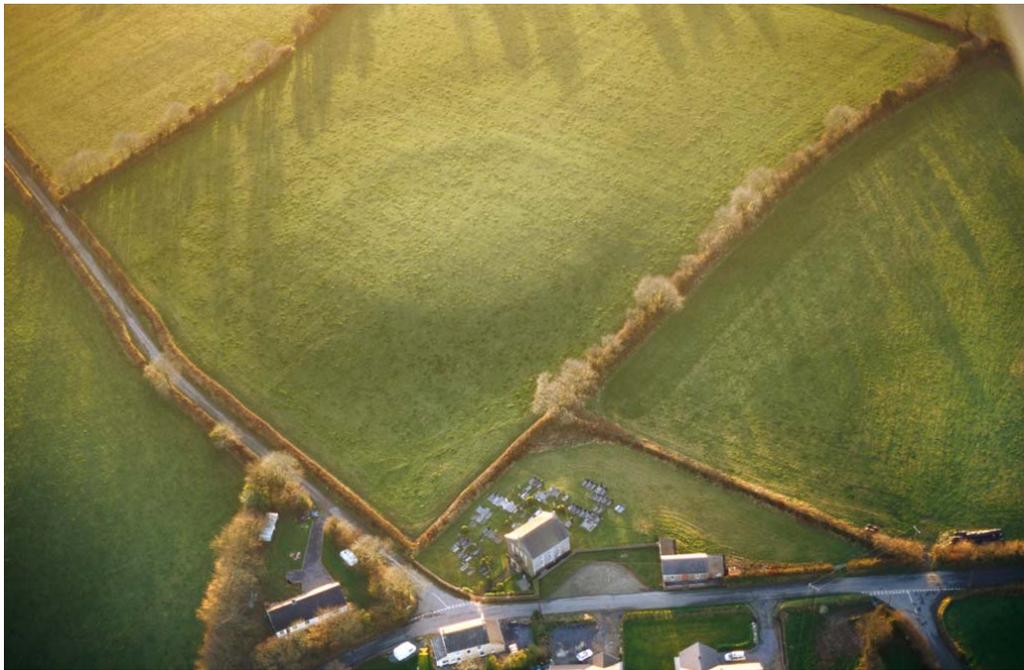
Aerial photograph of 35758. RCAHMW Crown Copyright © reference DI2007\_1659.

Cefn-y-Pant is a circular defended enclosure occupying the summit of a local hill at 65m above sea level. It survives as a low earthwork bank, up to 0.25m high with traces of an external ditch. The internal diameter of the enclosure is c.60m. It has a simple southeast-facing entrance. On aerial photographs the site shows as a cropmark ditch and a parchmark bank. Aerial photographs also seem to show a possible annexe on the west side of the enclosure. On the ground very low earthworks mark this annexe, which measures c.60m by 60m. There are also low earthworks to the south of the enclosure. In 2007 the site was under improved pasture.

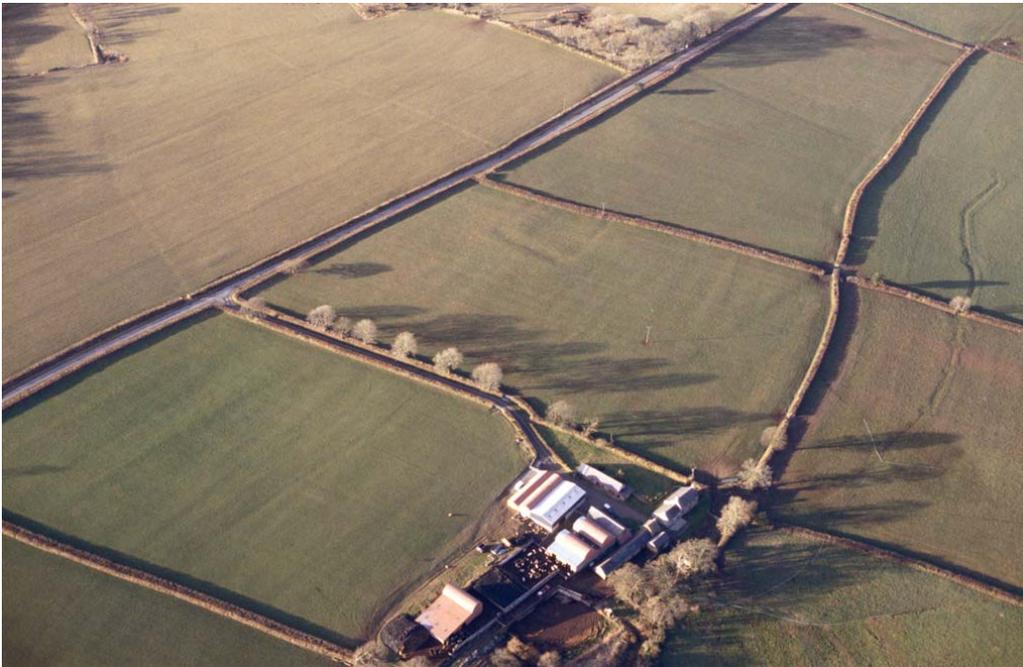
Aerial photograph of 35759. RCAHMW Crown Copyright © reference DI2007\_1658.

Aerial photographs show a small, sharp-cornered rectangular enclosure lying on fairly level ground (very gentle east-facing slope) at 150m above sea level. The enclosure is divided in two by an E-W hedgebank. The photographs show a bank and ditch of the defensive circuit, with all but the northeast corner visible. The enclosure measures c.55m N-S and c.30m E-W. On the ground the enclosure bank stands up to 0.35m high on the south side, but fades to nothing towards the north. There is no trace of an entrance. In 2007 the site was under improved pasture. According to the landowner the site has not been ploughed for over 70 years.
