A SURVEY OF DEFENDED ENCLOSURES IN CARMARTHENSHIRE, 2007-08: GAZETTEER OF ORDNANCE SURVEY GRID SQUARES SN51, SN52 & SN54

Prepared by Dyfed Archaeological Trust
For Cadw

RHIF YR ADRODDIAD / REPORT NO. 2007/27
RHIF Y PROSIECT / PROJECT RECORD NO. 62767

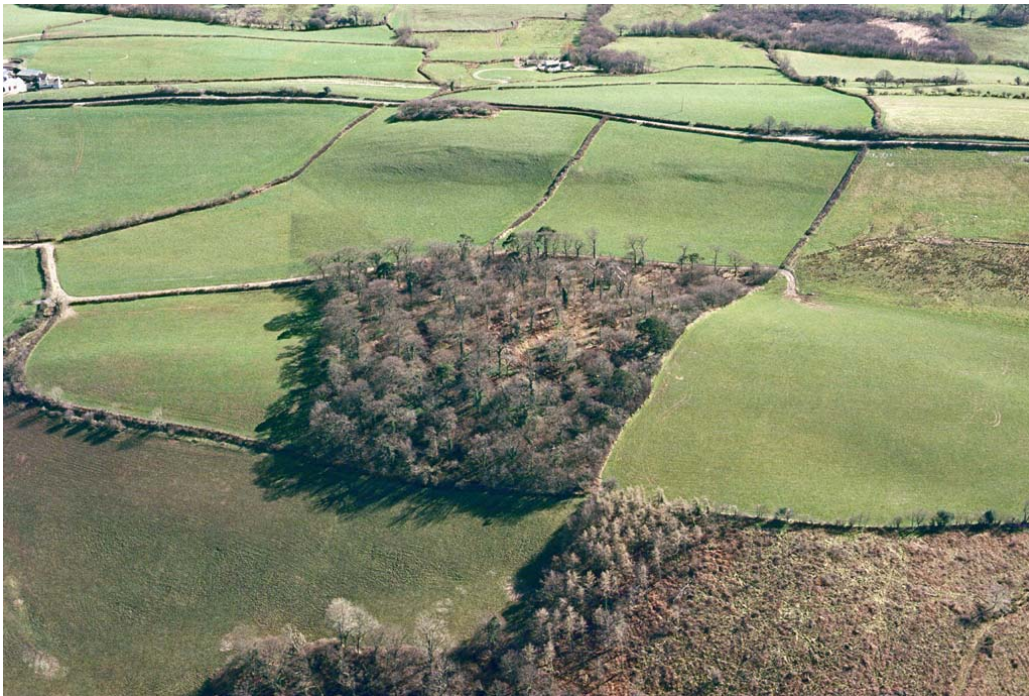
Aerial photograph of 641. RCAHMW Crown Copyright © reference DI2007_1712.

By 1994 the Cadw field monument warden reported that the site appeared much as that recorded by the Ordnance Survey, with rather an undulating upstanding bank on the southwest, west and northwest, and a pronounced scarp on the north and northeast. The western entrance was identifiable, but there was little evidence for any entrance on the south. No internal features were visible.

The enclosure lies in a small wood and is very overgrown with trees, bracken, brambles and scrub. The woodland makes the available views from the site difficult to assess.

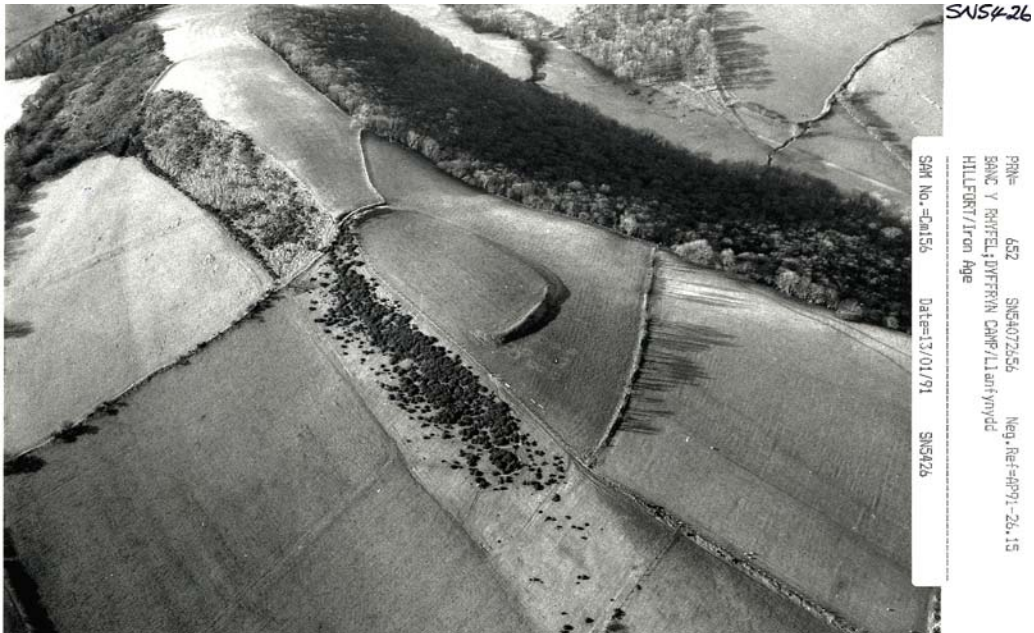
Aerial photograph of 652. Reference DAT AP91-26.15.

A small, oval, univallate enclosure, situated on an east-west running ridge at approximately 230m above sea level, that commands far ranging views across the valleys to the north and south. It is defended to the north, east and west by a single bank and ditch, and to the south by a naturally steep slope. In 1983, and subsequently reported in later visits, the Cadw field monument warden reports that the east and west ditches survive to an interior height of up to 1m, with an exterior height of up to 2m, and that the ditch is just traceable as a slight dip 0.15m deep on the east, 0.60m deep on the west. On the north there is a scarp giving a bank 2m high externally. The south slopes do not appear to have been artificially reinforced.

The simple entrance appears to have been in the southeast, between the bank and the natural slopes. No interior features are visible.

The interior and the northern scarp have been quite heavily ploughed in the past, and the whole site is now within improved pasture, with some areas of gorse.

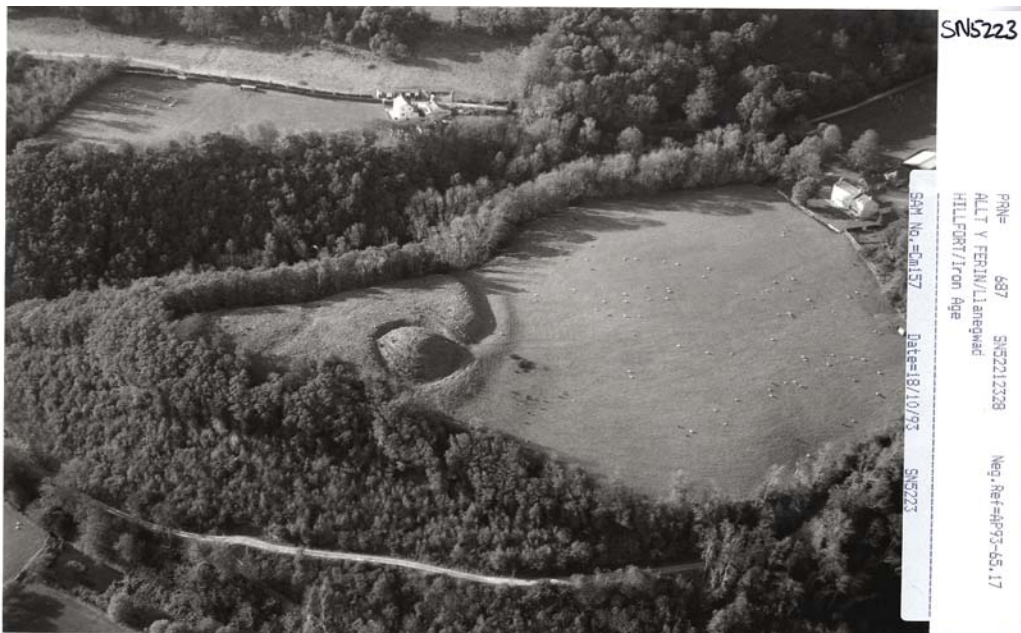
Aerial photograph of 687. Reference DAT AP93-65.17.

Allt y Ferin promontory fort is situated on a wooded promontory at some 80m above sea level with steep slopes on the east, west and south sides. On the north a well-preserved bank and ditch have been constructed across the neck of the promontory. The bank measures 3m high on the exterior, 1m high on the interior, and the ditch is approximately 1.4m in depth. HN Savory (1954) suggests a lateral entrance for the fort but no evidence appears to exist for this.

Some 800 years later the fort was re-used and adapted as a motte and bailey castle. The motte, 8m high, 12m diameter across the top, lies on the east side of the promontory and is surrounded by a narrow ditch with a 2m counterscarp. A bailey has been formed using the fort earthwork as a north boundary. A second slighter ditch and bank cuts off the tip of the promontory. It is uncertain whether this belongs to the Iron Age settlement or the later castle.

The whole scheduled area has in recent years been cleared of trees and scrub, and is now under improved pasture.

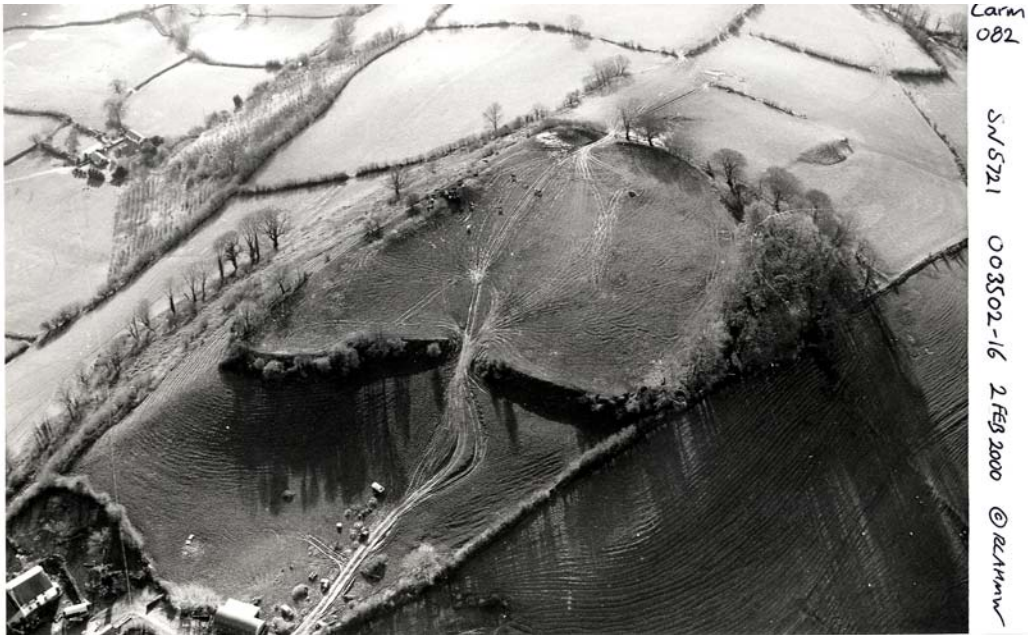
Aerial photograph of 704. RCAHMMW Crown Copyright © reference 003502-16.

On the summit of a hill, at approximately 140m above sea level, with fine views in all directions lies the roughly rectangular, univallate hillfort of Grongaer. It is defended by a bank that measures 1.1m high internally and 5m high externally, with a slight berm visible outside the bank indicating the probable position of the ditch. There are no other traces of a ditch. Two simple entrances are present: one on the southwest and another on the northeast.

The bank is best preserved on the short northeast and southwest sides. The natural steep slopes that exist to the northwest and the southeast defend the long sides of the enclosure, and here the bank is not so pronounced. The surface of the interior is irregular, and occasionally broken by outcrops of rocks, but there are no signs of internal features.

The interior of the fort is covered with short grass and is used as rough grazing; the banks are covered with grass with some gorse.

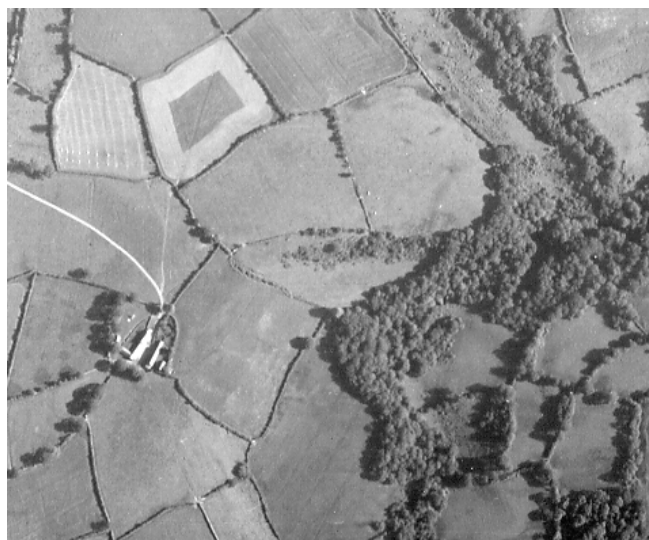
1946 aerial photograph of 4743. Reference – RAF 106G UK 1625 5101.

The RCAHM (1917) noted the field name of Cae Castell at this location but reported that it 'is not explained by any visible object and is now forgotten'. In 2008 the site visit discovered earthworks on the ground that established that this site was a southeast facing, triangular shaped, inland promontory fort, situated on a promontory created by the confluence of two streams. Ground to the east and south drops steeply to the streams below, and drawn across the level approach of the northwest side are two lines of defensive bank and ditch, that enclose an area of approximately 0.44ha.

The earthworks have been much reduced by ploughing. However, the curving inner bank and ditch are best preserved, and were traced for a length of approximately 86m. The inner bank has an internal height of c.0.3m and an external height of c.1.5m. The outer bank and ditch are visible, particularly on the west, but only as a slight earthwork. It was not possible to discern the position of the entrance.

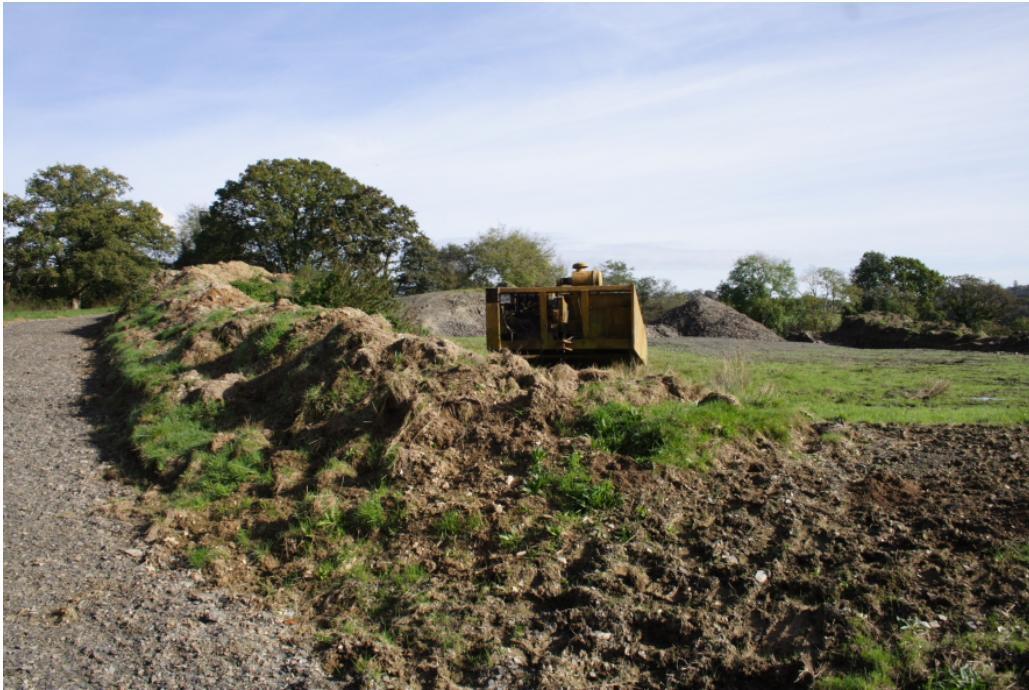
In 2007 it was discovered that the site had been destroyed. The spur of land had been quarried for shale to construct trackways. There is now no trace of the earthwork on the ground.

Looking NE across area of site now destroyed by quarrying

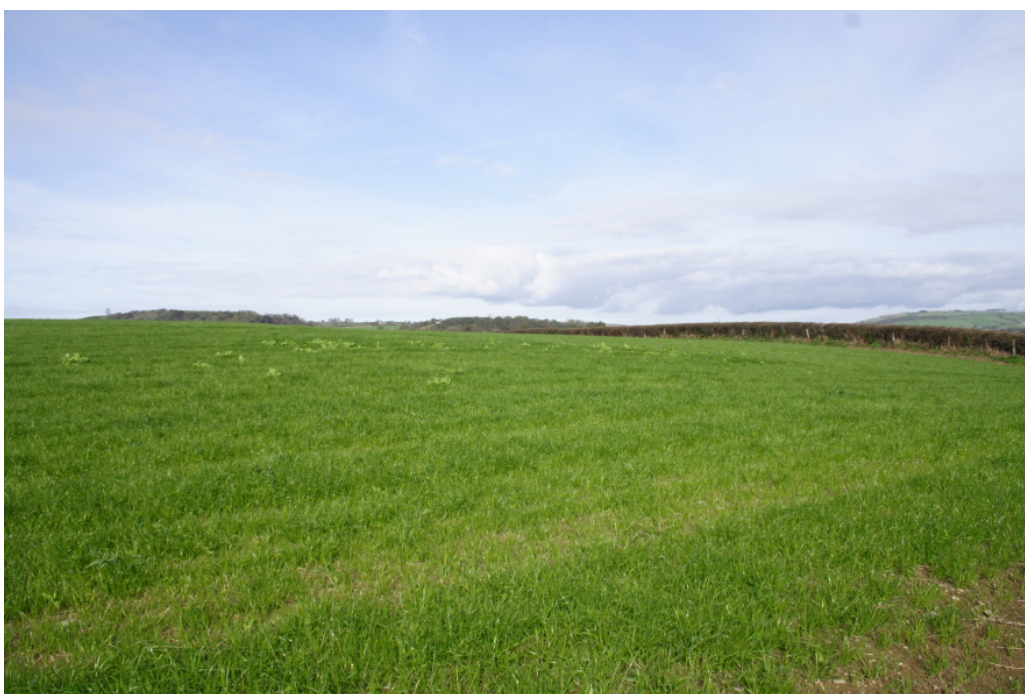
Nothing was visible on the ground in 2007. The site is within a field under arable; currently maize, and is regularly ploughed. It lies at 60m above sea level on a gentle southeast facing hillslope.

Facing NNW across area of cropmark site

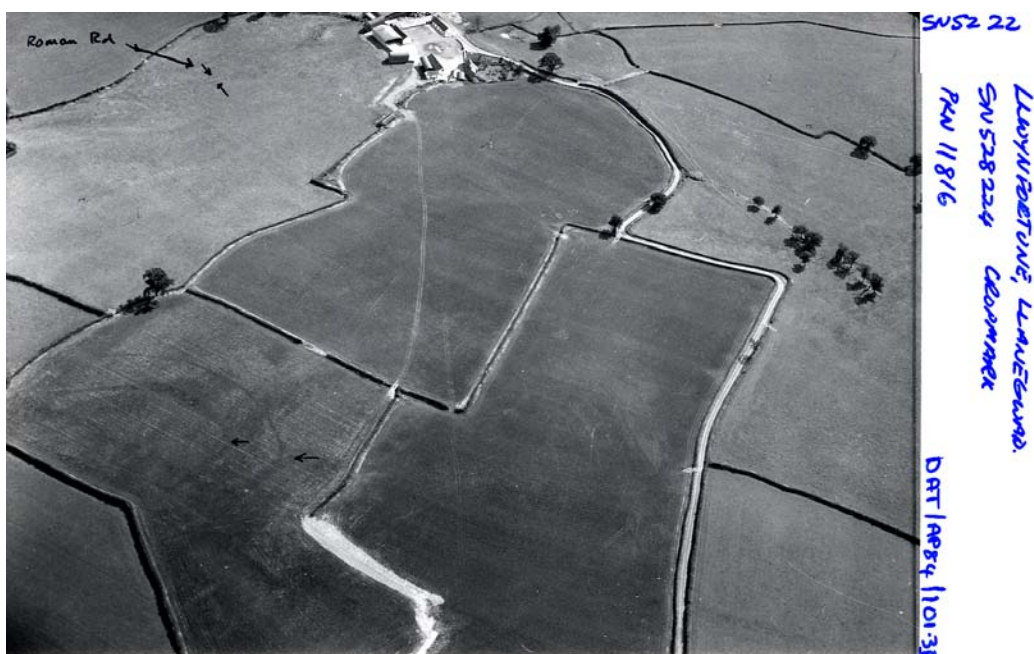
Aerial photograph of 11816. Reference DAT AP84-104.3.

A curving section of what appears to be a large bivallate enclosure or an enclosure with a concentric annex was noted during aerial survey in 1984. The whole circuit of the defences was not visible but it is probably circular in shape with two concentric ditches showing as dark cropmarks, but no sign of parching for the ramparts. The distance between the two ditches is about 30 metres.

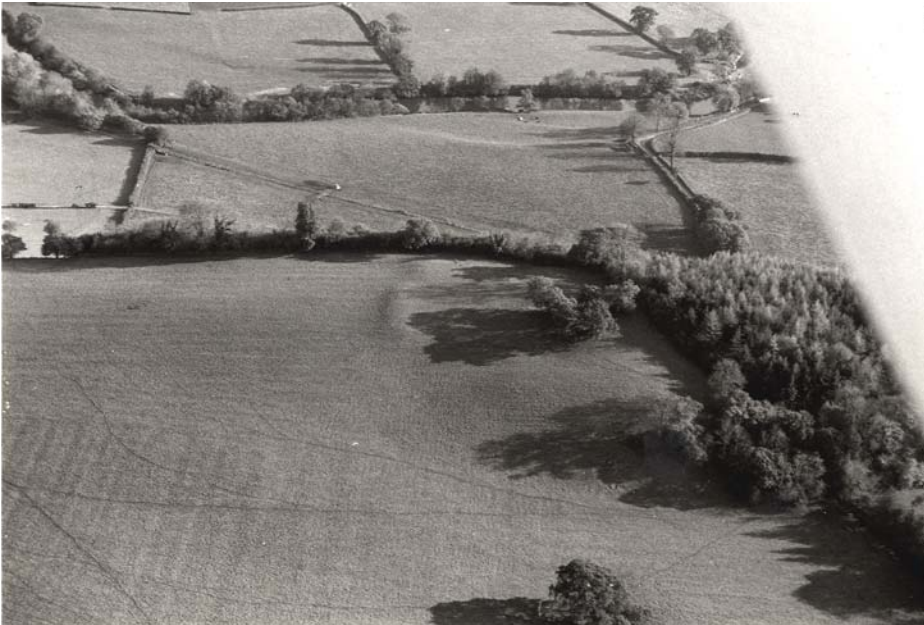
Aerial photograph of 16417. Reference DAT AP93-64.12.

The 2008 site visit was the first to this site and established that it was an inland promontory fort, situated on a south facing end of a narrow ridge of land at 60m above sea level. Steep slopes to the southwest and southeast naturally defended the enclosure, and to the north two lines of curving defensive bank had been drawn across the ridge of land to enclose an area of roughly 0.5 hectare. The outer bank had a maximum height of c.1.2m. The inner bank was c.1m high and had a visible outer ditch. There was c.27m between the two banks. Within the internal area of the promontory fort a telephone mast had been erected, and it had also been damaged by a small quarry; now extinct. The position of an entrance was not discernable.

The earthwork lies within a field of pasture, with woodland on the steep slopes.

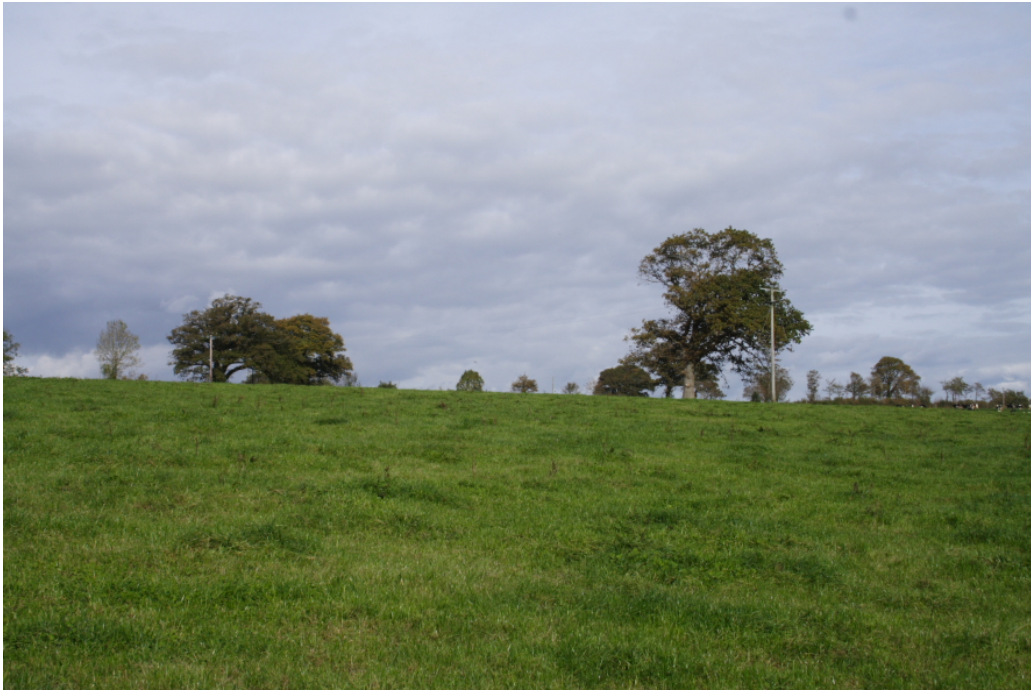
Nothing was visible on the ground in 2007. The site lies within a field of improved pasture at 40m above sea level, on a gentle southeast facing hillslope.

Looking NE across area of cropmark site

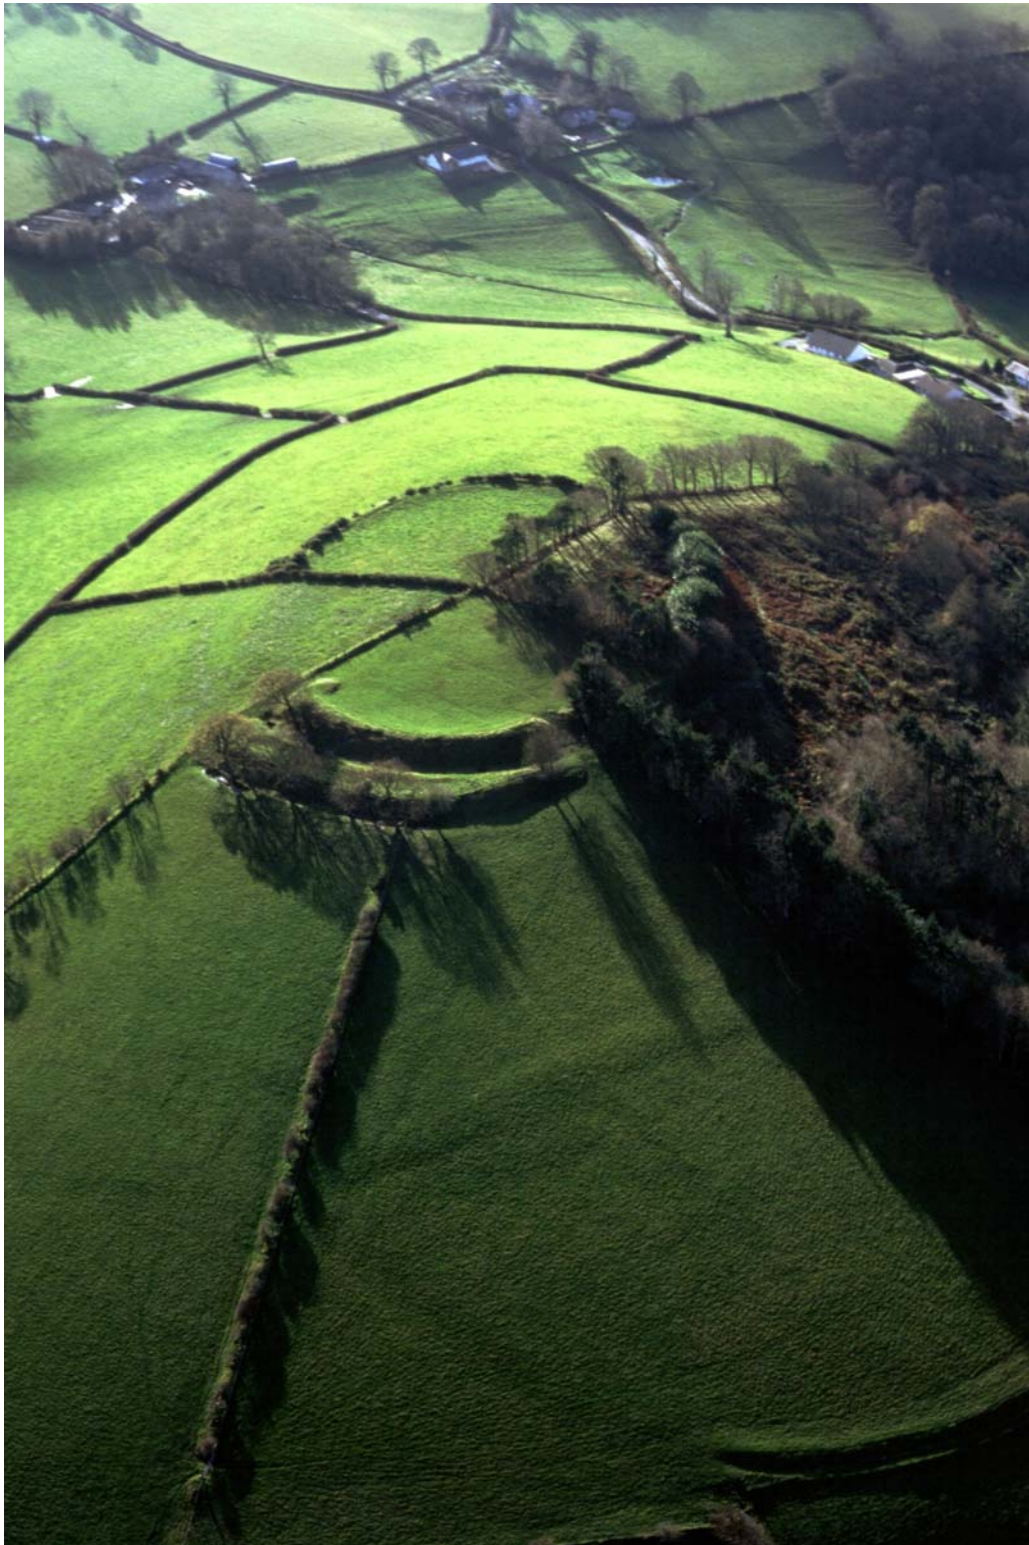
Aerial photograph of 741. RCAHMW Crown Copyright © reference 2002_cs_1600.

Impressive double banks and ditches are found in the northeast quadrant, although the outer ditch only survives in places. The ditch between the two banks is irregular and would appear to have been disturbed in the past. The northern half of the east entrance is well preserved. This part of the scheduled area is under rough pasture.

The northwestern quadrant is also well preserved. The single rampart here is 0.8 - 1m high internally and 1.3 - 1.6m high externally, with no trace of the ditch surviving. Much of the area is covered in bracken and the rampart is largely covered with laurels.

The dimensions of the bank in the southwestern section are similar to that of the northwestern section, with no trace of outer ditch. This quadrant has suffered from erosion by livestock over the years.

Within the southeast quadrant is where the bank, and half of the inturned entrance were removed. The bank is ploughed and very denuded. This area is under improved pasture.

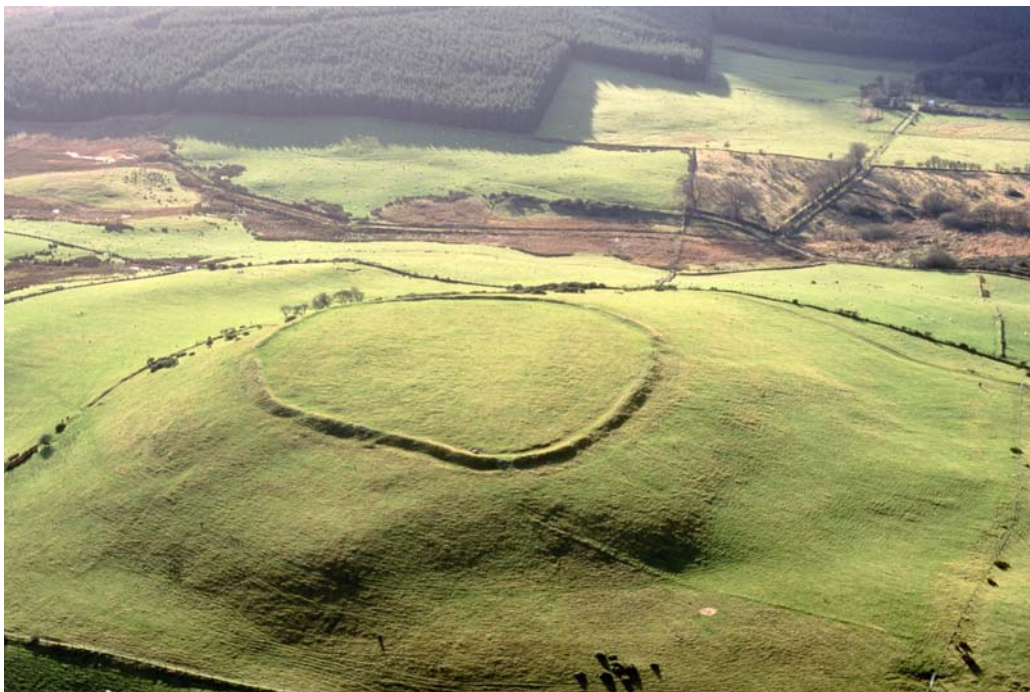
Aerial photograph of 787. RCAHMW Crown Copyright © reference 2002_cs_1640.

A very fine hilltop enclosure of approximately 1.2 hectares. It is sub-circular in shape, approximately 100m in diameter and defended by a single bank and ditch, with a simple entrance on the southeast. It is sited on the summit of a small knoll on Mynydd Pencarreg at 344m above sea level, and has commanding views of the surrounding area.

According to recent Cadw reports the bank has an external height of 1.8 - 2m, and an internal height of 0.7 - 1m. There are traces of the ditch in places. The Ordnance Survey reported in 1969 that plenty of stone was visible in the bank and within the enclosure, but no internal structures were apparent. More recently, erosion caused by livestock has revealed a rampart structure of soil and stones, and a possible stretch of rear rampart facing was visible on the north.

The whole site is covered in short grass and is used for the grazing of sheep.

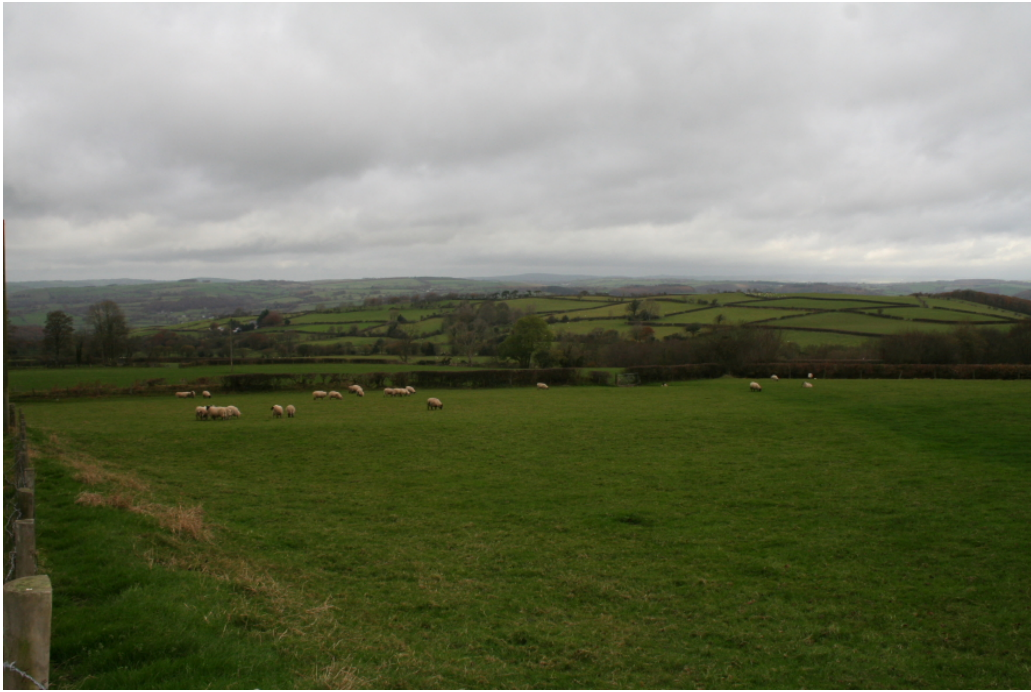
Castell Elwyn is a sub-circular enclosure situated on the western slopes of Mynydd Pencarreg, within a field called Cae Gaer, commanding extensive views to the north and south. It has a single bank that has been considerably spread by ploughing but survives as a visible earthwork, c.10m wide by 0.7m high, to the south and east, and as a slight change of slope to the north and west. The bank encloses an area approximately 50m by 40m. There was no evidence of an outer ditch or of any internal features nor of an entrance.

Looking N across circular earthwork of defended enclosure

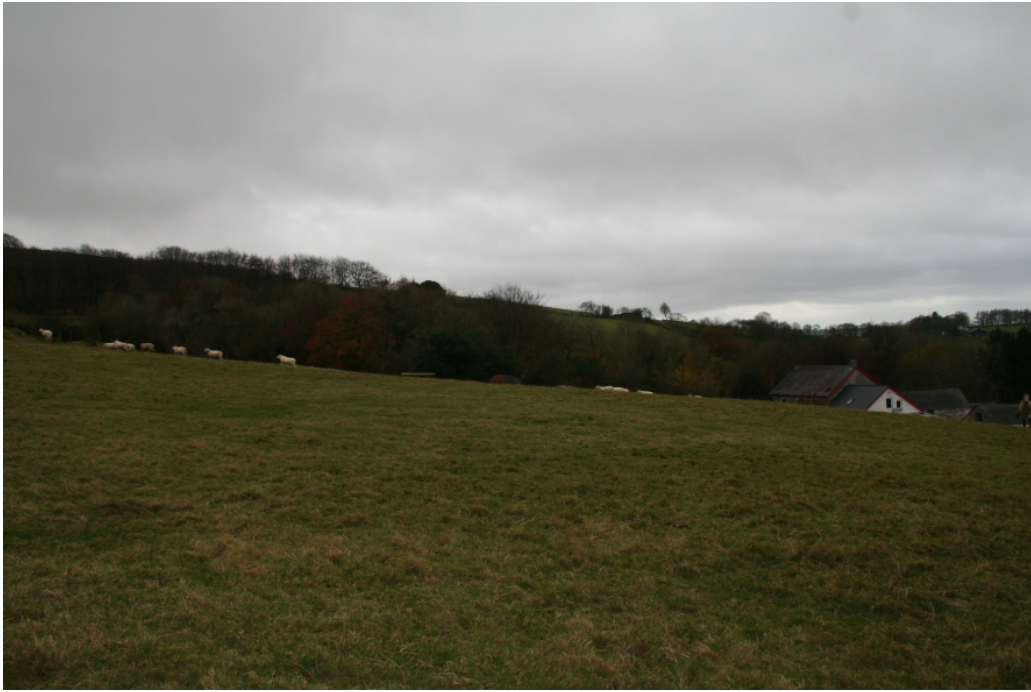
Looking S across area of site - nothing seen on ground

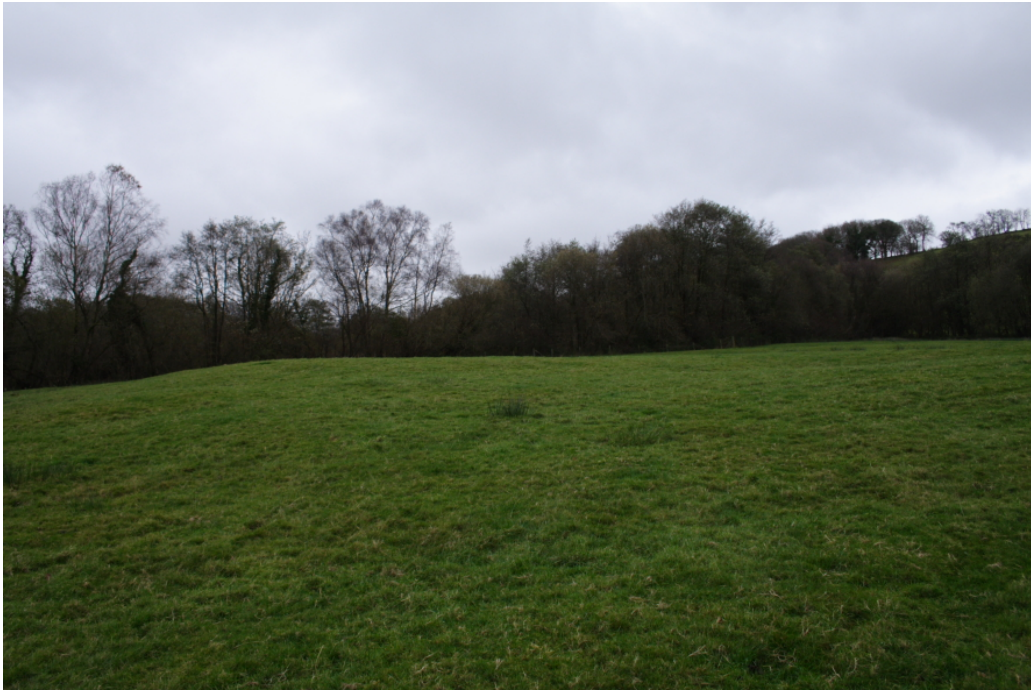
A sub-circular univallate enclosure located in a field of pasture at 170m above sea level. The site is on a gentle northeast hillslope, with a ploughed out bank that stands up to a height of c.1m and an outer ditch c.0.5m deep that peters out on the downward slope. The bank encloses an area approximately 70m by 50m. The Ordnance Survey in 1968 recorded a simple entrance on the downhill north side, but this is not clear on the ground in 2007. The eastern side of the enclosure has been damaged by a modern field boundary. A depression in the interior is reputed to have been a cock-pit.

Facing approximately E across ploughed out enclosure earthworks

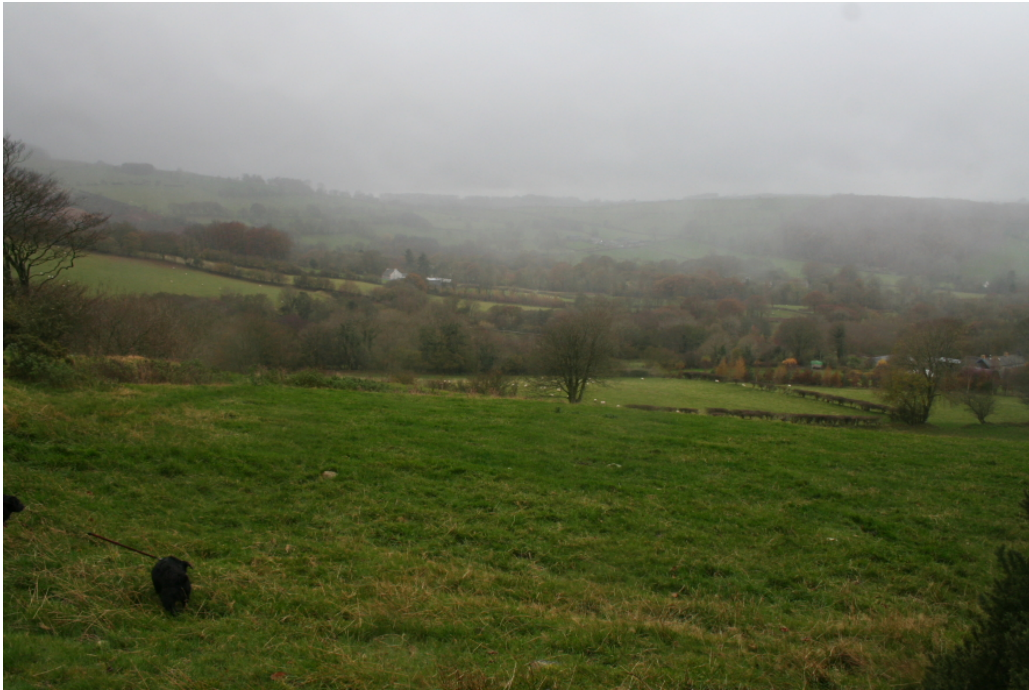
In 1972 the Ordnance Survey recorded this circular enclosure as a recognisable univallate earthwork. Situated on a steep west facing slope at 260m above sea level, it was 43m in diameter with a bank up to 1.9m high internally and 3.1m externally. A simple entrance was observed on the west side of the enclosure. A modern wall had damaged the enclosure on the eastern side. There was no evidence of any internal occupation.

Taken on summit of hill looking approx. NW across earthwork site- bulldozed flat in 1999

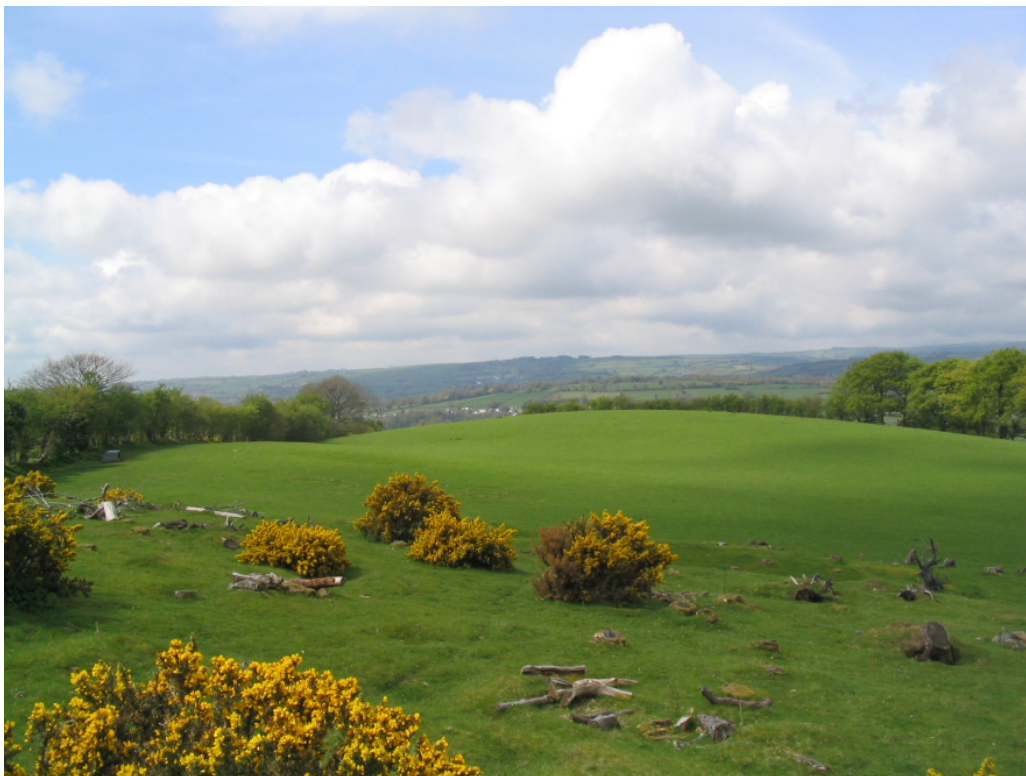
Looking W across internal area of enclosure earthwork
