BUILDING RECORDING AT THE GRANARY BUTTERHILL FARM S. ISHMAEL'S PEMBROKESHIRE

RHIF YR ADRODDIAD / REPORT NO. 2007/35
RHIF Y PROSIECT / PROJECT RECORD NO. 62773

BUILDING RECORDING AT THE GRANARY BUTTERHILL FARM, St ISHMAEL'S PEMBROKESHIRE

In advance of the conversion of an agricultural building known as 'The Old Granary', at Butterhill Farm, St. Ishmael's, Pembrokeshire, a RCHMW level 2 drawn, photographic and written record of the building was undertaken by Cambria Archaeology. This report presents the record made. Additional photographs are included in the archive for the building record.

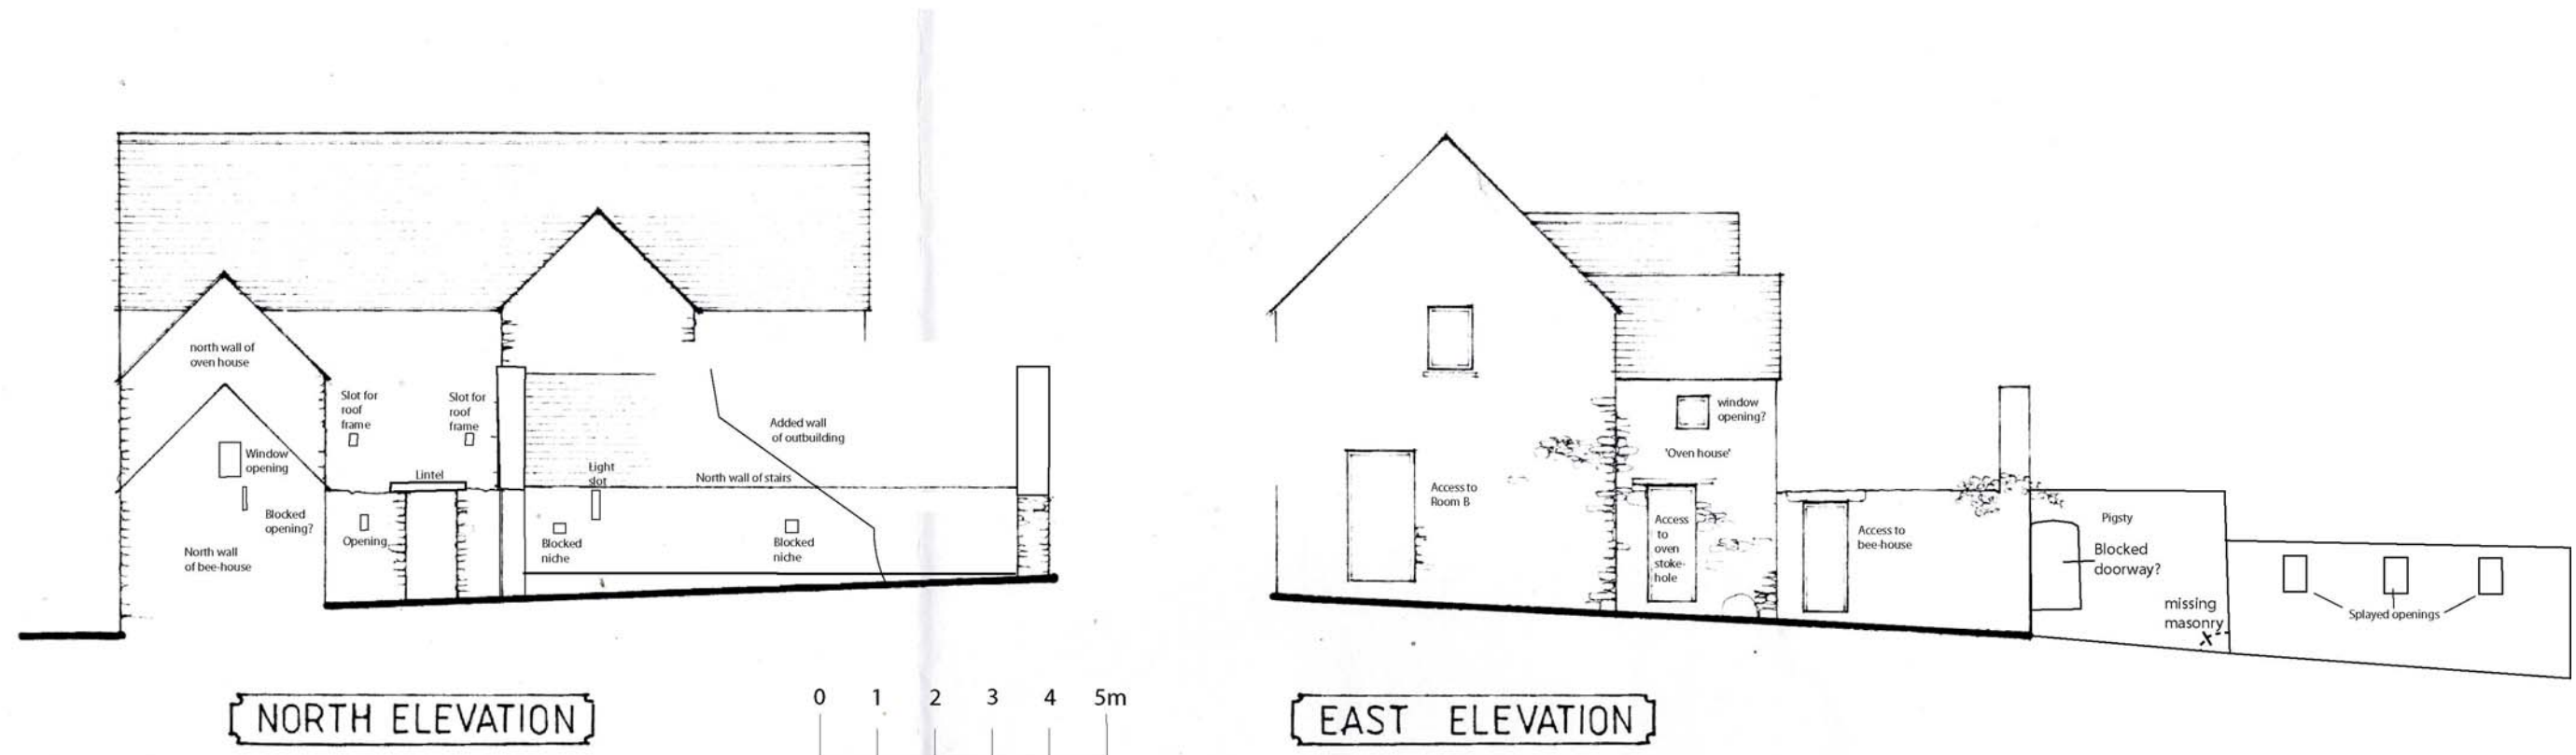
Figure 2: North and east external elevations

East facing exterior elevation (Fig: 2, Photos: 6, 7, 8,)

This elevation has a door opening on the ground floor and a rectangular loft window above. The 'Oven-house' elevation has a small square opening above the doorway leading to the oven hearth, perhaps suggesting that the annexe had a different function before the oven was constructed.

North facing exterior elevation (Fig: 2, Photos: 10, 11, 13)

This elevation includes various out-houses built against the north side of the main structure, including a probable corn-drying oven, a bee-house and a pig-sty, lean-to structures, and broad stone-built stairs leading to the upper floor. Light slots in the north wall of the 'oven-house' and outhouse A, may suggest that the bee-house and pigsty are later additions. Likewise outbuilding B appears to be a later addition, its back wall incorporating the north wall of the steps leading to the granary.

Two slots that would have supported the roof of outbuilding A (see fig 2), indicate the original height of the roof.

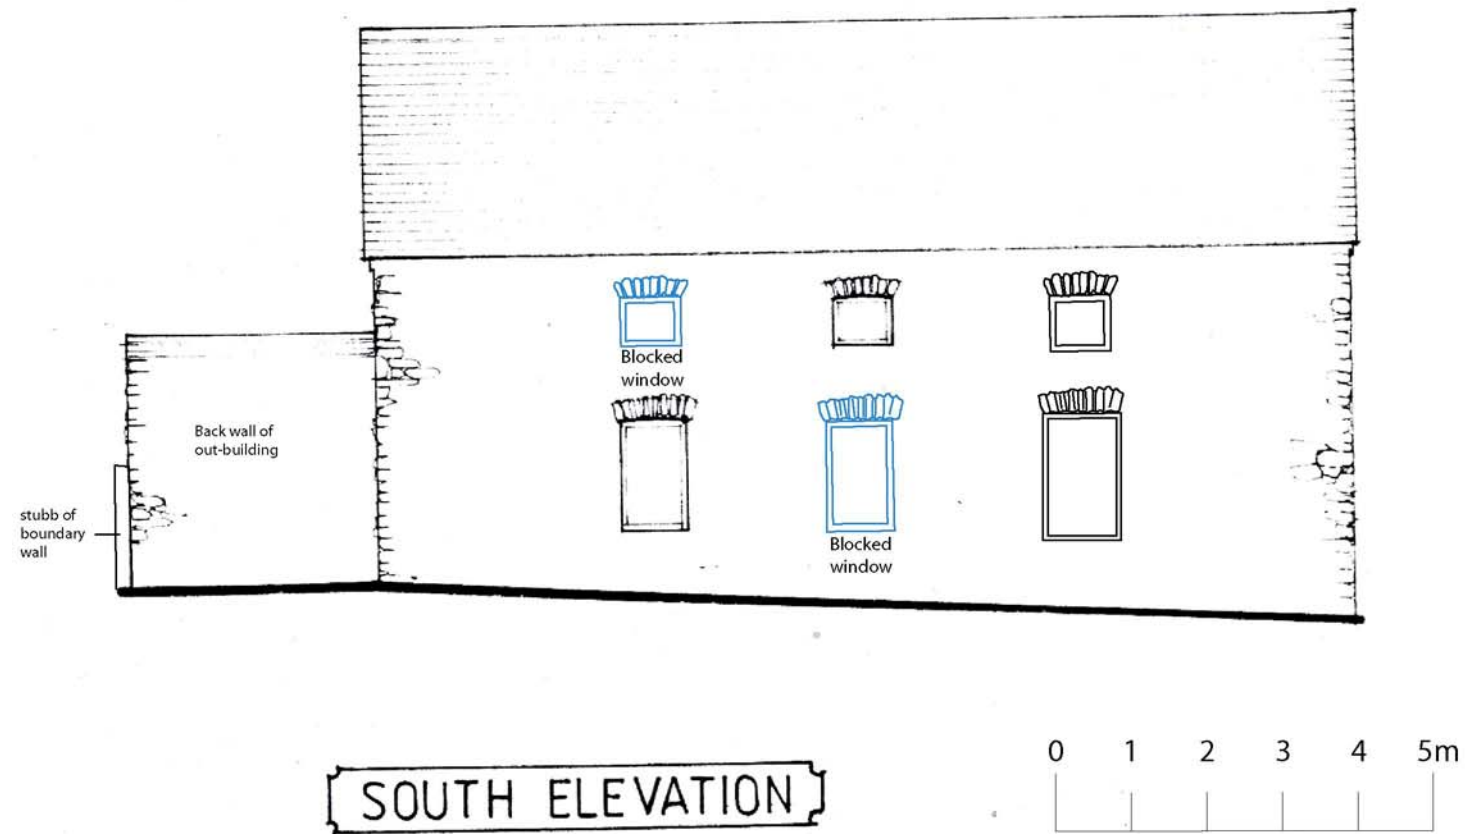
Figure 3: South and west external elevations

West facing exterior elevation (Fig: 3, Photos: 1,2)

The west end has a large cambered-headed entrance to the cart-house with stone voussoirs and a cambered-arch loft window above.

South facing exterior elevation (Fig: 3, Photos: 3, 4, 5)

The south elevation originally had three window openings on the ground floor and three on the first floor. The central ground floor opening has been blocked, as has the westernmost first floor opening. The easternmost ground floor window is larger than the others.

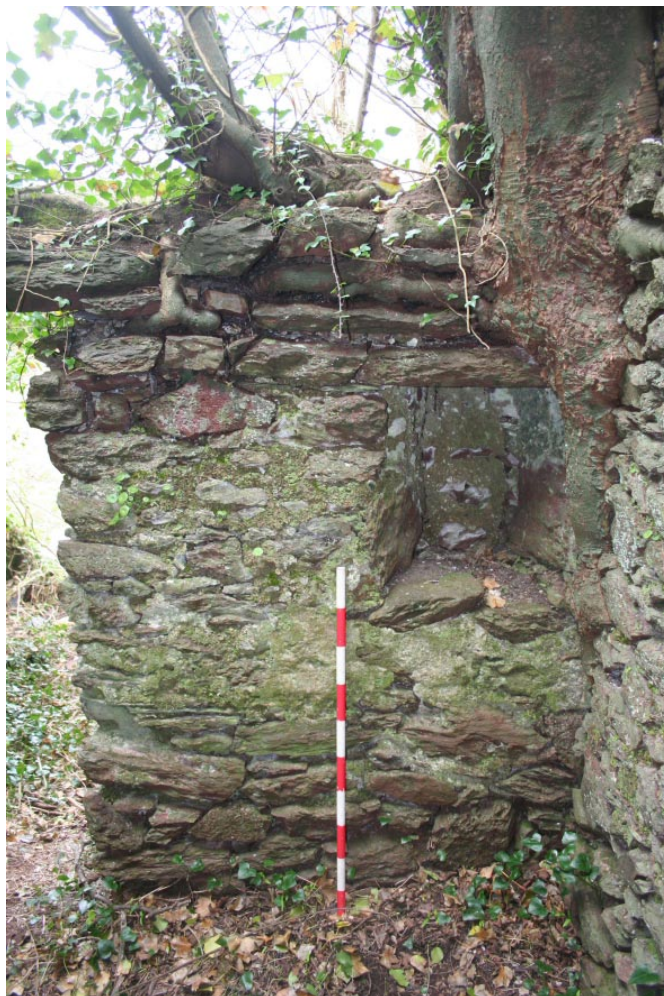
Photo 14: Opening in north wall of outhouse A

These structures have butt joints with the main building. The staircase leading to the granary is also butted up against the cart-house. Openings in the north wall of the staircase and the corn-drying structure (see fig. 1 and photos 14 and 15) suggest they pre-date the bee-house and the other outhouses. The corn-dryer itself (figs 16-22), may be a later modification to a previously existing structure, as is suggested by the upper window in the east elevation (see fig. 2) and a possible blocked opening in the north wall, partially obscured by the (later) bee-house wall (see fig 1 and photo. 15). Outhouse B also appears to be later, incorporating the north wall of the staircase in its back wall (see fig. 2). Phasing of the bee-house and pigsty needs further clarification. The corn-drying oven appears to be of 19th or 20th century origin. Fragments of a 'Thistle Boiler' are not thought to be associated with the original function of the oven.

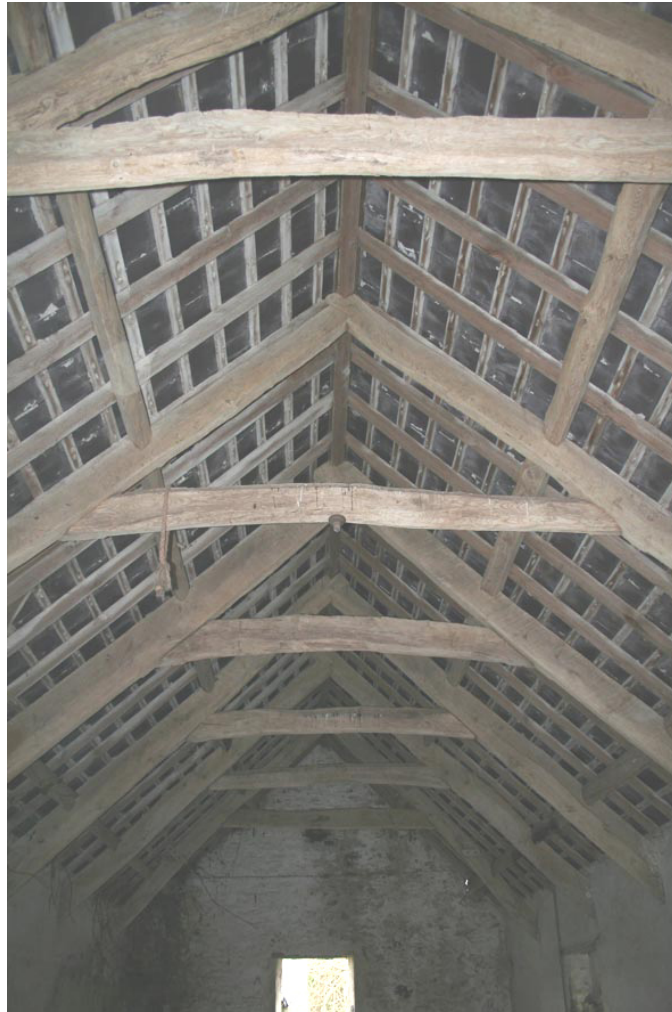
Photo 27: Roof structure in Granary

The roof consists of 6 roughly chamfered pegged collar trusses with two rows of purlins.
