# DANE HILL, SPITTAL, PEMBROKESHIRE ARCHAEOLOGICAL EVALUATION and WATCHING BRIEF

JUNE / AUGUST 2007

Prepared  
by  
Dyfed Archaeological Trust  
for  
Mr & Mrs R Davies

REPORT NUMBER: 2007/47  
PROJECT RECORD NUMBER: 62916

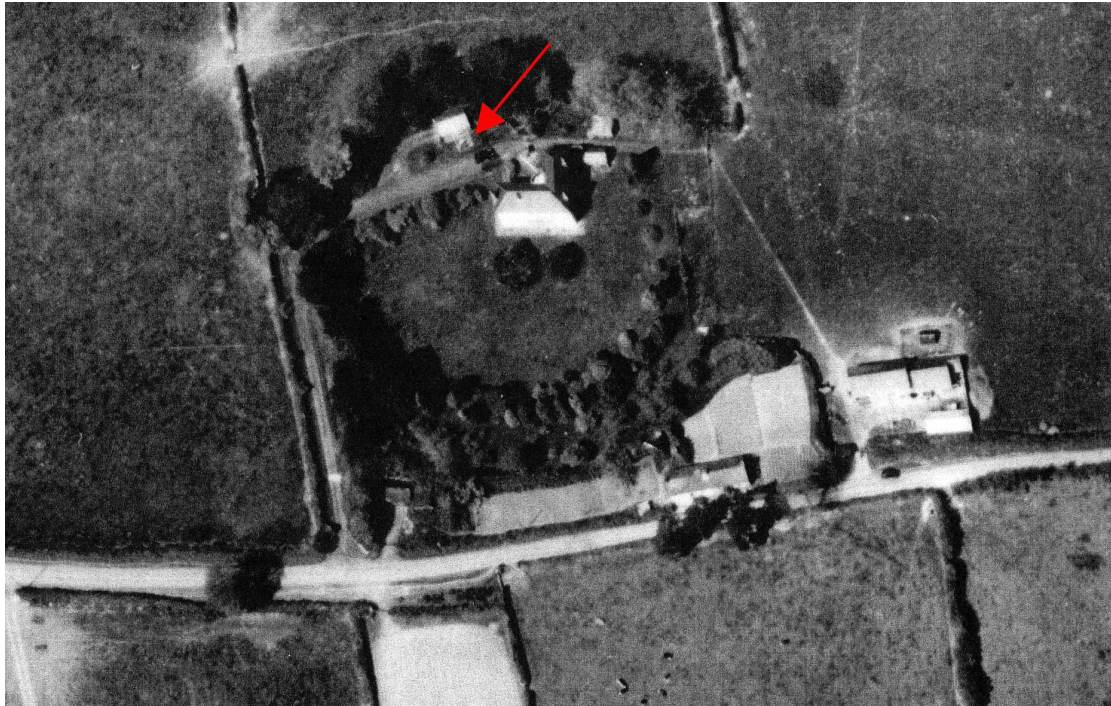
Figure 4: Aerial photograph from 1955 (Meridian Airmap), red arrow indicates features to south of garage.

Hand cleaning of the trench revealed a curvilinear cut feature (context 204) containing discretely placed small and medium sized angular stones (context 202), which appeared to have been set within the 0.24m wide cut 204 (Plate 5). During the machine excavation some of the stones had been displaced leaving their impressions in the reddish brown silty clay soil fill of 204 (context 203). In plan 204 was shown to be 2.3m long, extending beyond the centre of the south side of the excavation trench and continuing beyond the eastern end of the trench. On excavation, cut 204 was shown to be U-shaped, uniformly 0.23m deep along its exposed length and had been cut through the B-horizon soil (context 201) to slightly cut the natural subsoil (context 205). Not enough of this feature was exposed to fully characterise it, and it had been quite heavily disturbed and robbed of much of its stone fill. Whilst it cannot be ruled out as an Iron Age feature, judging from its relative superficiality it is perhaps more likely to have functioned as a garden feature or small boundary for the driveway access to the property. An aerial photograph taken in 1955 (Fig. 4) clearly shows some formal arrangement adjacent to the southeast side of the garage in the same location as the feature. No dating evidence was found in the fill of 204.

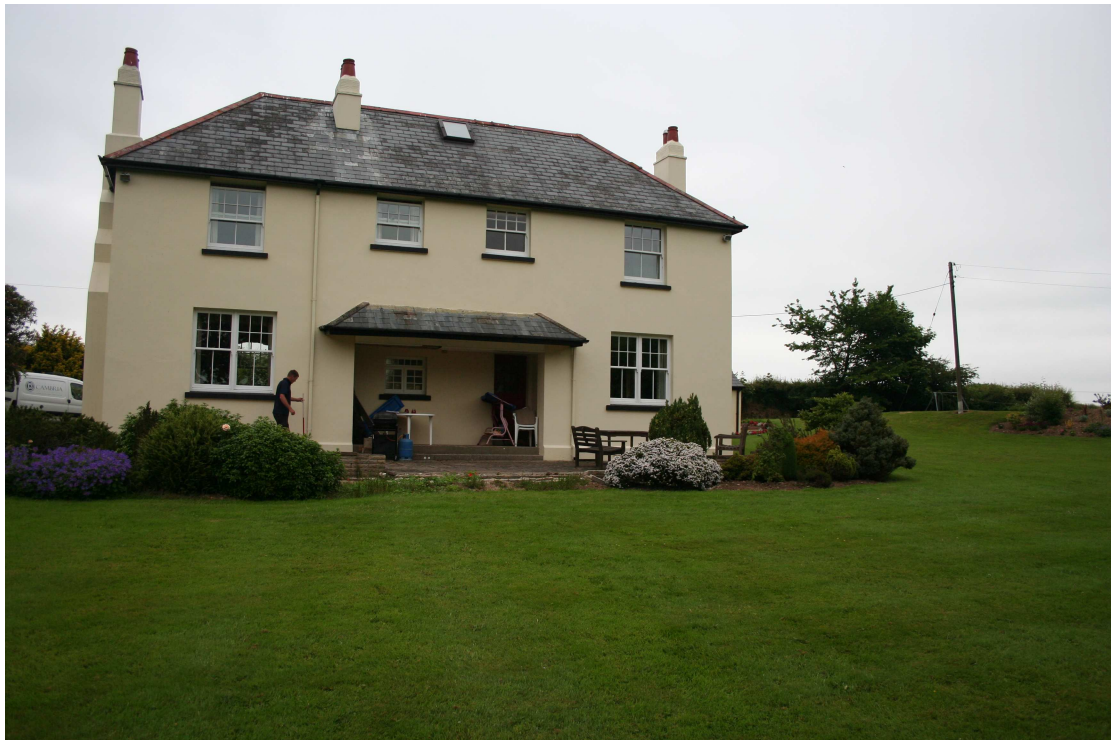
Plate 1: Dane Hill looking north, note rampart to right of the house

The small village of Spittal (Fig.1) lies 1 mile to the east of the A40 trunk road some 5 miles to the north of Haverfordwest in Pembrokeshire. Dane Hill (Plate 1) lies on the eastern edge of the village, just below the crest of a gentle south-facing slope, tucked behind and overlooking properties known collectively as Spring Gardens. Dane Hill and its garage are both situated within the interior of an Iron Age defended enclosure (PRN 2471 NGR SM97872294). The enclosure, known now as Spittal Rath (Fig.2), is oval in shape and measures about 75m east to west by 65m north to south and has a single defensive bank enclosing an area of about 0.27 hectares. The Royal Commission on the Ancient and Historic Monuments in Wales (RCAHMW), after visiting the site in 1915 described the curving rampart as being *"....much disturbed by cultivation; at its best it rises 3 feet and falls 6 feet to the outer level. There are no indications of a ditch"* (RCAHMW 1915, p385). Today the enclosure bank is much more disturbed having been breached by an access drive on its western side, and heavily landscaped on its northern interior side as well as being planted with trees and incorporated into flower beds elsewhere along its length. Some of the relatively recently built houses in Spring Gardens have added to the destruction of the earthwork that had already taken place on its southern exterior. The building of Dane Hill, sometime in the 1930s, with its access drive, and the landscaping of the garden is likely to have been destructive to much of any previously surviving archaeology in the interior of the enclosure. The original garage itself, even before any rebuilding, slightly impinged on the interior side of the enclosure bank.

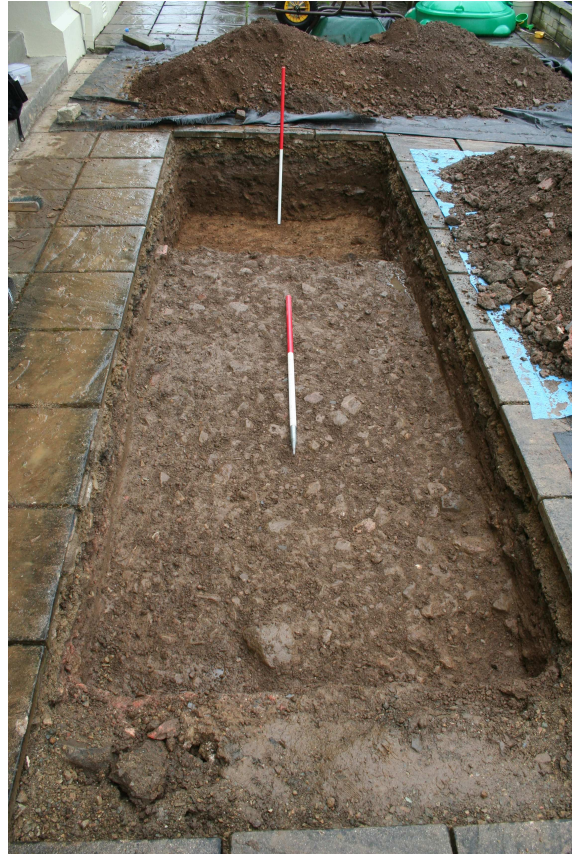
Plate 2: View of Trench 1, looking east

This trench (Plate 2) was hand excavated through the flagstone surface of a patio and was located some 0.9m from the rear (south) of the house. The trench measured 4.15m east to west by 1.4m north to south and was aligned parallel with the house.

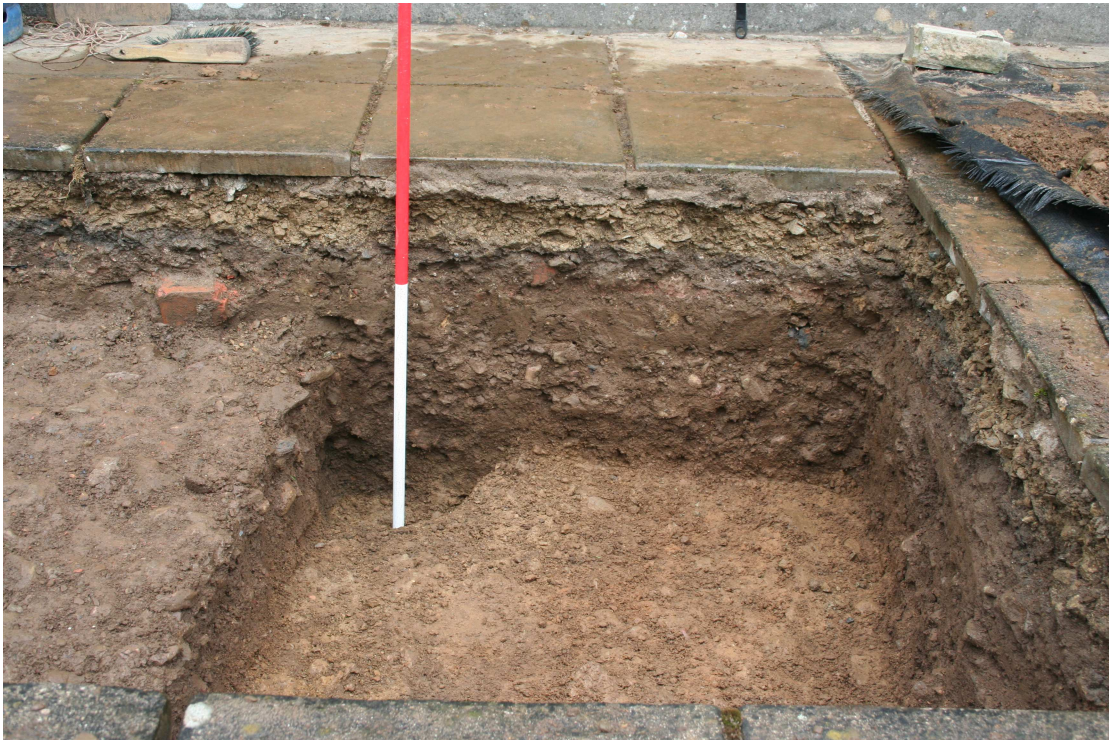
Plate 3: View of presumed posthole 107, looking north

Excavation and removal of layer 103 revealed a level compact surface (context 104). This layer was 0.18m deep and comprised a dark brown silty clay soil containing 80% large, medium and small angular stone fragments with occasional coal fragments. Once disturbed this layer broke up easily but had been purposely compacted, presumably during the original building construction, to create an area of hard standing adjacent to the back porch entrance to the house. At 3.1m along the excavation trench, from the western end and on its northern edge, a circular feature (context 107) was revealed which cut layer 104. This feature (Plate 3) was only half exposed, continuing beyond the northern edge of the excavation, but it was clearly circular, measuring 0.42m in diameter and 0.54m deep, with vertically cut sides and a nearly flat base. On excavation, 107 proved to be filled with building demolition debris in the form of broken brick, tile, and mortar fragments along with a high percentage of small angular stone fragments (context 106). The shape and form of 107 suggests that it was a posthole, and its location adjacent to the centre of the rear porch of Dane Hill may indicate that it once held a post that may have supported a verandah roof or other annexed area of the house, possibly covering part of the hard standing surface 104.

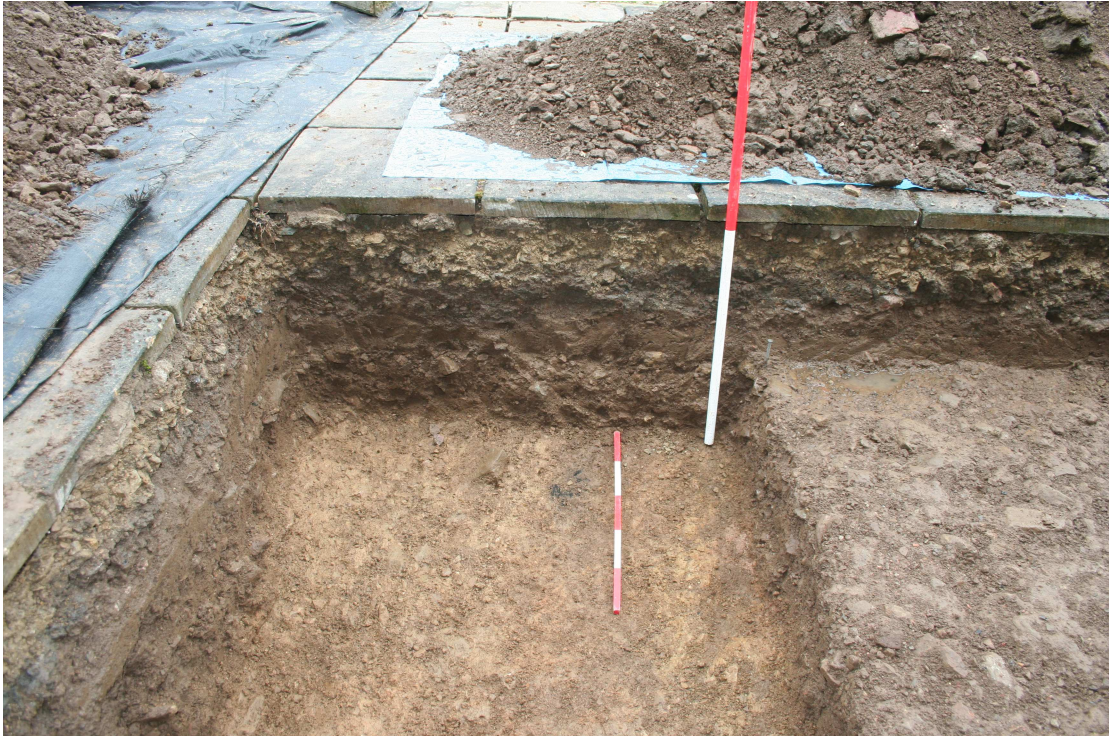
Plate 4: View of north facing section of test excavation in Trench 1

A test excavation (Plate 4) across the eastern end of the evaluation trench showed that the compacted layer 104 was laid directly over the natural subsoil (context 105), which comprised a yellowish brown silty clay soil containing c.70% small and medium sized angular fragments of shale. Presumed posthole 107 was seen to cut the natural subsoil but no other archaeological features or deposits were observed either within or overlying 105.

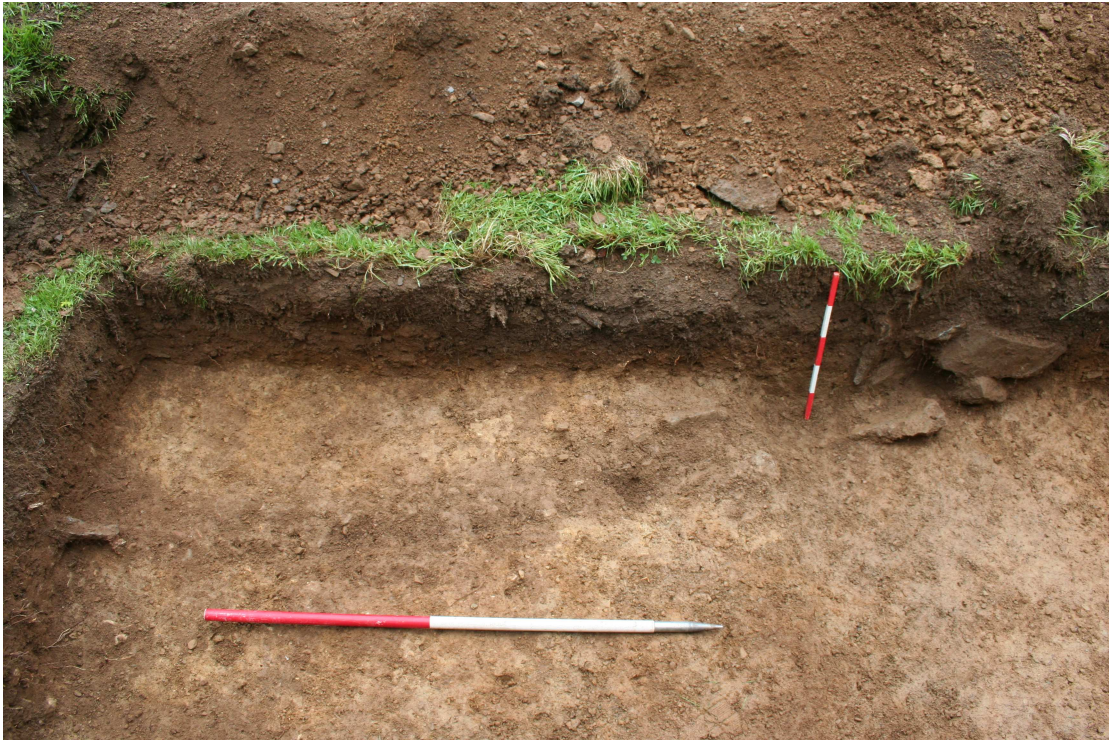
Plate 5: View of curvilinear feature 204, looking south

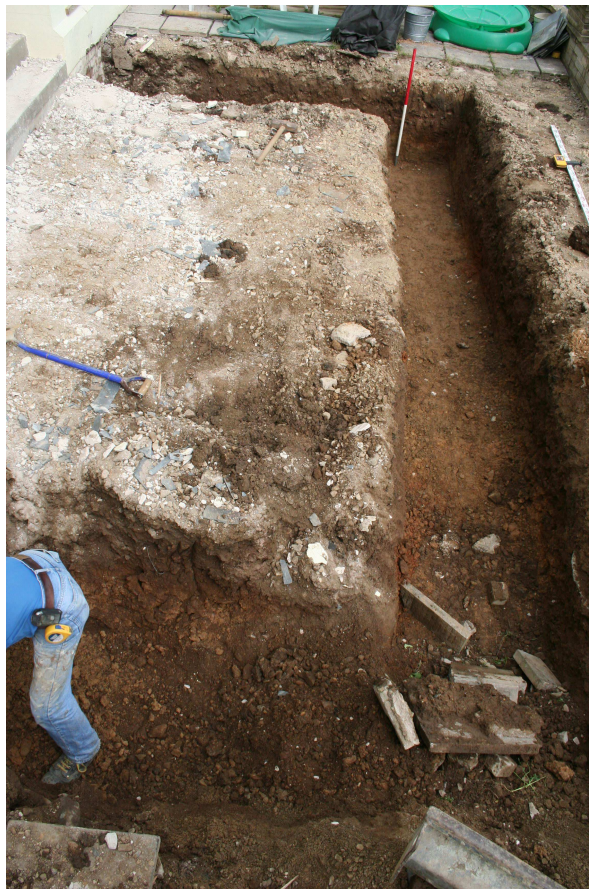
Plate 6: View of house extension footings, looking east

The foundation footings excavation for the house extension were 0.80m wide and dug to a depth of 0.9m below the present ground level of the patio (Plate 6). The west and east wall footings projected from just to either side of the back porch for a distance of 3.5m before being connected by the 6.1m long east-west footing for the south wall of the extension.

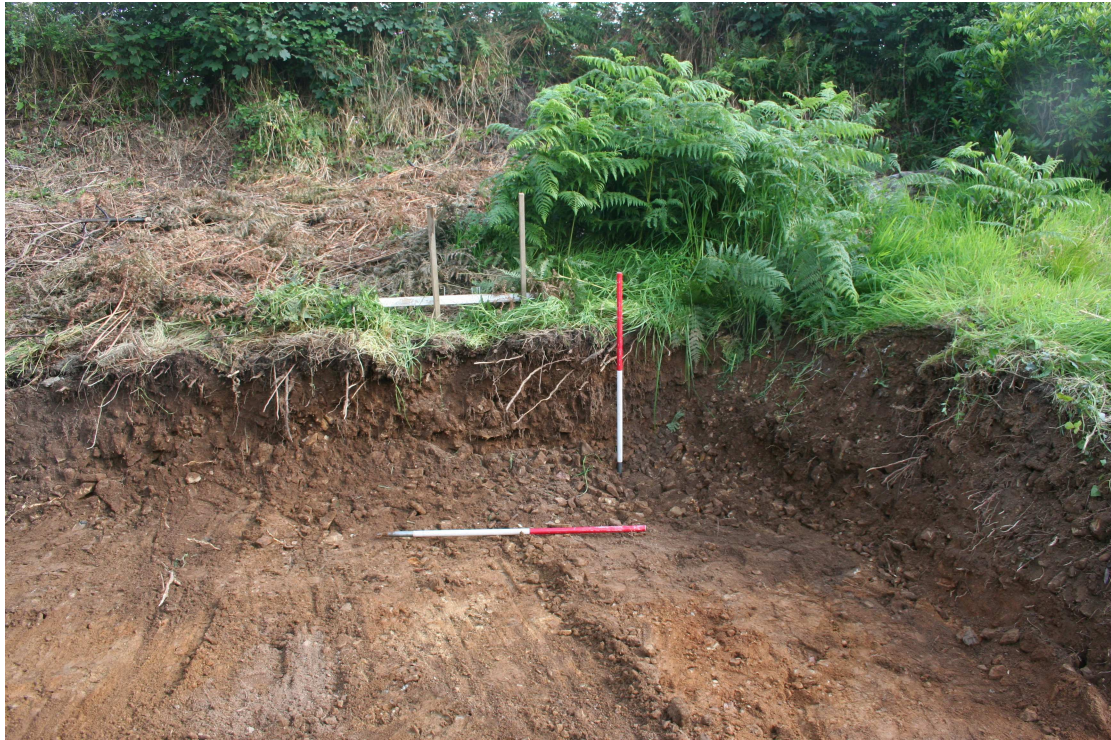
Plate 7: Revealed south facing section along interior of rampart

During the ground clearance some apparently recently deposited material (context 402), which formed a modern bank, and other dumped surface material lying on the south side of the enclosure rampart were also removed, revealing a clean south facing vertical section along part of the interior of the enclosure rampart (Plate 7). The section was 0.7m high (c.0.65m above the present ground surface) and revealed the structure of the rampart as a dark reddish brown silty clay soil containing about 65% small and medium angular stone blocks (context 403) overlain by a 0.2m depth of turf and dark brown silty clay topsoil (context 401). In plan the stony rampart material 403 was seen to extend into the cleared area for an average distance of 1m but extending further at both the western and eastern ends where its limits were shown to curve distinctly, respecting the line of the extant rampart. At the northeastern edge of the cleared area a vertical west-facing section was exposed showing modern bank material 402 overlying the rampart material 403 (Fig.5 and Plate 8).

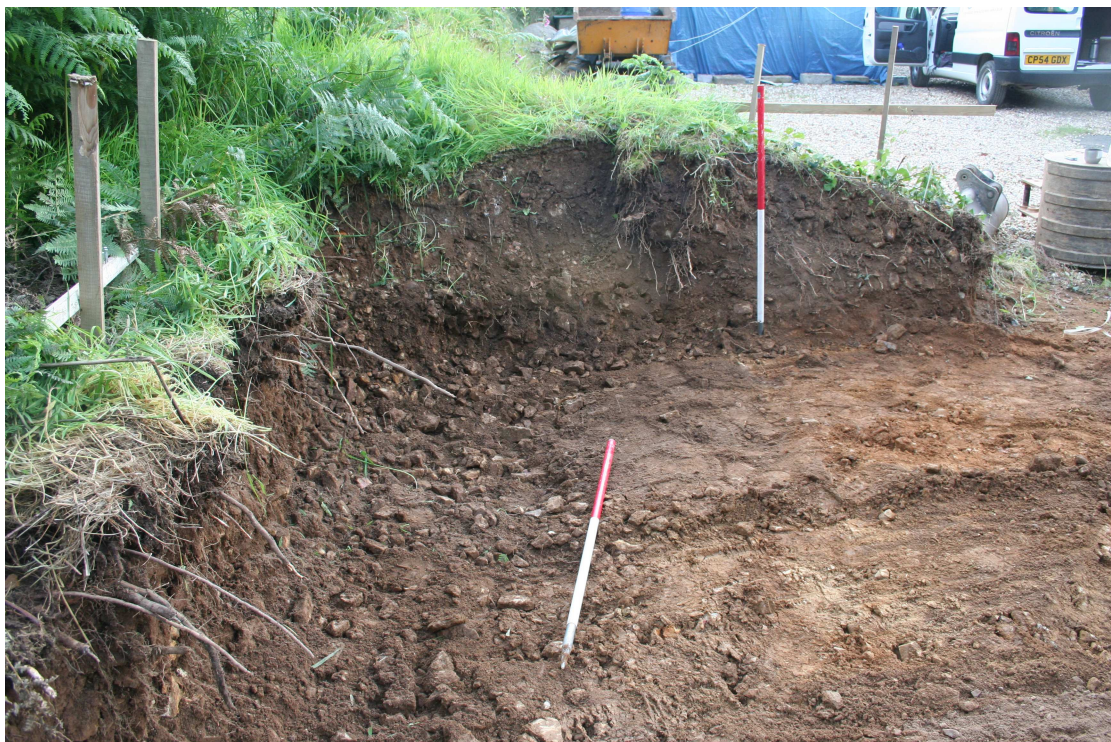
Plate 8: West facing section showing later bank 402 overlying rampart 403

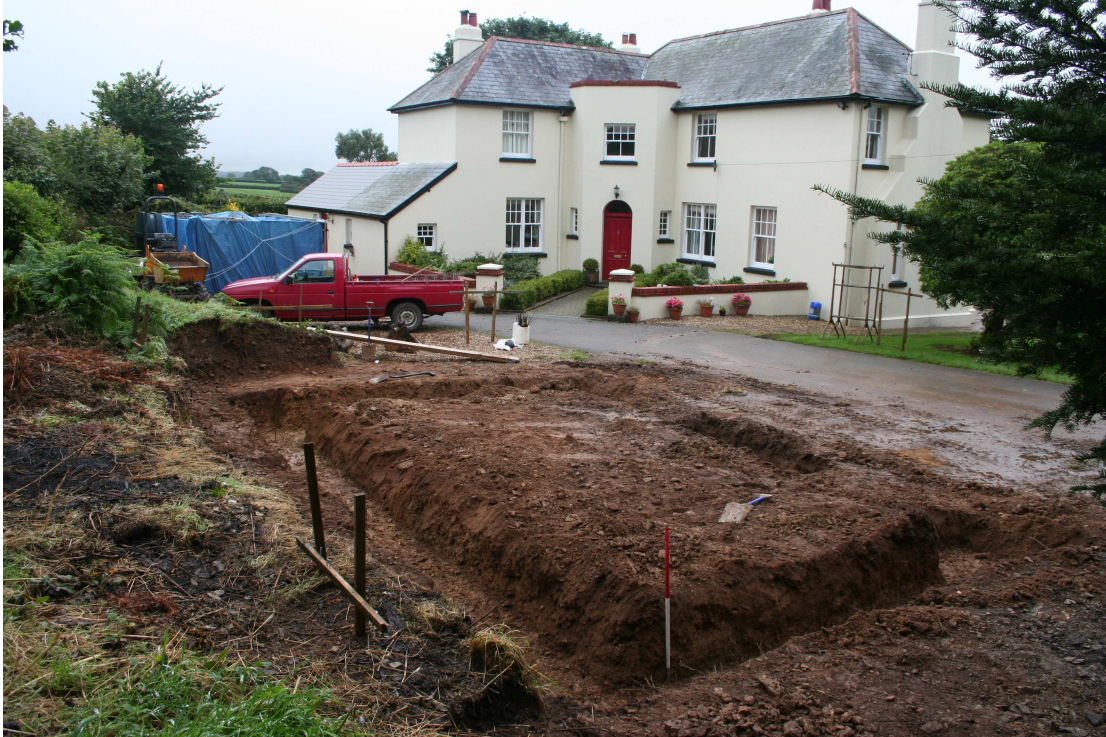
Plate 9: View of excavated garage footing, looking southeast

The footings excavations for the new garage were carried out by a machine using a toothed bucket and comprised a near continuous 0.6m wide trench around the footprint of the new garage (Fig.3 and Plate 9). The southern length of the east-west aligned trench was cut to leave two unexcavated entrance areas: the more westerly was 1.5m wide whilst the other was 2m wide. The depth of the footings was 0.5m throughout the excavations. The stratigraphic sequence throughout the southern length of the footings was the same as that found during the evaluation in Trench 2, with 0.2m of topsoil (context 404, same as 200 in Trench 2) overlying a 0.24m depth soil deposit (context 405, same as 201 B-horizon in Trench 2) which overlay a yellowish brown natural subsoil (context 407, same as 205 in Trench 2). No archaeologically significant features or deposits were observed in this part of the trench.

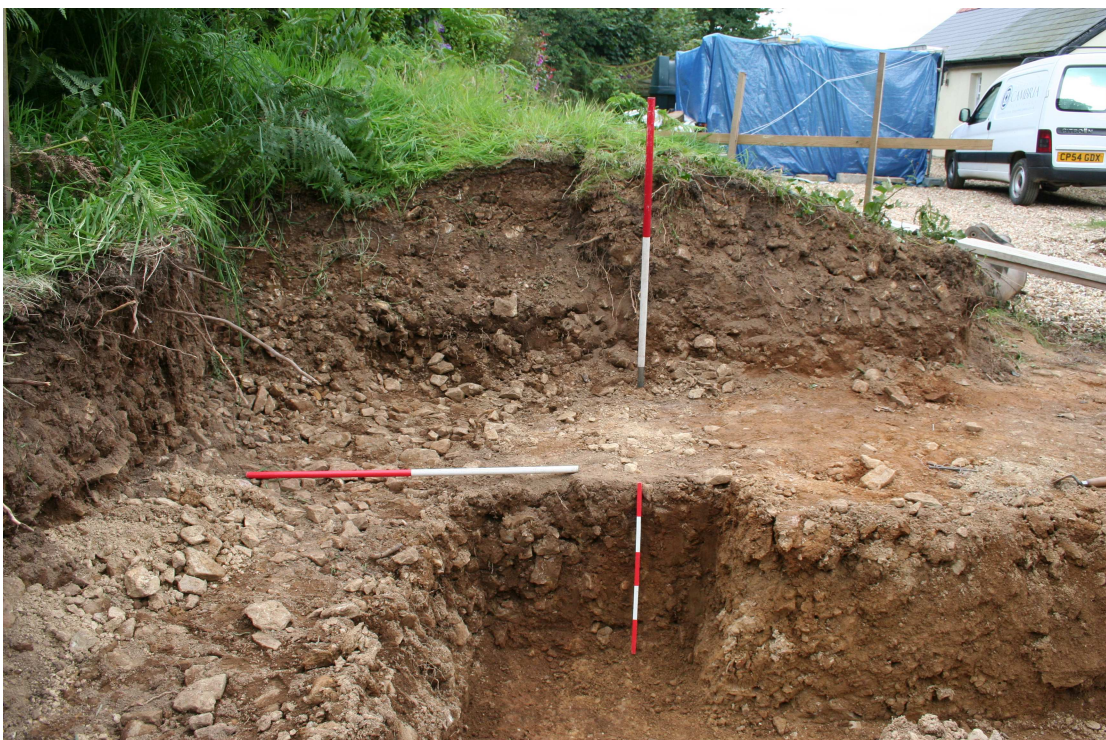
Plate 10: View of west facing section showing cut 406 and rampart fill 403 to left of 0.5m scale

In the northerly length of the footings trench the stony rampart material 403 was further exposed, and at the northeast corner of the trench was shown to fill a linear cut feature (context 406). In plan, cut 406 was 1.2m long and continued beyond the northern and eastern edges of the trench; further hand cleaning of the previously cleared area to the east of the footing trench revealed the edge of 406 continuing into the revealed section and beyond (Fig.6). In the revealed section 406 was seen to be steeply cut through deposit 405 and into the natural subsoil 407 to an undetermined depth and width (Fig.5 and Plate 10). As far as this feature was exposed, it appeared to run parallel with the rampart and contained only rampart material 403; not enough of the feature was revealed during the watching brief to allow full characterisation, but it clearly pre-dates the construction of the enclosure rampart. Interpretation is difficult, however it may represent an earlier phase of the defended enclosure's construction or possibly an earlier pre-existing feature re-used during the construction of the enclosure. Archaeological excavations undertaken at Woodbarn Rath (PRN 3558, NGR SN017170), near Wiston in Pembrokeshire, revealed pre-existing features and deposits sealed beneath its ramparts and although such features are rare this can be cited as a parallel example (Vyner 1986). Unfortunately, a combination of modern ground disturbance and the limited extent of the groundworks for the new garage footings at Dane Hill did not enable a buried soil to be identified beneath the rampart material.
