REPAIRS TO BEDD MORRIS STANDING STONE SAM Pe361

RHIF YR ADRODDIAD / REPORT NO 2007/48
RHIF Y PROSIECT / PROJECT RECORD NO 62917

June 2007

Repairs to Bedd Morris standing stone

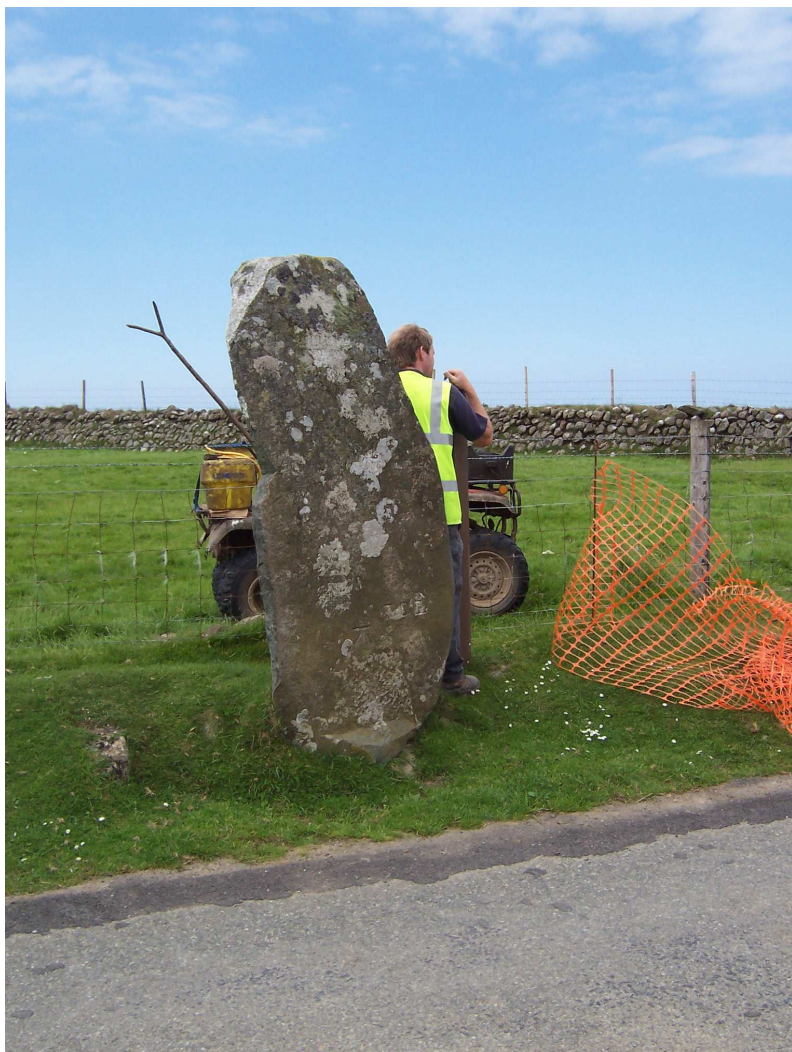
Picture 1: the stone before any works were carried out. The stone tapers to its base, and had become de-stabilised on the roadward side. The face has an inscription relating to its use as a parish boundary marker.

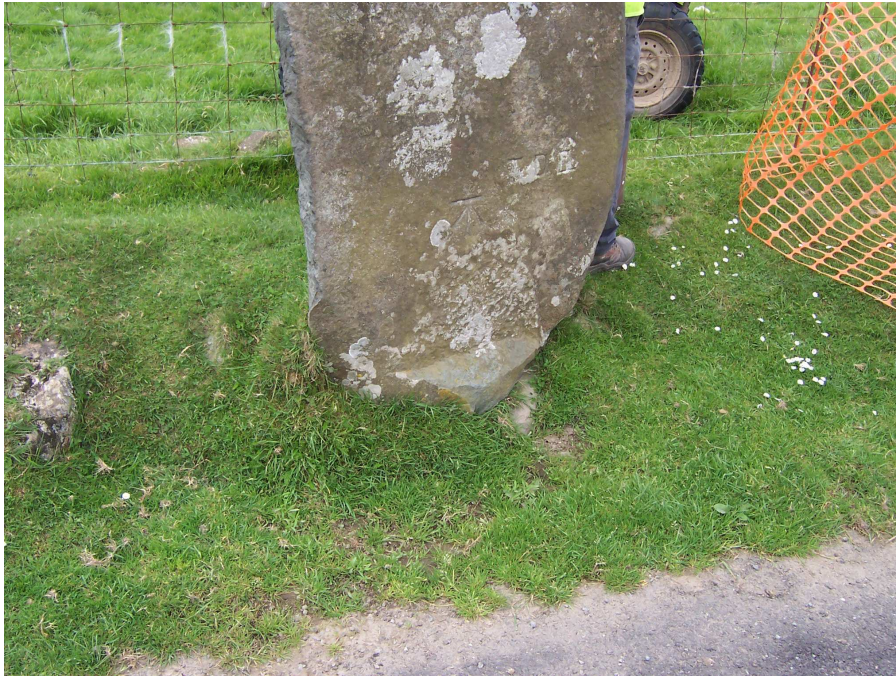
The erosion was limited to the eastern side of the stone, closest to the road, where the stone sat in a distinct hollow. The turf was lifted from the hollow and some of the loose topsoil scraped to produce a level, solid surface to build up from. In the course of this clearance, it was noted that the hardcore from the road surface extended almost up to the stone, underneath the topsoil, and that the topsoil contained a large amount of modern debris – mostly glass and plastic. There was no sign of any undisturbed deposits. Hardcore was not removed.

Picture 2: close-up of the base of the stone. The ground drops away from the verge (back of photo) towards the road, leaving a distinct hollow in front of the stone.

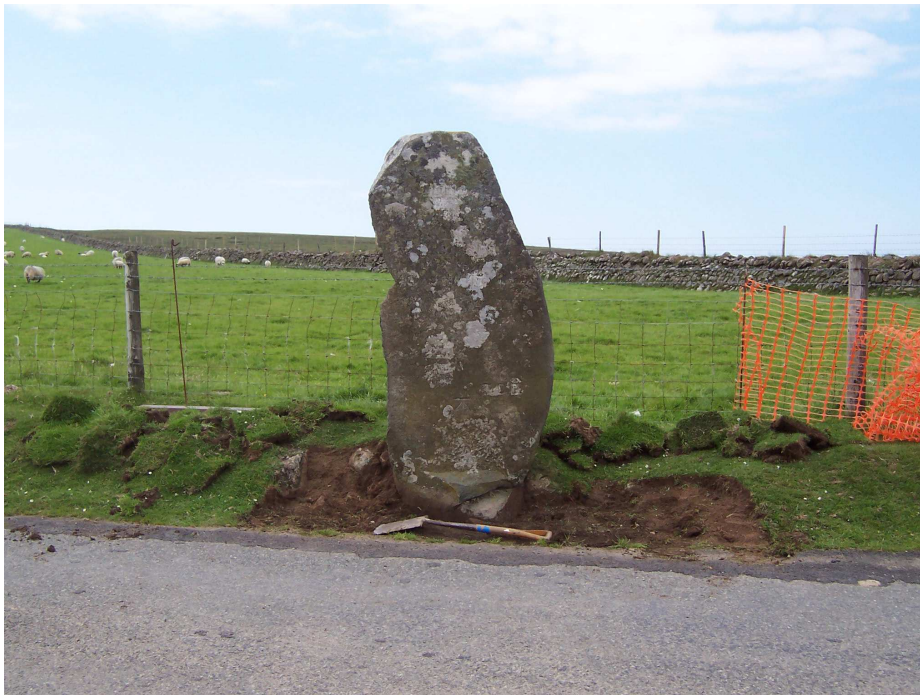
Picture 3: showing the stone with an area de-turfed and prepared for in-filling. Some of the topsoil had to be scraped away as it was so loose that it would not provide a solid base for repair work. The soil overlay hardcore from the road, and contained a large amount of glass and modern debris. In total, including turf, a total depth of around 150mm was removed.

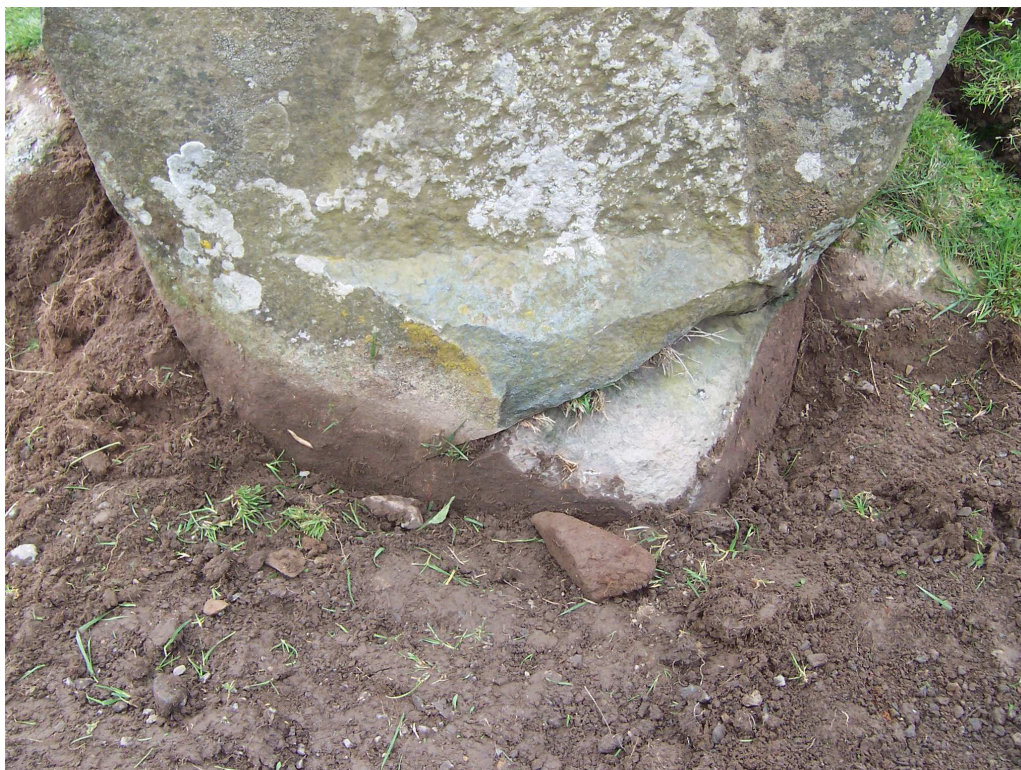
Once the turf was removed, part of the base of the stone was exposed. What could be seen of it appeared to have been deliberately shaped and 'squared off'. What had, initially, been taken to be a packing stone was actually part of the base of the standing stone, but a large crack was running right through it.

Picture 4: a close-up of the base of the stone. Note the large crack which runs through the base of the stone, and the square shape of the base.

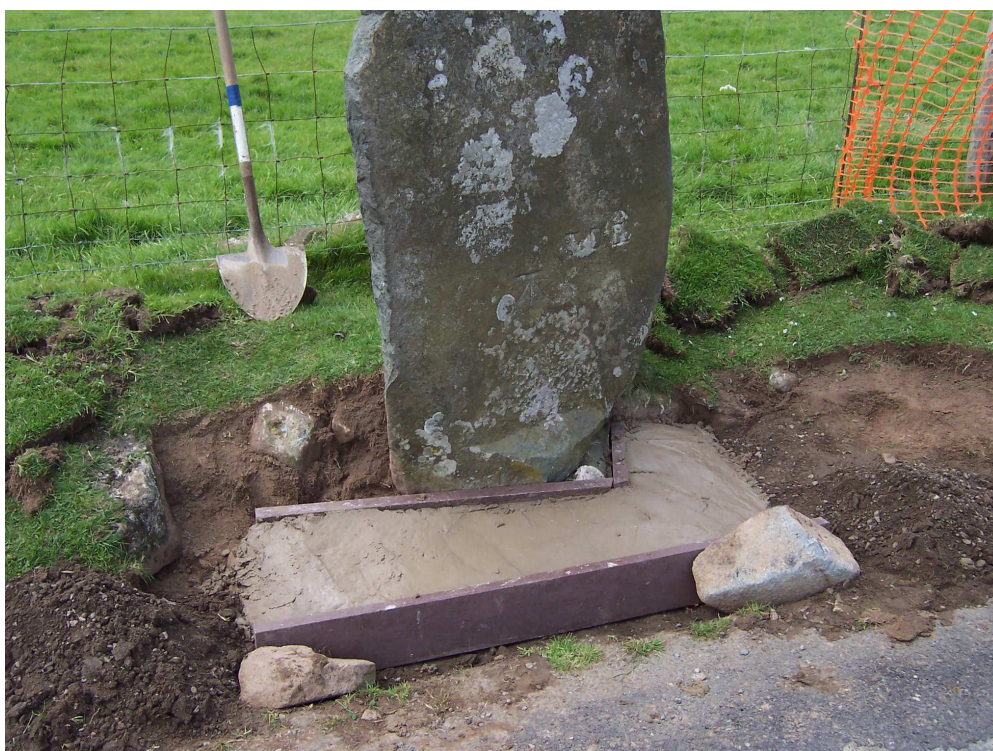
Picture 5: the concrete 'buffer' in place at the base of the stone. The square shape of the base meant that it was possible to use rigid beams of recycled plastic rather than plastic sheeting. No voids were left between the plastic and the stone's base.

Beams made of recycled plastic were placed adjacent to the square edges of the stone's base, and concrete poured in behind them. This is intended to act as a solid 'buffer' and prevent any movement of the stone. Earth was then mounded up over the concrete, the profile of the verge was restored, and the turf re-instated.

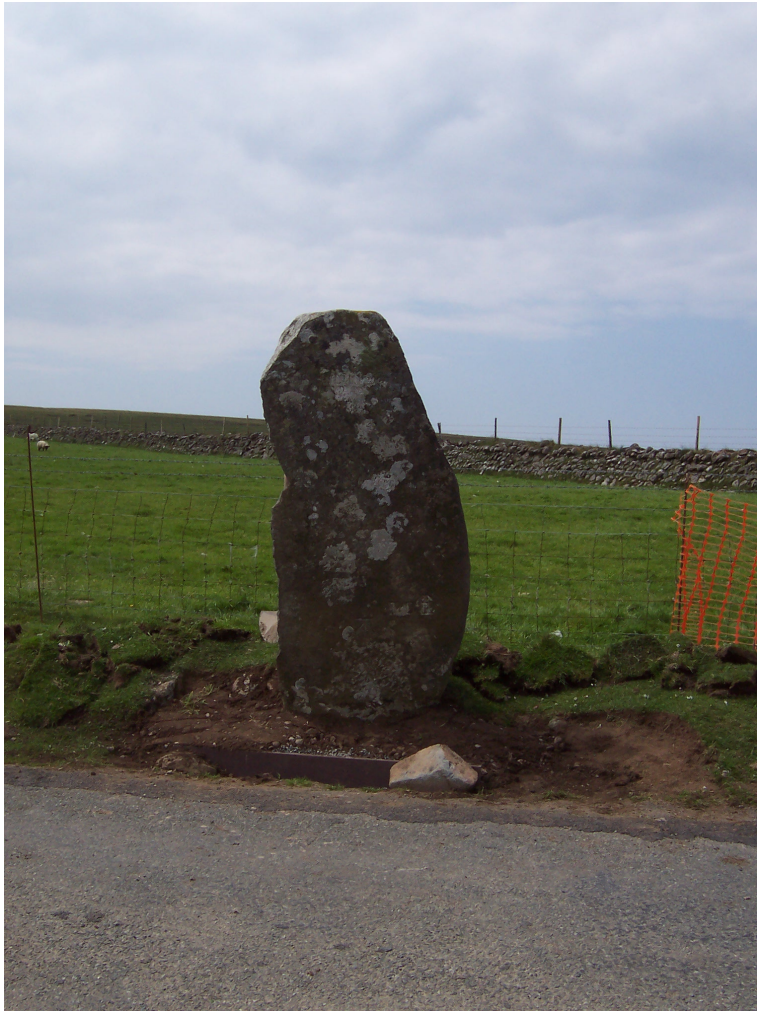
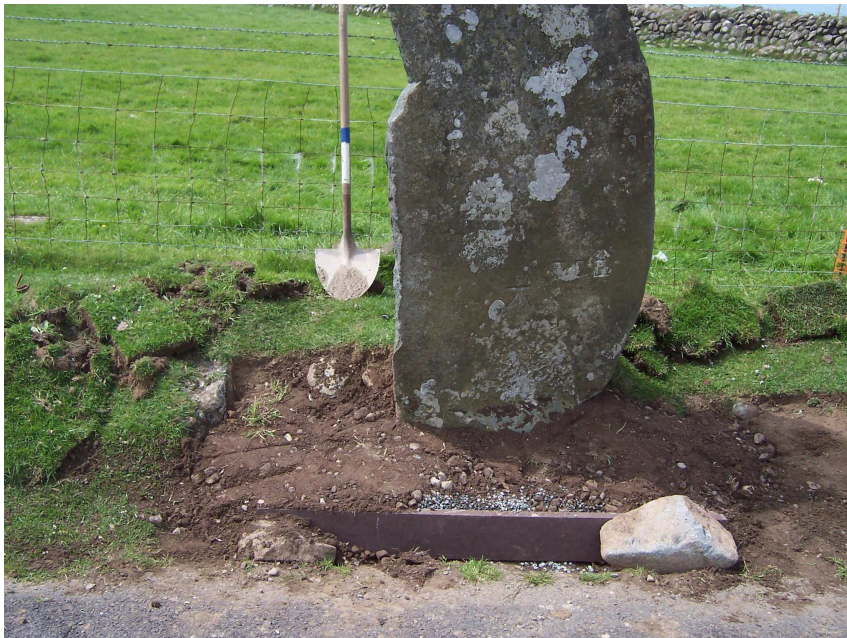
Pictures 6 and 7: covering the concrete with locally sourced soil.

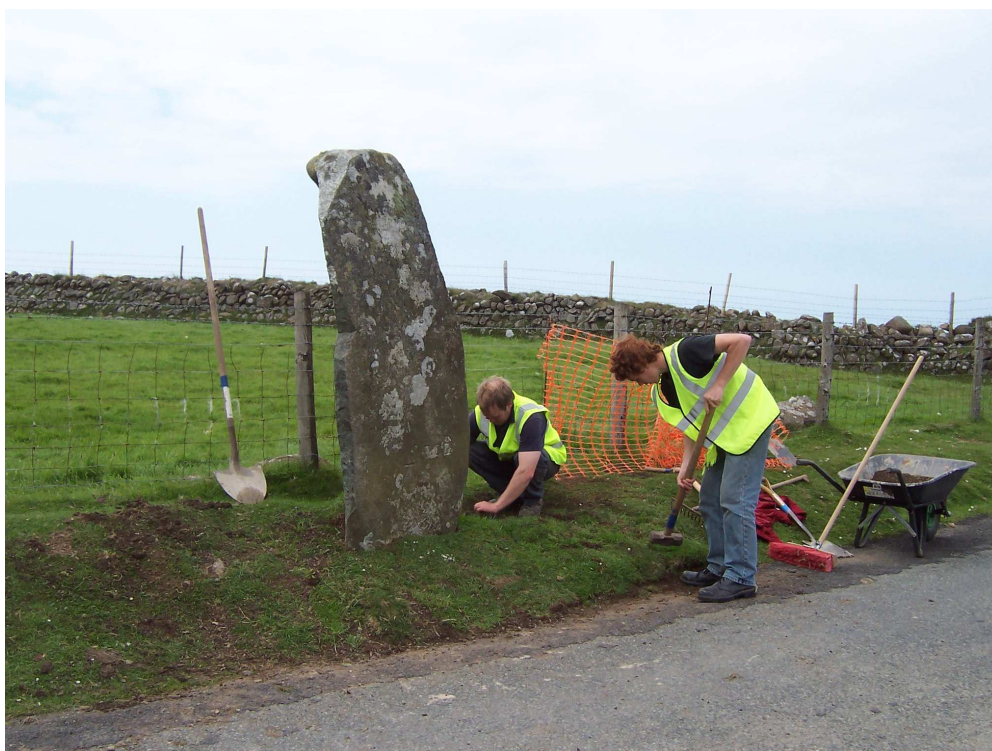
Picture 8: re-turfing

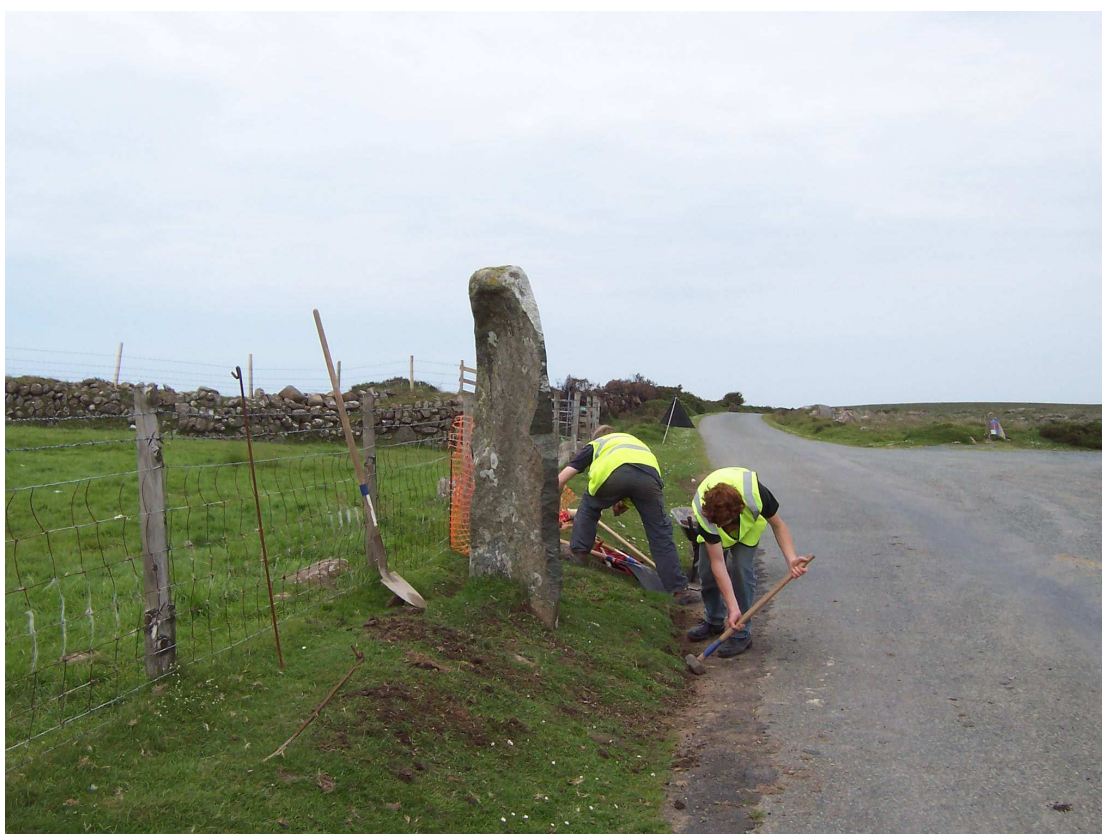
Picture 9: The restored profile of the roadside verge after re-turfing

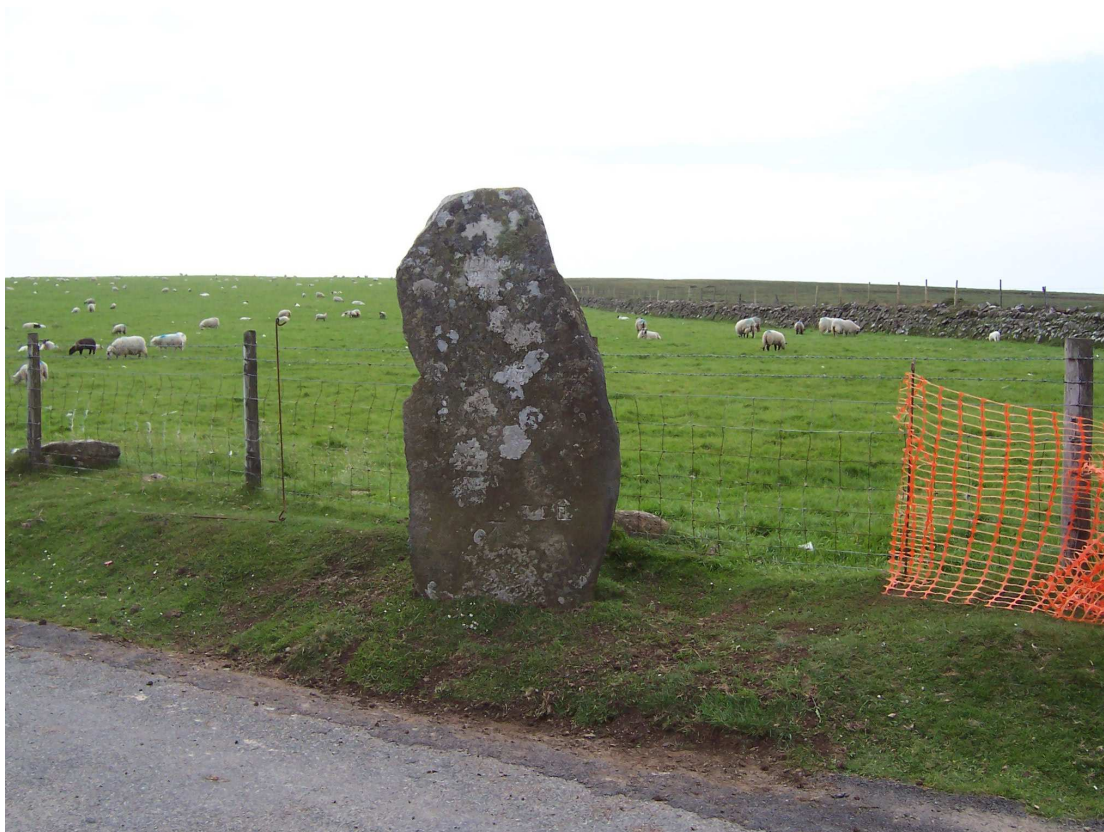
Picture 10: Showing the stone after work was completed. The temporary fencing has now been re-instated to give the turf a chance to 'take' before stock are allowed to return.

Temporary fencing has been put up around the stone to keep stock off until the turf has time to recover. The site will be monitored at intervals to ensure that the repair has succeeded.

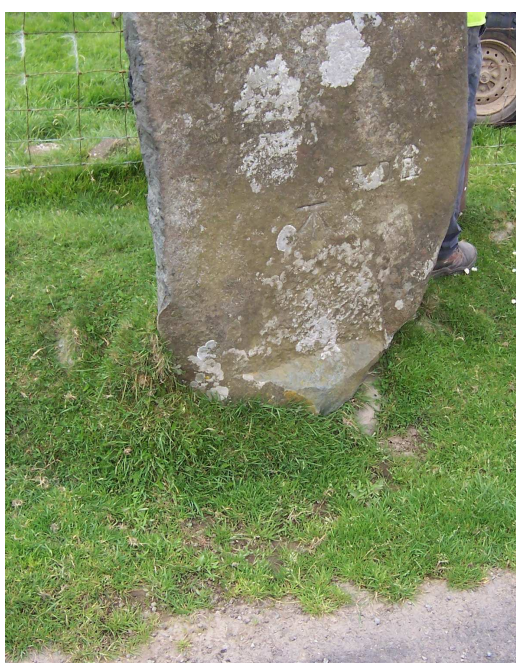
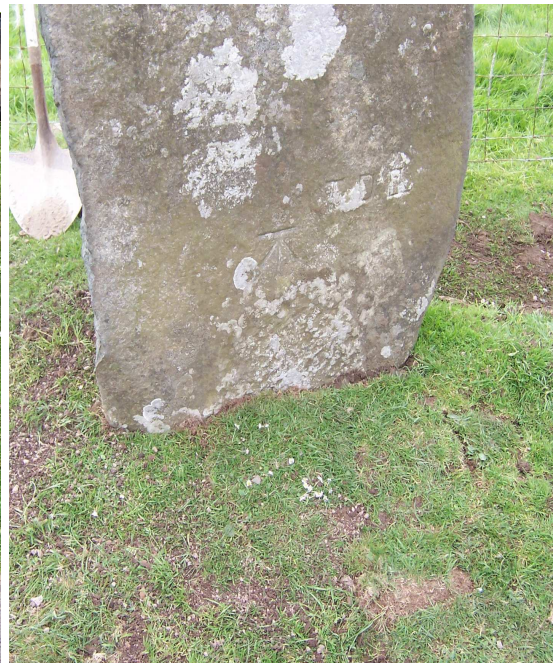
Pictures 11 and 12: showing the depth of stone which has been 're-buried'. The Ordnance Survey benchmark is a useful reference and monitoring point!
