PROPOSED RESIDENTIAL DEVELOPMENT AT MACHYNYS EAST, LLANELLI ARCHAEOLOGICAL FIELD EVALUATION

Prepared
by
Cambria Archaeology
for
LLANELLI COAST JOINT VENTURE

REPORT NO. 2006/52
PROJECT RECORD No.63022

June 2007

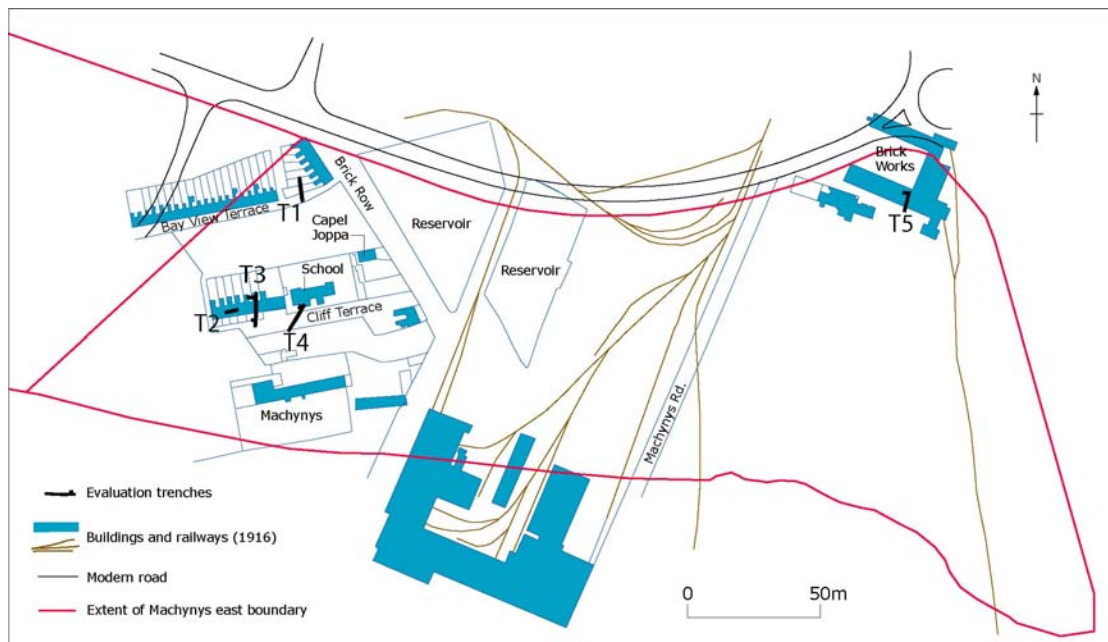
Figure 2: Plan showing the location of the trial trenches overlying information from early 20th century mapping of the area.

Five trenches (Fig.2) each measuring 10m x 1.8m were excavated using a JCB excavator with a 1.8m wide toothless grading bucket. In all trenches the turf and topsoil was removed by machine down to the top of the archaeological deposits or natural subsoil. Where archaeological features or deposits were revealed they were cleaned by hand, photographed, drawn to scale and then either wholly excavated or test excavated to establish as far as possible their character. During excavation all exposed deposits and features were described and allocated their own individual context number. After excavation, all features were photographed and planned at 1:20 scale and, where relevant, sections were drawn to a scale of either 1:10 or 1:20.

The trenches were intended to investigate specific targets identified from Ordnance Survey mapping during the original desk-based assessment (Page 2005). Modern changes to the landscape meant that positioning the trenches accurately was difficult. A hand-held Global Positioning System (GPS) was used to position the trenches as close to the chosen locations as possible, however, in the event this was accurate in only three of the five cases. On site constraints also influenced the final trench locations, but the results of the evaluation have not been compromised as all five trenches provided good information about the extent, character and, importantly, the condition of the buried archaeological resource.

Overlaying the final position of Trench 1 on early 19th century Ordnance Survey mapping of the area (Fig. 2) has shown that the trench was placed in the back yard area of the houses and that wall 102 lined up well with a wall dividing two yard. Therefore, some of the other features in Trench 1 are probably robbed walls, with the robbed out wall trenches backfilled and levelled with debris.

Overlaying the final trench location onto the Ordnance Survey map (Fig. 2) the walls appear to correlate well with the walls of a back extension on one of the houses of Cliff Terrace. This makes the space between the walls, occupied by 317, the inside of the extension. The lack of a recognisable floor in this space suggests that, as with Trench 2, the houses had been demolished to below floor level and then backfilled and levelled using the debris from the buildings.

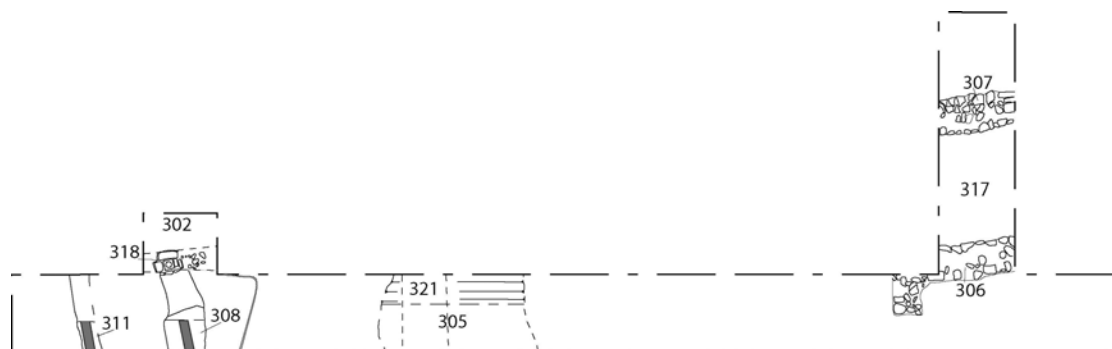
Figure 3: Plan of the main features in Trench 3

Sections of two north-south walls (306 and 307) were uncovered. One (306) had a short return to the east at its southern end, but this had been truncated during demolition or later landscaping works. The walls were of identical construction, with good stone faces and a rubble core bonded by a hard light grey mortar. They were both c.0.75m wide and survived to at least two courses high. The 3.25m space between the walls was filled by a deposit of brick rubble, clay and building debris (317).

Approximately 8m to the south of wall 306 was an east west rubble filled trench (321) that ran east west across Trench 1. The trench was 0.7m wide x 4m deep and was filled by large blocks of brick rubble and hard grey mortar (305). Again, once the trench location was overlain onto the Ordnance Survey map this feature correlated well with the line of the front walls of the Cliff Terrace houses. Therefore, this appeared to be the robbed out and backfilled foundation trench for the front of the houses.

The dimensions of the excavated building are identical to those on the Ordnance Survey maps, being 25ft (8m) from front to back, with a 8ft-9ft (c.3.25m) wide back extension.

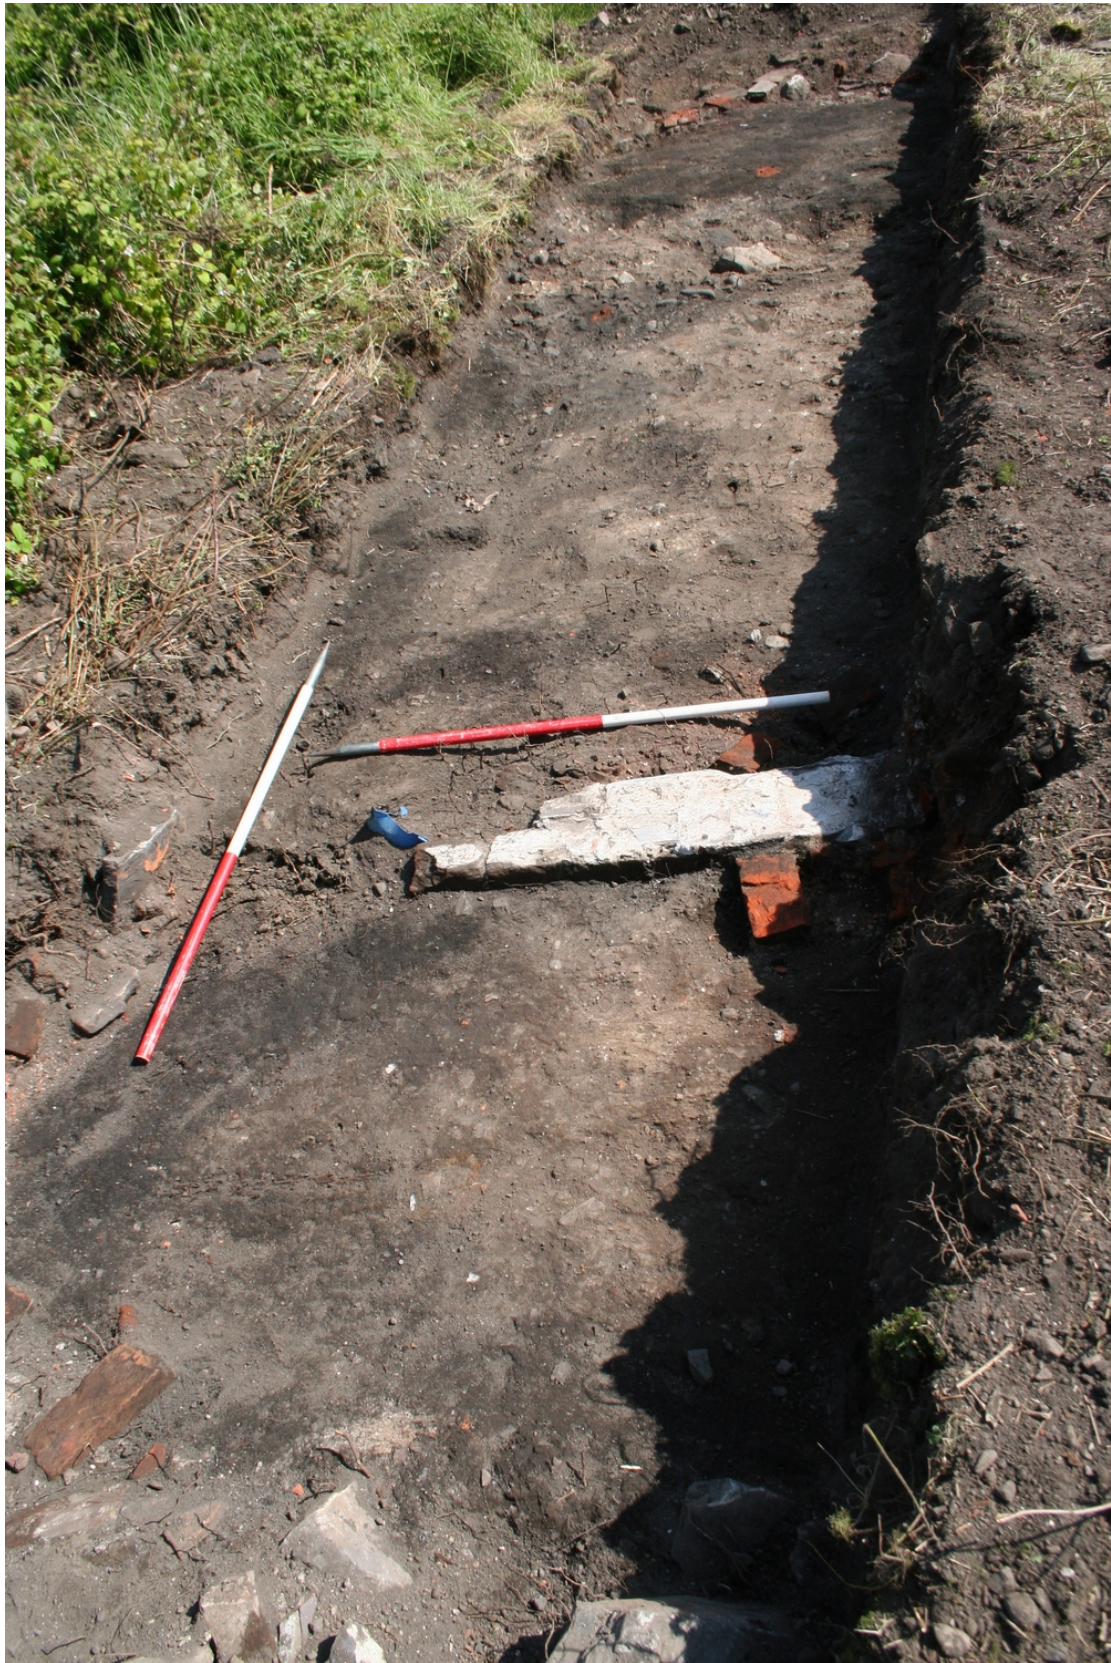
Plate 1: Wall 102. view to south.

A short length of brick wall extended for c.1m across the trench: it extended beyond the west edge of the trench. The wall consisted of at least two courses of English bond brickwork capped by a layer of slate, which had been laid as a damp proof course. A small buttress of three bricks had been constructed against its north face.

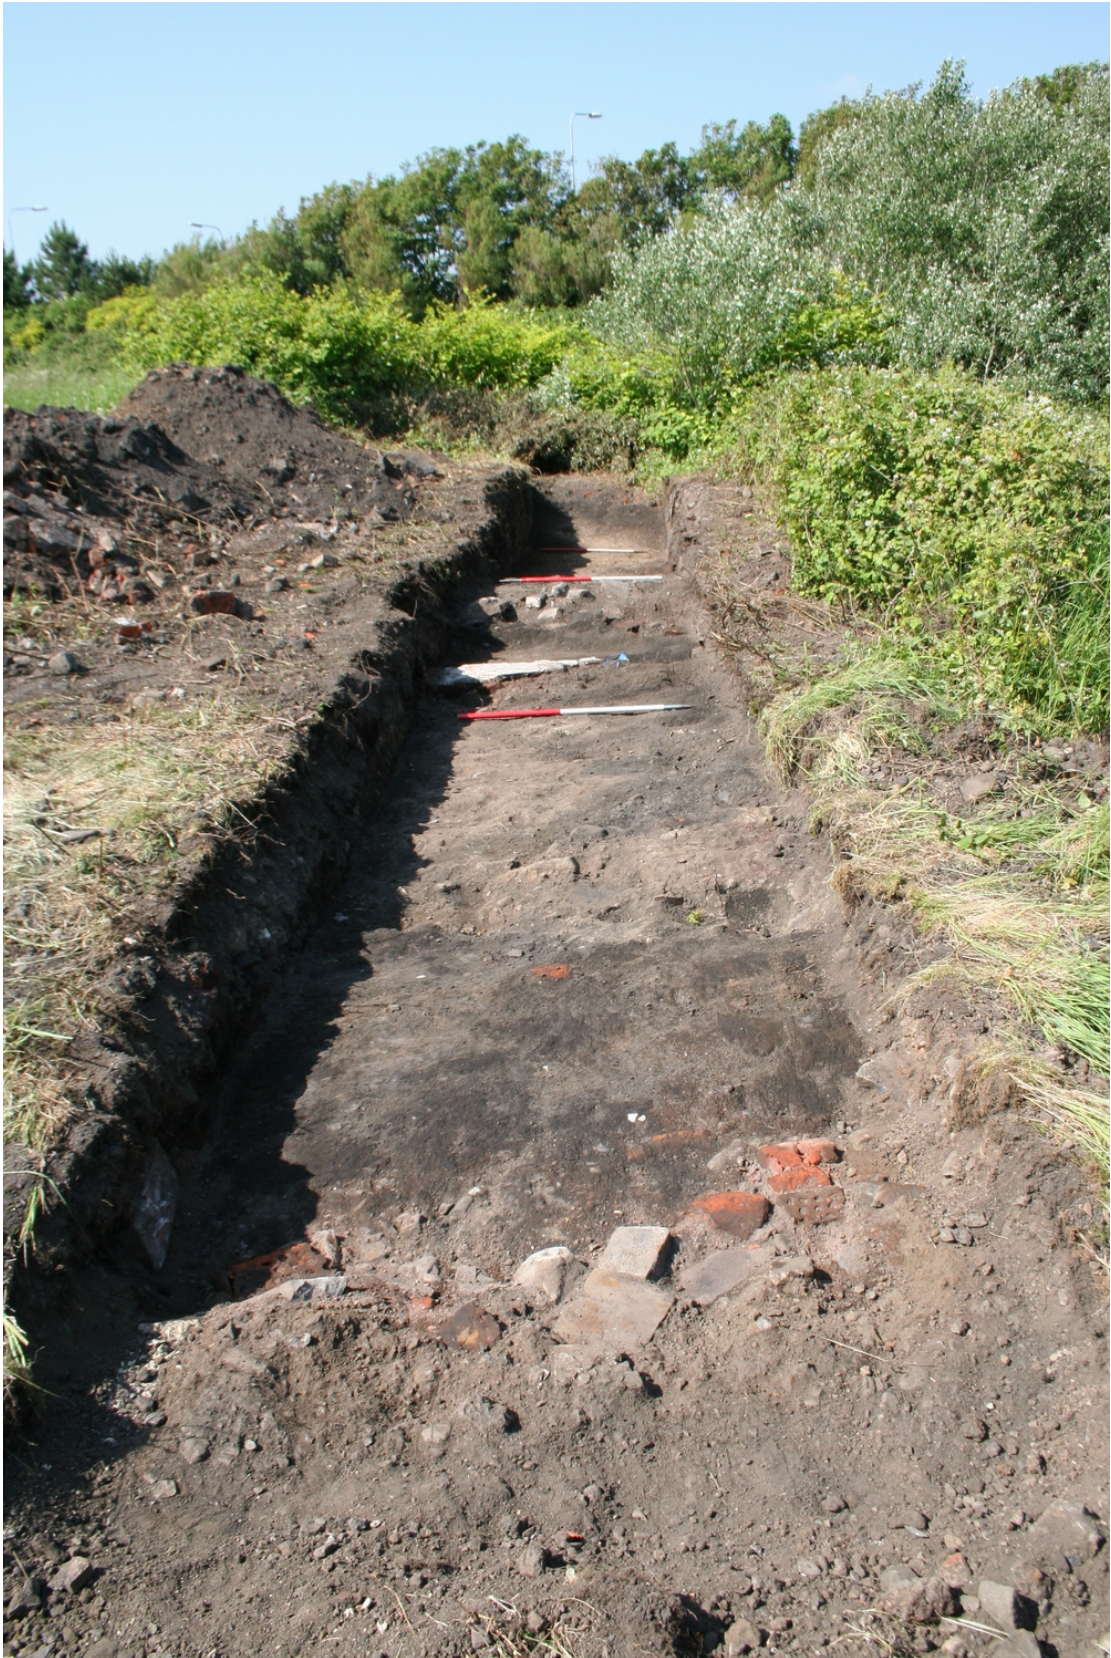
Plate 2: general view north along Trench 1 showing wall 102 and other deposits.

Removal of c.0.3m of grass and topsoil (100) revealed a very compacted and mixed deposit of dark brown/black clay containing c.40% building rubble, made up of brick, stone and mortar (101). This deposit was at least 1m deep at the north end of the trench where it was part filling the hollow left by the removal of Brick Row. Although very mixed, there were features visible within it, which for the most part were 'stripes' of different coloured clay and rubble. A short length of brick wall (102) was also encountered.

These features were very similar in make up, consisting of 'stripes' of varying shades of dark brown and black silty clay containing large amounts of building debris. All of these features, and wall 102, were on an east – west alignment and were, therefore, clearly not the effect of random site clearance.

The results from Trench 1 showed that the houses of Brick Row would formerly have stood on the site of the wet hollow. Therefore, it seems likely that they have been removed to below foundation level leaving a hollow that has subsequently become a small wet area.

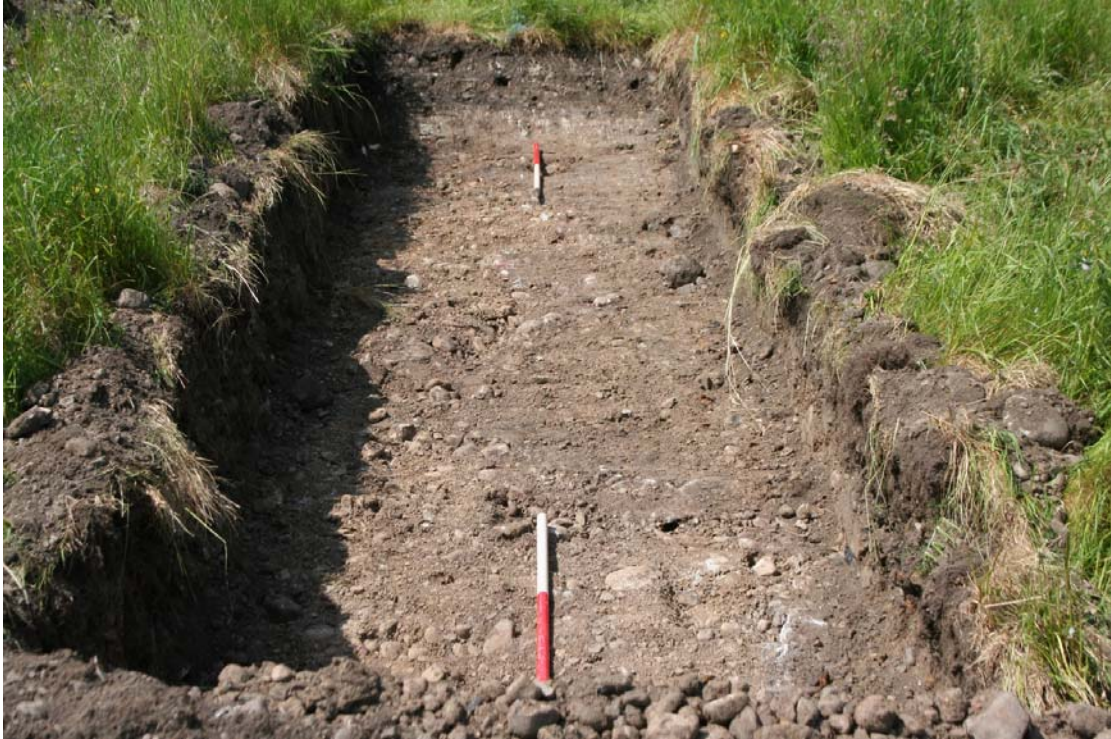
Plate 3: General view west along Trench 2.

Removal of 0.3m of vegetation and topsoil (200) revealed a very compacted mixed layer of dark brown/black clay and building debris (201), which overlay what appeared to be natural glacial gravels (Plate 3).

This trench was stopped at a depth of 0.5m and it was thought that it had missed the buildings. However, it now seems that it was inside the buildings, but that when they were demolished the floor layers had been removed, a situation confirmed in the other trenches. Following the demolition the debris was spread around to level and up and landscape the area.

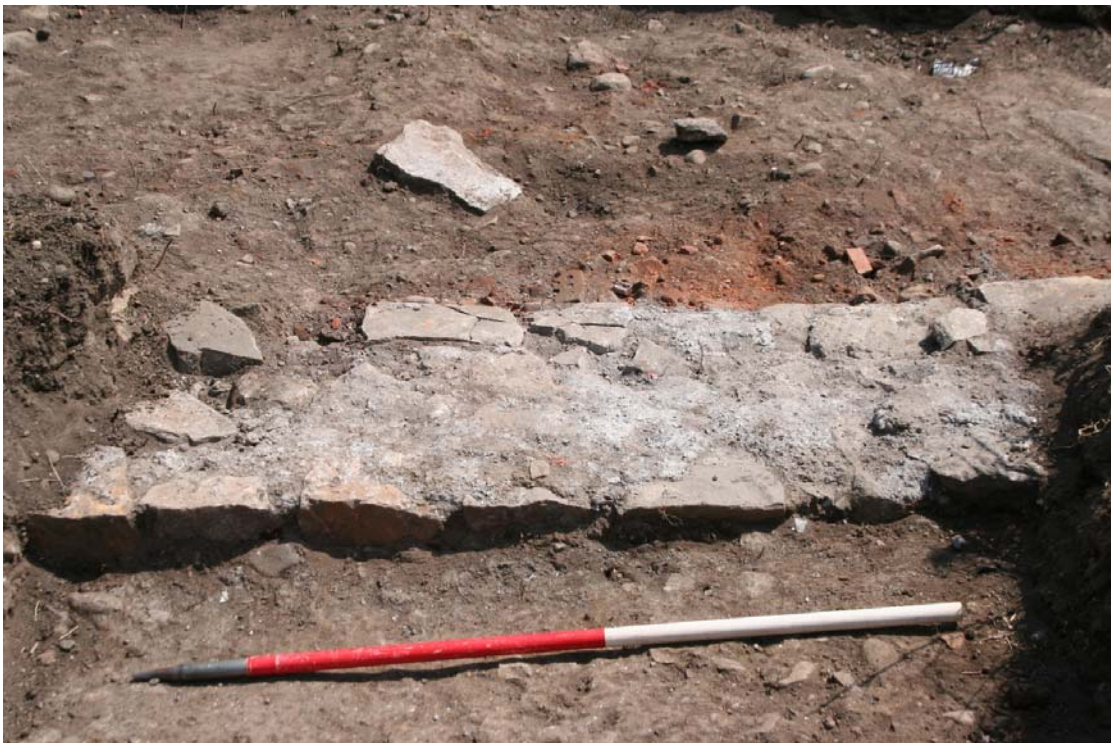
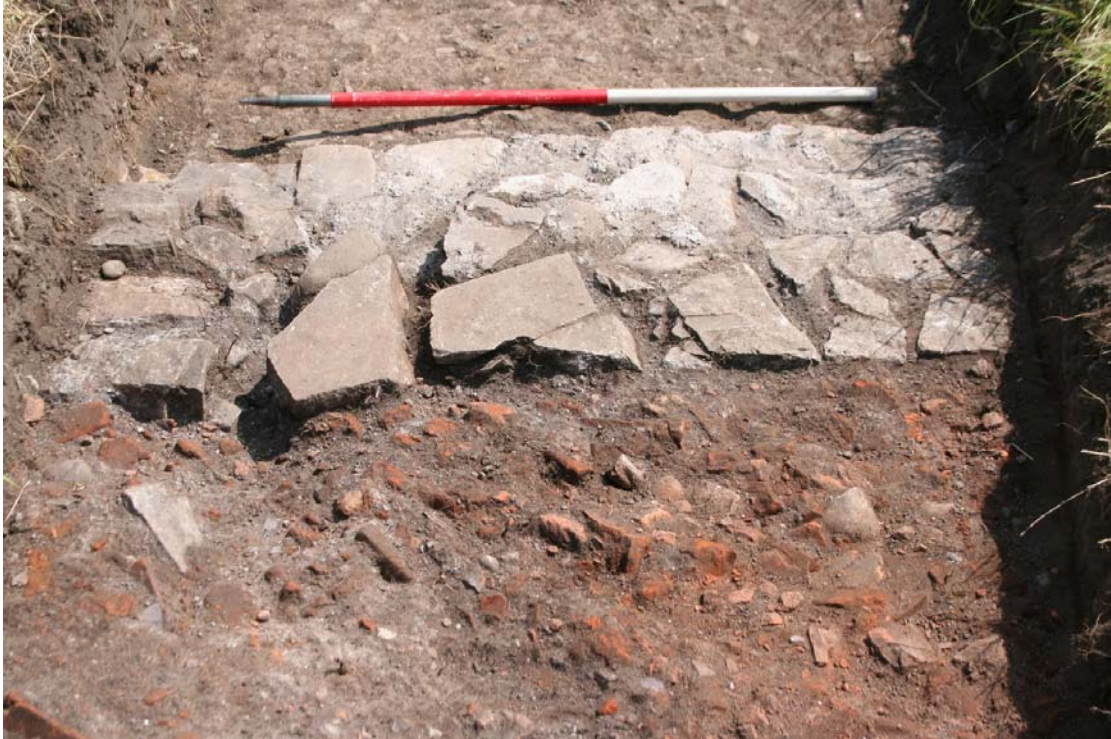
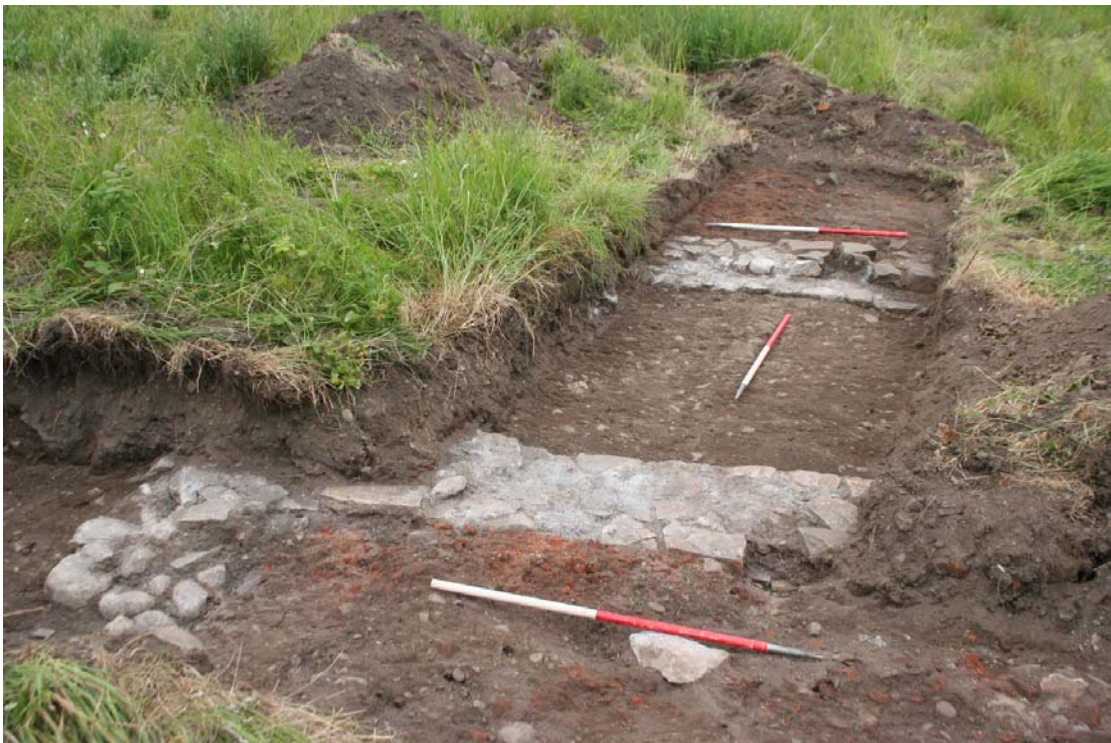
Plate 6: Walls 306 and 307 marking the former back extension of one of the Cliff Terrace houses.

Plate 4: Detail of Wall 306.

Plate 5: Detail of wall 307.

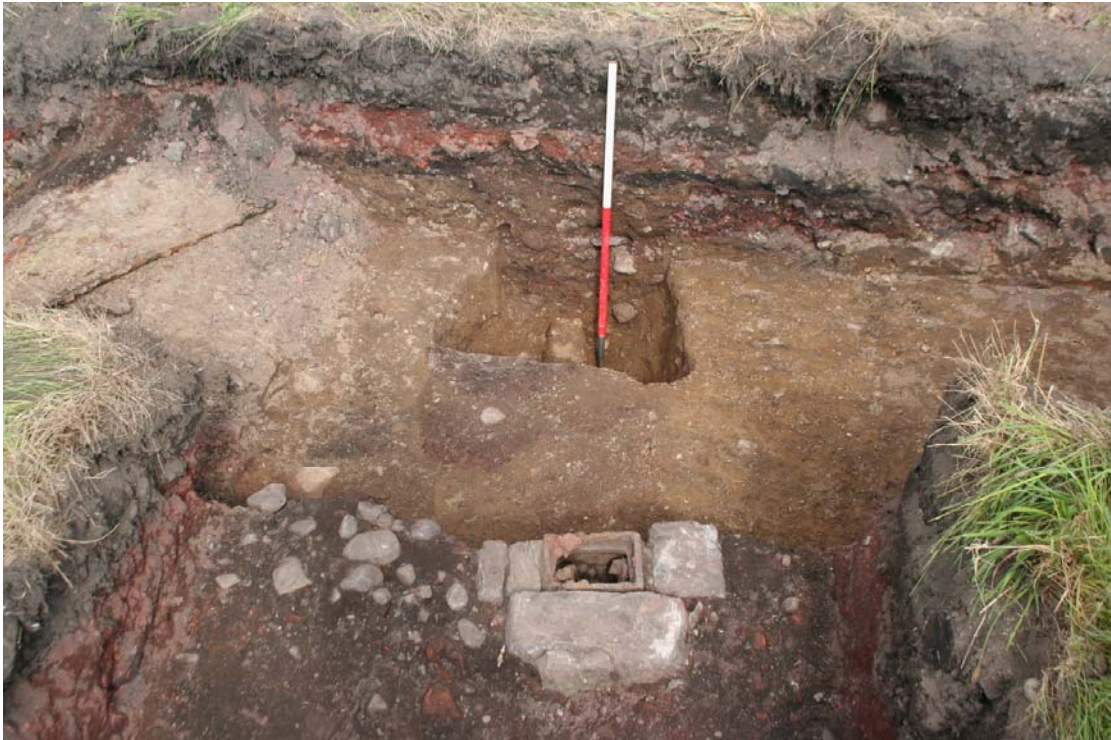
Plate 7: Detail of water main 308 and drain 318.

The other features recorded in this trench were at the southern end of the trench and consisted of two water mains (308 and 311), a lead encased electricity cable and a stone and brick built drain (318) that serviced water main 308. The water mains were cast iron pipes aligned east west, parallel to Cliff Terrace. Drain 318 sat on junction between water main 308 and a north-south drain 304 (Plate 7).

The services recorded were originally located in the road, presumably with branches to the houses of Cliff Terrace.

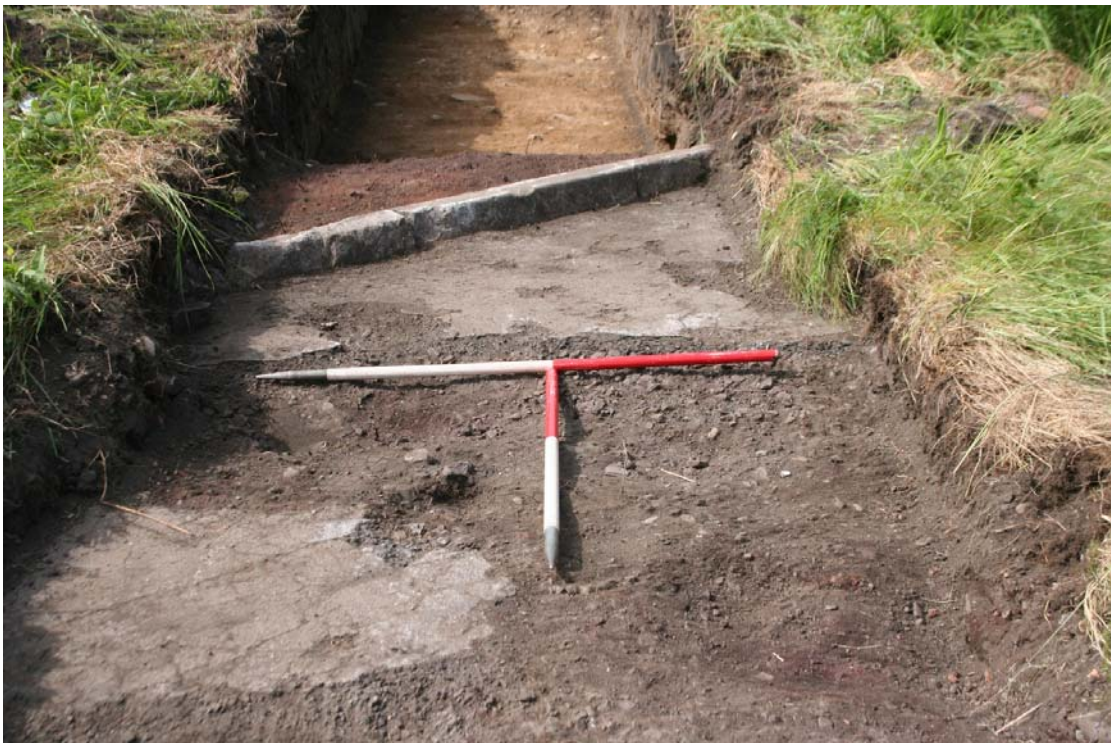
Plate 8: Detail of road and kerb of Cliff Terrace.

Removal of the topsoil revealed part of a damaged tarmac road, with surviving kerbstones along the south side (404) (Plate 8). The road surface survived well in some places, but in others the surface had been damaged and the north side had been completely removed. A lead encased electricity cable ran along the line of the road; this was continuation of the cable recorded in Trench 3. A cut feature 405, which ran along the line of the road was on the same alignment as the water mains recorded in Trench 3, and it was thought that 405 represents the extension of either 308 or 311.

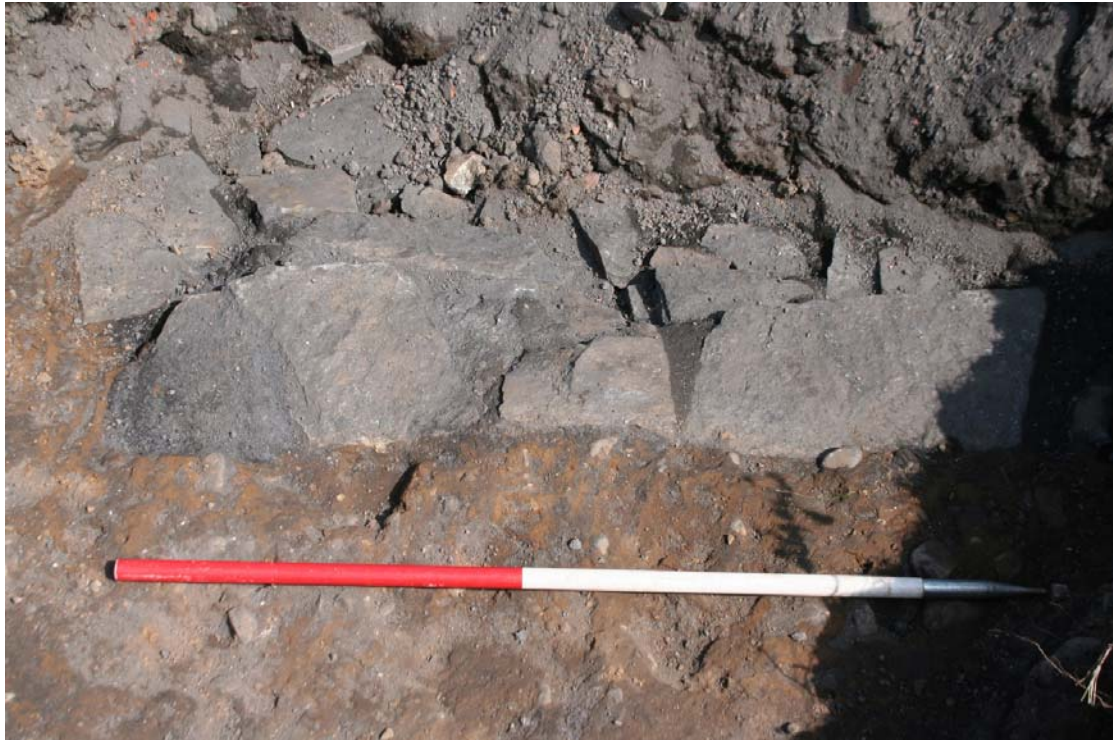
Plate 9: Wall 411, part of Machynys School.

The only other feature was part of a stone-built structure (411) recorded in the very northern extent of the trench. It consisted of two courses and had a good face on its southeast side. Only its southeast face was exposed and it extended beyond the trench edges (Plate 9).

The form and function of this feature are unknown, but overlaying the trench on to the Ordnance Survey mapping shows it to be very close to the front of Machynys School, and it could therefore represent part of the front wall.

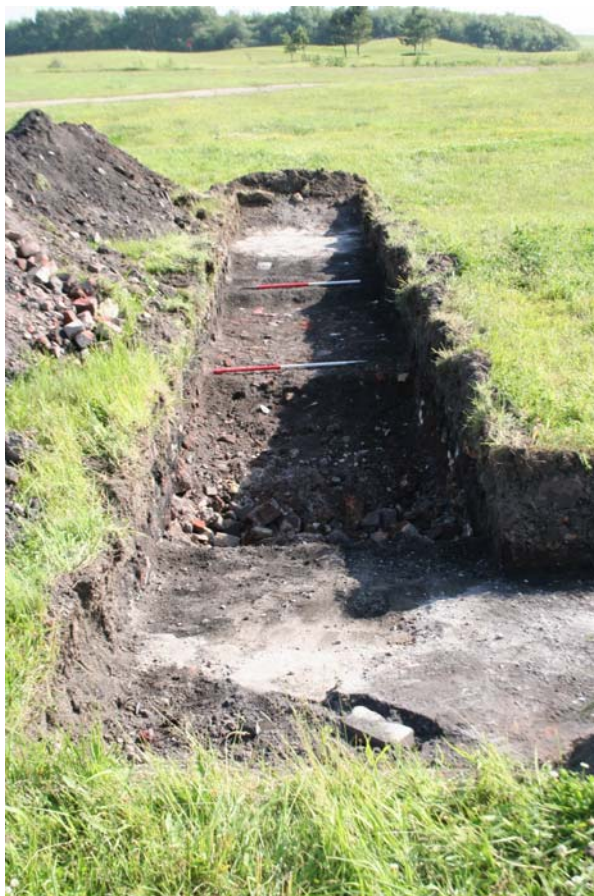
Topsoil removal revealed two concrete surfaces (501 and 504) (Plate 10) at the northern and southern ends of the trench respectively. These overlay a 0.24m thick deposit of black clinker, ash and crushed coal (502), which covered the entire trench. This in turn overlay a dump of bricks (503) that appear to be filling a large void, possibly a cellar.

There was no conclusive evidence of the brickworks structure, despite the trench being placed in the right location. The amount of brick rubble (503) suggests that it had been completely demolished prior to deposit 502 being spread across the site. It is likely that 502 was the residue from the firing of the brick kilns, which was spread about the site after the demolition of the works and the landscaping of the area. The two concrete surfaces are clearly a later reuse of the site, although their function is unknown.

Plate 10: View south along Trench 5 showing concrete surfaces 501 and 504.
Brick rubble 503 is visible in the centre.
