# HARBOUR WALL RECONSTRUCTION, ABERAERON, CEREDIGION: TIMBER DISCOVERY

JULY 2007

REPORT NO. 2007/ 68  
PROJECT RECORD NO.63185

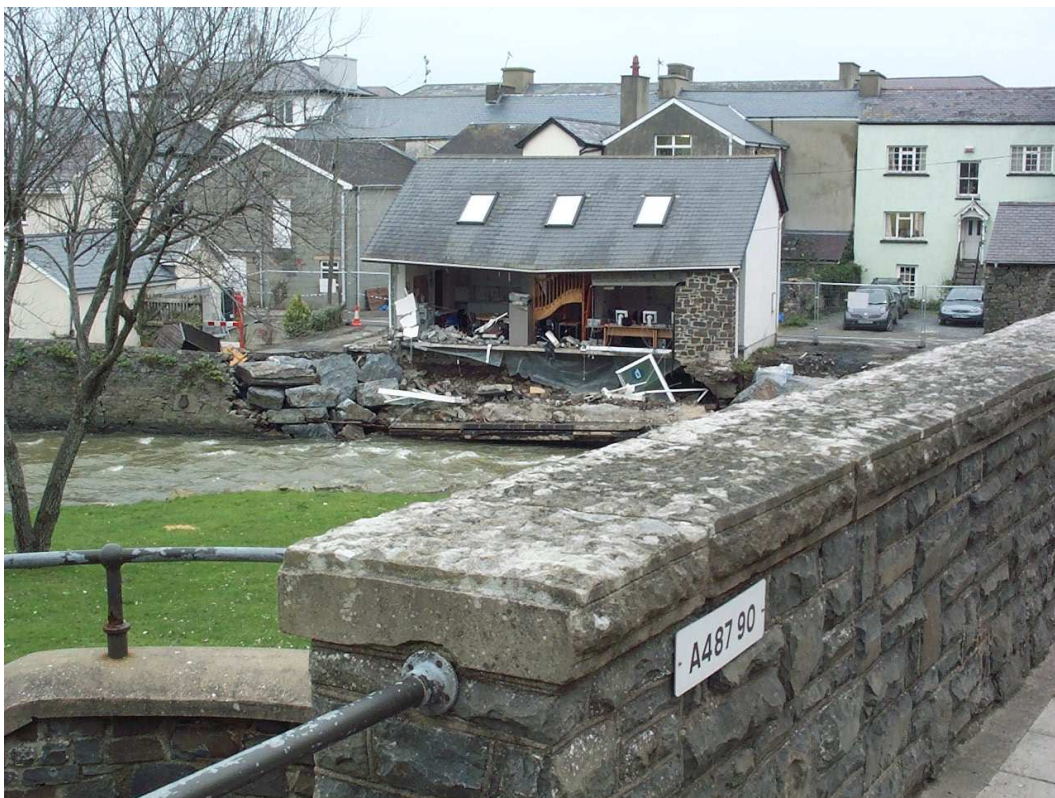
**Photo. 1** Part of the destroyed harbour wall soon after the storm subsidence in November 2005, looking NNW

The reconstruction work to Aberaeron harbour wall currently being carried out has its origins in flood damage caused by heavy rain in November 2005. The great volume of rain caused subsidence of the harbour wall that resulted in serious damage being caused to a harbour-side building at grid reference SN45816283. The building was in use at the time as an Information Technology learning centre and was being leased from the owners by Ceredigion County Council. Technical and legal issues delayed commencement of repair and reconstruction but eventually, it seems, these were resolved and the Welsh Assembly Government allocated Ceredigion County Council a grant to help with the cost of the project.

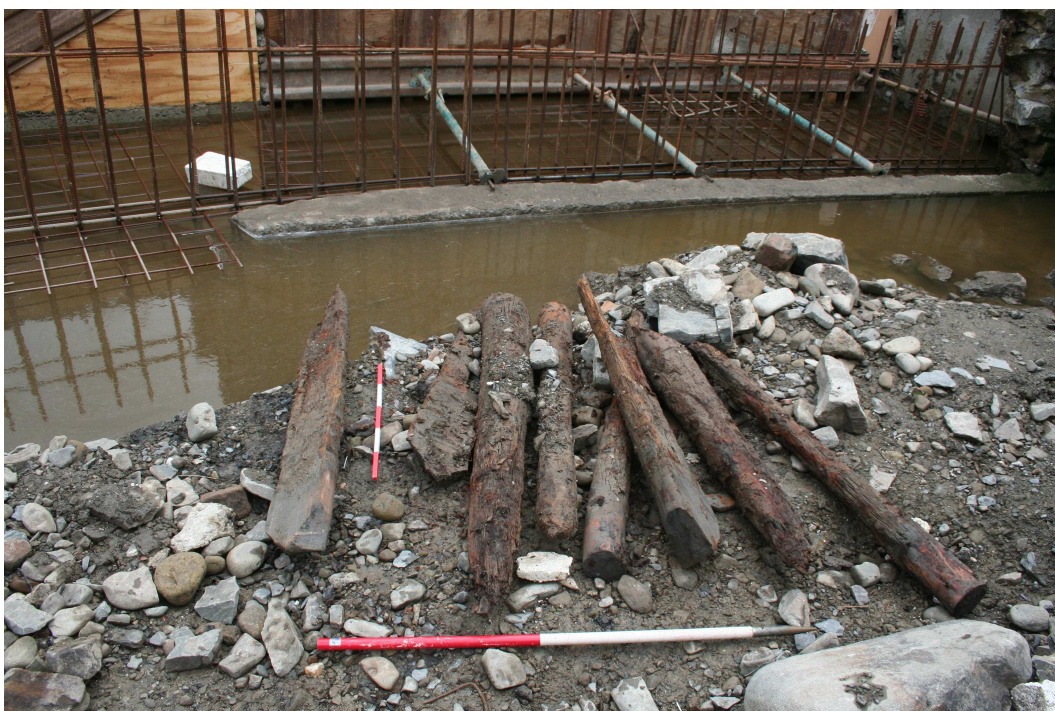
All the posts were of softwood and some appeared to have been pressure treated or "tanalised". The posts varied in size from 0.8m in length to a maximum 1.5m, with five of them being full round and three half round (see Photo 2 below). All were in a good state of preservation with slight rot at their non-sharpened top ends.

**Photo. 2** The timber posts after being set aside for assessment

It seems likely that the timbers were set in place in order to retain some of the bank material close to a modern water services inspection chamber. None of the evidence suggests that they were part of the original early nineteenth century harbour wall makeup.

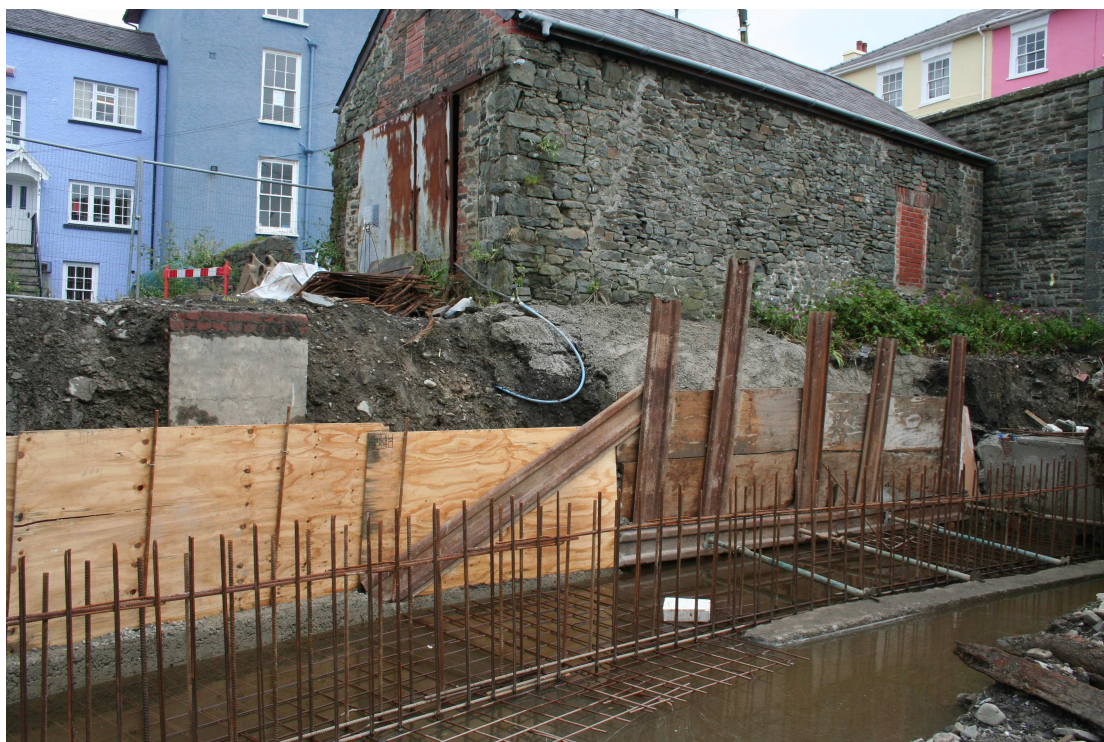
**Photo. 3** The site during reconstruction groundworks, looking northeast
