HAVERFORDWEST CASTLE MUSEUM HAVERFORDWEST PEMBROKESHIRE

ARCHAEOLOGICAL EVALUATION

REPORT NO. 2008/21
PROJECT RECORD NOS. 63297

February 2008

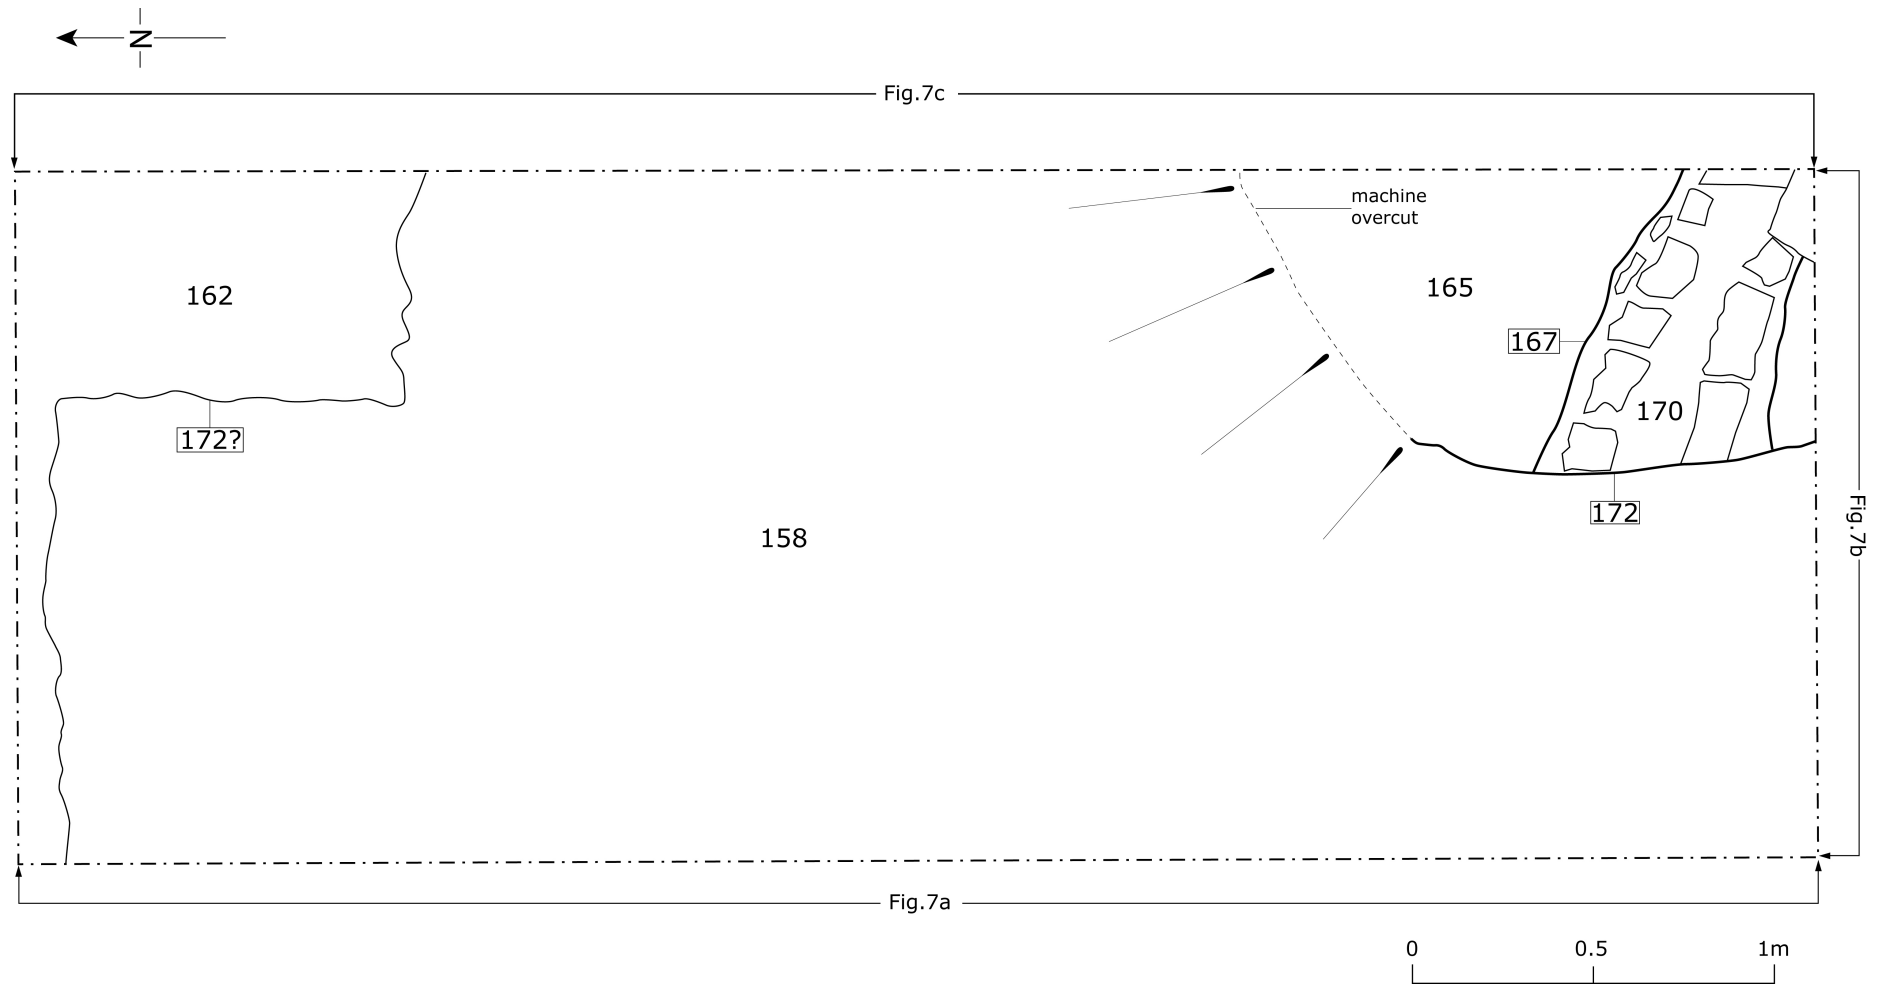
The earliest layers were at either end of the trench, and were very similar, both containing a lot of crushed mortar (159 and 162).

Above the southern layer (159) there was a thick deposit of rubble and mortar (165) that was possibly a continuation of deposit 159. The upper portion of layer 165 had been cut by a construction trench (167) for a small stone drain with stone capping (170). In the lower part of 167 was a shallow fill (171), which appeared to have been laid to level up the base of the trench for the construction of drain 170.

Drain 170 had been cut on its west side by a large feature (172), which also extended into the deposit below (165) and around its north side. It may also have cut the mortary deposit (162) at the north end of the trench.

Figure 6: Trench 2. Plan

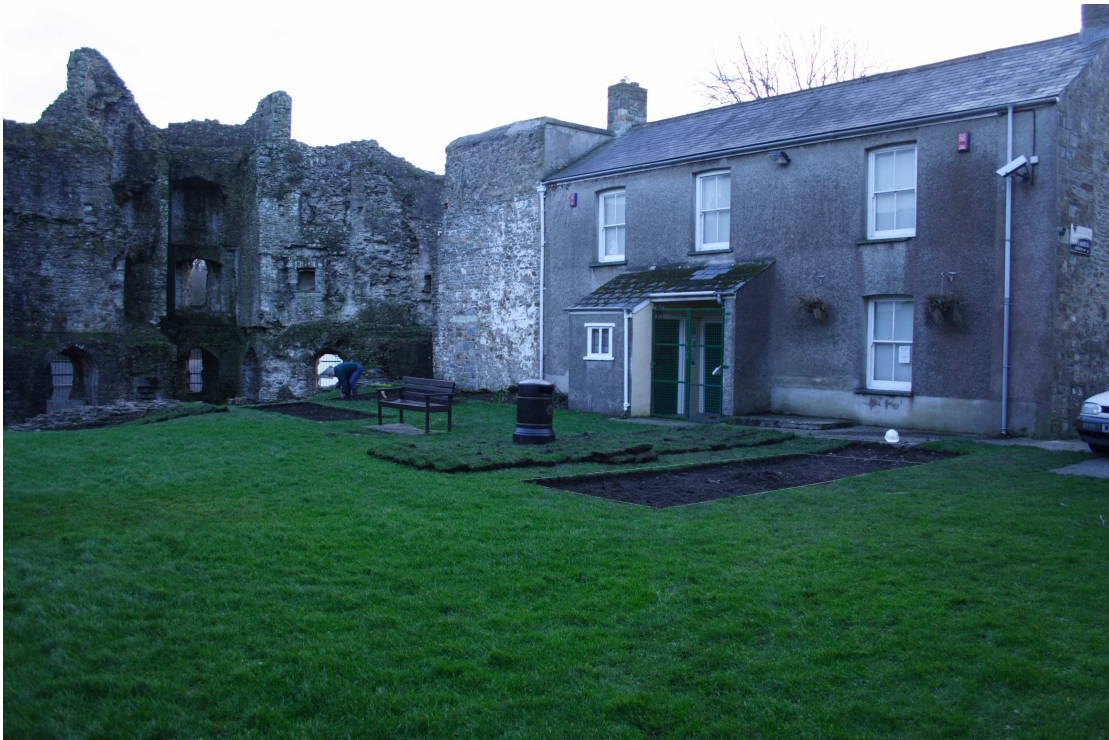
Plate 1: Location of trenches

Three trenches (Fig. 3 and Plate 1), 2m wide by 5m long, were laid out approximately on the line of the south, east, and north walls of the proposed new extension. The turf was hand stripped and positioned so that it could be replaced in the same order. The area and the trenches were also scanned with a Cable Avoidance Tool (CAT); this established that there was a live cable running across the middle of the southern trench (Trench 1) and also near the western end of the north trench (Trench 3). The north trench was therefore extended eastwards so as to miss the cable. There were also indications of a number of other non-live services but it was not possible to plot these to any great degree as the generator could not be placed far enough away from the CAT but still cover these pipes or cables.

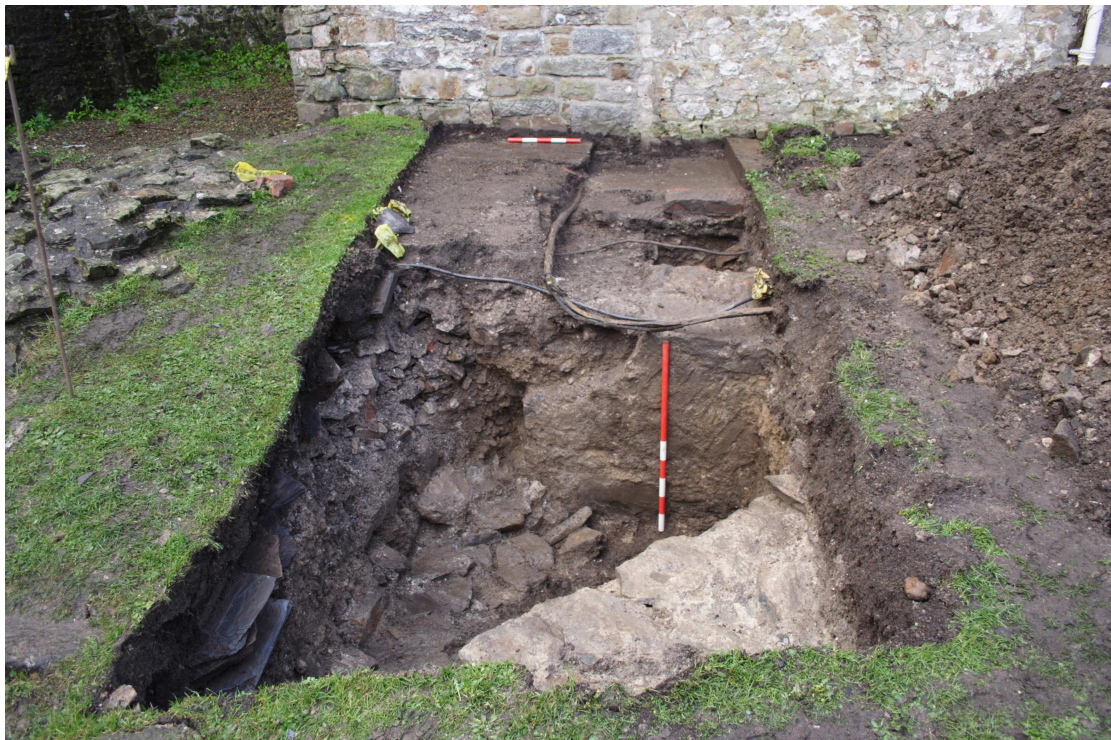
The earliest feature encountered was part of a north-south wall (111). Only one face of this wall could be revealed as later features and electricity cables prohibited further excavation to the west (Plate 2). This wall must have been at least 0.9m wide and survived to over 1m high as it extended below the level excavated. It was a stone wall and bonded with a hard off white/yellowish mortar. The east side was of faced stone with the remains of a relieving arch (Plate 3). The lack of weathering on this face suggests that it may have been internal rather than external. This wall had been cut on its west side by feature 110 and truncated by an east-west drain (117); both of these features are probably much later.

Plate 2: Trench 1 View W. Scales 0.5m and 1m

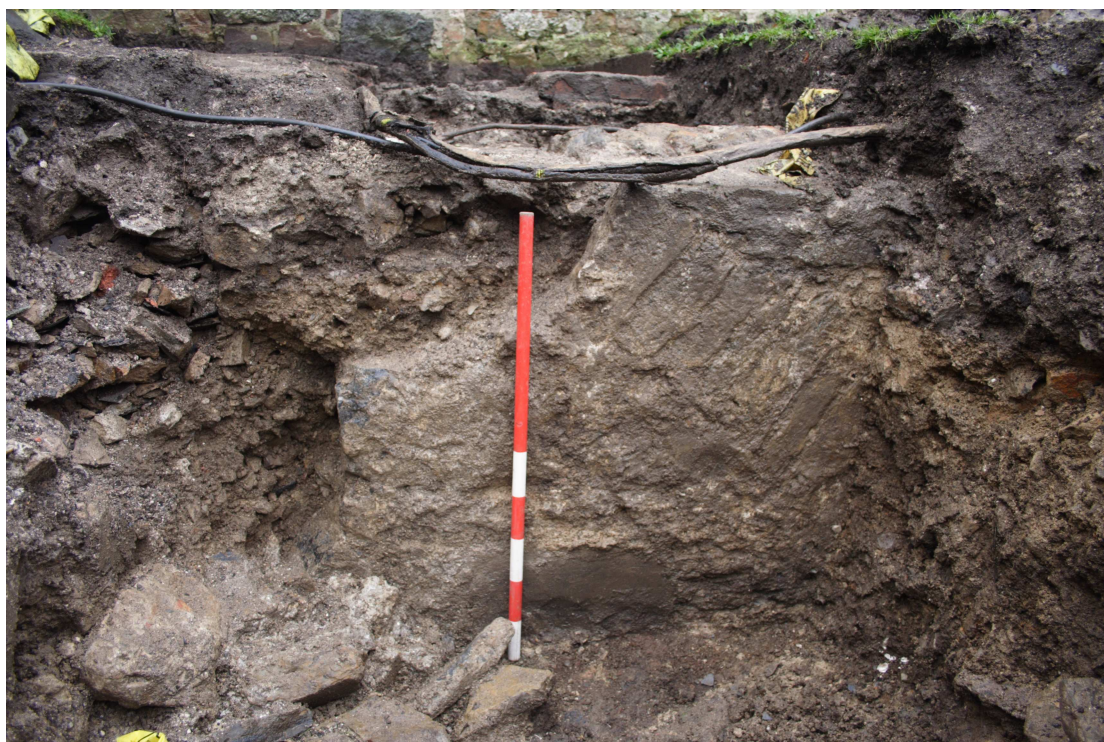
Plate 3: Trench 1, detail of medieval wall 111. View W. Scale 1m

The north-south wall (111) contained a relieving arch, probably either because of a weakness in the foundations or to take the stress off a doorway to the south. This wall may be part of the rear wall of the inner gatehouse of the medieval castle, but without more extensive excavation this interpretation must remain tentative.

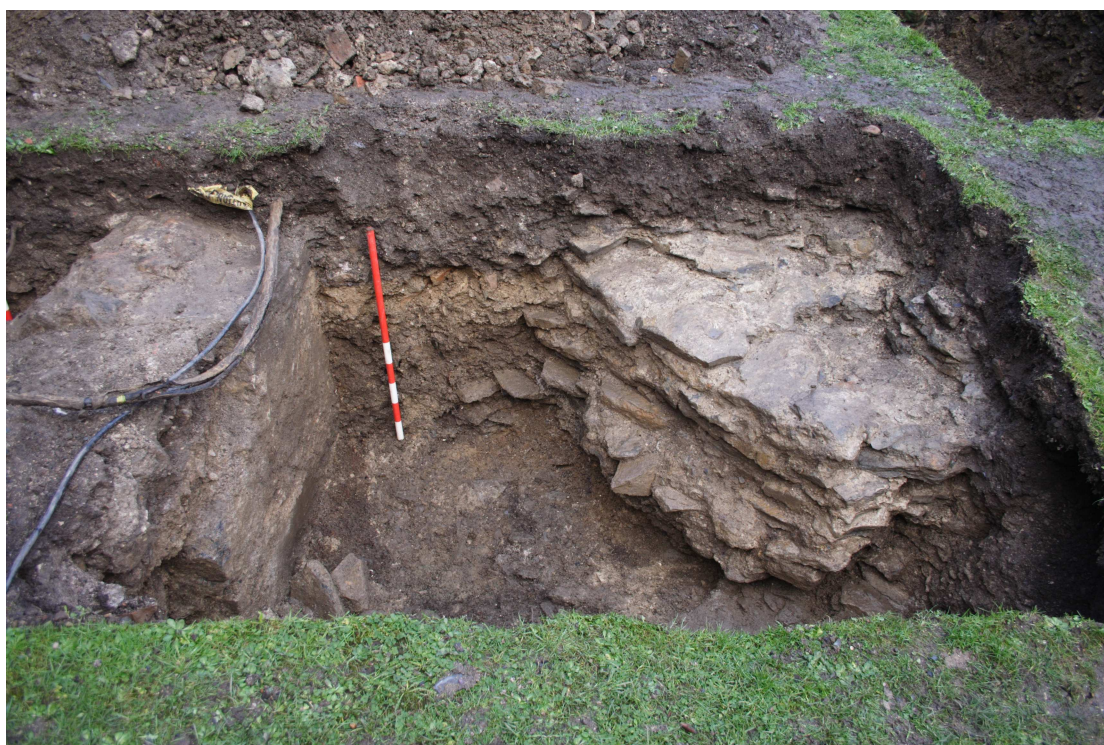
In the northwest corner there was a lump of masonry (112) bonded with a similar mortar to that of wall (111). Again this was cut (116) for the much later drain.

The construction trench (116) for drain 117 was infilled with layer 114 (Fig 5 north-south section; Plate 4), the upper western part of which contained fragments of sheet iron and plain brick, although this may be later disturbance. Fill (114) was itself cut by a later feature (118), which was filled with loose large slates and soil (113: Fig. 5a; Plate 4). Above this was topsoil and turf (102).

Plate 4: Trench 1, detail of medieval wall 111 and masonry 112. View N. Scale 1m

The masonry (112) would appear to be from a collapsed wall and the impression is that any facing stones had been robbed, presumably for reuse. The infill layers (104 to 107) between the wall (111) and the masonry (112) are probably all post-medieval, although two sherds of medieval pottery were recovered.

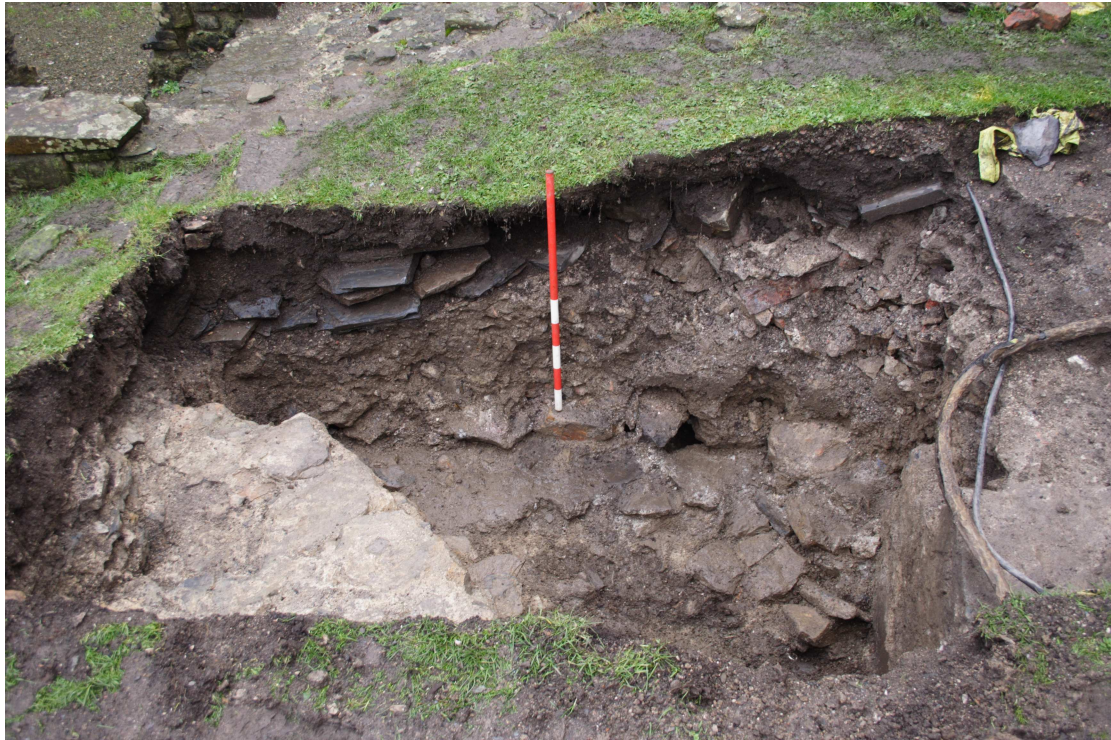
Plate 5: Trench 1. View 23. Scale 1m
