# **Hafod Flower Garden 'Mariamne's Garden', Hafod Estate Ceredigion Archaeological Evaluation**

RHIF YR ADRODDIAD / REPORT NO. 2007/86  
RHIF Y PROSIECT / PROJECT RECORD NO. 63302

Hydref 2007  
October 2007

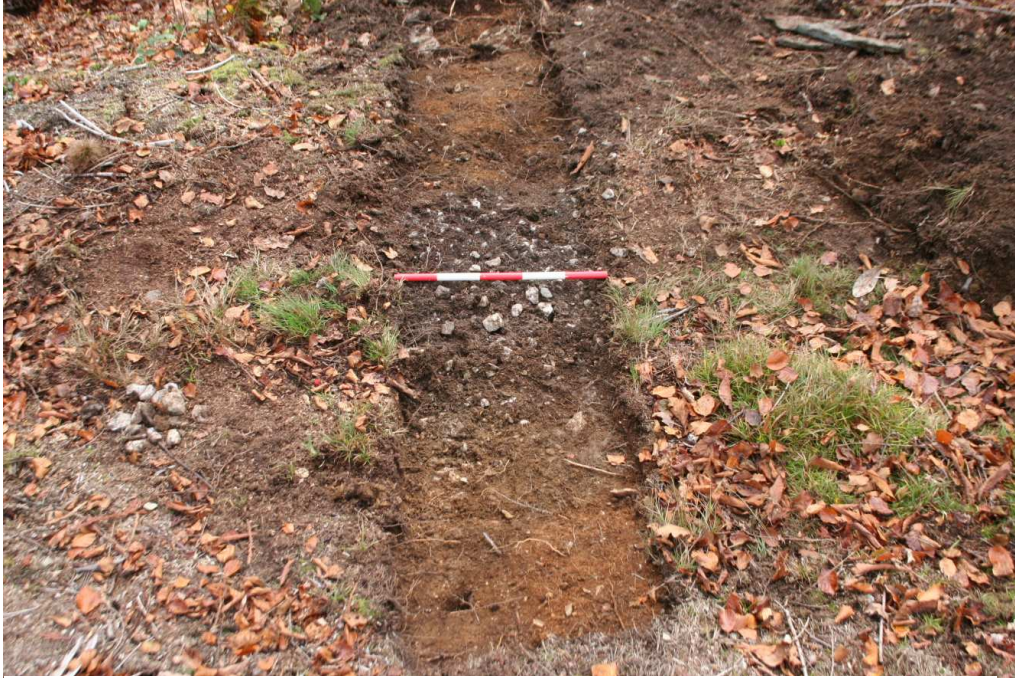
Plate 1: South-east facing shot of Trench 1. 1 x 0.5m scale

This trench was located across a probable path terrace already picked up in previous survey work to investigate the form and condition of the path. This terrace was quite distinct, measuring roughly 1.2m wide, running along the lower edge of the main upper section of the garden. A corresponding path is shown on the 1:2500 1<sup>st</sup> edition Ordnance Survey map of 1888. The trench measured 2.7m by 0.5m and was aligned northwest – southeast. Removal of the turf, leaf mould and topsoil, up to 0.1m thick, revealed remains of the pathway and a slumped retaining wall.

The path measured c.0.65-0.7m wide and was located to the northern end of the terrace running east-west. The path surface was made up of loosely laid angular quartz stones, with an average size of 50mm x 30mm x 30mm, simply laid on to the loose silty subsoil. The stones were not removed but the stone band appeared to be only one or two stones thick. The southern (downslope) edge of the terrace has clearly eroded and slipped downslope, and it is likely that the path was originally wider on this side.

Around 0.7m to the south and further downslope from the path and terrace several loosely laid flat stones were revealed. These stones measured on average 200mm x 100mm x 50mm, and appear to be the remains of a coarse revetment wall that has clearly slipped downslope over time. Remnants of this revetment wall are still visible further west along the lower edge of the terrace.

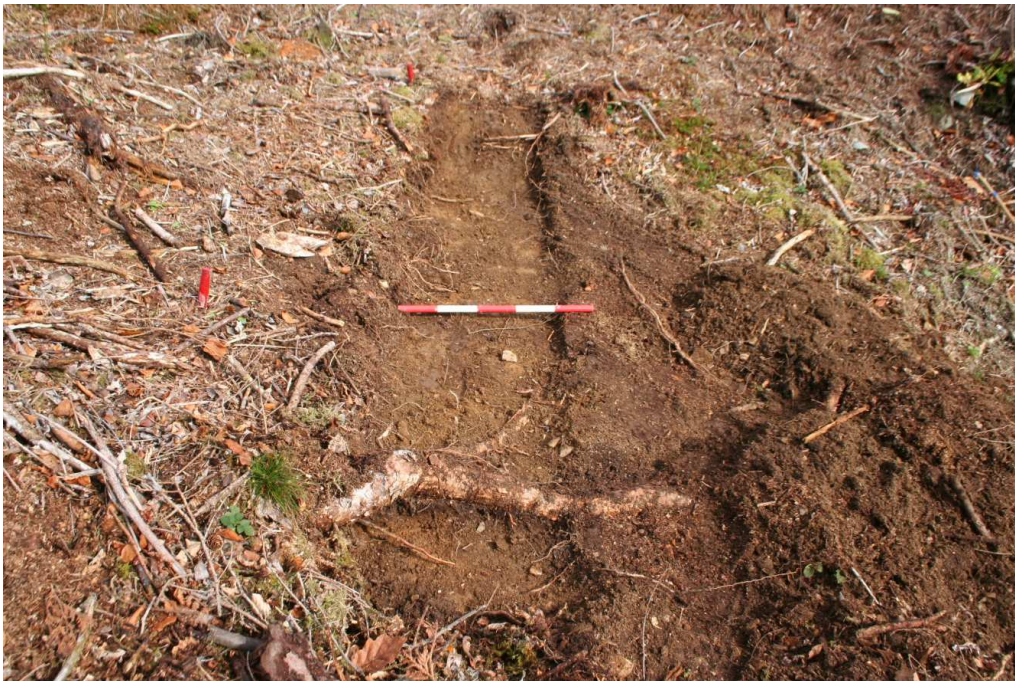
Plate 2: North-east facing shot of Trench 2. 1 x 0.5m scale.

This trench was located in the northern part of the garden in an area that was thought likely to contain a pathway climbing the slope connecting an upper pathway running along the northern wall of the garden and a viewpoint/seat located on a small rock outcrop. This pathway is marked on the 1:2500 1<sup>st</sup> edition Ordnance Survey map of 1888 and this gradient would appear to be the only obvious choice for a pathway to traverse the slope.

The trench measured 2.1m by 0.5m and was aligned north-south across the sloping ground. Between 0.05 and 0.1m of turf and leaf mould were removed overlying the subsoil, but no trace of a pathway was revealed. The lack of any quartz stones within the trench and the immediate area suggests that there may have been no formal surfacing to the path, or that it has completely eroded due to the nature of the sloping ground in this area.

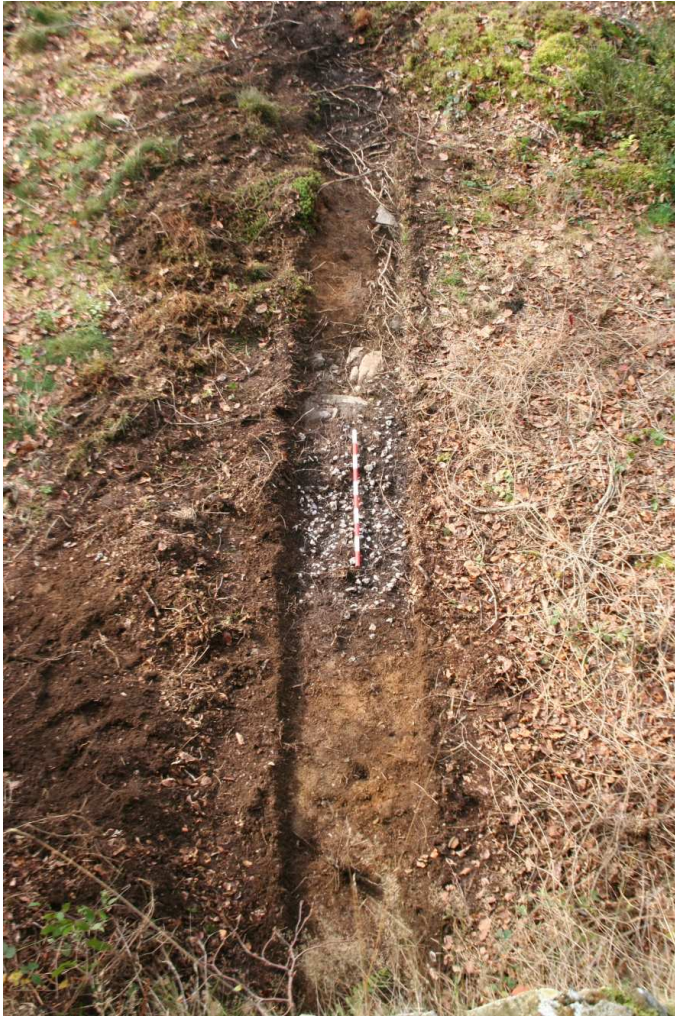
Plate 3 (left): South-west facing shot of Trench 3. 1 x 1m scale.

This trench was located at the eastern end of the garden across a level terrace area that may have contained two pathways, according to the 1:2500 1<sup>st</sup> edition Ordnance Survey map three pathways met in this area. The trench measured 7m by 0.6m and was aligned northeast-southwest across the terrace. Removal of c.0.1m of turf, leaf mould and topsoil revealed a wide central pathway and the edge of a further pathway to the southwest.

The central pathway measured at most 2.04m across and it was located approximately 2.38m to the southwest of the rock face to the northeast. The path surface was made up of loosely laid angular quartz stones, with an average size of 50mm x 30mm x 30mm, simply laid on to the loose silty subsoil, the same as the path revealed in Trench 1. The southwestern edge of the quartz-stone path was intermingled with an area of large flat loosely laid stones. These stones vary from 150mm x 80mm x 30mm up to 400mm x 200mm x 30mm, and appear to form part of a surface rather than a collapsed revetment wall. The edges of the path appear slightly splayed, being wider to the northwest than the southeast. The greater width of the pathway in this area may indicate this was indeed where pathways converged.

Approximately 1.4m further to the southwest the edge of a second path was revealed. This path was also made up of loosely laid angular quartz stones, with an average size of 50mm x 30mm x 30mm, simply laid on to the loose silty subsoil. The revealed edge of this path was disturbed by root action but it appeared to be curving, suggesting the path continued to run in a more southwesterly direction out onto a rocky outcrop where it meets with another path running towards some rock-cut steps taking the pathway down onto a lower terrace (a path marked on the 1:2500 Ordnance Survey map). The curve also suggested the path may have followed the contours to meet with the path visible within Trench 1.

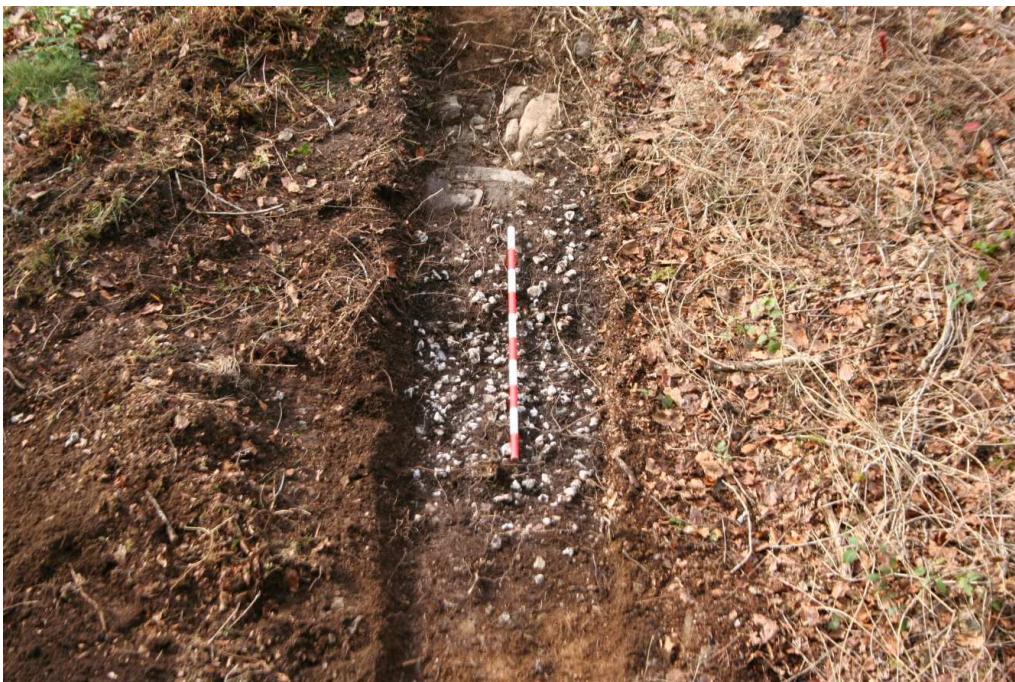
Plate 4 (below): Close-up of central pathway.

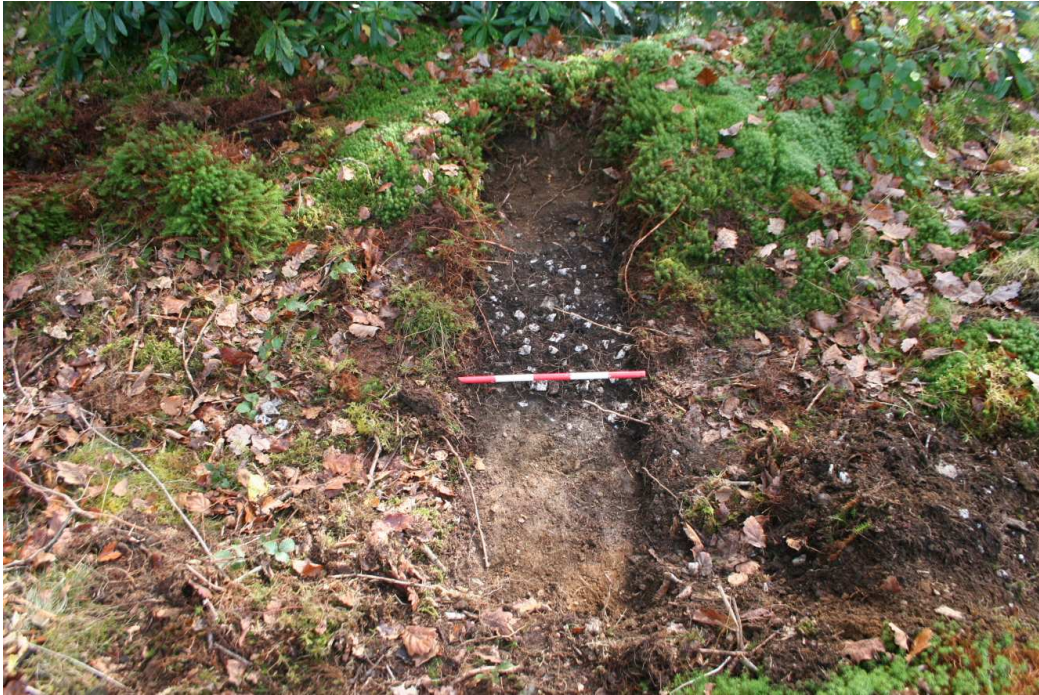
Plate 5: South-east facing shot of Trench 4. 1 x 0.5m scale.

This trench was located close to the gateway in the southeastern wall of the garden on a level terrace that was thought to have contained a pathway. The 1:2500 1<sup>st</sup> edition Ordnance Survey map shows a pathway running along the inner edge of the garden wall in this area. The trench measured 1.8m by 0.5m and was aligned northwest – southeast to run across the terrace. Removal of a thin layer of turf, vegetation and topsoil revealed pathway crossing the centre of the trench.

The path measured c.0.8m wide, running in a roughly northeast – southwest direction. As with all the other revealed paths this was also made up of loosely laid angular quartz stones, with an average size of 50mm x 30mm x 30mm, simply laid on to the loose silty subsoil.
