TIR GOFAL MANAGEMENT PLAN: HERITAGE MANAGEMENT INFORMATION (HE2)

**Prepared for:
Penpedwast, Eglwyswrw, Crymych, SA41 3UR**

**Tir Gofal Reference No
W/13/7846**

**DAT Report No. 2008-96
Project Record No. 63603**

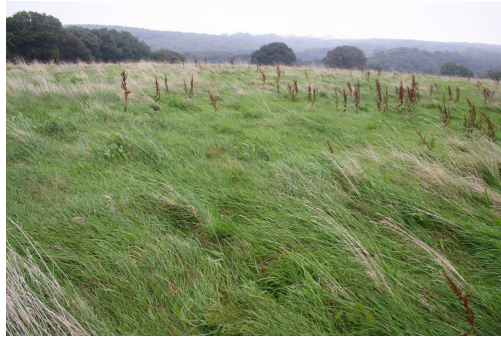
Location of the Iron Age enclosure

The location of the site was visited during the Tir Gofal archaeological farm visit (15/09/2008). As would be expected, as all the archaeology is below ground, nothing of the enclosure was visible and the field was under thick grass - the farmer informed me that a hay-crop is taken every year and that no ploughing occurs. In 2006 a geophysical survey was conducted on the site and the results are presented below:

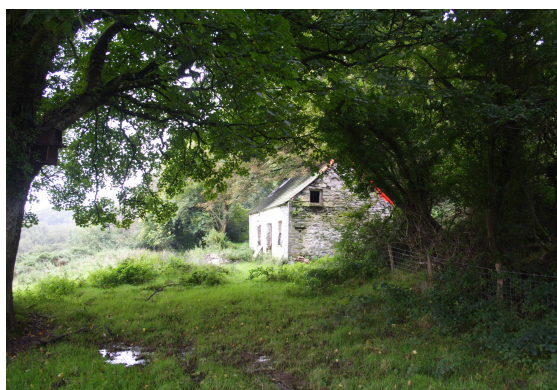
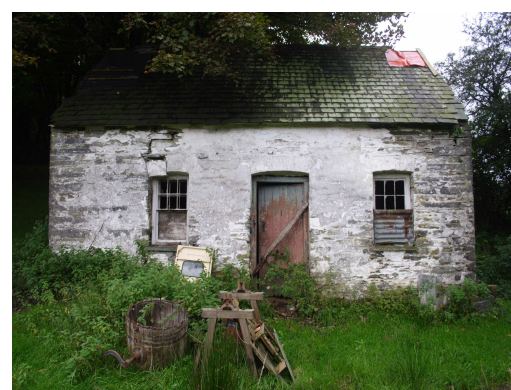
Ty Cwm Cottage (PRN 38301)

Cottage shown on Bronwydd estate map of Eglwysrw Parish in 1822. The cottage was visited during the Tir Gofal archaeological farm visit (15/09/08). A stone-built, white-washed cottage, measuring approximately 6 x 8 metres, with a slate roof, wooden sash-windows and a wooden plank doorway. Internally it is now a single space, but the site of a kitchen range in the southeastern corner and a fireplace and mantelpiece in the centre of the opposite wall indicate the former division of the groundfloor. In the southwestern corner there is a small window that may once have been in a pantry and an angled groove in the wall where stairs to the upper, loft floor would have been. The walls are plastered and there is a remnant of paint in the living room.

The upper floor has now gone, with the roof-rafters and 'A'-frame structure now exposed, but timber remnants and wall-sockets indicate the original ceiling height. There are some outbuilding remnants attached to the northwestern sidewall. The cottage is now redundant and at risk of becoming derelict. Tarpaulin has been placed on the roof and the windows are boarded to keep the structure weather-tight. Two 'pheasantrys' (PRNs 94138 and 94139) are shown to the south of Ty Cwm on the 1907 2nd edition Ordnance Survey map. These structures were not seen during the Tir Gofal farm visit and are not marked on modern mapping.

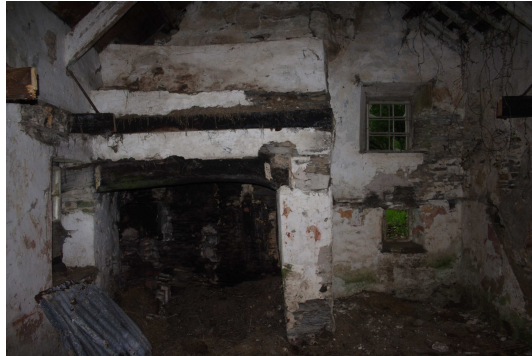
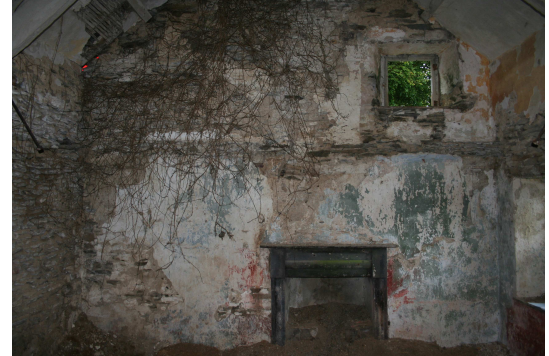
Interior of Ty Cwm Cottage. (Left) kitchen and possible pantry. (Right) fireplace in living room.

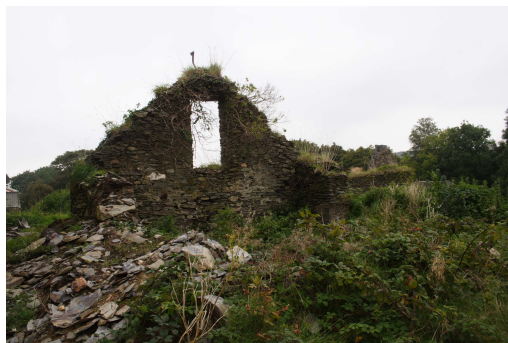
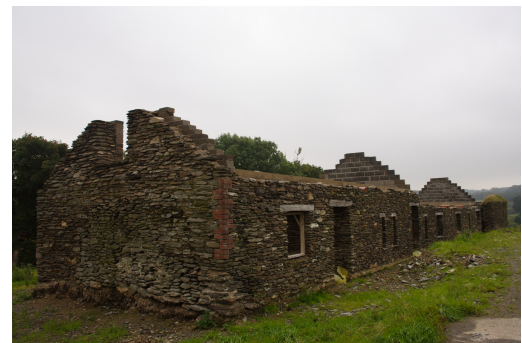
Penpedwast Farmstead, recorded on 1889 1st edition Ordnance Survey map, comprises a fairly haphazard complex of farmbuildings located around the farmhouse (PRN 17264). These included a long building with a circular feature marked behind it, which may represent a horse ginny ring used for powering farm machinery (threshing, winnowing, chaffing etc.) before the arrival of oil or diesel engines, a pigsty, a possible granary, two stone buildings - possible workers' cottages and a potential brewhouse. At the time of the Tir Gofal archaeological farm visit (15/09/2008) the main long farmbuilding was undergoing extensive restoration work and there was no sign of the probable horse-engine recorded on the 19th century OS map. Also, the farmbuilding alongside the farmhouse has fallen into ruin with only the rear, northern, gable end still standing. A flight of external stone steps leading to a loft doorway suggests that the building may have been a granary.

(Left) the remains of the possible granary. (Right) Restoration works on the long farmbuilding.
