## **TIR GOFAL MANAGEMENT PLAN: HERITAGE MANAGEMENT INFORMATION (HE2)**

**Prepared for:  
Alltgoch**

**Tir Gofal Reference No  
W/11/6304**

**DAT Report No. 2009-27  
Project Record No. 63614**

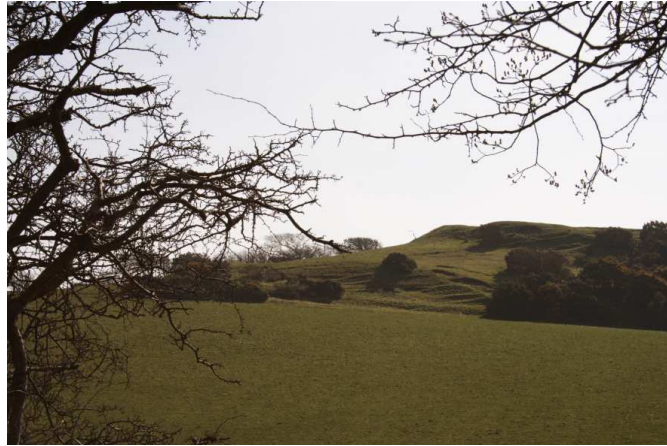
easiest line of approach being from the northeast. This has been protected by the construction of a stretch of rampart with an external ditch. Today, the bank stands to a height of between 3-4 metres above the external ground level and approximately one metre above the interior ground level of the fort. The top of the bank measures some 3-4 metres across and is flattened in appearance. The fort entrance appears to lie at the northern apex of the site.

*Looking south towards Caer-allt-goch Iron Age hillfort (PRN 2009)*

The interior of the hillfort is roughly oval in shape and covers an area of some 0.8ha. It stands on a natural rocky knoll and there is an outcrop of natural rock forming a line running down the length of the interior on its southern side. This limits occupation of the interior to the northern and western parts. In the southwest of the site there are indications of quarrying, in the form of a series of shallow scoops. Within the interior it is possible to identify the locations of a number of house platforms. They have the appearance of flattened platforms, of varying dimensions from 5-6 metres to 7-8 metres in diameter (K.R., 1998). A scar was noted on the northern side of the site by the Cadw Field Monument Warden in 2005. The site was seen, during the Tir Gofal archaeological farm visit of 18/03/2009, to be under low-intensity grazing and was under a cover of short grass.

The hillfort is a Scheduled Ancient Monument (CD169) and the following management recommendations have been made in consultation with the Cadw Field Monument Warden. The site is located within a pasture field, which should be ideally suited to maintaining the monument under a cover of low growing vegetation. The main immediate threats appear to be the extensive growth of gorse on the monument and a scar at the northern corner that measures some 2x1 metres with a depth of 0.3 metres.

- Repair work to the scrape would need Scheduled Monument Consent (please contact the Tir Gofal Project Officer for details). Alternatively the scrape could be filled with brash or gorse trimmings, which might have to be pegged or pinned in place, to help to reduce wear in this area.
- The amount of gorse on the site as a whole remains considerable, and is likely to increase if not managed. A sustained effort should be made to keep the gorse off the top, the upper part of the sides and the east end. The gorse should be cut rather than pulled out and disposed of away from the site.
- Stock levels should be monitored with no supplementary stock feeding on or near the monument.
- No groundbreaking activities should be undertaken within the area of the monument or a ten metre buffer zone around the edge.

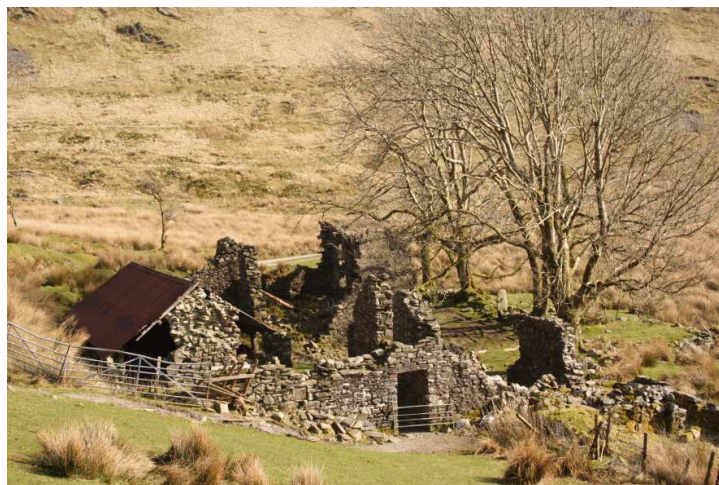
Identified from 1888 1st edition Ordnance Survey map as a 'L'shaped complex and farmhouse, apparently now ruined although two buildings still recorded on modern map. The farmstead is recorded by the RCAHMS (Nprn 282,260) as "now abandoned and in complete ruin", comprising the main farmhouse (Nprn 282261) and series of 3 outbuildings (Nprns 282,262, 282,263 and 282,264) (R.S.J., 2004). The farmhouse is "now unroofed and ruinous". The building was two-storey and approximately 10 x 5 metres (east-west), with a stone built porch and arch in the south wall. Rubble and roofing covers internal area. Farmstead mentioned as a 'Lluest' in Lewis Morris's text and map of 1744 (R.S.J., 2004).

*Looking southeast over the abandoned Bwlch-y-styllen farmstead (PRN 64162).*

The farmstead was recorded during the Tir Gofal archaeological farm visit of 18/03/2009 as comprising the ruined farmhouse, as described above, an 'L'-shaped complex of two farm buildings and several boundary walls. The south-facing house is built from large, dressed blocks of stone, although the side walls have largely collapsed leaving the facade and rear walls standing proud to second floor height. The groundfloor plan includes a brick arched doorway into the front porch, leading through to the main living room, with a fireplace on the eastern wall, and a possible, single-pitched, kitchen extension at the back. Three window apertures, two on the groundfloor, with brick lintels survive in the facade and there is a north-facing window, with a timber lintel, in the rear extension. The staircase to the first floor appears to have been in the southwest corner of the living room but the second storey has collapsed. The interior is filled with the loose stone from tumbled masonry.

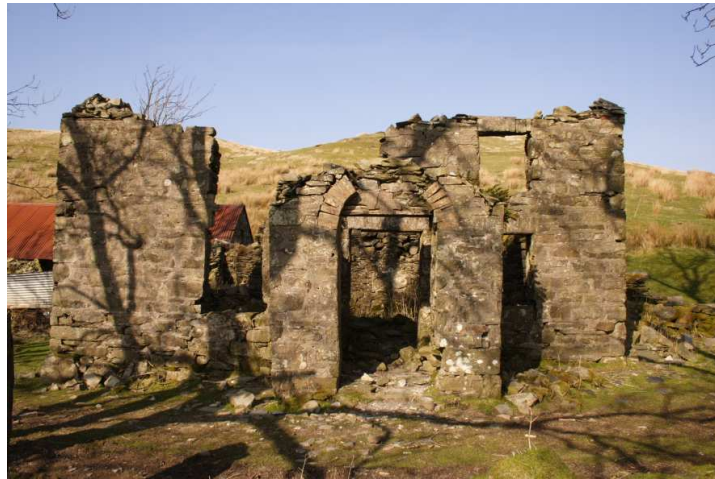
*Looking north, main entrance to Bwlch-y-styllen farmhouse*

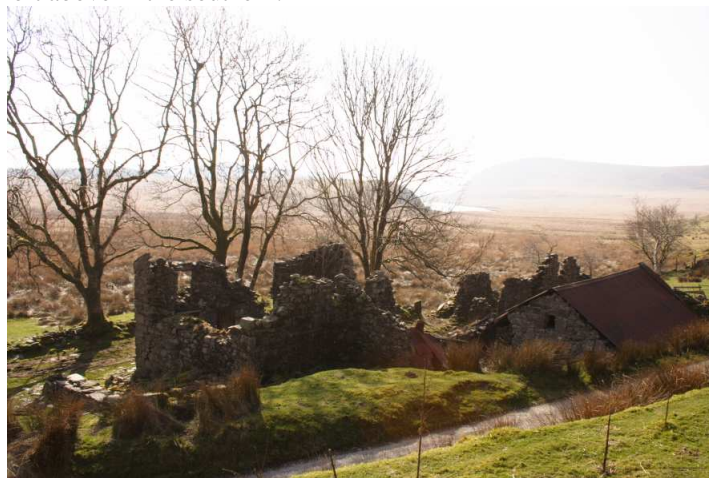
A gable ended, stone built farm building is aligned east-west at right angles to the rear of the farmhouse, cut into the hillslope. The structure, a probable cow shed, is now largely ruinous, although the gable ends survive to full height if not width and the rear wall still stands. There is now a corrugated-iron roof (it was recorded as unroofed in 2004), which has been supported along the open front length by timber posts. There is a small square window aperture within the east-facing gable. The second farm building abutts the western gable end of the first and is aligned north-south, parallel to the farmhouse. It is divided into two sections, with a gabled structural wall between them that suggests that the building was two storeys high. The rest of the structure is in a ruinous state, with the side walls in varying states of collapse. The northern part of the building has opposing doorways in the west and east-facing walls and there is a loft entrance within the central dividing wall. The southern part of the building has a possible entrance in the southeast corner and a window in the east-facing wall. A suggested function for the building is a threshing barn in the north side and a stable with hayloft above in the southern.

*Looking southwest across Bwlch-y-styllen farmstead (PRN 64162)*

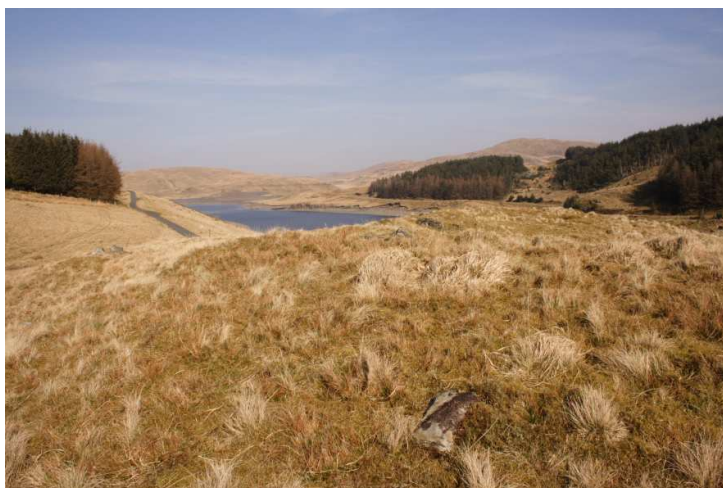
The Royal Commission on the Ancient and Historical Monuments of Wales (RCAHMW) record a cairn, possibly dating from the Bronze Age. The area was seen during the Tir Gofal archaeological farm visit of 18/03/2009 but it seemed uncertain whether the exposed stones at the given coordinates were archaeological or natural. The surrounding landscape is very undulating, under moorland and marsh, and there are numerous natural outcrops of rock and exposed boulders.

*Looking northeast across suggested site of Bronze Age cairn (PRN 64159)*

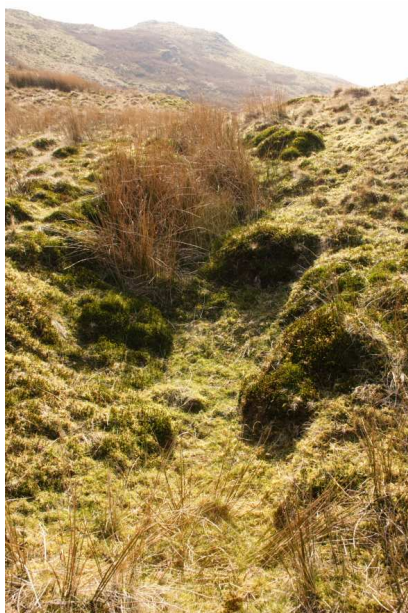
A pit of unknown date recorded by RCAHMW. The location of this pit was found during the Tir Gofal archaeological farm visit of 18/03/2009. It was seen to be a linear, elongated oval, although fairly amorphous, hollow at the base of a hillslope within an undulating area of moorland and marsh. It measures approximately 2.50 X 2.0 metres, aligned north-south, and is some 0.50 metres deep. There is nothing to identify the feature as archaeological and it is possibly a natural depression formed by water running off the hillside.

*Looking southwest, hollow / possible pit (PRN 64160)*

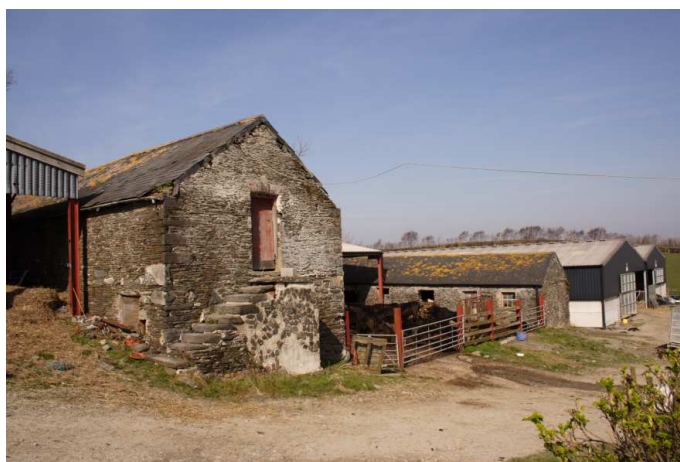
The Allt-goch farmstead is depicted on the 1888 1st edition Ordnance Survey map as a 'U'-shaped pattern of farm buildings set apart from the farmhouse and this layout has remained intact through to the present day, now lying in the centre of an expanded complex. The southernmost farm building, aligned northwest-southeast, is a combination range comprising a cart shed with granary loft above, a threshing barn and a stable with hayloft above. Parallel to this, to the north, is a cowshed and at right angles to both buildings to form the 'U'-shape is a stock shed. The buildings are currently used for housing beef cattle and a modern, open-sided shelter now stands in the space between the three 19th century buildings. The three buildings are gable-ended and constructed of rubble stone, with dressed stone quoins, and slate roofs.

*Allt-goch farmstead (PRN 64152), looking north.*

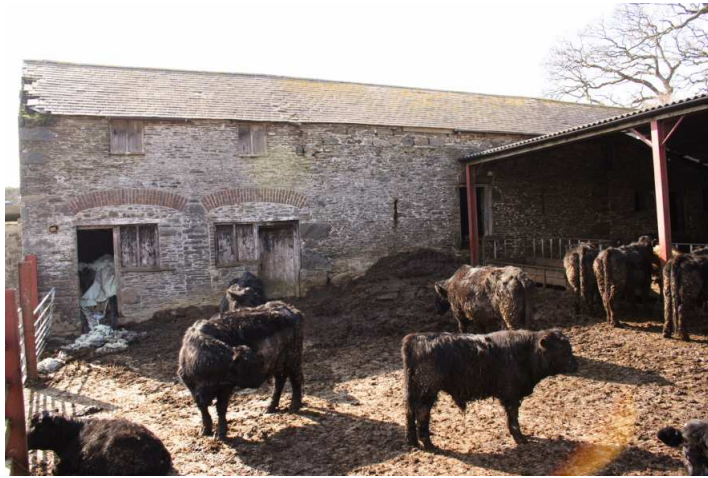
The two-storey cart shed, in the southeast corner of the complex appears to be a later addition on to the side of the threshing barn. The demarcation between the two buildings is more pronounced in the masonry of the rear walls, although large squared quoin stones are still in situ in the facade where the two buildings abut, forming the edge of one of two square entrances. These have elongated red-brick arches above but have subsequently been partially blocked up with masonry and now each has a timber-framed window. with a

wooden shutter, and a solid wood plank door under a timber lintel. Directly above each original entrance is a wooden-shuttered window within the granary loft. There is a further doorway located within the rear wall.

*Looking southwest, the cart shed and threshing barn within Allt-goch farmstead.*

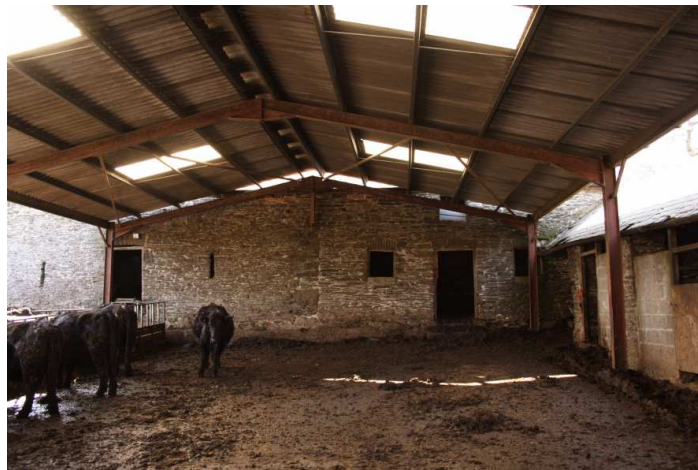
The facade of the rest of this combination range is partially obscured by the modern shelter. When viewed from the front, the threshing barn is to the right of the cart shed. It has a central timber-framed entrance doorway, with a red-brick lintel, and ventilation loops either side in an arrangement mirrored within the rear wall, although the rear door has a lintel of pitched stones. The interior is open to the 'A'-frame roof timbers and has a concrete floor. A first storey window and two ventilation loops have been blocked-up within the southeast gable and a doorway has been inserted through to the later cart shed.

*Looking southwest, the threshing barn and stable, partly obscured by modern shelter, and (on right) the stock shed.*

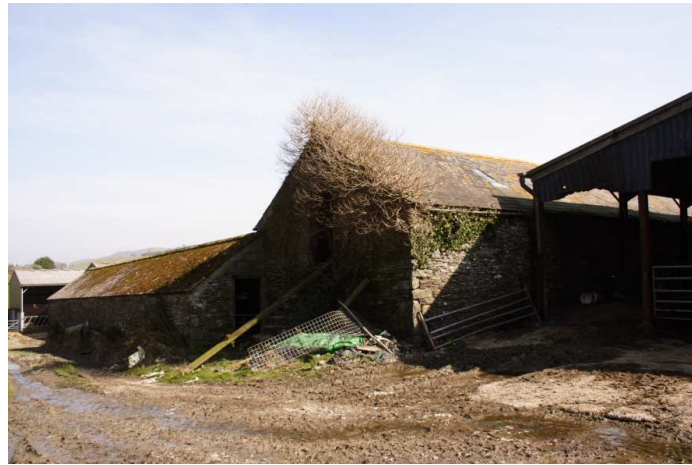
storey stock shed. While the front pitch of the roof is still slate, the rear has been replaced with corrugated-iron.

*Looking east, the northwest gable end of the stable and the rear of the stock shed.*

The building is open-fronted and supported by four stone pillars, although the space between most of these pillars has now been infilled with breezeblocks. Breezeblocks have also been used to consolidate the building's southwest facing gable after the insertion of a doorway. The northeast end of the building has been partitioned off by a structural masonry wall. The single-storey cow shed forms the northeast perimeter of the complex, running parallel to the combination range and at right angles to the stock shed. There are four doorways, one with a solid wooden plank door, and two windows, with red-brick flashings, within the facade and a further doorway within the northwest facing gable end, again with a solid wooden plank door. There are ventilation loops and one small, shuttered window within the rear wall.

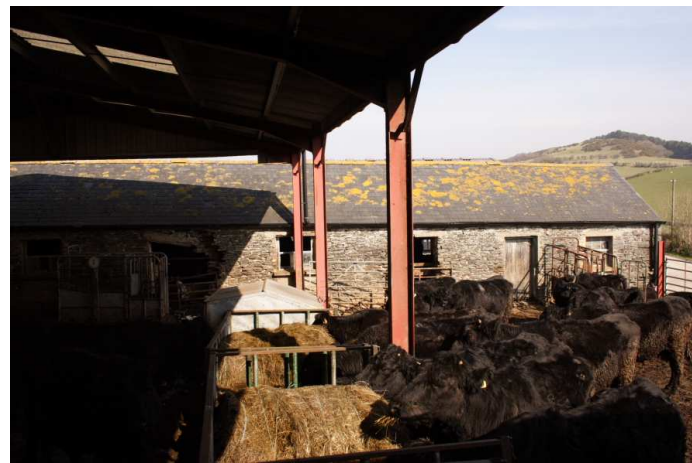
*Looking northeast, the cow shed, partly obscured by the modern shelter.*

There were a number of cattle within the building at the time of the visit and the interior could only be viewed through the gated doorways. Approximately eleven stall partitions were noted, located along its length. A further surviving feature of the farm that is recorded on the late 19th century maps is the orchard, just to the north of the farmhouse.

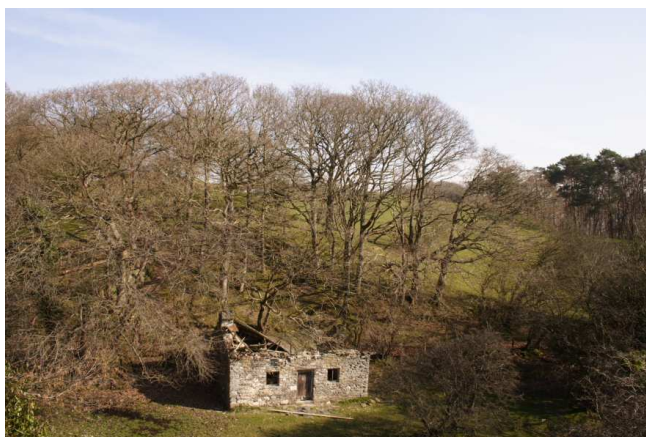
Cottage site identified from the 1888 1st edition Ordnance Survey map and still marked on the modern map. During the Tir Gofal archaeological farm visit of 18/03/2009 the cottage was seen to be a single-storey, gable-ended building of partly dressed stone construction with dressed stone quoins.

*Looking northeast, abandoned cottage Allt-goch fach (PRN 64153)*

The pitched slate roof had recently collapsed inwards and the roof timbers and slates still lie within the walls. There is a central doorway in the facade, with a solid wood planking door, and a window either side. All these apertures are timber framed and have stone lintels. Much of the southeast gable end wall has now gone, either fallen or taken down, and the edges of the remaining masonry appear to have been consolidated with stone, leaving a wide opening, the purpose of which is uncertain. Possibly the abandoned dwelling was subsequently used as a livestock shelter. The interior of the building is now obscured by the fallen roof debris, which prevented a clear view of any internal features including the wicker-work chimney on the northwest gable.

- Repair is always preferable to replacement, keeping as much of the original fabric of the building in place as possible. Retain as many of the original slates as possible.
- Ideally the building should be re-roofed in slate but should too many original slates be unusable then it might be acceptable to replace with corrugated-iron, a more economic alternative.
- Replacing roof timbers: As a general rule, replacement features should be modelled on similar surviving examples. Where these do not exist the emphasis should be on matching details appropriate for the locality and the age of the building. The original roof timbers are still available for reference and it is possible that some, if not all, could be re-used.
- Monitor trees close to the building and fell any that are at risk of causing damage, either from windthrow or dropping branches.

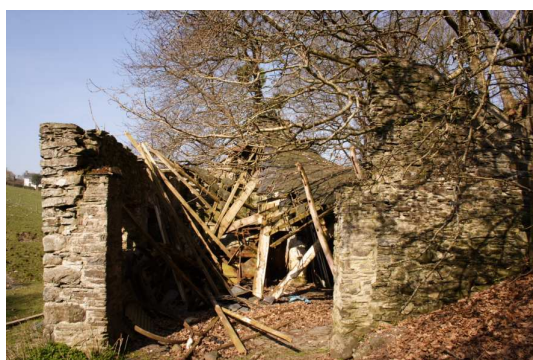
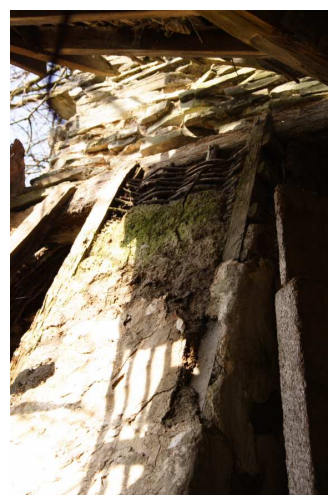
*(Left) the widened gap in the southeast side wall and (left), surviving wicker-work on the chimney breast.*

The cottage roof has now collapsed inwards, leaving the structure open to the weather, exposing the wall tops and possibly damaging internal features. The chimney is a rare surviving example of a wattle louvre that would be daubed with clay or clay and cow-dung (Peate, 1940). Areas of the well preserved basket-work wattle are visible it is important that some thought is given to its protection. Ideally the roof would be restored, using as much of the original material as is salvageable to return the structure to a weathertight condition. If left in its current condition the chimney will quickly deteriorate.

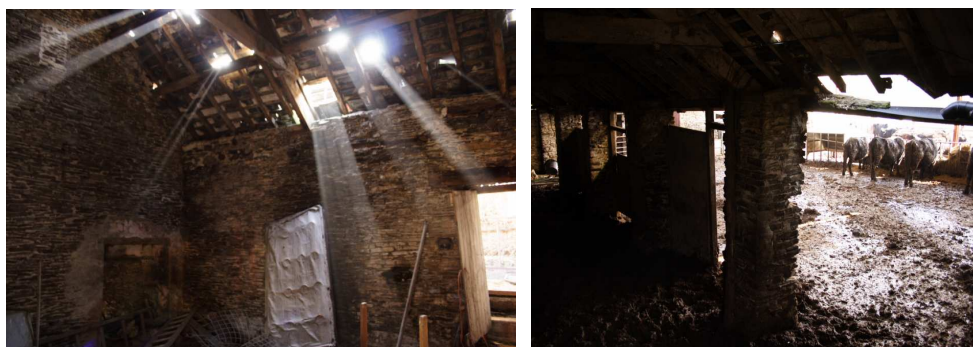
The most pressing need for repair on the Alltgoch 19th century farm buildings are the slate roofs, particularly the rear pitch of the combination range. Repair work is also required on the front pitch of this building and on the front pitch of the stock shed. Many of these buildings are currently used as cow sheds and it is important that they are kept weathertight.

*(Left) interior of the threshing barn showing gaps in the slate roof and (right) interior of the stock shed, illustrating the need for roof and masonry repairs.*

Other required work includes masonry repairs, most noticeably on the southeast gable wall and around the doorways of the cowshed and the stone pillars of the stock shed. The weatherboarding on the southeast gables of the cow shed and cart shed also needs repairing or replacing.

- Repair is always preferable to replacement, keeping as much of the original fabric of the building in place as possible. Replacement is only to be carried out where necessary.
- Repair or replace missing or displaced roof slates and weatherboarding.
- When repairing or rebuilding walls, match the type of stone used originally and the method of laying. Fallen stone may be salvageable although additional local rubble stone brought to rough courses is appropriate.
- Consolidate areas of loose masonry using a traditional lime mortar mix, trying to follow the original mix and appearance as far as possible.
