TIR GOFAL MANAGEMENT PLAN: HERITAGE MANAGEMENT INFORMATION (HE2)

**Prepared for:
Hook Quay**

**Tir Gofal Reference No
W/13/6355**

**DAT Report No. 2009-9
Project Record No. 63661**

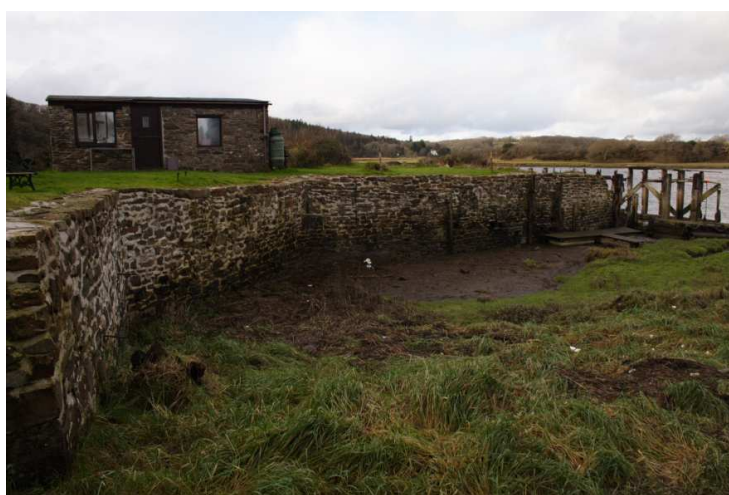
Looking west, the eastern stonewall of the quay and wooden structure at its northern end.

The linking, northern wall has suffered collapse and is incomplete. A wooden structure is located at the northern end of the quay, with posts driven into the mud and supporting a pair of horizontal and continuous crossbeams, between which are diagonal bracing beams. The structure projects some 5 metres beyond the north end, and continues along the east and west sides, of the stone quay. It is unknown whether the wooden construction is contemporary with the building of the stone quay or is a later addition, possibly replacing the damaged northern stonewall. (Source: Cadw Scheduled Ancient Monument Record (2005))

It is understood, from the Cadw Inspector of Ancient Monuments, that 'the work required to make the quayside stable is quite large in scale and requires an engineered solution which has yet to be drawn up' (23/01/2009). Such works fall beyond the parameters of the Tir Gofal scheme.

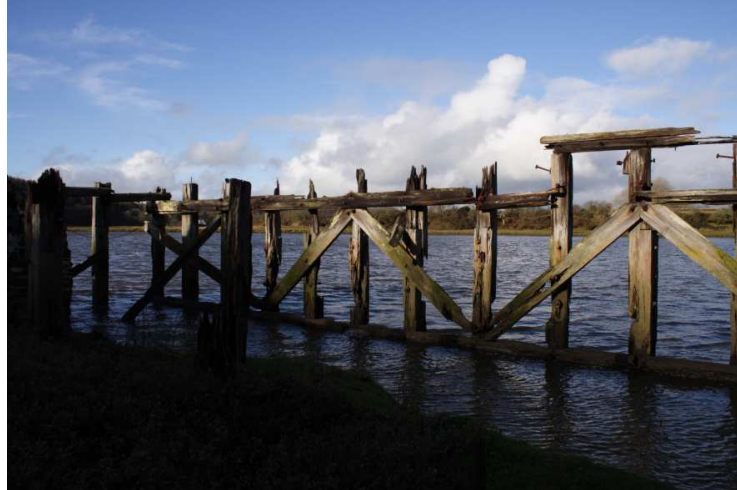
The remains of the wooden platform on the northern end of Hook Quay.

The areas alongside both the western and eastern walls are silting up, to some 2 metres depth according to the owner, and becoming salt marsh. There is apparently a solid base beneath. The wooden structure is slowly deteriorating and there is little that can be done to prevent this - a comprehensive photographic and drawn record of the remains would be desirable. An area of scrub in the northwest corner of the stone structure has had to be left in place as it has been a home to an otter for several years.

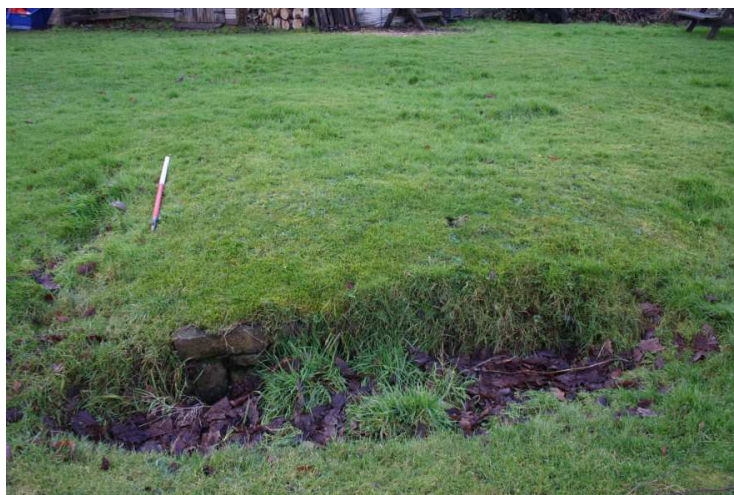
Looking west, stone foundations of 18th-19th century building PRN 94563

The square foundation is now under turf but its extent can be seen from the slightly paler colour of the grass. The southeast corner has been exposed revealing dressed stone blocks.

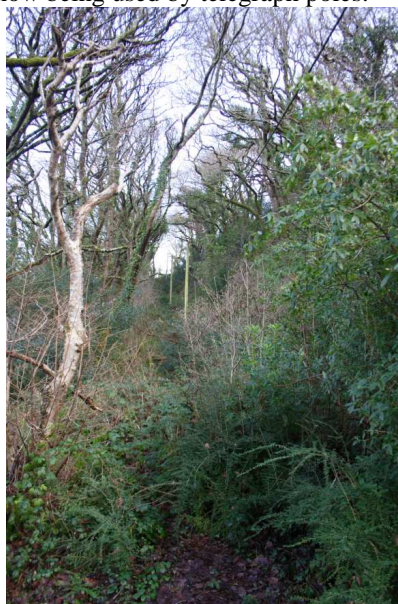
An aerial tramway recorded on the 1908 2nd edition Ordnance Survey map, used for conveying coal to Hook Quay (PRN 64808), running to the north and east of Hook Quay cottage (PRN 64810). The course of this tramway is still defined to the east of the cottage by a continuous clearing in the heavily wooded hillside (Cadw, 2005). During the Tir Gofal archaeological farm visit of 19/01/2009 the line of the tramway was still clearly visible through the woods, now being used by telegraph poles.

Incline through the woods, route of the 19th century aerial tramway PRN 94564

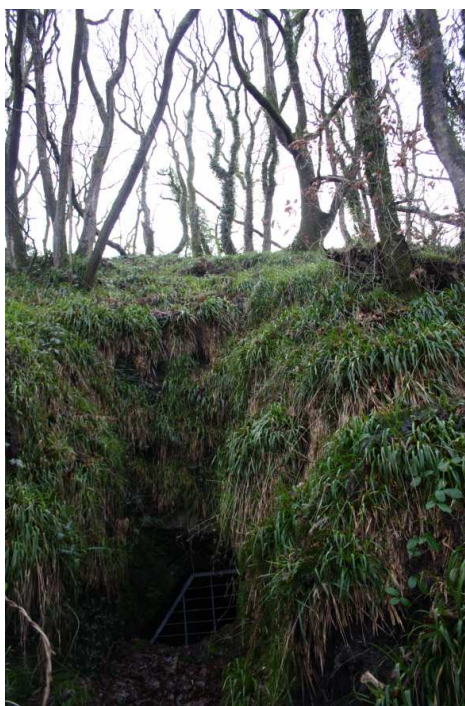
Entrance to the mine workings PRN 94569 within the woods.

The mine was visited during the Tir Gofal archaeological farm visit of 19/01/2009. The entrance to the workings have been secured by an iron gate so it was only possible to see a narrow tunnel, approximately 1.75 metres high, hewn into the rock and heading straight back into the hillside.

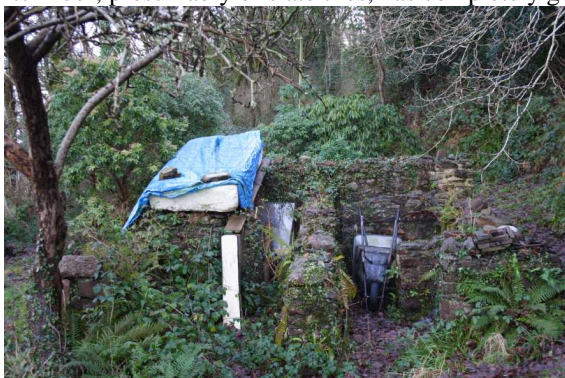
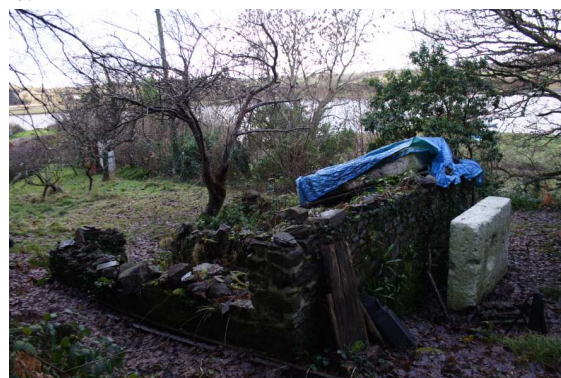
A 19th century pigsty, located to the east of the house at Hook Quay, comprising two separate, symmetrical pens with access to a low building. It is built from stone-rubble with dressed, squared quoins but the single-pitch roof, presumably of slate tiles, has completely gone.

Looking east and looking northwest, the Hook Quay pigsty

The walls appear to stand to full height, with the exception of a small area of tumble in the northwest corner, and the rear corners of the building have been consolidated, by the owner, with lime-mortar.

The walls look solid and the rear corners have recently been consolidated with lime- mortar. The remaining walls would benefit from similar consolidation to prevent moisture penetration and the vegetation needs to be controlled, particularly the ivy, bracken and coarse grasses growing on the walls. There appears to be a discreet area of masonry tumble at the northwest corner that requires reparation but the main work required on the building is the restoration of the roof.

The roof of the pigsty is completely gone, exposing the wall tops of the pig house to the elements.

The pigsty doors no longer survive and their original appearance is no longer known.

The management aim is to return the pigsty to a weatherproof and stable condition. Tir Gofal advice advocates the use of materials that match those used originally. Repairs should be undertaken on a like-for-like basis, modelled on the originals and using similar materials and methods of construction.

Repointing is premature until mortar has weathered back to a depth equivalent to the joint width or is very loose. New pointing should match the material and finish of existing pointing as closely as possible. A nearly flush finish is appropriate in this instance. Vegetation on the walls should be cut back, leaving the roots in situ, and spot-treated to prevent re-growth. Following vegetation removal masonry should be consolidated and repointed.

Replacing roof timbers: as a general rule, replacement features should be modelled on similar surviving examples. Where these do not exist the emphasis should be on matching details appropriate for the locality and building's age. In this instance slate is the appropriate roof covering and should be used over a softwood supporting structure.

Historically the trend in pigsty doors was towards simple wooden plank doors. They tended to be of softwood construction and finished with an estate paint colour. The doors should be replaced to these specifications, reusing old door furniture if it is available.

Consolidate areas of loose masonry using a traditional lime mortar mix, trying to follow the original mix and appearance as far as possible.

Consider capping the wall tops in order to prevent water from washing out lime mortar bonds and accelerating collapse.

Cut back vegetation on the walls, leaving the roots in situ and spot treat to prevent re-growth.

Monitor mature trees close to the building. Consider felling trees that are at risk of causing damage by windthrow and removing branches in danger of falling on the building.

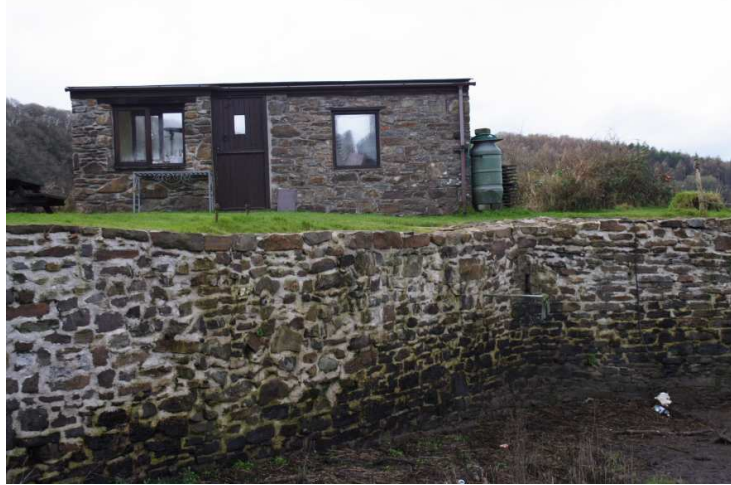
The restored and extended weigh house and the eastern quay wall.

The building was seen, during the Tir Gofal archaeological farm visit of 19/01/2009, to be in a good, weathertight condition following its restoration and extension.
