TIR GOFAL MANAGEMENT PLAN: HERITAGE MANAGEMENT INFORMATION (HE2)

Prepared for: Nantarast

Tir Gofal Reference No W/12/6268

DAT Report No. 2009-10 Project Record No. 63665

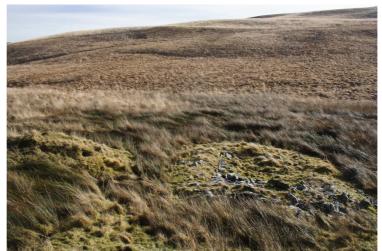
Looking east, the Deserted Rural Settlement of Esgair Gaeo (PRN 36015).

This site was seen during the Tir Gofal archaeological farm visit of 28/01/2009. It lies in an area of upland grazing and appeared to be in a stable condition and under no immediate threat.

The Deserted Rural Settlement site of Esgair Gaeo, incorporating long hut (PRN 36016), enclosures (PRNs 36017 and 36018) and sunken feature (PRN 36019), is a Scheduled Ancient Monument (SAM CM298). Cadw do not identify any real issues with the management of the site, which is under upland grazing, but do suggest that some control of the rushes now and again would be useful (Cadw, 2008)

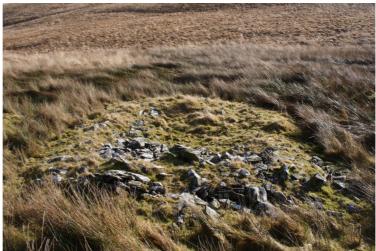
Looking southeast, remains of Esgair Gaeo longhut (PRN 36016)

The house ruins were seen during the Tir Gofal archaeological farm visit (28/01/2009). The site is in an area of low-intensity, upland grazing and is under no immediate threat. Much of the house foundation is under grass cover with exposed stone concentrated towards the northern end of the site and the area is surrounded by a thick growth of reeds.

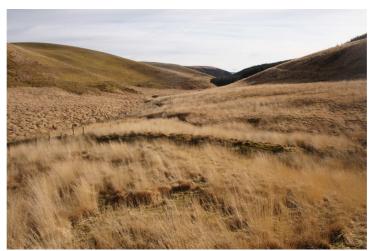
Looking southeast, earthwork bank, possible pillow mound (PRN 94610), across centre of photograph.

The profiles of upland pillow-mounds tend to be more ridged and the mounds are normally higher than those found in lowland areas. The length of the mounds varies greatly, from less than 6 metres to 150 metres, but the majority have a width of between 4 and 8 metres. "Pillow mounds can occur in level situations but are more common on sloping ground, where they are usually orientated roughly at right angles to the contours... There are well over two thousand individual pillow mounds recorded in England and Wales...most have been noted in the west, especially on the moorlands of Wales, Devon and Cornwall, in the Cotswolds, and on the chalk downlands of Wessex. Up to a point this distribution is the consequence of later land-use patterns" (Williamson, 2006)

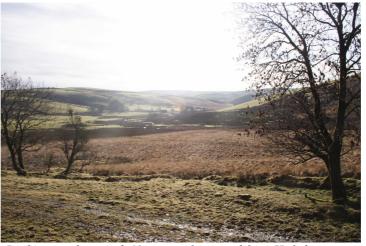
Farmstead recorded on the 1888 1st edition Ordnance Survey map as a courtyard complex. The farmhouse still stands, albeit modified and extended but the farm buildings were seen, during the Tir Gofal archaeological farm visit of 28/01/2009, to be modern constructions of mainly breezeblock and box-profile corrugated-iron.

Looking south towards Nantarast farmstead from Hafod y garreg
