TIR GOFAL MANAGEMENT PLAN: HERITAGE MANAGEMENT INFORMATION (HE2)

**Prepared for:
Stangs Farm**

**Tir Gofal Reference No
W/13/6473**

**DAT Report No. 2008-108
Project Record No. 63673**

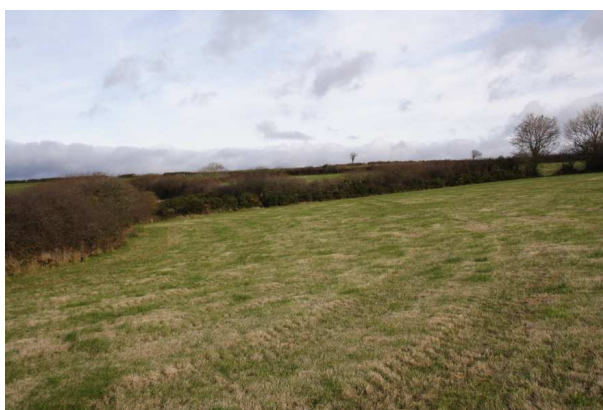
The area was explored during the Tir Gofal archaeological farm visit but no visible traces of the mound were positively identified. From the description provided by Cantrill it appears that the four mounds recorded here were located alongside the main stream, running north-south along the western field boundary, and the tributary stream, that forms the field boundary to the east (see Fig 2). The first two mounds (presumed to be PRNs 3811 and 3812) were recorded in 1911 as being "close together at two strong springs situated 150 yards east of the main stream, three furlongs north of Tavernspite". The area of the two springs was located during the Tir Gofal visit but the only area of compacted stone in the vicinity looked to form part of a bank alongside the stream and no burnt stone or charcoal was recovered during closer inspection. The tributary stream runs along the eastern boundary of an arable field. (see photograph below) and if a mound had been here it is likely to have been levelled. The area immediately adjacent to the stream is under impenetrable brambles, gorse and woodland, forming a six metre wide corridor, and it is possible that the mound site may survive under this thick vegetation

Looking northeast, across cultivated field towards the hedgeline that borders the tributary stream.

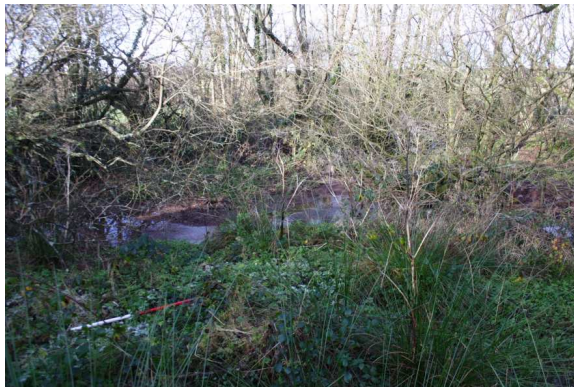
The area was explored during the Tir Gofal archaeological farm visit but no definite traces of the mound were identified. From the description provided by Cantrill it appears that mound (PRN3813) was located alongside the stream running along the western field boundary, to the north of the sewage works, a "few yards below the mouth of the tributary and 470 yards due east of Carfan-uchaf Farm". The tributary joins the main stream just within the northern boundary of the farm holding, in an area of woodland that borders the waterways and impenetrable gorse and bramble. A possible mound was found in the location suggested by the 1911 record, with an approximate diameter of 7 metres. This area was distinctly stony when prodded with a ranging-rod but further investigation of the site is required to determine its true nature. It lies under a thick cover of river silts and vegetation and it may merely represent deposits heaped onto the stream bank during dredging or a natural undulation in the topography.

Looking north towards area where the tributary meets the main stream. The red and white pole locates the site of a possible mound, although it is unknown whether this is archaeological.

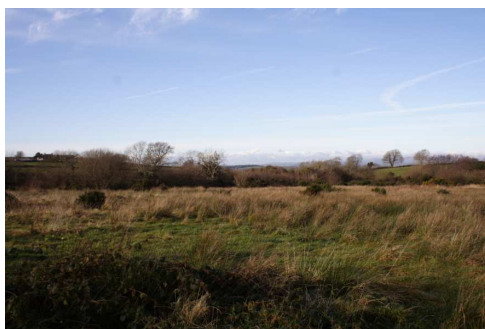
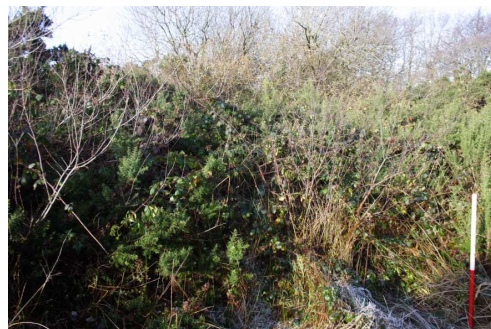
The area was explored during the Tir Gofal archaeological farm visit but no visible traces of the mound were identified. From the description provided by Cantrill it appears that mound (PRN 3814) was located alongside the main stream running along the western field boundary, to the north of the sewage works, "130 yards further down the main stream" from mound PRN 3813. During the farm visit this area alongside the main stream was under thick, impenetrable vegetation and it is conceivable that the mound survives beneath it.

(Left) looking northwest, across marshland field towards western boundary of farm holding, trees marking the line of the main stream, on left of picture, and tributary, on right. (Right), the thick vegetation that now covers the suggested site of mound PRN3814.

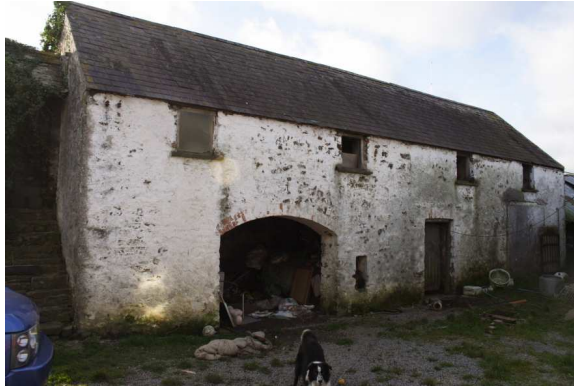
Looking west, the cartshed, stable and threshing barn with granary loft above.

The southwestern building comprises a cartshed, probable stable and threshing-barn with a granary loft above. The single-storey building attached to the northwestern end is a cowshed. The cart-shed has a red-bricked archway entrance and is now used as a storage area. The adjacent stable, with a solid wood plank door, has a stone-floored passageway through the width of the building and is now partitioned off as a grain store. The northwestern end of the building was most probably a threshing barn, to the rear of which was the horse-engine depicted on the 1907 2nd edition Ordnance Survey map. This has now gone and the characteristic wide entrance to the barn is now blocked up. The granary loft above is reached by external stone steps, on the southeast end of the building, the top of which are under a timber and slate porch.

The most pressing need for repair on the buildings are the roofs. The farmer has repaired dislodged slates and the front pitch of the cowshed has been replaced with corrugated-iron but there are still a few missing and dislodged slates on all three buildings. The plasterwork torching on the roof interior within the 19th century cowshed has also deteriorated and would benefit from restoration.

The exposed stonework of the granary steps and the rear of the western cowshed were noted to be in need of some remedial action and these same areas also had vegetation growing on the walls, as does the corner of the 20th century cowshed.

- Consolidate areas of loose masonry using a traditional lime mortar mix, trying to follow the original mix and appearance as far as possible.
- Consider cutting back vegetation on the walls, leaving the roots in situ. Spot treat to prevent re-growth.

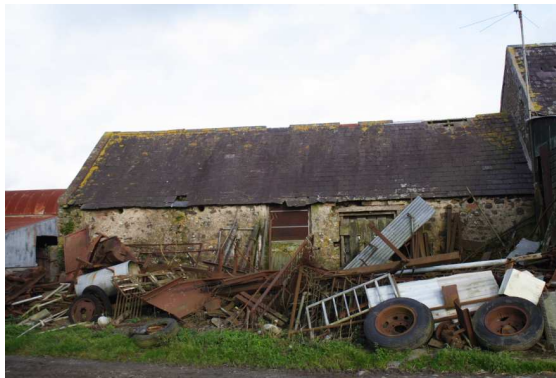
Looking northeast, the rear of the cowshed- entrance is blocked on the inside.

The cowshed attached to the northwestern end is a single-storey gable-ended building, again built of stone although the frontage has been concrete-rendered and the front pitch of the roof is now of corrugated iron, with flush window lights, while the rear pitch retains its slates. The interior is open to the rafters with plaster torching evident between the roof battens. Cast iron cattle stalls face along the front and rear walls, with a central aisle between them along the length of the building. The internal walls are limewashed and the floor is stone. There are two doorways in the southeastern corner and northern end wall, and a double-door entrance in the rear wall, with wooden doors still in place externally but sealed with breezeblocks internally.

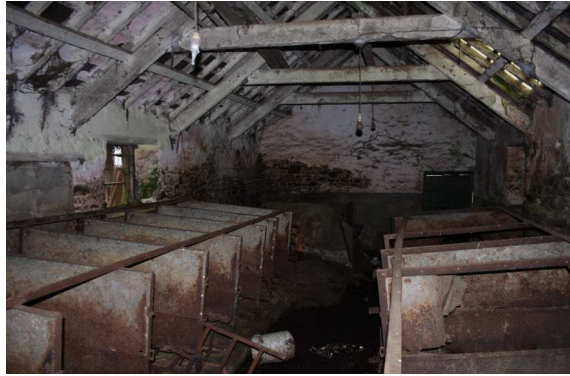
Interior of the cowshed, looking north west

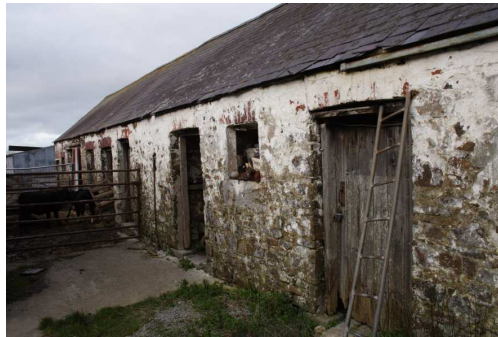
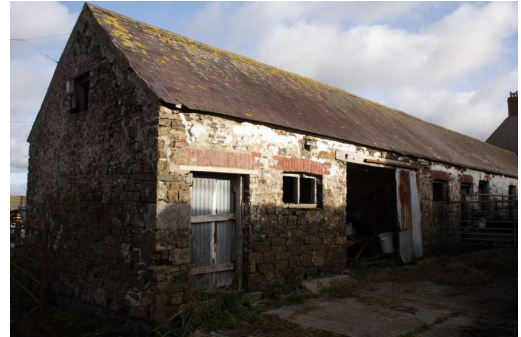
The opposite, parallel building comprises cowsheds and a probable hay barn. Attached to the farmhouse at its southeastern end, the building comprises six separate compartments, now used as two cowsheds, two storage areas, possible garage and the farm office, with a cobbled passageway through the width of the building.

The second long farmbuilding, (left) looking north . (Right), looking east., showing northwest gable-end , the probable site of a hay barn.

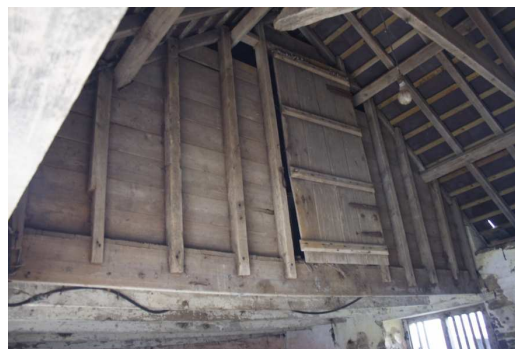
Generally the interior roof along the length of the building is open to the rafters but there are two, timber enclosed loft areas. One lies over the central cowshed, adjacent to the passageway, and was once farmworkers' sleeping quarters.

Loft over cow shed, once used as farmworkers' sleeping quarters.

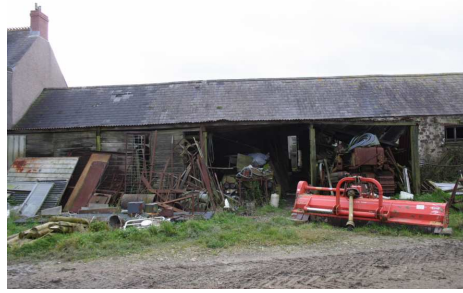
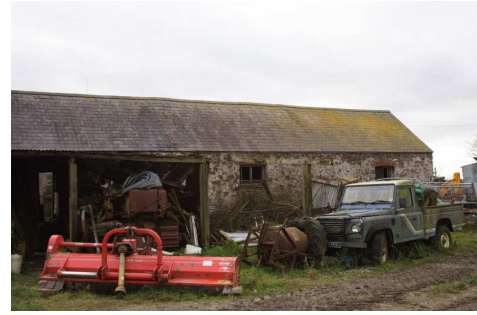
The other is over the northernmost compartment that is likely to have originally been a hay barn. The timber and corrugated iron lean-to attached to the rear of the building is used for the storage of farm equipment and machinery.

Rear of the second long farm building, with timber and corrugated iron lean-to.

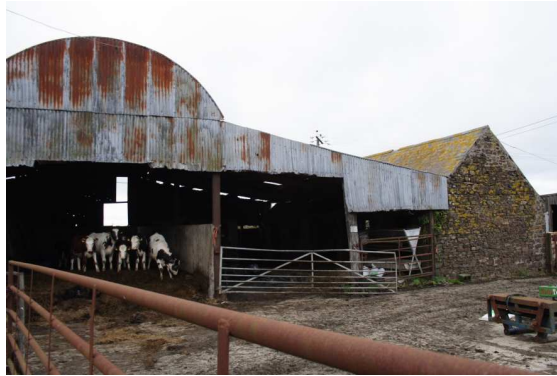
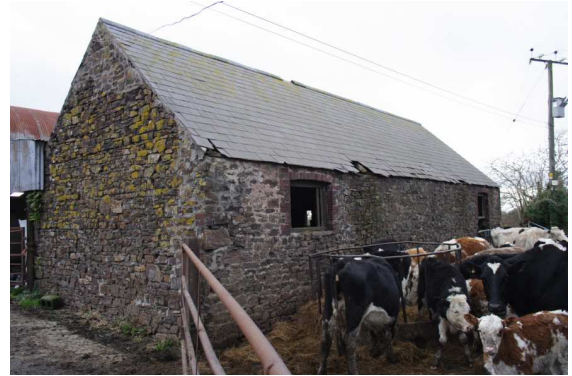
The (circa.early 20th century) cowshed located in the north of the farmstead is constructed in the same style as the 19th century buildings, of stone with brick dressings and a slate roof. The shed is a single storey, gable-ended building with two doorways and a large double-width entrance in its front, southwest-facing, wall and a further doorway in the rear wall. The lintel over the main front entrance has been raised to allow machine access to muck out the interior. A large corrugated iron and timber shelter shed is attached to the front of the stone building.

(Left) looking north, the shelter shed attached to the stone cowshed and (right) the cowshed looking northwest
