TIR GOFAL MANAGEMENT PLAN: HERITAGE MANAGEMENT INFORMATION (HE2)

**Prepared for:
Manorafon Farm**

**Tir Gofal Reference No
W/12/6468**

**DAT Report No.2009/31
Project Record No. 63723**

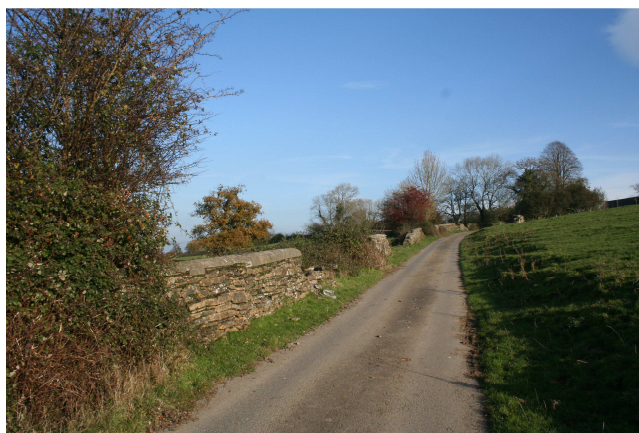
Name (& PRN)	Period/Site type	NGR	Status SAM/listing	Management required
1	MANORAFON FARM (94487)	Post Medieval boundary wall	SN64942314	B	Specific
	A mortared stone wall lines the left side of the drive leading to Pentre-parr mansion. The wall is of rough rubble stone construction standing to approximately 1.2m with a mortared weathering protecting the top. The wall is today broken down in sections. Vegetation growth is prising apart masonry bonds and the walls are in a poor state of repair in some locations.

The wall follows the line of the driveway to Pentre-parr. View facing east.

- Consider restoring the wall taking care to match the type of stone used and method of coursing. Reform the mortared weathering to protect the top.
- If wall restoration is not carried out consider cutting trees and other vegetation growing out of the walls in order to slow down the natural decay process. Spot treat to prevent re-growth.

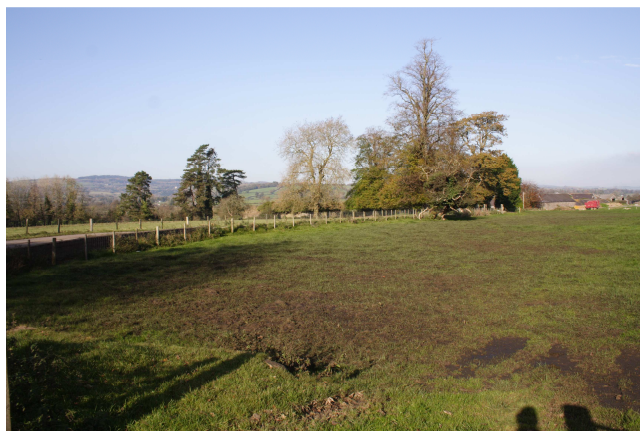
The west drive to Manorafon Farm, in use today as the only access to the farmstead. The drive diverts from the road at SN65302339 before taking a curving course across the parkland past the old mansion site on the left and meeting the farmstead.

The Ordnance Survey 1st edition map (1887) marks a loose avenue of trees lining the drive. Many of the trees marked on the Ordnance Survey 1st edition map have since been lost.

Facing northeast along the main drive. Many of the original trees are now gone.

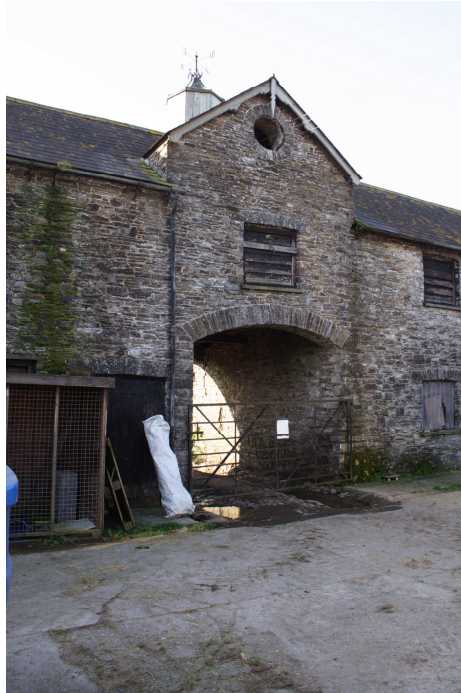
An entry arch provides access to the farm court. Seen from the west.

The farm court retains good historic character: the layout is unchanged since the early 18th century, and the buildings have escaped large scale modernisation such that the pattern of original door and windows openings is intact. Traditional cast iron rainwater goods have been replaced with modern substitute materials in some locations and a number of the historic doors and windows have been lost. Modern breeze block structures detract from the historic character of the farm court, comprising a milking parlour and cattle yards. Their effect is cosmetic however as they have not, in the main, required major alterations to the historic buildings themselves.

Condition: It is in recognition of their survival as a complete group that these buildings are today Grade II listed. The owners maintain the buildings routinely but in recent years they have developed some signs of neglect with localised ivy growth on the walls and some deterioration to the roofs. A rapid appraisal identified several areas needing attention including the southern part of the threshing barn, the southern facing elevations of southern courtyard buildings and the north part of the entrance range. Less localised problems include saplings established in the wall tops in a few locations and occasional missing or displaced roof slates.

Priorities: The farm court and centre calf house (PRNs 94480-94481) are the earliest buildings within the group and are today Grade II listed. The buildings are beginning to show signs of neglect with localised ivy growth on the walls and some deterioration to the roofs. It is in light of this that these buildings should be the primary focus of any Tir Gofal grant aid. Restoring the attached cart house range which is also listed should be a secondary consideration whilst the restoration of the cart shed and stable should be considered a lower priority.

1. The management focus is to return the buildings of the farm court to a stable and weatherproof condition using historically appropriate materials and methods of construction. Repairs should be undertaken on a like for like basis, modelled on the originals using similar materials and methods of construction.

N.B. North end of entrance range - a large crack in the west facing wall implies movement. It is not known if the crack remains active. Seek advice from a structural engineer or experienced builder who has experience of working on historic buildings.

Reinstate slipped or missing slates in order to prevent damage to roof timbers. Replacement slates should aim to match the type, colour, and size of the originals as closely as possible.

Roof timbers - missing roof slates above the southern end of the threshing barn have led to water ingress which is promoting rot in the roof timbers. The emphasis on roof restoration should be on repair rather than replacement. New roof timbers should be replaced on a like for like basis taking care to match the original construction as closely as possible.

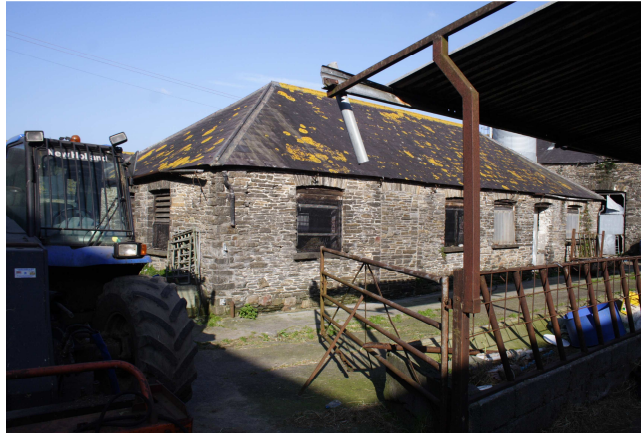
A late 18th or early 19th century calf house, the centre piece to the farm court at Manorafon. The calf house has a slate hipped roof, with replacement red brick and timber stall partitions internally. The building has alternating doors and louvred windows arranged symmetrically. According to the farmer it was originally divided internally into eight small pens with very decorative woodwork and gates.

The calf house, seen from the south.

Condition: The calf house is Grade II listed individually as a component part of the model farm group at Manorafon. The owners maintain the buildings routinely. The calf house is currently in a fairly stable condition. A rapid appraisal of the building noted no pressing concerns.

The farm court and centre building are the earliest buildings within the group and are today Grade II listed. The buildings are beginning to show signs of neglect with localised ivy growth on the walls and some deterioration to the roofs. It is because of this that these buildings should be the primary focus of any Tir Gofal grant aid.

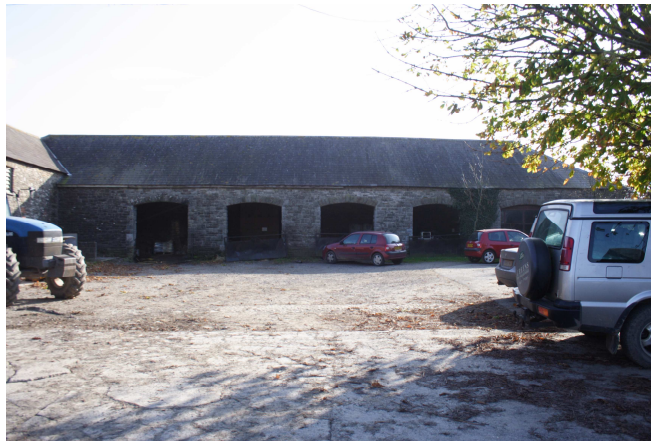
A later 19th century cart house range attached to the southwest of the farm court at Manorafon Farm. The cart house has a slate hipped roof with five stone arched openings in the front (northwest) facing wall. The cart shed range is listed as part of the farm court as a very rare example of an enclosed farm complex.

The front, northwest, facing elevation of the cart shed.

Condition: The cart shed is included within the listing for the farm court. It relates to a later phase of building sometime during the later 19th century. The owners maintain the buildings routinely but in recent years they have developed some signs of neglect. The cart house is in a fairly weatherproof condition although has several missing or displaced slates on the rear roof pitch and localised climbing vegetation growth on the rear walls.

The cart house is included within the listing for the farm court (Grade II). It remains in a fairly weatherproof condition and is not therefore considered to be a primary focus for Tir Gofal building restoration.

Restoring this building should be a secondary aim after repairs have been completed on the buildings of the farm court (PRNs 94480, 94481).

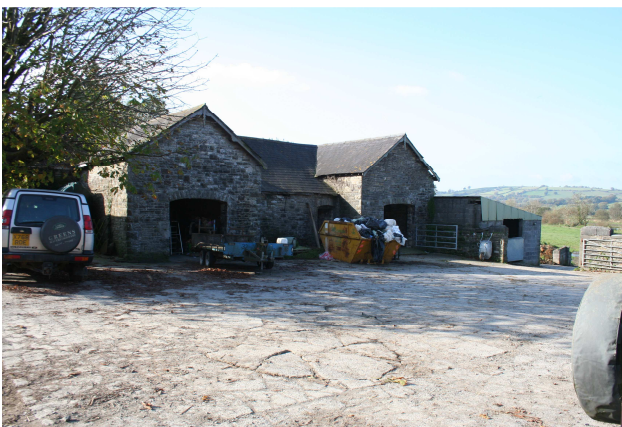
To the west of the farm court is the former bailiffs cottage and an attached symmetrical range with projecting wing at either end, probably a cart house and stables originally. The modern farmhouse lies behind to the west.

Facing west to the possible cart house and stable building.

Condition: These buildings are not listed in their own right, however they are part of the farmstead group and therefore fall within the curtilage of the listed buildings and so are subject to the same constraints. The cottage is today an occupied dwelling and therefore ineligible for any Tir Gofal grant. Ivy growth now covers much of the rear and side walls of the adjoining cart house and stable range, and a number of roof slates are missing or displaced.

The following is recommended in order to slow down the process of decay to the building in the event that traditional building restoration is not carried out. Tir Gofal management recommendations:

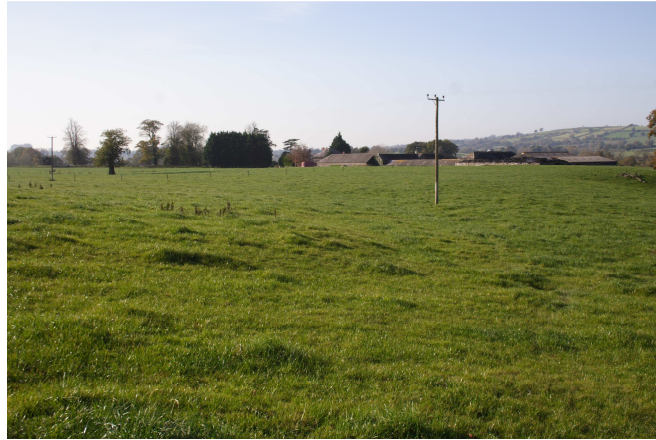
Name (& PRN)	Period/Site type	NGR	Status SAM/listing	Management required
6	MANORAFON (25583)	Post Medieval park	SN6523	B	Specific
	A substantial area of parkland associated with the former gentry estate of Manorafon. The parkland straddles the Tywi flood plain and lower valley sides complementing the setting of both Manorafon Farm: the old mansion site, and the later seat, today known as Crymlyn Manor.				
	The Ordnance Survey 1st edition map (1887) records scattered individual trees on the slopes with carefully placed clumps on the valley floor. The planting of individual specimen trees appears to have been predominantly broadleaved whilst historic maps (OS 1887, 1906) indicate that the valley floor copses were a mixture of broadleaved and conifer species. Lining the southwest drive to Manorafon Farm is a loose avenue of broadleaved trees.				
	Elements of the historic planting are degraded although the area retains a strong parkland feel today. The valley floor clumps, consisting of mixed scots pine, lime, ash and oak trees all survive, although some specimens are nearing the end of their natural lives. The open character of the valley sides remains largely intact with a few broadleaved trees (lime, oak, ash) remaining. It is noticeable however that a number of trees have been lost, whilst others may be reaching the end of their natural lives. A few of the individual trees shown lining the drive remain.

Facing west across the parkland. Few of the individual parkland trees now remain.

Future management should address how best to maintain the historic configuration and visual character of the parkland. The applicant has expressed an interest in carrying out parkland planting in some areas. Tir Gofal management recommendations:

- The 25 inch 1st edition Ordnance Survey map is most appropriate and accurate map to be used as the baseline for any future restoration of the parkland. Positions of parkland trees should follow as closely as possible the planting scheme represented on it (Ordnance Survey 1887).
 - Replacement planting should focus on reinstating scattered individual trees on the lower valley slopes as well as under storey planting in the valley floor clumps. Historic maps (OS 1887, 1906) do not indicate that scattered individual trees were a characteristic of the valley floor.
 - Replanting lost broadleaved trees along the drive should also be considered. Consider removing *Ilex* close to the farmstead which currently detracts from the historic parkland character.
 - Tree species should be based on the evidence of species represented in the parkland.
-

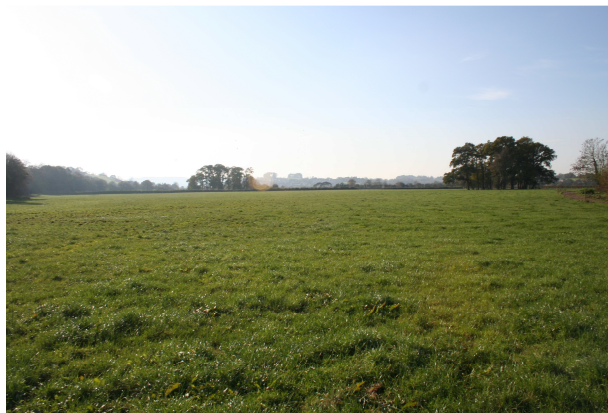
The valley floor clumps remain a prominent feature in the landscape. Facing west.
