SCHEDULING ENHANCEMENT PROJECT 2009: PREHISTORIC SITES FIELDWORK - CARMARTHENSHIRE

Prepared by Dyfed Archaeological Trust
For Cadw

RHIF YR ADRODDIAD / REPORT NO.2009/11
RHIF Y PROSIECT / PROJECT RECORD NO.63966

F. Murphy, R. Ramsey, and M. Page

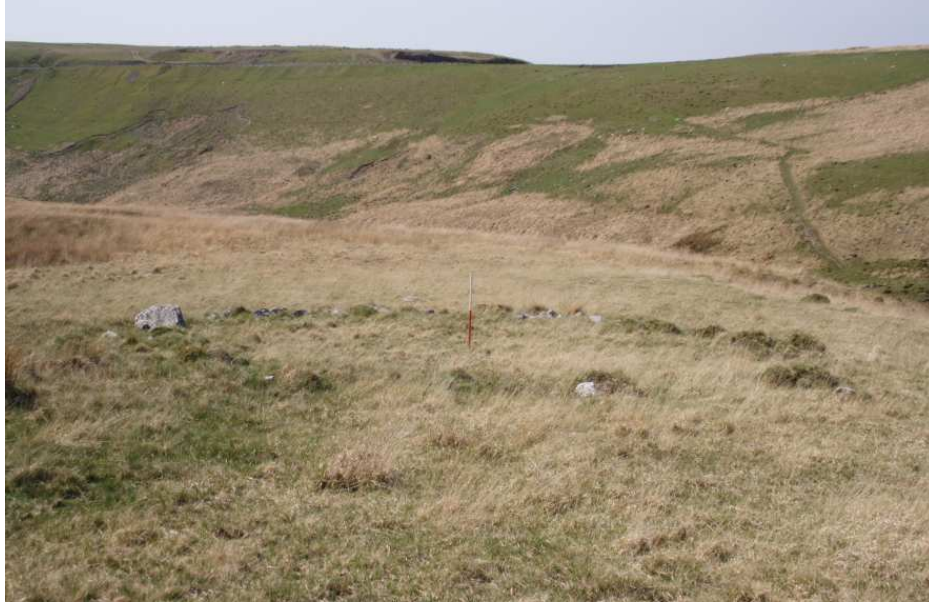
PRN 32178 An unusual feature - a roughly circular enclosure 11.5m in diameter that lies on a gentle south facing slope overlooking the Nant Garw valley. It has an 'entrance annexe' on the NW approx. 2.5m square, and another entrance gap on the east of the ring, from which a wall runs to the NE for 50m at the end of which is a hut circle.

An enclosure, 7m in diameter, with a bank of turf-grown limestone rubble, loose on the south and east, spread to 1.5m wide and 0.3m high, with an entrance gap on the NW 1.5m wide. The wall that runs NE from enclosure PRN 32178 stops some 3m to the SW of this enclosure.
(RCAHMW 1986 Meithrin Mynydd Project)

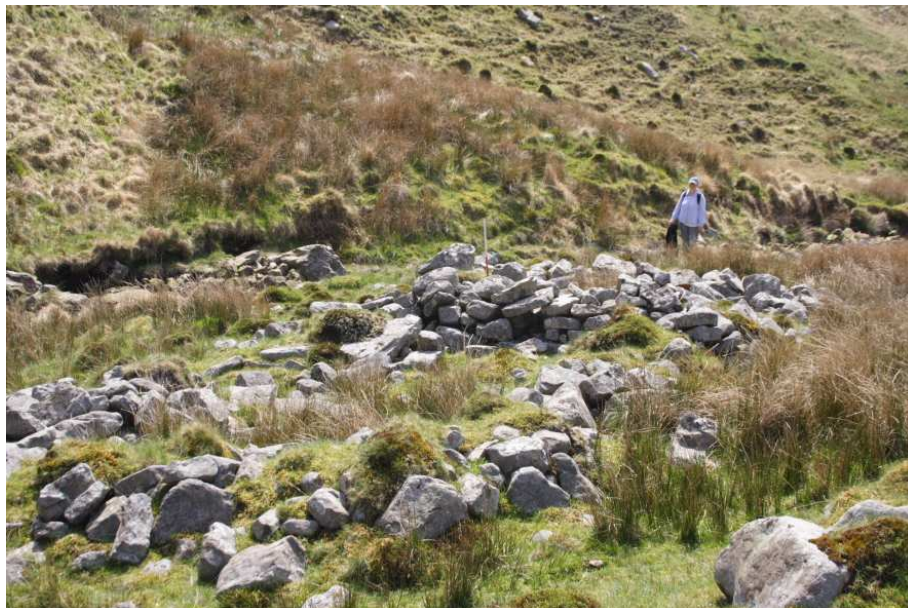
PRN 32200 Medieval/post medieval long house on the west bank of the Nant Garw.

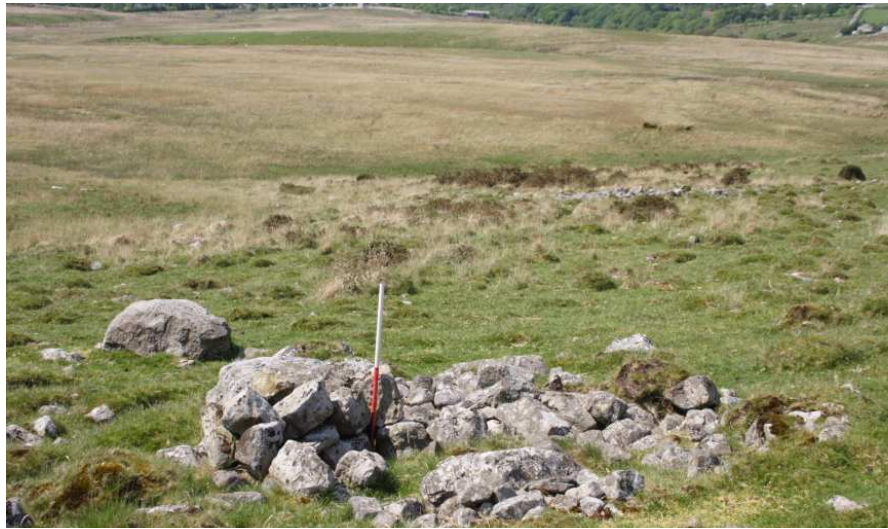
PRN 32212 Situated on a steeply sloping SW facing slope north of boggy ground that falls southwards to the Aman valley. Good views to south and west. The hut circle is slightly terraced into the hillside on the north

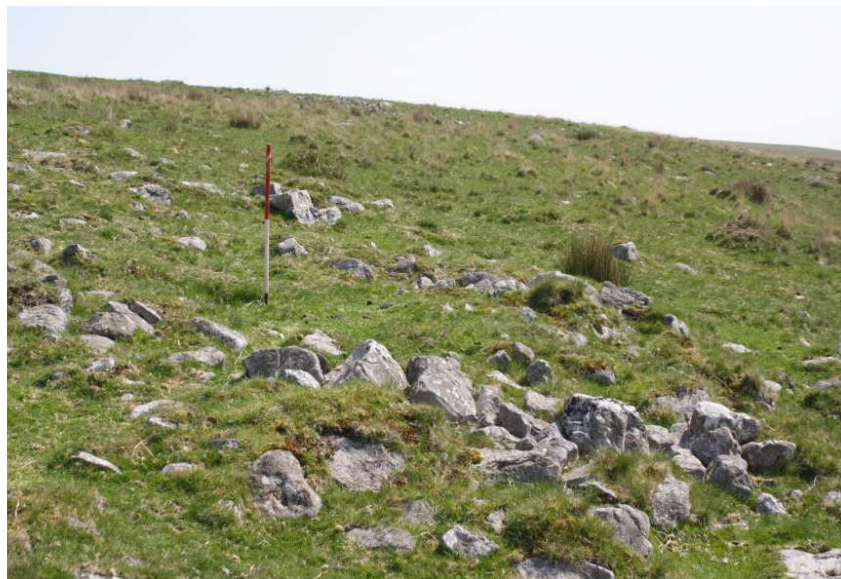
PRN 32213 A possible hut circle scooped out of the hillside. It measures 5m SE-NW by 3.5m. It is terraced into the hill on the NE, and revetted on the SW.
