PREHISTORIC DEFENDED ENCLOSURES 2009 – ADDITIONAL SITES

RHIF YR ADRODDIAD / REPORT NO.2009/15
RHIF Y PROSIECT / PROJECT RECORD NO.63968

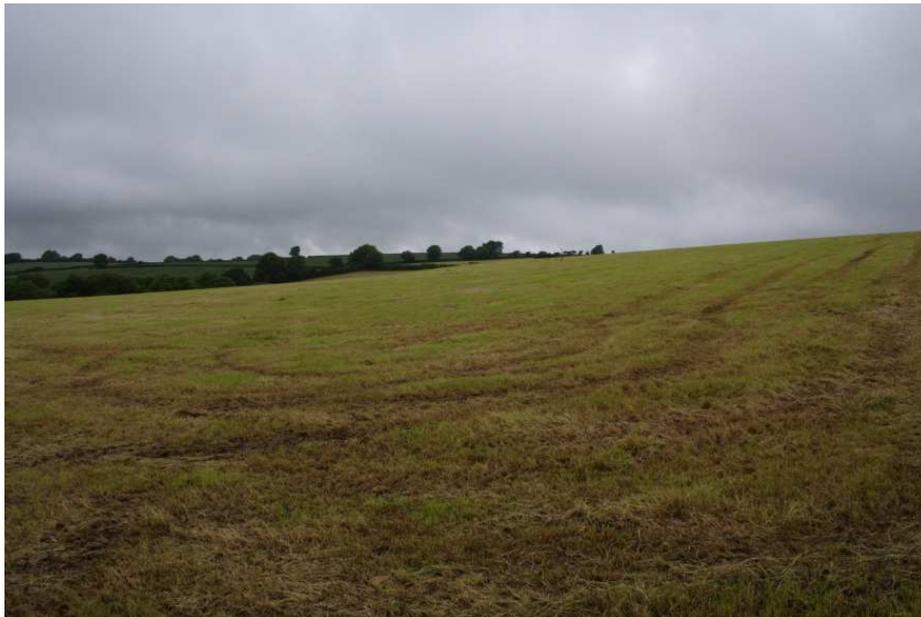
Aerial photographs of the 1980s appear to show a circular univallate defended enclosure with a concentric annexe. Situated on a moderate west facing hillslope at 150m above sea level, this site is overlooked by ground to the east. The inner circular enclosure measures approximately 40m in diameter and the concentric annexe has an approximate diameter of 100m. On the southwest an approaching ditched/banked trackway runs between the two concentric ditches of the inner enclosure and the outer annexe. Darker splotches within the annexe area visible on the aerial photograph may indicate the presence of hut circles. A linear feature/ditch runs from the outer edge of the concentric annexe on the southeast to the centre of the enclosure. In 2008 no earthwork could be identified on the ground. The site lies within a field under arable and is regularly ploughed.

Looking N across area of cropmark enclosure site

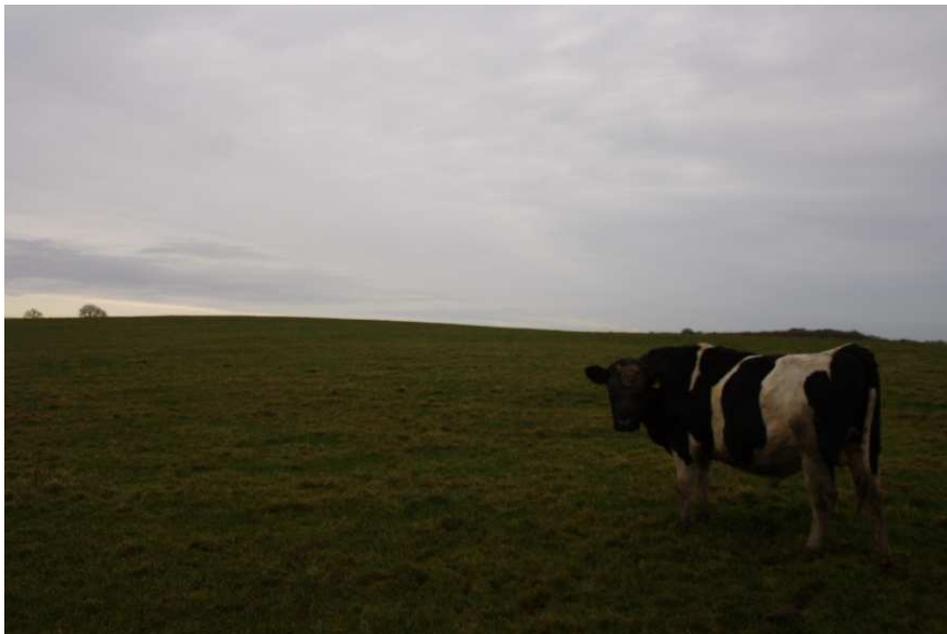
No evidence for any earthwork was noted during the 2008 visit, although some rather belligerent bullocks hampered the survey and the surface of the field, currently under pasture, was pitted and muddy from their hoof-prints. The site is regularly ploughed.

Looking SE - across area of putative cropmark enclosure site - nothing visible on ground

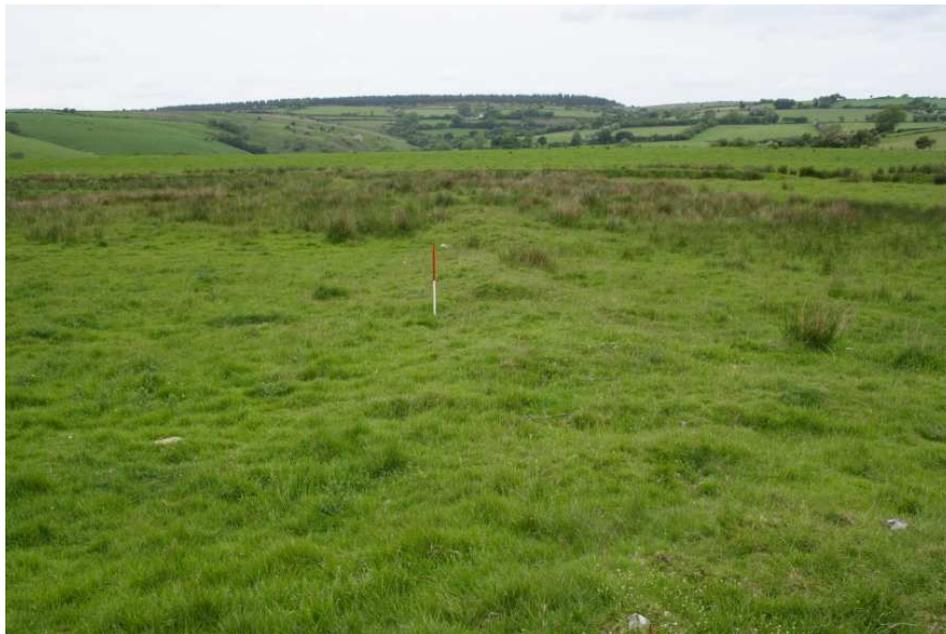
Maes Ifan is a large, elongated, D-shaped, univallate defended enclosure located on level ground at 270m above sea level. A single bank forms the three rounded sides of the 'D-shape' but the straight side of the 'D' runs along the edge of a northeast-southwest scarp slope that drops steeply to the southeast valley below, and here no bank exists. In 1968 the Ordnance Survey describe the enclosure as having axes of 180m by 100m, and as comprising a turf covered stone bank, 0.5m high, except in the northwest where it is overlaid by modern walling, and on the southeast where the bank is superseded by the steep natural slope. They identified a possible entrance on the west where there was some inturning. In 2008 the site is much as described by the Ordnance Survey, although the banks appear more denuded at c.0.3-0.5m high, and in places are harder to trace. The site lies within a field of improved pasture.

Looking NW at low linear bank of earthwork enclosure
- bank runs NW to SE

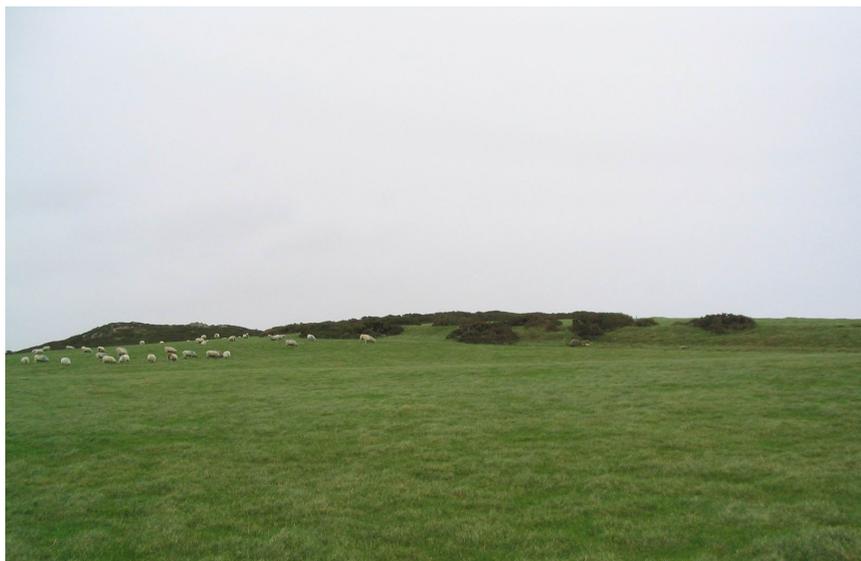
A further enclosure, perhaps forming a northern annexe to the main enclosure, was suggested by evidence viewed during the site visit, and this seems to be substantiated by aerial photographic evidence. Aerial photographs of this part of the promontory show faint lines of possible banks/ ditches extending north from the main enclosure, heading towards a third rocky outcrop. On the ground, a very substantial bank consisting of heaped loose stone with a flattened top has been identified. The bank lies on steeply sloping ground, on the southeastern side of this northern rocky outcrop, and runs almost parallel to a surviving field boundary. The land upslope of this bank is not suitable for ploughing, making it unlikely to be a lynchet. The size and location of the bank strongly suggest a defensive function. The general area is heavily overgrown with gorse at present.

Looking E - towards the northern end of the main enclosure

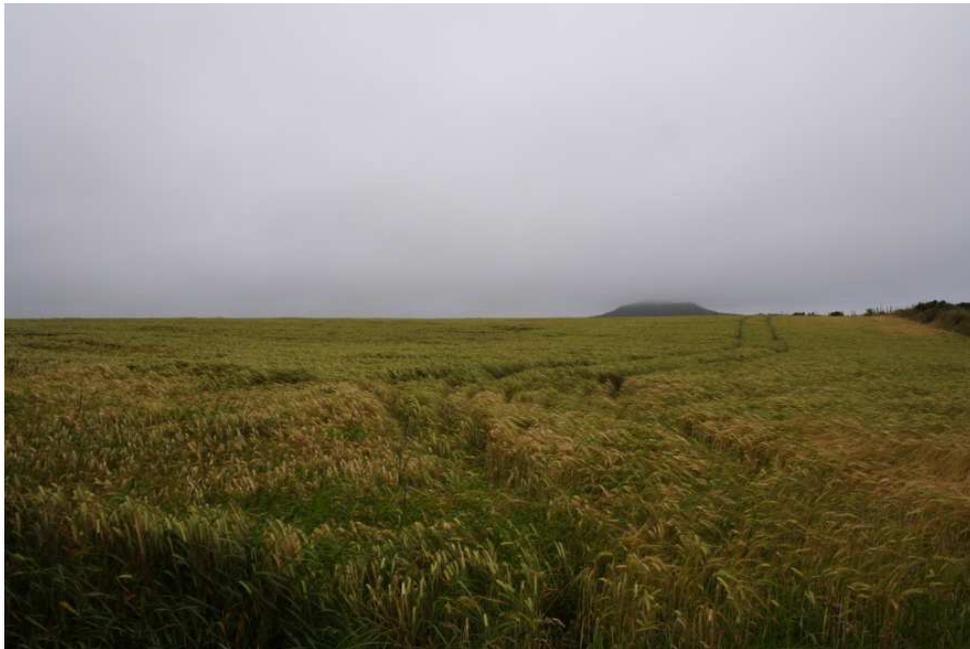
A large circular parchmark is visible on aerial photographs of the 1950s within a level field situated at 85m above sea level, 260m southwest of Tremynydd Farmhouse and cist findspot (PRN 2965). The field is named 'Parc Caer Ain' on the St Davids tithe schedule of 1838. The circular cropmark has a diameter c.120m and appears to incorporate a wide bank. At the time of the site visit in 2008 the field was under a mature wheat crop and no earthworks were visible on the ground. The nature of the site is uncertain, but the field name would suggest that it is an Iron Age defended enclosure.

Looking WSW - across area of possible defended enclosure cropmark -
under field of wheat.

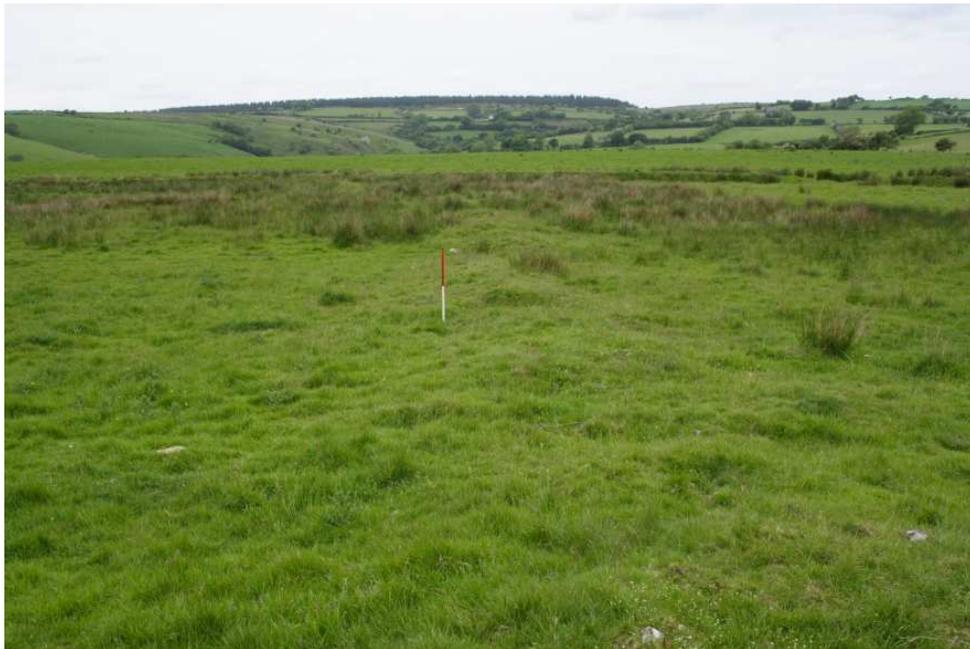
The site is located in a pasture field, at 60m above sea level, on a wide natural shelf approximately two thirds of the way up the southeast facing valley side of the Western Cleddau. In 2009 it was noticeable that the site of the cropmark is more level than the surrounding land although no clear earthwork traces of the defences or other associated features could be discerned.

Looking NE - across site of possible cropmark defended enclosure

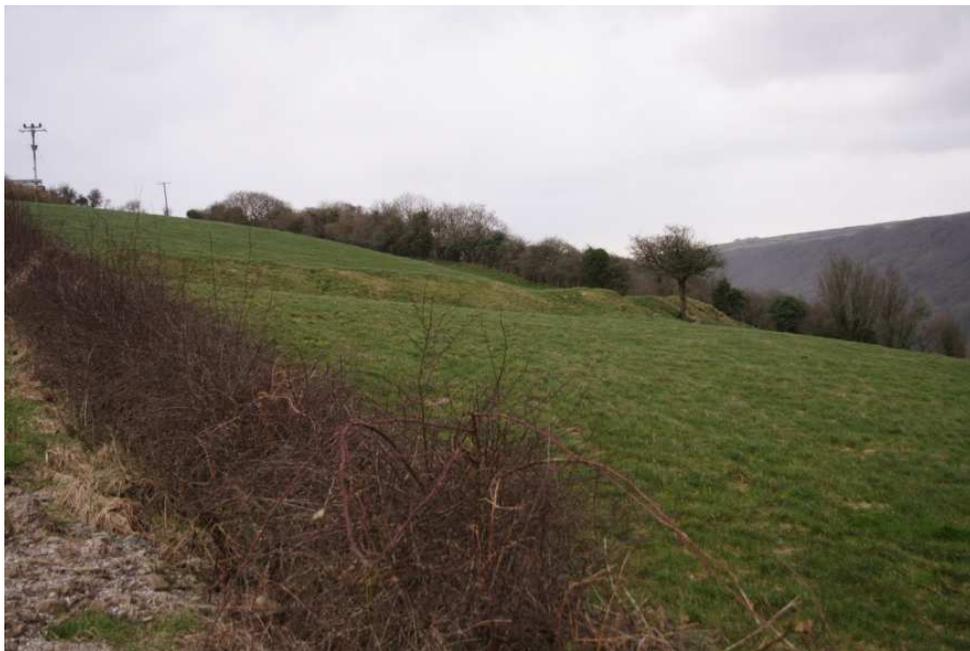
The eastern portion of the bank has been utilised as a field boundary in the past, and was once planted with a hedge. There are signs of possible modern repair in at least two places on the east. There are also signs that livestock are causing the bank to erode in places.

If the bank once formed a complete circle there is no evidence of any earthwork to the southeast of the minor road that cuts across the site, but it is possible that this area has suffered from more intensive ploughing and the construction of modern farm buildings.

Looking W - from road - at curving defensive bank of enclosure PRN 63970
