# Former Carpenters Workshop, Hayguard Lane, Haverfordwest Archaeological Watching Brief

Report No 2008/99

**Former Carpenters Workshop, Hayguard Lane, Haverfordwest  
Archaeological Watching Brief**

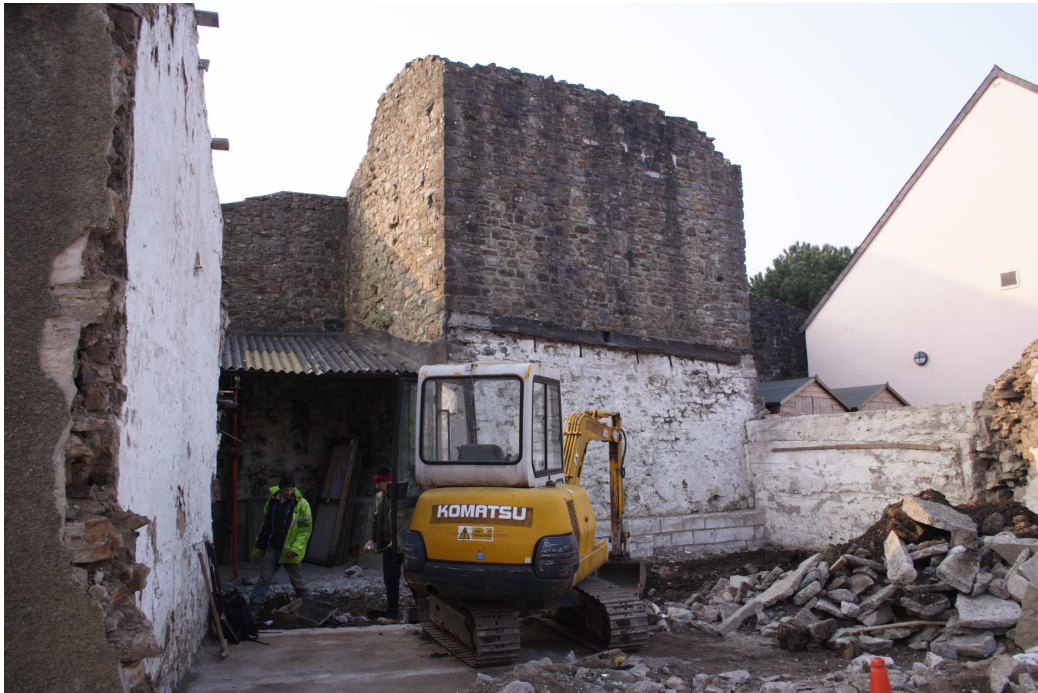
The watching brief was undertaken on 17 April 2008 and continued into the following day. The weather was fine but cool, becoming overcast. The building on the site had been demolished, with the concrete floor remaining, and one test pit, in the location of the rear footings for the new building, had been dug before arrival (Photo. 1).

Photo. 1: Site at commencement of watching brief. View S

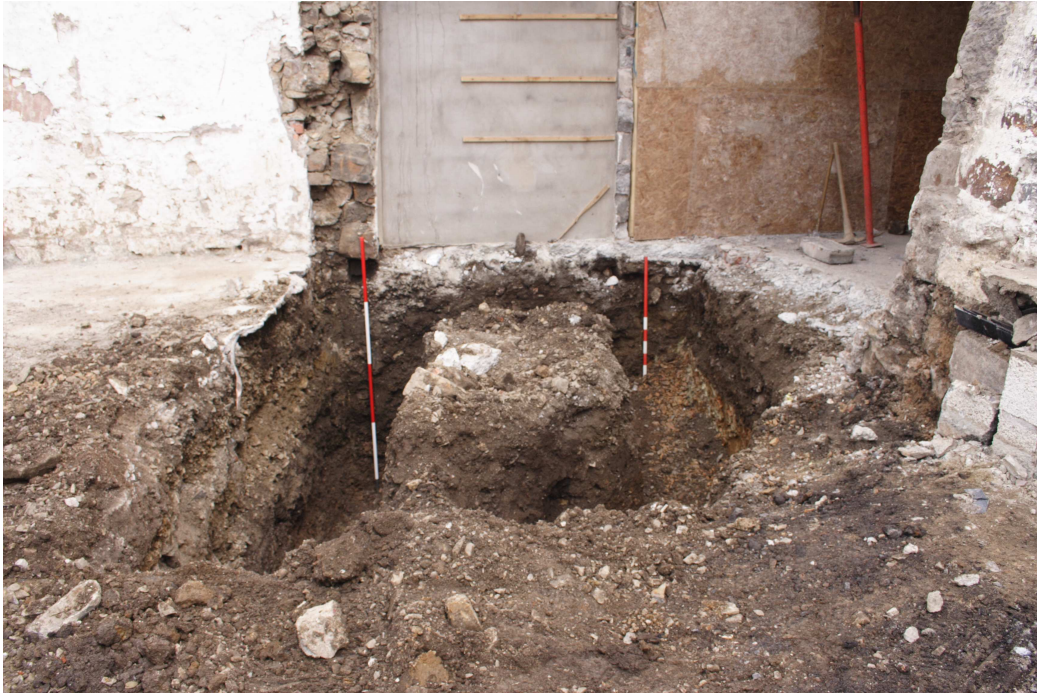
The only archaeological feature encountered was the inner edge of the castle ditch, found in the area of the rear extension, and part of the bottom of the ditch, seen in the rear footing trench. Most of the rear extension trenches were cut down to, or into, the bedrock as also was nearly all of the rear wall footing trench, except for a small part of its eastern end. Here the bottom of the ditch

was below the 2m depth of the trench (Photo. 2) and was therefore not encountered. The inner edge of the ditch was cut at a slope of roughly 45° in the mudstone bedrock. However, in the rear wall footing trench, in front of the tower, the side of the ditch was only 1.3m below the bottom of the concrete floor (Photo 3), indicating that the profile of the ditch is not uniform, possibly with the inner edge of the ditch bowing out around the tower.

The lowest ditch fill seen in the rear of the site was shaley stone with little soil that lay directly on the side of the ditch. Above this there was a thick layer, or layers, of very dark grey silty soil with angular shale. On this layer there was a limited deposit comprising mostly of small angular stones, and above this there was another layer, almost as deep, of dark brown grey loam clay, possibly old topsoil. Above this there was a similar soil, but disturbed, containing brick, slate, oyster shells and one fragment of 19<sup>th</sup> century pottery. Cut into this disturbed layer was the footing trench for the former cottage (Photo. 2), and above it make up for the cement floor.

Photo. 2: Rear extension footing trenches and the east end (left) of the rear wall footing trench. View E. Scales 2m and 1m

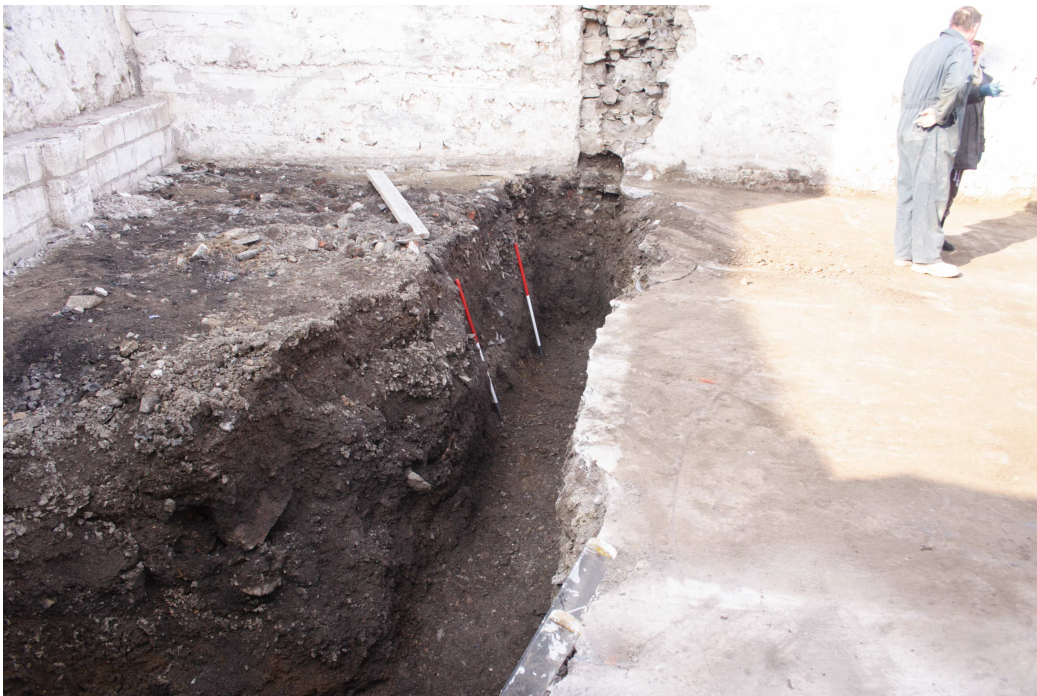
Photo. 3: Rear wall footing trench in front of the tower. Note that natural is at a shallower depth than in photo. 2. View W. Scales 1m and 1m

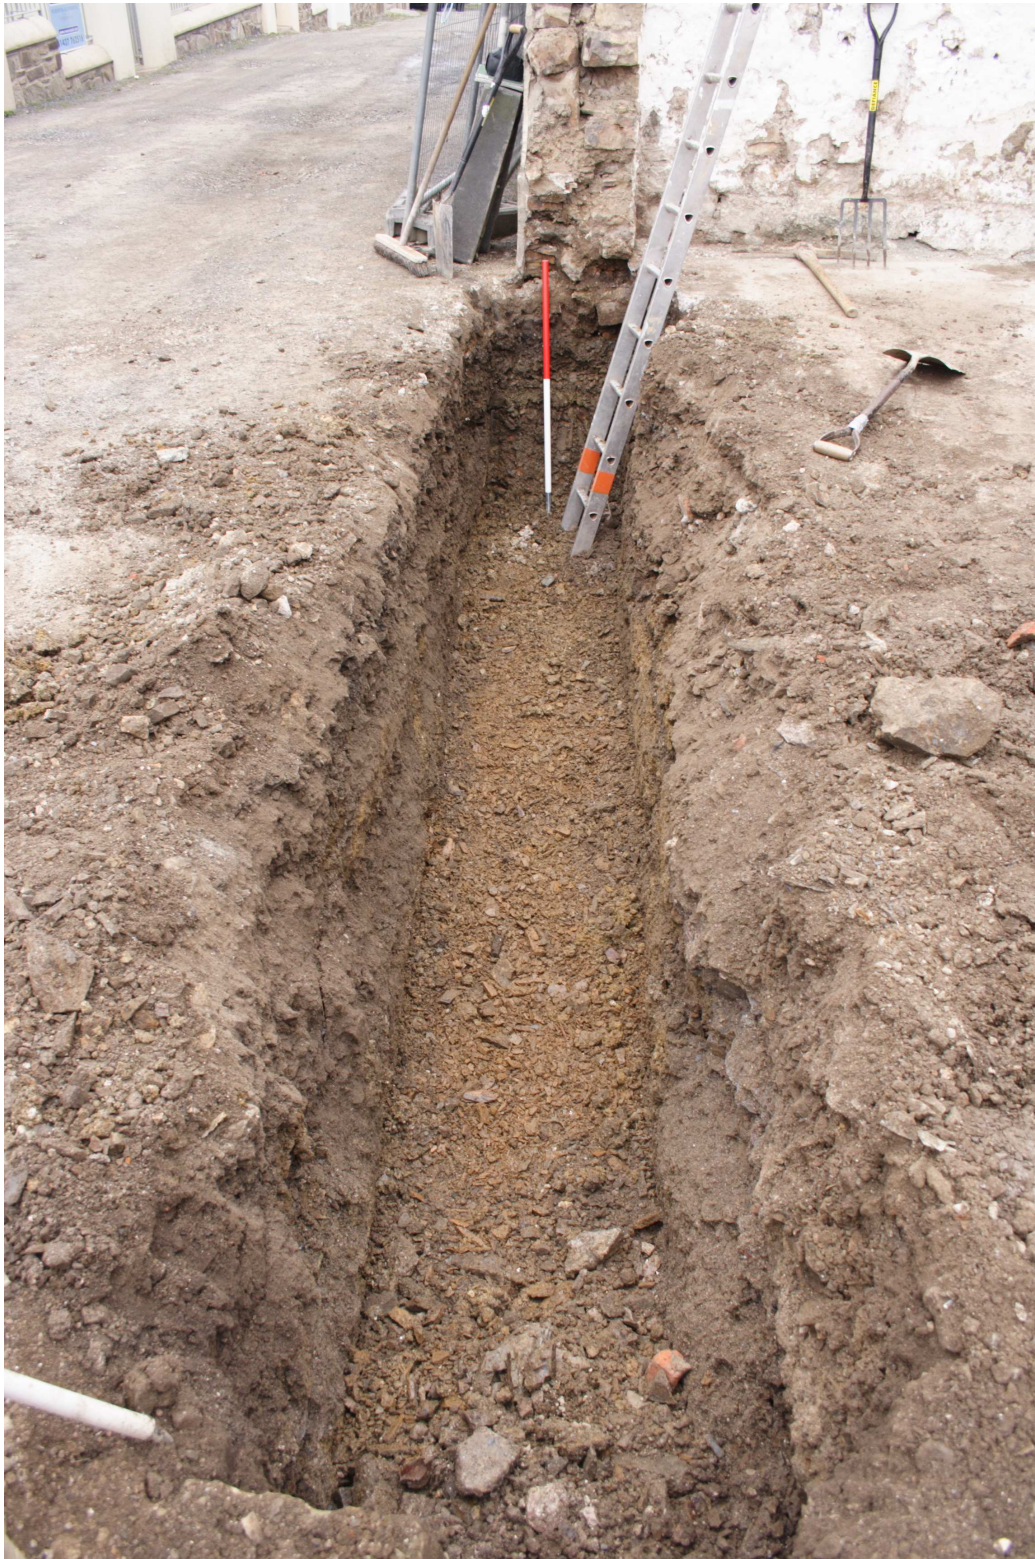
In the front footing trench there was a small deposit of dark silty soil at the western end of the trench, below a layer of shaley stone very similar to that against the inner side of the castle ditch. Above this there were layers of clay and soil and above 0.4m deep there were more mixed modern deposits.

Only in the extreme west end of the front trench was a layer seen below the clean shaley deposit occupying the lowest observed ditch deposits. This shaley layer was so similar to that seen in the rear trenches on the inner side of the ditch; it is possible that they are all part of the same deposit and would appear to represent deliberate infilling, possibly in the 1700s. It was also very similar to that seen in the Hayguard Lane excavation of 2003 that was interpreted as part of the levelling of this period. The very dark soil layer above is less likely to be deliberate infilling and was partly derived from silting up of the hollow left after infilling along with more "casual" deposits. Above this deposits would appear to be old topsoil or garden soil; this was below further deposits probably relating to the period just before the cottage was built.

Photo. 4: Front wall footing trench, note clean shaley stone deposit in the bottom  
View E. Scale 1m
