1A ROCK TERRACE, PEMBROKE ARCHAEOLOGICAL WATCHING BRIEF

1A ROCK TERRACE PEMBROKE ARCHAEOLOGICAL WATCHING BRIEF

Project Record Number 64747 Report Number 2008/52

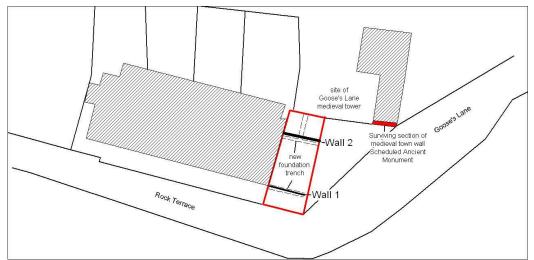
Figure 2: Plan of new foundation trenches and old wall lines (heavy black lines) encountered during the watching brief.

The remains of two former walls were exposed during the excavation of the new foundation trenches. One was a modern wall (Wall 1) that had been removed as part of this development towards the front of the plot and the other was older, possibly post-medieval/early modern (Wall 2) towards the rear of the pot. Both were on the same alignment as the standing buildings of Rock Terrace.

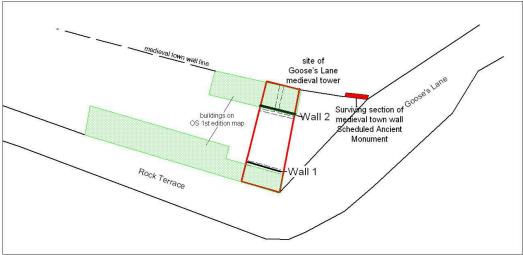
Figure 3: Plan of the watching brief site showing former buildings and Walls 1 and 2.

The line of the wall also appears to be close to the line of the rear wall of a building that was shown in this position on the Ordnance Survey 1st edition 1:2500 map (Figure 3).

The wall may be the south wall of a building that was shown approximately in this location on the Ordnance Survey 1st edition 1:2500 map of the later 19th century

(Figure 3). The building was aligned roughly east-west and built against the outside of the medieval town wall. The building had been replaced by the existing buildings of Rock Terrace by 1906.

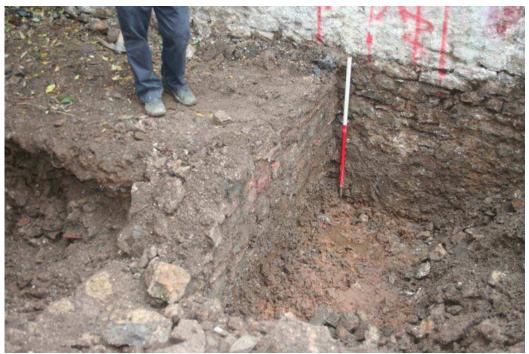
Plate 1: Wall 2.

Wall 2 was built from shaped stone blocks and bonded with a hard yellow/grey mortar. It was 1m high x 0.4m wide and on the same alignment as Wall 1, although, they did not appear to be associated. The northern face of the wall had a lime plaster finish.
