## **TIR GOFAL MANAGEMENT PLAN: HERITAGE MANAGEMENT INFORMATION (HE2)**

**Prepared for:  
Llandre**

**Tir Gofal Reference No: W/12/7431**

**DAT Report No. 2009/75  
Project Record No. 64982**

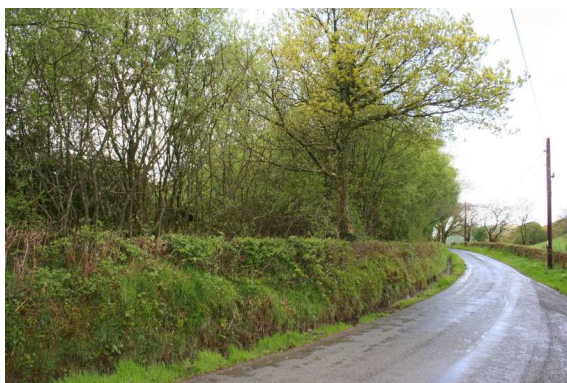
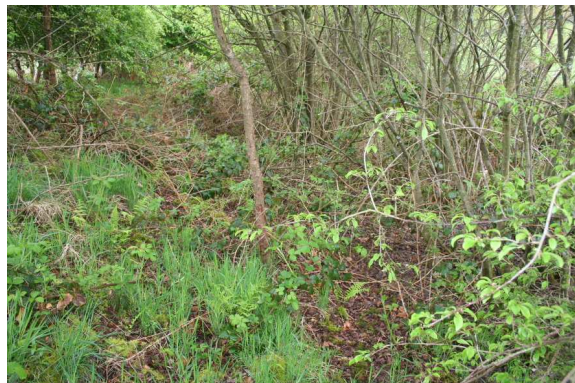
This site is a Scheduled Ancient Monument (SAM Cm 20, section L). A well preserved surviving section of leat (PRN 1947) that supplied the Roman gold mines at Dolacothi. This section of leat was seen during the 2009 Tir Gofal archaeological farm visit to be fenced off from the surrounding pasture and is now under thick, largely impenetrable woodland and scrub. No evidence for earthworks could be found.

*(Left) Fenced off area of woodland to left of road encloses the scheduled area (Cm20), now virtually impenetrable (right).*

This site is a Scheduled Ancient Monument (Cm 20) and management recommendations for the site were sought from Cadw.

Cadw have confirmed that the scheduled stretch of the aqueduct within the farm boundary is now fenced out from the adjoining field and covered in thorns. The extent of the archaeology is unknown and the Cadw Field Monument Warden has no record of it being tested by excavation. Cadw have provided no specific management recommendations.

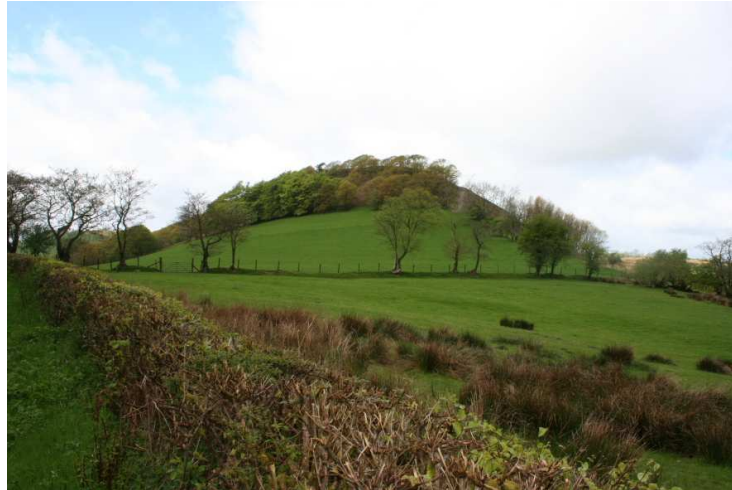
Allt Dinbeth is a prominent hill in the upper Cothi valley. Its form, location and name (with regard to the Din- element in Dinbeth) are suggestive of it being the location of an Iron Age hillfort. A Meridian Airmaps aerial photograph of 1955 shows that there may have been some earthworks on the northern side of the hill, but afforestation, woodland growth and recent land improvement have altered the appearance of the hilltop and there is no concrete surface evidence of any defensive earthwork on the hilltop.

*Looking west towards Allt Dinbeth (PRN 45941)*

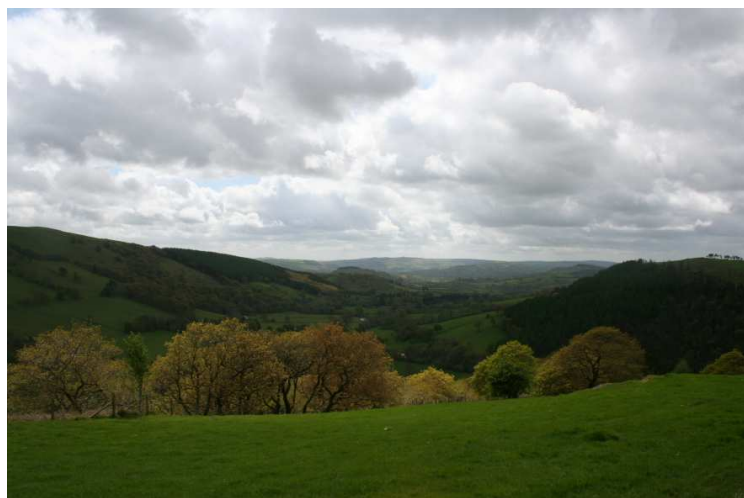
Similarly, no earthworks were evident during the Tir Gofal archaeological farm visit. The southern slopes are under thick, broadleaf woodland while the northern slopes, once under coniferous woodland, appear to be under a process of deforestation, with a trackway carved into the eastern side of the hill. The treeless plateau top is under pasture, with occasional exposed natural rock outcrops.

*Looking south, down the Cothi Valley, from the top of Allt Dinbeth*

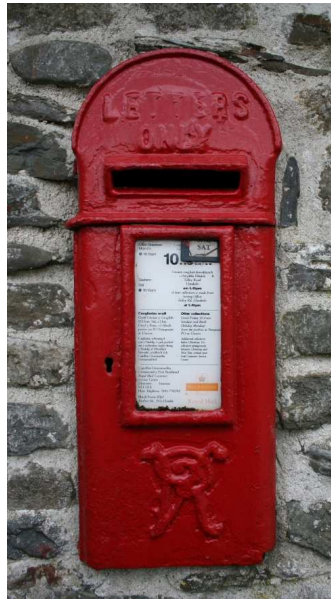
The Ordnance Survey 2nd edition map (1906) marks the abbreviation "L.B." close to Llandre Farmstead suggesting that a letter box may have been set into the wall of one of the buildings. The letterbox was seen during the 2009 Tir Gofal archaeological farm visit, set within the rear wall of the former milking parlour and still in use.

*Victorian post box at Llandre Farm*

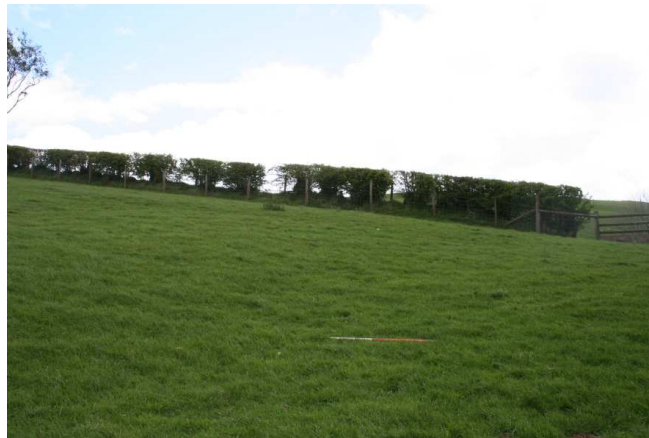
*Looking southwest across indistinct linear earthwork.*

No distinct earthworks were recorded but there was an ephemeral linear earthwork running downslope, southwest-northeast, and curving off towards the west some 4.0metres wide and 0.30m deep. It is not certain whether this was an antiquated earthwork or the line of a modern field drain.

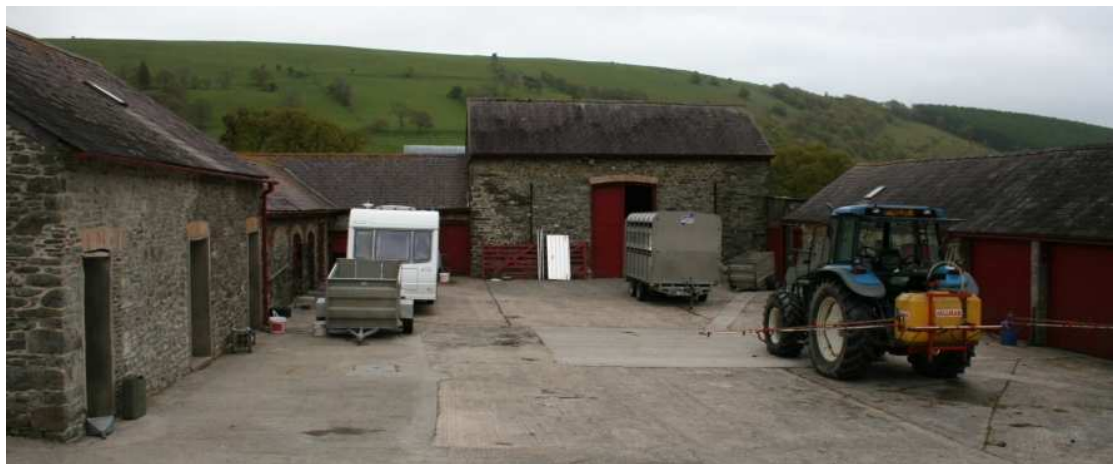
Farmstead depicted on the 1888 1st edition Ordnance Survey map, with the farm buildings in a U-plan layout and the house facing away from the buildings a short distance to the west. Modern farm buildings lie to the south and east. The U-plan layout at Llandre is still in use and these traditional buildings were recorded during the Tir Gofal archaeological farm visit. They include a milking parlour, stock shed, cow shed, threshing barn, stable and cart shed set around three sides of a concrete yard. Modern buildings have been added to the complex, particularly to the southeast, and the farmhouse stands separately to the northwest. The buildings are of rubble-stone construction with dressed stone quoins, gable-ended, slate-roofed and slate weather-boarded. Door and windows have yellow brick dressings and all joinery and guttering is painted red. The farm is currently maintained by the National Trust and all the buildings are in good condition.

*Looking south, the Llandre farmstead complex (PRN 93886)*

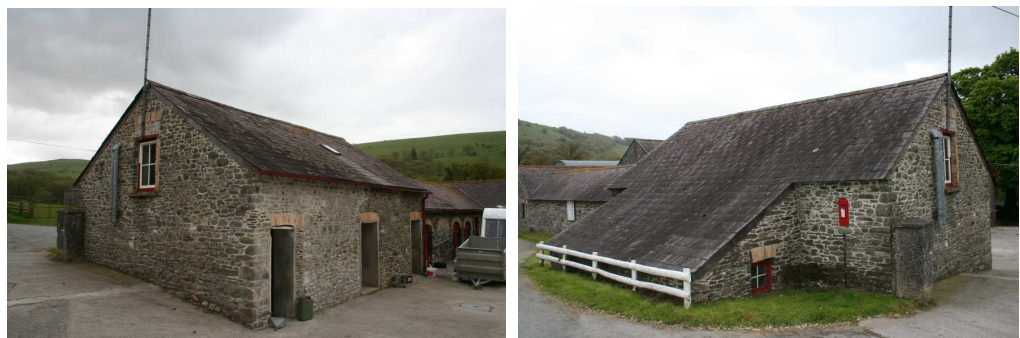
The northernmost building of the complex is two storeys high and has three wide doorways in the facade, now consolidated in concrete, with yellow brick arched dressings above. Two doorways have red, solid wood plank doors but the left-side door has been partially blocked up to create a narrower, open access. Internally the building is open to the roof timbers, comprising an A-frame construction affixed by iron pins. The internal walls and floor are concrete and there is a first floor timber-framed window in the north gable. Originally a probable cow shed, it is mainly now used for storage but the owner confirmed that it was once the milking parlour.

*The front and rear of the former cow shed/ milking parlour.*

There are two ventilation loops in the rear wall and a, now blocked-up, doorway once led through to a single-storey, single-pitched loose box. The pitch of the roof descends almost to the level of the adjacent roadway. There is a timber-framed window in the northwest facing wall and an external doorway entrance, with red-painted solid wood plank door, in the southeast facing wall. This building appears to be contemporarv with the cow shed/milking parlour. and is denicted on the 1888 OS map. but some red brick

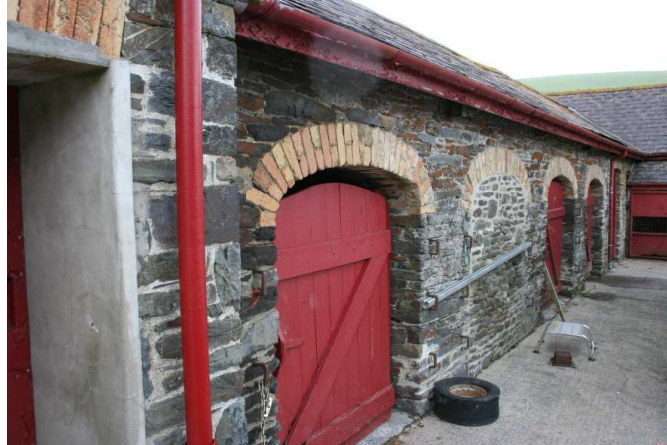
To the right of the milking parlour is a single storey shelter shed with four arched doorways in the facade, three with solid wood plank, red-painted doors and the fourth (second from the left) now blocked up. The interior is open to the A-framed roof timbers and concrete-floored.

*The façade to the shelter shed*

The building is divided across the middle by a wooden feeding trough and hayrack. The right-hand end of this building comprises a separate loosebox, divided from the main shelter shed by a wall, with a doorway and window in the facade, partially obscured by a modern kennel block.

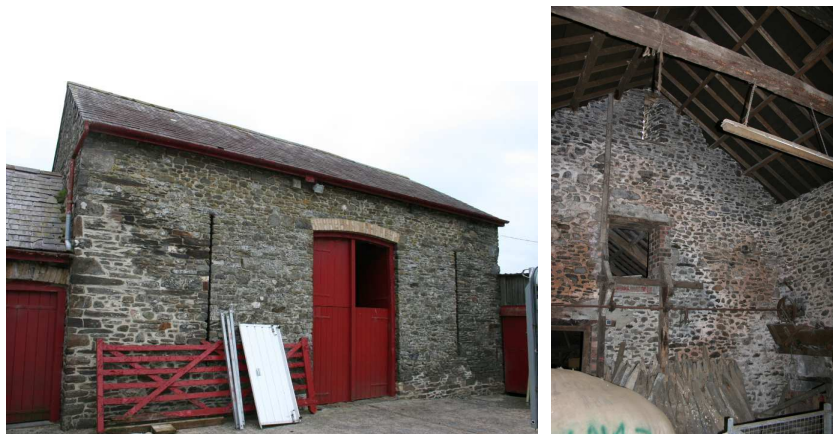
The threshing barn is a two-storey building with tall, doubledoor apertures opposite one another in the facade and rear wall and ventilation loops. The interior is open to the roof timbers and the floor appears cobbled, although much was obscured by straw.

*(Left) The Llandre threshing barn and (right) interior of the threshing barn showing machinery remnant*

The 1888 OS map depicts a possible horse-engine behind the threshing-barn, near the southwest corner, in an area now overlain by modern buildings. However, the remnant of a belt-driven threshing machine remains in situ along the northeast end wall. The rear and southwest gable of the threshing barn are now abutted by modern cattle sheds.

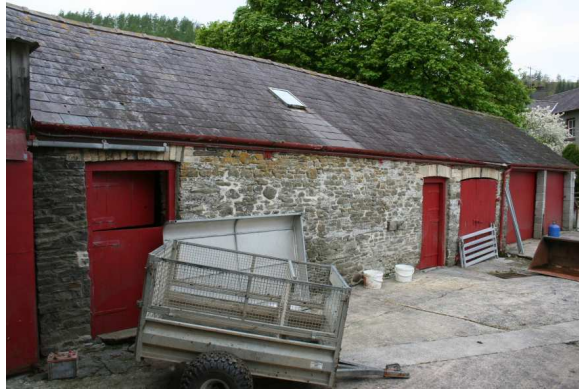
At right-angles to, but not abutting, the threshing barn is a possible single-storey stable or cow shed. There are two split "stable-type" solid wood-plank doors within the facade, a ventilation loop in the southeast facing gable and a latticed window in the rear wall. The floor is concrete and there are three metal cattle stalls run the length of the building, with a drainage channel behind and feeding channel in front. The northwest end of this building is separated by a supporting wall and comprises a cart shed, with a double-door entrance, now covered by red-painted corrugated-iron gates. To the right is a modern breezeblock double garage extension and the rear of the cow shed/stable and cart shed is abutted by modern buildings.

*The northeast facing range, comprising possible stable/ cow shed and cart shed, with modern garage extension at far end.*
