TIR GOFAL MANAGEMENT PLAN: HERITAGE MANAGEMENT INFORMATION (HE2)

**Prepared for:
Cefn Farm, Cynghordy**

**Tir Gofal Reference No
W/12/7011**

**DAT Report No. 2009-25
Project Record No. 64984**

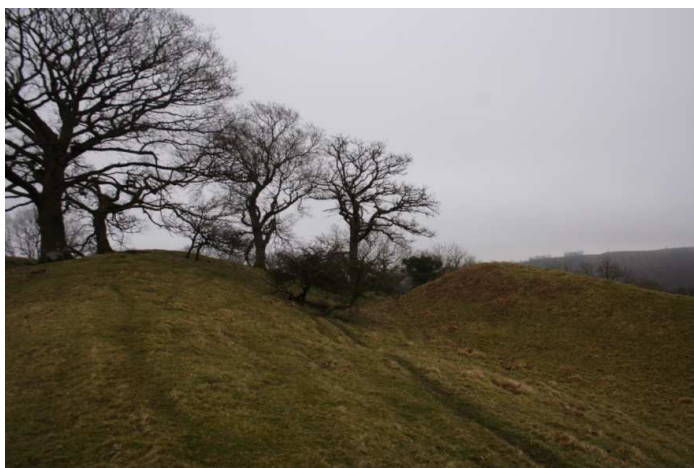
Looking east, profile of the defensive ramparts.

Aerial photographs show that the outer bank is not as curved as the inner bank and at both ends it appears to be turning outwards slightly. They also appear to show potential for the earthwork continuing, at least as a cropmark, into the adjoining field. In 2008 the enclosure appeared much as described by the Ordnance Survey, although it is apparent that the earthwork is suffering from the effects of vehicular damage, with large wheel ruts cutting through both defensive banks. On the ground a curving defensive bank does appear to exist in the adjoining southwest field as suggested by the aerial photographs. The enclosure is bounded on the northwest and southeast by steep natural slopes but is open on the southwest along the ridge. There is no trace of an entrance. The site is situated within fields under pasture. (F.Murphy & R.Ramsey, 2008)

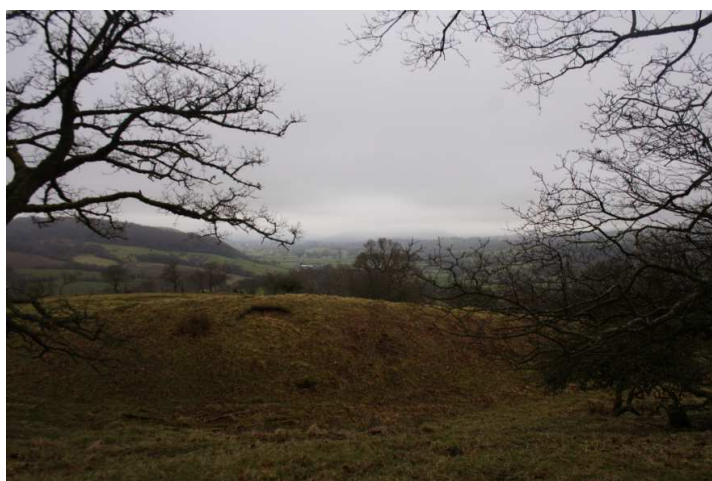
Looking southwest across the enclosure ramparts

The site was visited during the Tir Gofal archaeological farm visit (11/03/2009) and found to be in a similar condition as recorded in 2008. The ditches are waterlogged in part and reeds are growing within them. The site was proposed for scheduling on 30th September 2008.

Tir Gofal management recommendations, made in consultation with Cadw, are to retain a low growing vegetation cover over the monument, with no breaks in the ground surface, and the current farming techniques should be ideally suited. However, the greatest immediate threat appears to be vehicular damage, erosion and poaching. A further possible threat is that of windthrow of the mature trees that grow on the ramparts, which could potentially damage the profile of the ramparts and disturb below ground archaeological remains..

- Avoid driving vehicles across the monument as this can break the ground surface, leading to erosion or denudation of the vegetation cover, or compact possible below ground archaeological deposits.

- Stock levels should be monitored with no supplementary stock feeding on or near the monument.
- Sheep paths have caused considerable poaching within the defensive ditches and moving stock in concentration across the monument should be avoided. The cutting back of the reeds, that grow extensively to the north of the enclosure and within the defensive ditches, might help to alleviate such pinch-point erosion by enlarging the corridor of livestock movement. Vegetation should not be uprooted as this may damage below ground archaeological remains.

- Elsewhere, erosion has been caused on the rampart slopes by sheep seeking shelter and further sheep paths. These areas should ideally be restored to prevent progressive deterioration and possibly alternative shelter provided away from the monument.

- No groundbreaking activities should be undertaken within the area of the monument or a ten metre buffer zone around the edge.
- The trees growing on the monument should be monitored and any that are in danger of windthrow should be removed and disposed of away from the site. Any trees that require removal should be cut down and their roots left in situ.

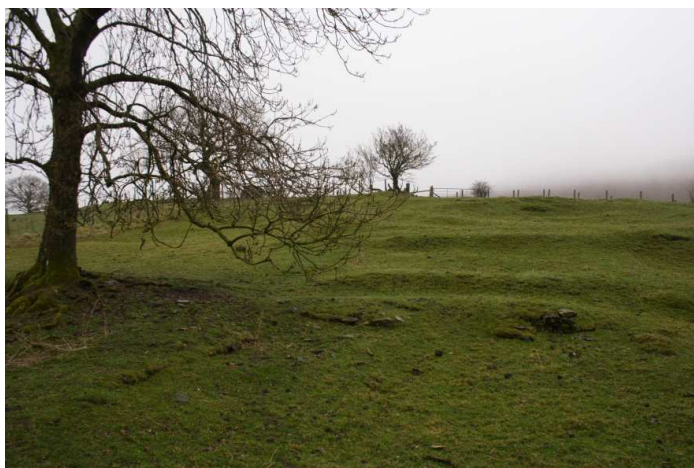
Looking east across the site of Pen y rhiw cottage with wall remnants in the foreground.

There is now little of the cottage left to be seen with the stone removed, presumably for use elsewhere, and most surviving foundations under grass. There are some stretches of exposed stonework, standing to a maximum of four courses high and defining a rectilinear area aligned northeast - southwest and measuring approximately six by five metres. There is also a discreet area of loose stone and fragmentary slate lying on the surface. Elsewhere there are grassed over earthworks that outline further buildings and enclosures.

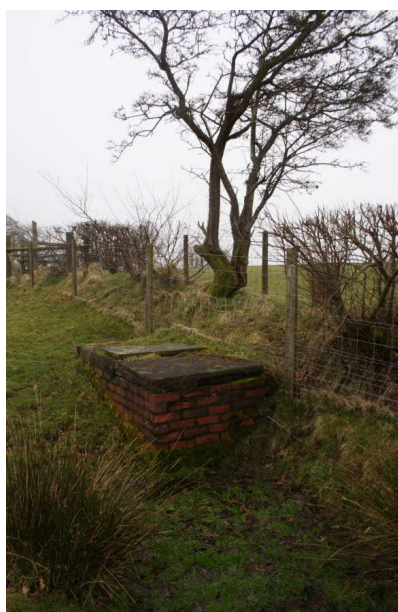
Well recorded on the 1888 1st edition Ordnance Survey map, associated with Cefn Farm (PRN 94115). The site was visited during the Tir Gofal archaeological farm visit (11/03/2009) and found to be surrounded by a red-brick wall capped with concrete and a heavy stone slab. It sits on the break of a west-facing slope behind Cefn House (PRN 19870).

The well located behind Cefn House

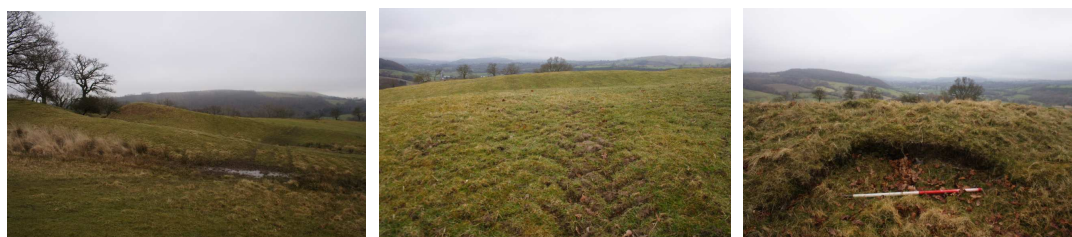
(Left-right) poaching, vehicular damage and erosion evident on the Iron Age enclosure.

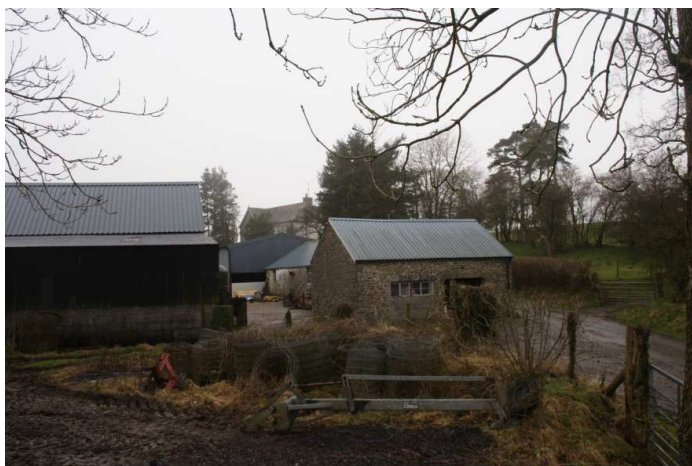
Looking west, Cefn Farm with cart shed in foreground and Cefn House between the trees in the background.

The Tir Gofal archaeological farm visit of 11/03/2009 confirmed that many of the 19th century buildings still stand, although they have been modified, and the complex now includes a number of modern structures. The traditional buildings around the courtyard comprise a cow shed, cart shed, threshing barn, pigsty and brewhouse. The building to the east of this complex is a Dutch barn but it is uncertain whether or not this is the same structure as recorded on the 1905 map. Cefn Farm is currently a sheep farm and the farmstead buildings have been adapted or built for this purpose.

The 19th century buildings at Cefn Farm have been incorporated into the modern farmstead and new uses have been found for them. They have therefore been maintained and made weathertight, although not with traditional materials. Grant aid is available through Tir Gofal for the maintenance and repair of traditional buildings. Tir Gofal advice advocates the use of materials that match those used originally. Repairs should be undertaken on a like for like basis, modelled on the originals using similar materials and methods of construction. Future maintenance should consider how best to keep the character of the farmstead group as a whole, rather than focusing on one particular building at the expense of the others. No essential repairs or maintenance issues were raised by the owner or noted during the Tir Gofal archaeological farm visit so any recommendations relate to possible historical enhancement of the buildings' appearance.

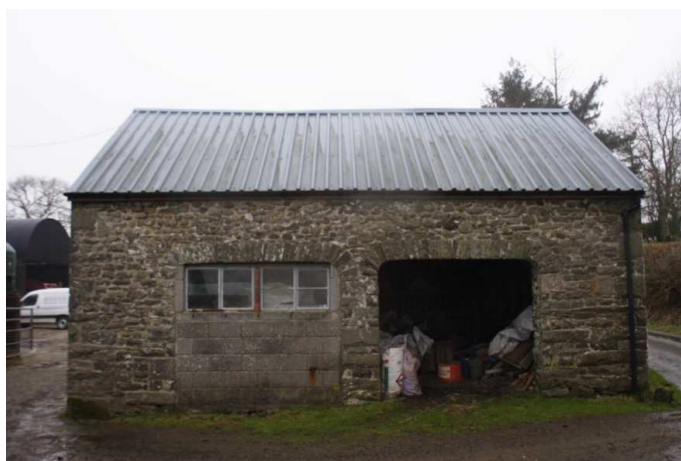
Cefn Farm cart shed.

The cart shed is located in the northeast corner of the farmstead. It is gable-ended and built from rubble stone with dressed stone quoins. The rear pitch of the roof is under corrugated-iron and the front pitch is under modern, box-profile tin. There are two square entrances in the facade, one now filled in with breeze-blocks and windows and there is a doorway in the rear wall that leads out to the courtyard. Internally, the floor is cobbled and the roof is open to the timbers.

- Reinstall joinery elements (doors, windows) to traditional specifications. Inappropriate doors and windows can significantly impair the character of a historic building. Ideally the metal doors would be removed from the threshing barn and replaced with traditional solid wooden plank doors, in keeping with the style and age of the building.

- Joinery should be finished in a historic paint colour, based on evidence from within the farmstead itself. Grey paint is evident on the cow shed, cart shed and pigsty. Stained or varnished finishes are not appropriate.

- Ideally the roofs of the traditional buildings would be returned to slate, although it is recognised that such a move would be prohibitively expensive and, considering that the buildings are weathertight, somewhat impractical. It is suggested that any further repairs should be carried out with curved-profile galvanised corrugated-iron, a cheap and durable

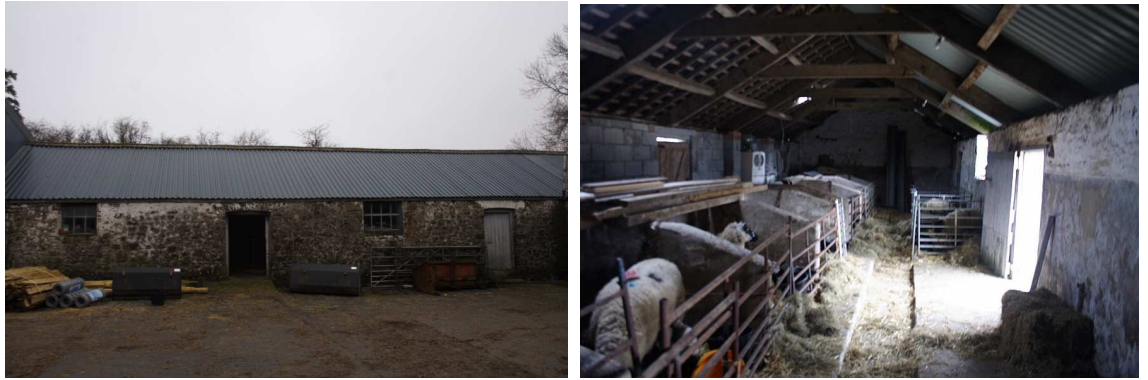
Cefn Farm cow shed, façade and interior

Attached to the rear of the cart shed is the cow shed that runs along the northern side of the courtyard. This single-storey, gable-ended building is of similar rubble stone construction and has its rear pitch under slate, incorporating two rooflights, and the front under box-profile tin. There are two solid, wooden plank, grey painted doors in the facade and a single door in the rear wall. Internally the floor is concrete and the walls are concrete rendered, with the rear wall reinforced with breeze-blocks. There is a row of concrete stall partitions along the length of the building, currently used for lambing ewes, with a drainage channel behind them and a feeding gallery running along the rear wall. The roof is open to the timbers.

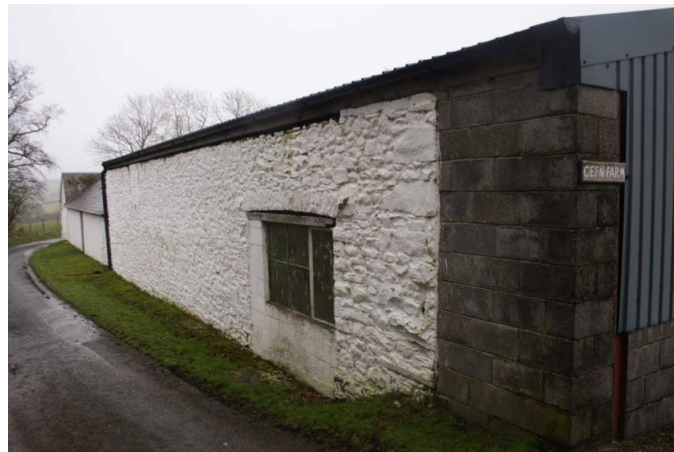
Looking northeast, rear wall of possible stable with blocked-up cart bay, with cow shed and cart shed in background

This rear wall stands to two-storey height and is of the same rubble stone construction as the cow shed. Within it is a blocked-up bay similar to those within the cart shed. The external length of this wall, together with the rear of the cow shed and side elevation of the cart shed that faces the road has been painted white.

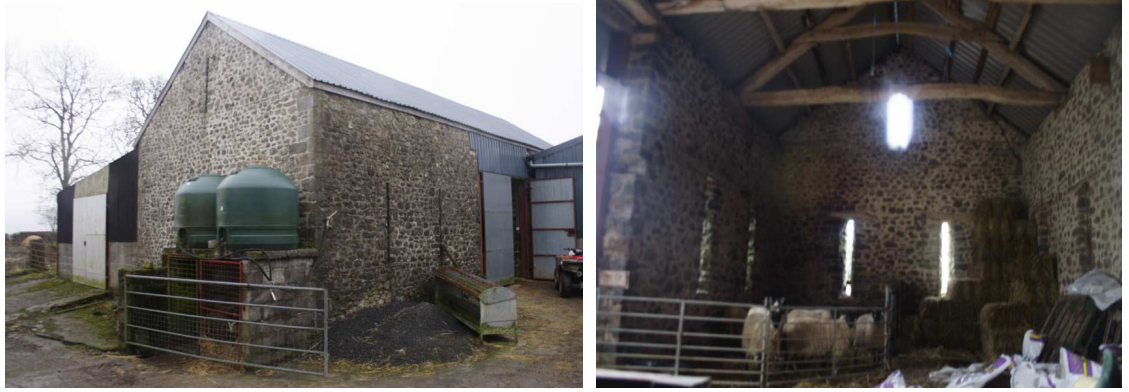
The threshing barn

The threshing barn is located in the southeast corner of the farmstead, on the same north-north-west - south-south-east alignment as the cart shed. It is a two-storey, gable-ended building built from rubble stone with dressed stone quoins and the roof is under box-profile tin. There are ventilation loops, with internal timber lintels, within both gable and sidewalls. The high, double-door entrance now has metal doors, with box-profile tin flashing above, and the similarly sized opening in the opposite, northeast facing wall leads into a modern breeze-block and tin extension. The barn is open to the 'A'-frame roof timbers, many of which appear to be original, that rests upon the level wall tops. The owner confirmed that the roof was originally slated - some stacked slates are located behind the building - and was replaced approximately 15 years ago.

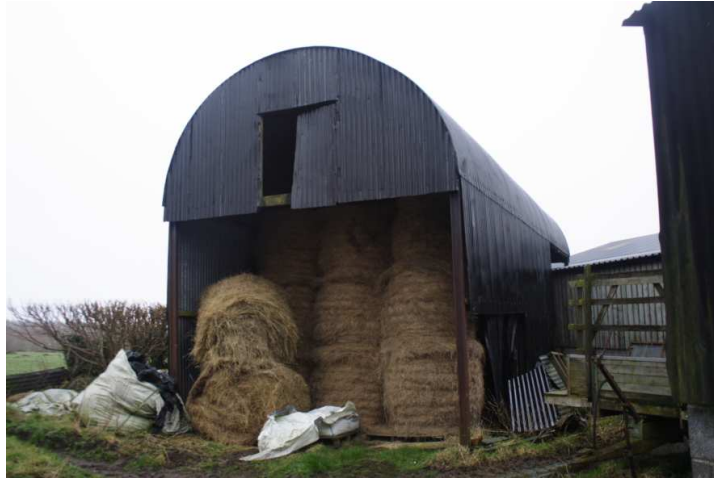
Looking south, Cefn Farm Dutch barn

The Dutch barn is located to the southeast of the historic farmyard, on the same north-north-east - south-south-west alignment as a building depicted on the 1905 map and cut away at its southern end to accommodate the modern livestock shed.

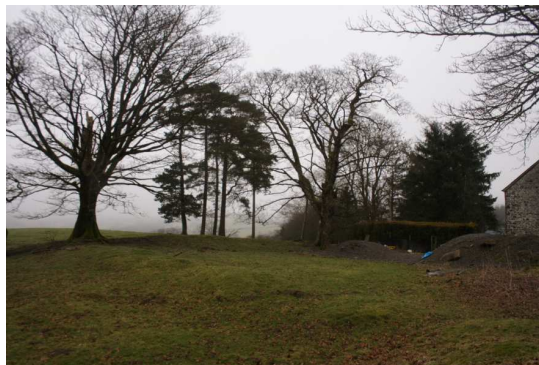
The current farmhouse (PRN 94115) at Cefn Farm is recorded on the 1886 1st edition and 1905 2nd edition Ordnance Survey maps. It was noted during the Tir Gofal archaeological farm visit of 11/03/2009 that there was still a remnant of the mixed woodland behind the house as recorded on the late 19th-early 20th century maps. There is also a disused boundary line, in the form of a low earthbank, marking the extent of the rear garden.

Boundary earthworks and woodland behind Cefn House
