## **TIR GOFAL MANAGEMENT PLAN: HERITAGE MANAGEMENT INFORMATION (HE2)**

**Prepared for:  
Brawdy Farm**

**Tir Gofal Reference No  
W/13/7436**

**DAT Report No. 2010/19  
Project Record No. 64994**

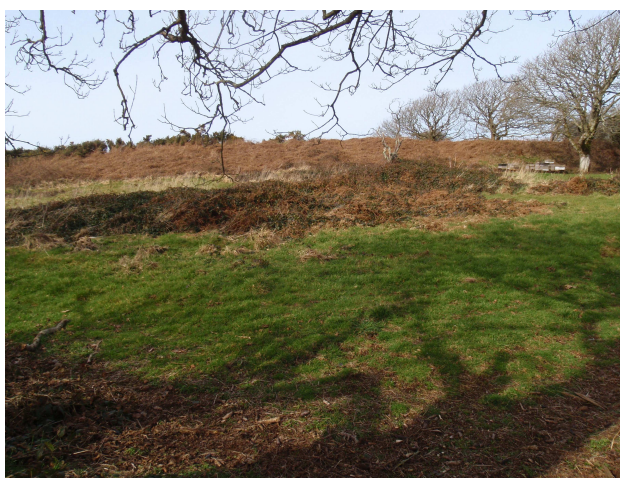
*Interior of the enclosure, looking west, with inner bank (under brown bracken) at rear.*

Partial excavations were conducted at the site by K.R.Dark in 1985-1991 and showed that Brawdy had a 'very long stratified pre-Roman sequence and substantial Roman-period use.' (Dark 1990). The monument was part of a five-year management agreement between the farm owner and the National Assembly for

Brawdy Castle is a Scheduled Ancient Monument (SAM PE422) and subject to the following specific management recommendations from Cadw:

The aim of the management should be to retain a good grass cover within the scheduled area. The priority at this site is to prevent the re-establishment of scrub, including gorse, bracken and brambles, within the scheduled area.

- 1) The interior and flatter parts of the monument should be controlled by twice yearly topping.
- 2) Gorse and weeds on the banks should be cut annually.
- 3) Dead or unstable trees or fallen branches should be removed from the scheduled area when ground conditions are dry to avoid disturbing the archaeological layers.
- 4) Ploughing operations in areas adjacent to the monument should be kept 5m outside of the scheduled area.

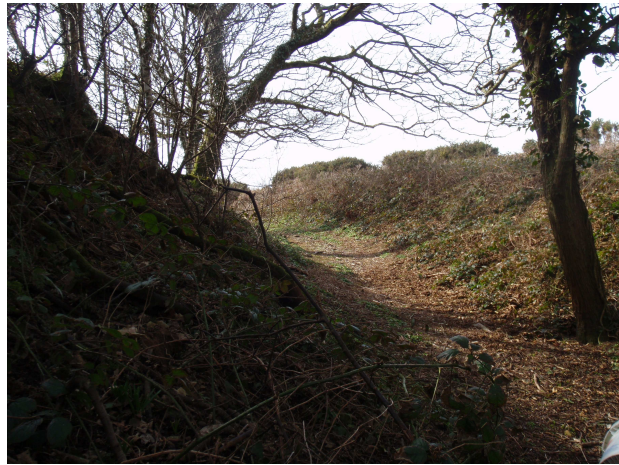
*Inner and middle banks of the promontory fort, looking southwest*

When the monument was seen during the Tir Gofal archaeological farm visit (02/03/2010) it was due to have the vegetation cover cut back. There was thick gorse on the defensive banks and extensive bracken and brambles in the ditches and interior. There are also several trees growing within and close to the monument, with the steep natural slopes to the south and east under broadleaf woodland. Some erosion of the northern defences was evident, where a footpath is located to provide access to the interior of the monument. It was also noted that the field to the west of the monument is currently ploughed right up to the outer defensive bank.

In addition, it was noted during the Tir Gofal visit that a pathway through the northern defences of the monument has resulted in some erosion of the site. These areas should ideally be restored to prevent

progressive deterioration. A proposed quad bike trail around the farm runs close to the western defences of the monument. A buffer of some 10 metres should be maintained between the line of this track and the edge of the scheduled area.

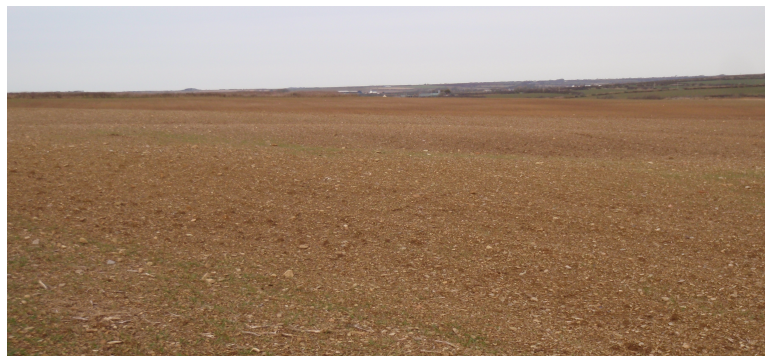
*Ephemeral earthwork remains (PRN 2772), looking north.*

The site was seen during the Tir Gofal archaeological farm visit (02/03/2010) while under very low winter wheat. It was possible to discern the slight earthwork bank and the presence of a ditch, roughly 6 metres in width, was apparent from a slight change in soil colour. Although the feature is very ephemeral and regular ploughing has reduced and spread the earthwork, there is still good potential for the survival of archaeological remains below ground.

The site has been ploughed regularly and is now very ephemeral in nature. However, earthworks are still visible and archaeological deposits potentially survive below ground.

Ideally the area of the field containing the feature would cease to be ploughed in order to preserve and consolidate the archaeology. Grass should be allowed to cover the site and vegetation should subsequently be monitored, with scrub regularly removed. The farm is wholly arable so grazing the area is currently not an option.

Alternatively it should be ensured that the level of ploughing is not deepened.

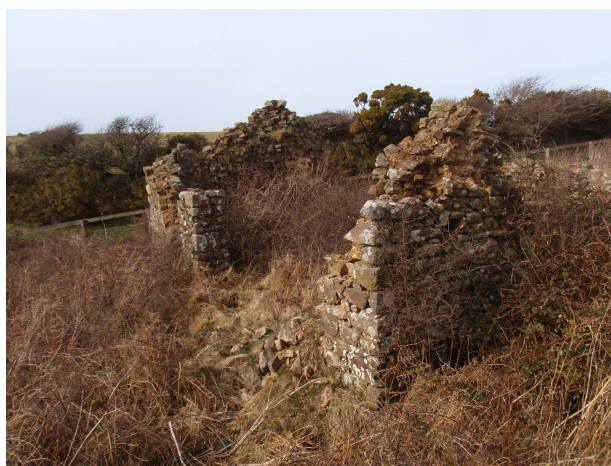
*Looking northwest, Blaen-Llyn cottage (PRN 94326)*

This ruinous cottage was recorded during the Tir Gofal archaeological farm visit (02/03/2010). It is a gable-ended building of mortared, semi-dressed stone blocks aligned east-west overlooking St Brides Bay. The western gable stands to full height but the eastern side has partially collapsed and red bricks within the remains of a fireplace appear to be shoring up the wall. The rear wall still stands to almost 2 metres for most of its length but the front wall has almost completely collapsed, apart from the northwest corner where the lower half of a window aperture survives. No roofing material was evident in the vicinity. The rear door, in the southeast corner of the cottage, has been blocked in and consolidated suggesting that the building may have been reused as an animal shelter.

The roof of the cottage has completely gone, leaving the structure open to the weather and exposing the wall tops. The ruins are now under threat from encroaching vegetation and some control would be advised. The remaining wall tops might also benefit from consolidation.

Cut back vegetation on the walls, leaving the roots in situ. Spot treat to prevent re-growth.

Clear vegetation from around and within the structure.

Consider consolidating areas of loose masonry using a traditional lime mortar mix, trying to follow the original mix and appearance as far as possible.

Consider capping the wall tops of derelict and ruinous structures in order to prevent water from washing out lime mortar bonds and accelerating collapse.

Ideally the building would find a new use and be made weathertight, either through the reinstatement of a timber framed roof under slate or corrugated-iron. Any such proposals would require approval from the Pembrokeshire National Coastal Park authority. Should such restoration works be undertaken, please contact the Dyfed Archaeological Trust for further specific recommendations.

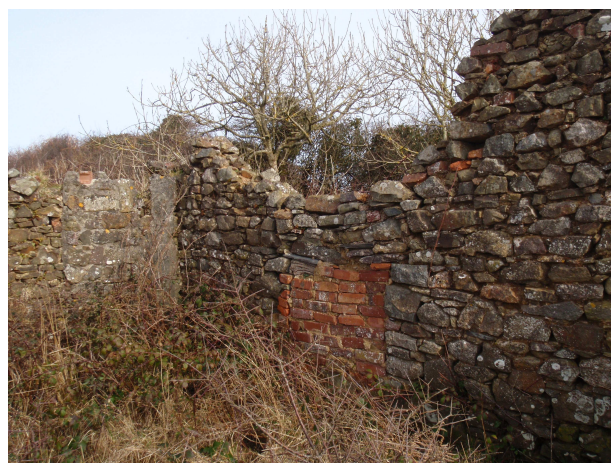
*Looking southeast, blocked doorway and shored-up fireplace within Blaen-Llyn cottage*

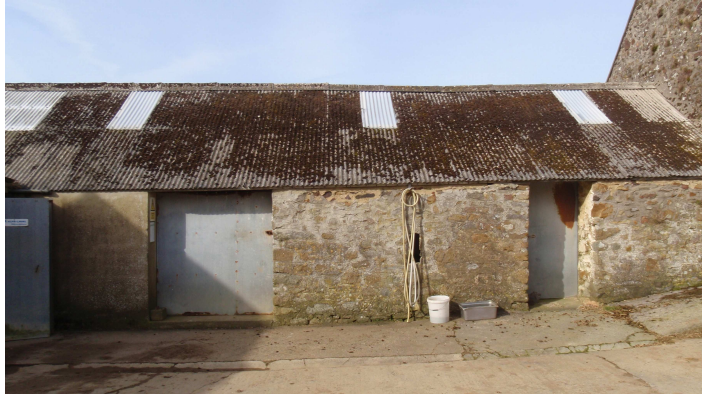
At right angles to the cart shed is a long range, lying along the western edge of the yard and aligned approximately north-south, comprising (from south to north) a cow shed, threshing barn and stable. The cow shed is a single storey building with a 1757 inscription and is now used for storage. There are two doorways, both with metal doors, and a ventilation window in the facade. The southern entrance appears to have been widened and the wall south of it has been concrete rendered. The floor is concreted and the interior walls have been whitewashed, while the roof is now corrugated-iron. The southern end of the building has been partitioned by a modern, breezeblock wall.

The traditional buildings within the Brawdy farmstead are generally in a good state of repair and weathertight, although some remedial repair may be required on the cart shed roof and the northern gable of the cow shed. The need for some piecemeal maintenance work to the roof of the cart shed was discussed with the farmer, where some slates have slipped. The gable wall of the cow shed is now green with damp and the cause of this problem requires investigating and repairing.

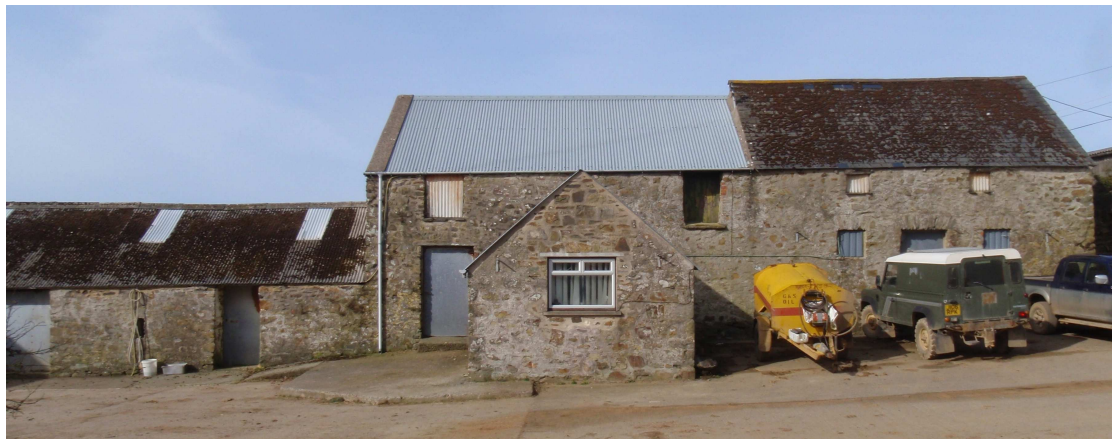
Abutting this building to the north is a two-storey threshing barn, with a tall, wide doorway in the facade and rear walls, the latter now blocked up, and a further blocked doorway in the rear wall. There are two loft windows in the facade and the roof is under corrugated-iron. It appears, from comparison with the adjacent stable, that the replacement of the roof has lowered it slightly. Inside, the floor is half stone -possibly the original threshing floor - and half concrete, while wooden steps just inside the entranceway lead up to the loft. A horse-engine, used to drive threshing and winnowing machines, is depicted on the 1889 1st edition Ordnance Survey to the front of this building. There is now a stone-built, gable-ended extension on this spot, at right-angles to the main building and originally used to house the diesel engine that replaced horsepower. It now serves as the farm office.

The two-storey stable adjoins the northern gable of the threshing barn. It has a central doorway in the facade, with pitched stone lintel and metal door, and an opposite doorway in the rear wall that is now blocked up with breezeblocks. The front pitch of the roof is under slate and the rear is corrugated-iron. Stone steps against the north-facing gable lead to the hayloft and there are two loft windows in the facade. Most of the loft floor has now been removed and the ground floor is concrete, with a drainage channel running down the centre. The building is now used for storage.
