TIR GOFAL MANAGEMENT PLAN: HERITAGE MANAGEMENT INFORMATION (HE2)

**Prepared for:
Highmead Farm**

**Tir Gofal Reference No
W/13/7624**

**DAT Report No. 2009/77
Project Record No. 64995**

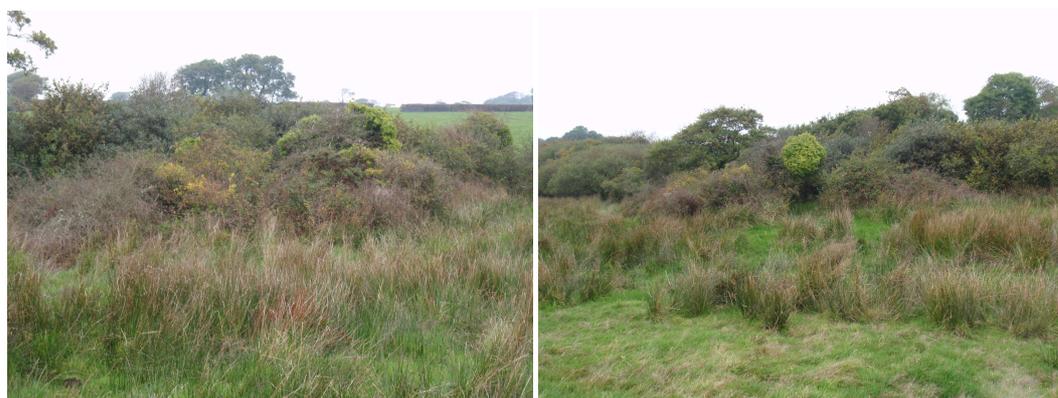
(Left) Looking northeast across the area of the burnt mound, which is hidden beneath thick overgrowth. (Right), looking northwest, showing part of the mound under grass before the scrub takes over.

The site was seen during the 2009 Tir Gofal archaeological farm visit to be within an area of waterlogged marsh at the northern edge of a pasture field, adjacent to the field boundary. The mound itself is difficult to see as it has become very overgrown with thick scrub and thorns, although it was possible to discern its limits. The areas of the mound free from overgrowth are under thick grass but the area around the mound base near the fence are heavily poached..

The archaeological description of the monument remains unchanged from the previous reports. The site lies by a stream on the northern edge of field OS number 0016. The field is grazed by cattle. The permanent pasture has not been ploughed for at least 50 years. Hawthorn, blackthorn, reeds and brambles also grow on the mound. The condition of the monument has been recorded as stable, since the condition is unchanged from the preceding visit. However, the monument would benefit from some clearance of vegetation.

The current condition of the monument is not ideal. The growth of scrub within the scheduled area is potentially causing root damage to sub-surface archaeological remains.

- 1) Continued grazing by cattle, and sheep if possible.
- 2) Cutting of vegetation from the mound, cutting stems at ground level, leaving roots in-situ and undertaking work when ground conditions are dry (to avoid damaging the ground surface). Cut vegetation should be removed from the scheduled area.
- 3) The scheduled area should not be ploughed.
- 4) The scheduled area may need to be protected by electric fencing during periods of wet weather, to

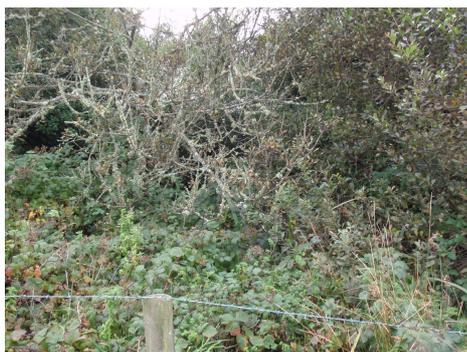
A natural mound, 9m wide x 0.3m high, adjacent to a stream, with overlying black soil and burnt stone at its eastern end (JH based on GW 1995). The location of the mound was seen during the 2009 Tir Gofal archaeological farm visit to be within a fenced off section of a pastoral field alongside a stream. This fenced off area is heavily overgrown with impenetrable brambles and trees, which totally obscured the potential archaeology.

Location of the possible burnt mound (PRN 2989), looking southwest

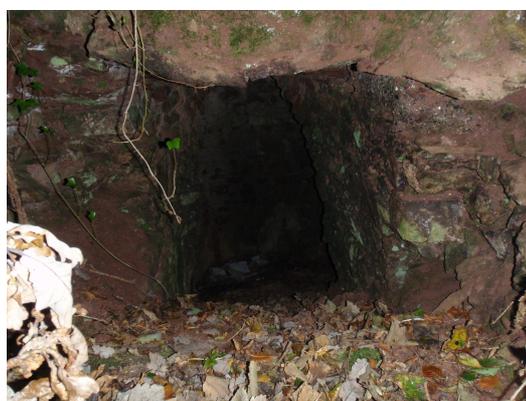
View into the entrance of the ice-house (PRN 94333)

The site was seen during the 2009 Tir Gofal archaeological farm visit, although the interior of the feature was not looked at due to accessibility and visibility problems. The subterranean, circular ice-house is located on the high southern bank above a stream flowing through broadleaf woodland. Little of the feature could be seen from the surface other than the square-shaped aperture, on its northern edge, constructed of roughly dressed sandstone that angled steeply to the interior. The top is under a cover of earth, now thickly overgrown. The owner had previously been into the ice-house and described it as having a domed ceiling and niches within the sidewalls. Winter ice was presumably available from the nearby stream.

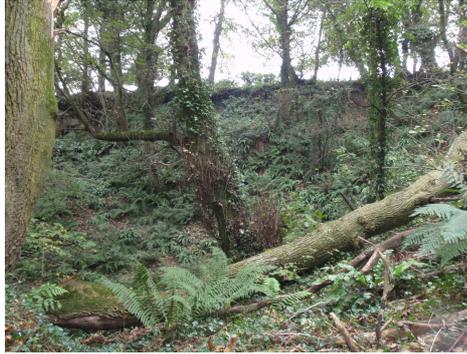
Looking southeast across the quarry crate (PRN 94334).

The quarry was seen during the 2009 Tir Gofal archaeological farm visit, located within the woods to the west of Woodsend cottage. It is an extensive feature where the rock has been removed from the hillslope, leaving a large, open crater. The edges and base of the quarry have now become overgrown and wooded.

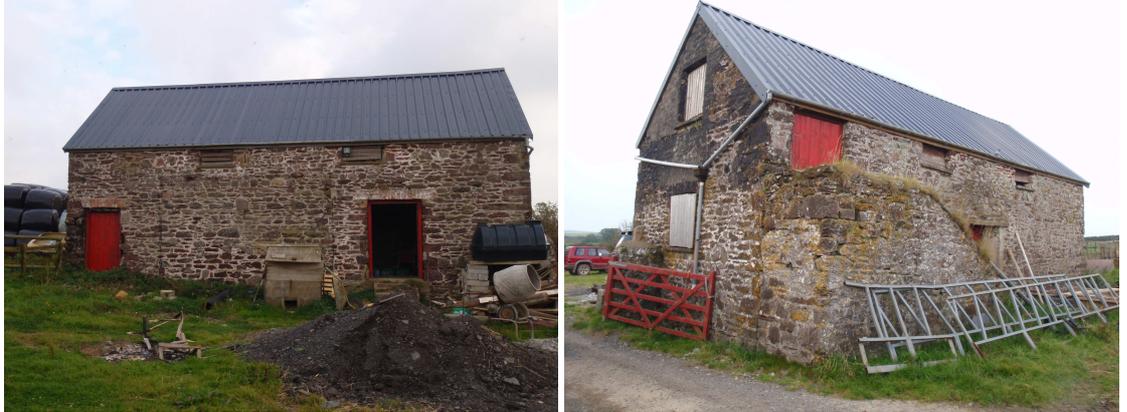
The threshing barn at Lower Winsle

The northernmost building in the farmstead complex is the threshing barn, a two-storey, gable-ended building of rubble stone construction. The original slate roof has since been replaced with box-profile tin. There are two wide groundfloor doorways in the facade and, in the rear wall, a double-door access and external steps leading to the loft access. All doors are red-painted solid wood planking. There are groundfloor and loft windows in each gable, the apertures now boarded up, and loft ventilation windows in both front and rear walls. The interior floor has been concreted and the building is now used for storage. The loft was not looked at and it is understood that the floor timbers are unsafe in places. The access track to the farmstead runs between the southern gable of the threshing barn and the northern gable of, what was originally, the pigsty.

The farm buildings at Lower Winsle are all in good condition and are weathertight, two through the fitting of modern box-profile roofs. Although the conversion of the pigsty into a stable block has now disguised the look of the original range, care has been careful to blend in with the buildings either side. Ideally its roof, and that of the threshing barn, would be returned to slate but this would obviously be expensive. The following recommendations are very small-scale, designed to stop minor problems from escalating and to help maintain the traditional buildings in a stable condition.

There is little repair work that is obviously required on the farm buildings, with just some very minor repairs to dislodged slates and ridge tiles on the cart shed possible. Repair is always preferable to replacement, keeping as much of the original fabric of the building as possible replacement is only to be carried out where necessary.

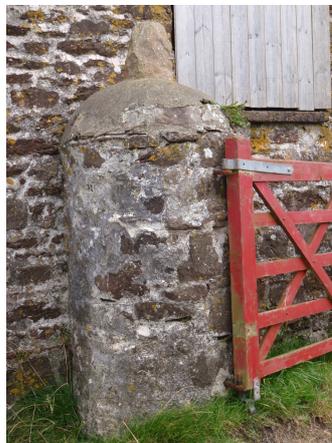
Lower Winsle gatepost

Between these two buildings is a gateway flanked by substantial cylindrical stone gateposts capped with concrete. The pigsty has been converted to a stable block, which has raised the height with breezeblocks to almost that of the adjacent cart shed and re-roofed it with box-profile tin.

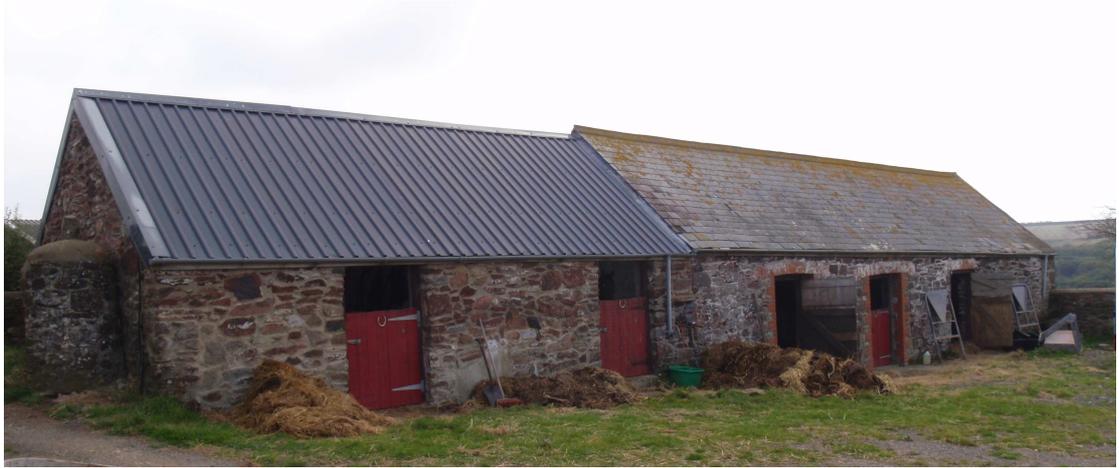
Converted pigsty and cart shed at Lower Winsle

The raised facade and north-facing gable have been faced in stone to blend in with the buildings either side. The adjacent building to the south was originally a cart shed with two bays and a doorway in the facade and a further cart bay in the rear wall. The building is gable ended and slate roofed. The bays have red brick arches above and the two in the facade have subsequently been partially blocked and dressed with red brick when the building was converted to a stable block. There are diamond shaped apertures - possibly owl holes - high in the gable walls. The interior is open to the A-frame roof timbers and there is a remnant of cobbling within the middle bay. Breezeblock walls now partition the building into three stables.
