TIR GOFAL MANAGEMENT PLAN: HERITAGE MANAGEMENT INFORMATION (HE2)

**Prepared for:
Treddiog Fawr**

**Tir Gofal Reference No
W/13/7645**

**DAT Report No. 2009/13
Project Record No. 65005**

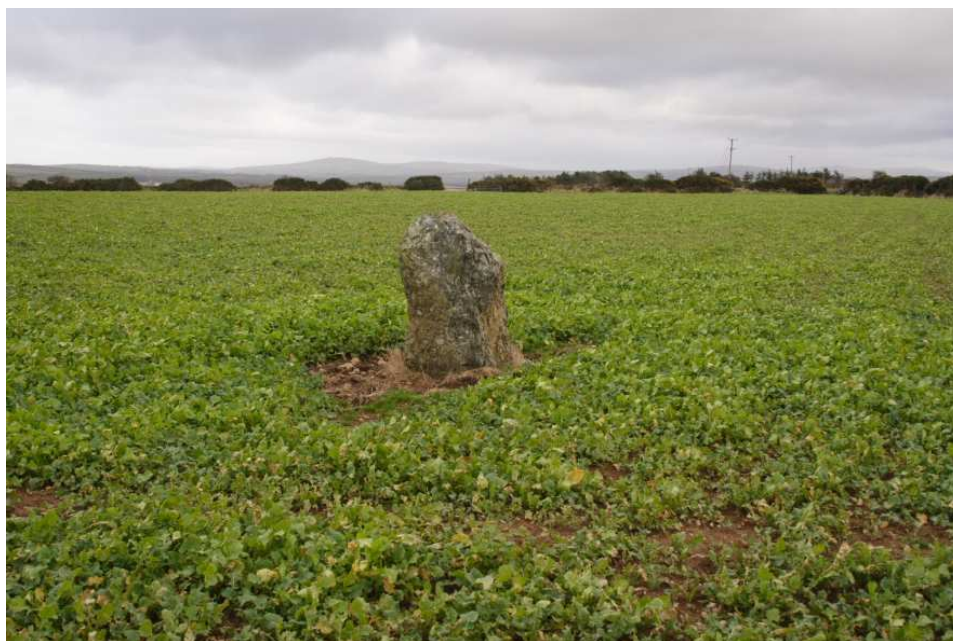
Facing east towards standing stone PRN 94446.

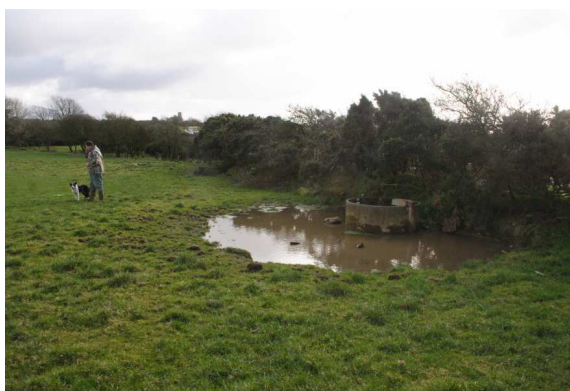
The very ruinous remains of a probable burial chamber lie in a hedge, approximately 100m east of Treddiog-fawr farmstead. The area is very overgrown with scrub, and any proper description of the remains would only be possible after clearance. Two massive stones, one seemingly upright, certainly are visible (after Rees 1981).

A round concrete water trough is located 3m to the north west of the stones in the hedgebank (on the edge of or possibly outside of the scheduled area). The field appears to be routinely ploughed; the ploughing headland stands 1.5m east of the stones. The field to the west is outside of the scheduled area.

At the time of the Tir Gofal archaeological farm visit, the field was under pasture, previously grazed by cattle and now heavily poached due to excessively wet conditions. A water filled erosion hollow with a radius of approximately 2.5m now surrounds the concrete trough extending to the edge of the stones.

Facing south towards the site of the chambered tomb.

Current Condition: The condition of the monument has deteriorated since the previous Cadw Field Monument Warden visit (L. Mees, 22/01/2004). The recent Tir Gofal archaeological farm visit reports that the hedge is overgrown and the area around the drinking trough is badly poached.

The scheduled area is situated within a field of pasture. The aim of the management should be to retain a good grass cover within the scheduled area. Scrub should be cut annually. The drinking trough should be removed from the scheduled area. The ground surface may require repair, by infilling the area with inert material, reseeding and protecting to allow the grass cover to re-establish (scheduled monument consent is required).

The surviving stones of the burial chamber lie within the hedge on the western side of the scheduled area. The stones are obscured by the overgrown gorse. The gorse should be cut back and trimmed annually. TG hedge restoration is not recommended, as this would require fencing within the scheduled area and would result in the development of a dense hedge which would obscure the stones.

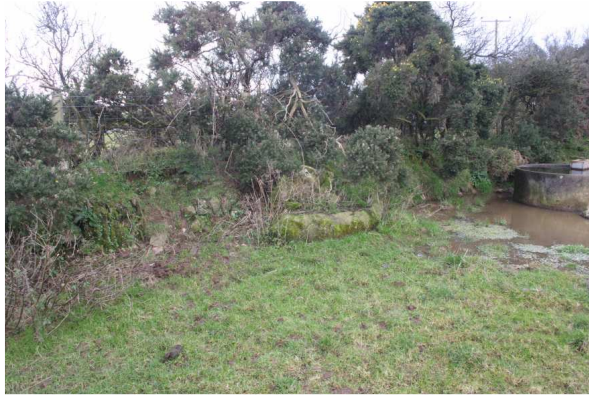
The remains of the chambered tomb seen from the southeast.

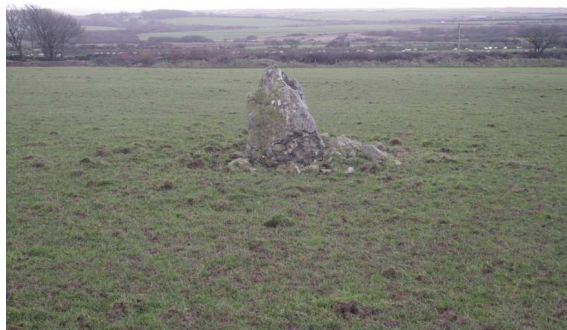
This standing stone is located within an enclosed field on a south facing slope. It is 1.25m tall, 1.1m wide and 0.8m deep. It is oriented northwest-southeast and tapers to a point. The stone has many quartz inclusions.

At the time of the Tir Gofal archaeological farm visit the field in which the stone stands was under pasture. There is some light poaching in the area of the stone but the grass cover remains largely intact. No specific management concerns noted.

The standing stone, seen from the southeast.

Current Condition: The recent Tir Gofal archaeological farm visit reports that the field is still under pasture. There is some light poaching in the area of the stone, but the grass cover remains largely intact. The DAT TG visit also reports that the field is managed in rotation and cultivated periodically.

Recommendations for Management within the Tir Gofal Scheme: The aim of the management should be to retain a good grass cover at the base of the stone and within the scheduled area (a 6m diameter circle centred on the stone). Scrub should be cut annually. Ploughing should avoid the scheduled area.

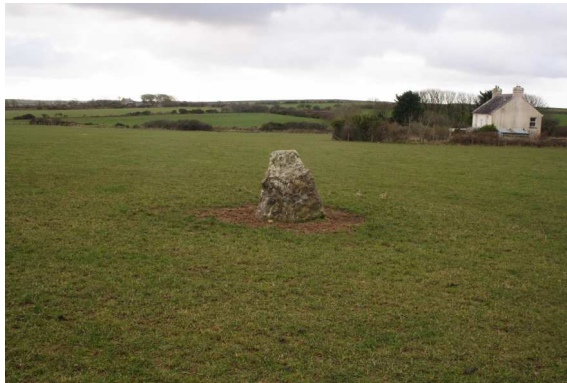
This fine standing stone is located on a south-facing slope. It measures 1.3m tall, 1.1m wide and 0.8m deep. It is oriented N-S and has a bluntly pointed top. The stone is noted for its very pitted appearance and quartz inclusions. The standing stone is believed to be of religious or ceremonial significance and to date to the Bronze Age (c.2300 BC - 800 BC).

The surrounding field was under pasture at the time of the Tir Gofal archaeological farm visit. Surrounding the stone is a shallow erosion ring where the grass cover is broken, approximately 0.5m wide. No specific management concerns noted.

Facing the standing stone from the west.

Current Condition: The recent Tir Gofal archaeological farm visit reports that the field is currently under permanent pasture and there is a slight erosion ring at the base of the stone.

Recommendations for Management within the Tir Gofal Scheme: The stone is situated within a field of pasture. The aim of the management should be to retain a good grass cover at the base of the stone and within the scheduled area (a diameter circle centred on the stone). Scrub should be cut annually. Ploughing should avoid the scheduled area.

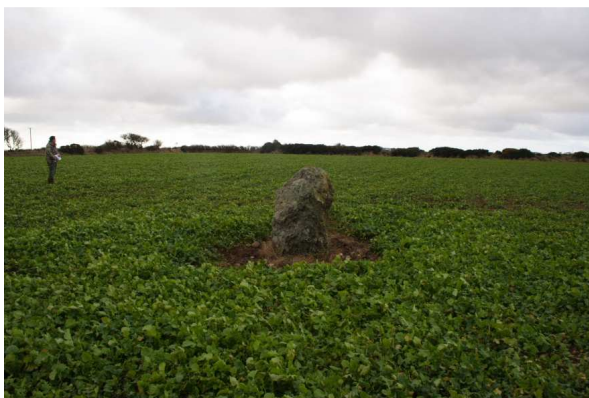
This large and squat standing stone is situated on the NW shoulder of a hill. It measures 1.3m tall, 1.0m wide, 0.8m deep and 2.8m in circumference. The monument leans slightly to the NW and has a rounded top. Strumble Head and St George's Channel are visible to the N.

The field in which the stone stands was down to a root crop at the time of the Tir Gofal visit, cultivated to within two metres of the base of the stone.

The standing stone, seen from the south.

Current Condition: The recent Tir Gofal archaeological farm visit reports that the field is managed in rotation. It has been cultivated recently and is currently under a root crop. The cultivation has been taken to within 2m of the base of the stone.

Recommendations for Management within the Tir Gofal Scheme: The aim of the management should be to retain a good grass cover at the base of the stone and within the scheduled area (a 6m diameter circle centred on the stone). Scrub should be cut annually. Ploughing should avoid the scheduled area.

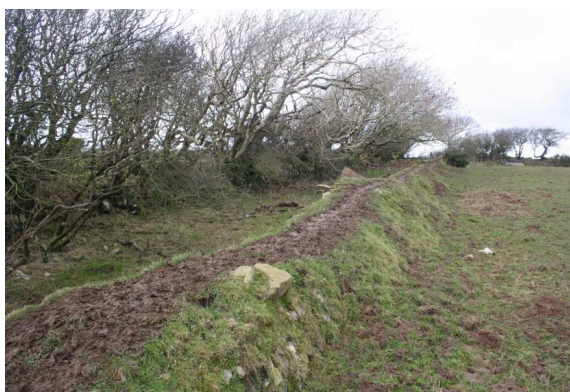
A redundant hollow way leading north from Tre-howell, recorded on the Ordnance Survey 1st edition map (1889).

The hollow way is approximately seven metres wide with a high earth and stone bank on either side and relict hedges on the banks. The hollow way runs along one side of a pasture field. A section of the hollow way, approximately 40m long was destroyed to make way for a shale quarry in recent years. Other sections of the hollow way remains substantially intact, grazed within a pasture field although overgrown in areas.

Facing north along the redundant hollow way.

- Ensure that the surviving sections of the hollow way are not damaged by heavy machinery during the infilling of the quarry.
- Consider reinstating lost sections of the hollow way. Contact the Dyfed Archaeological Trust for further advice if this option is taken up.

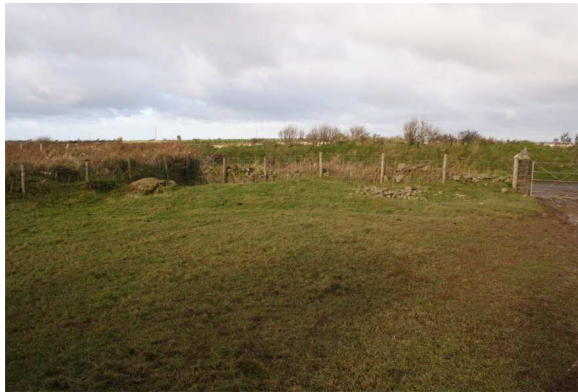
Former cottage site. Identified as Pen-lan on OS 1st edition (1889).

The site is today in the corner of an improved pasture field and there are no visible signs that a dwelling once stood here. Field boundaries have been grubbed out and the cottage has been levelled. Stone in the vicinity may be building debris or field clearance material. No specific management recommendations.

The former cottage site, seen from the southeast.

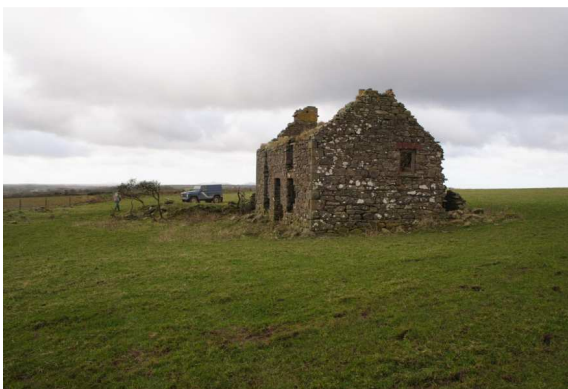
A ruinous cottage, situated in the corner of an improved pasture field. Today a stone shell. Identified as Pen-lan-oleu on the OS 1st edition (1889).

The cottage is stone built of two storeys with a central doorway and symmetrical façade including opposing end chimneys. Lean-to kitchen to rear and single storey shed adjoining the west gable wall. To the south, the remains of a circular well (PRN 94294). No specific management threats identified.

The cottage is today a stone shell. View from E.

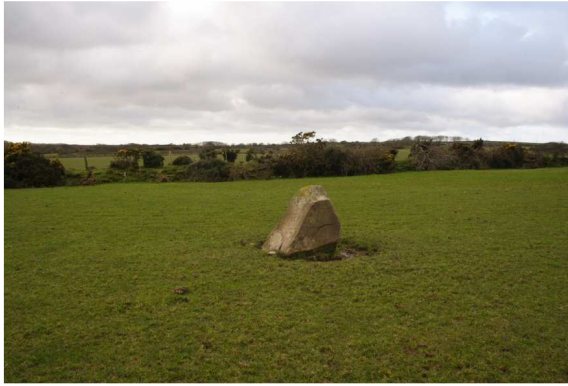
An unscheduled standing stone located within an enclosed pasture field on a gentle south facing slope. The stone is a smooth upright slab approximately 1.2m high triangular in profile tapering to a point. The stone is one of a large number of stones in the vicinity (eg. PRNs 48324, 48325, 94446) but differs from the others in not having a pitted appearance or quartz inclusions.

The stone lies within a field which although cultivated in the past is now under permanent pasture. There is slight erosion ring around the base through livestock poaching. No management threats otherwise.

The standing stone, seen from the east.

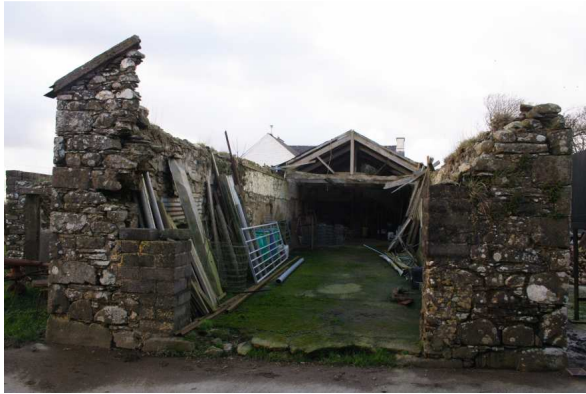
Name (& PRN)	Period/Site type	NGR	Status SAM/listing	Management required
1	TRE-DDIOG (94445)	Post Medieval stable; cow house	SM88992870	B	Specific
<p>A derelict stone and slate roofed stable and cow house range sited across-the-slope on the western side of the farmyard at Treddiog Fawr. The range was subject to alterations in the early 20th century when a door with two flanking windows in the upper (north) end of the west wall was blocked and a wide door and three wide windows inserted in the east wall. A roofless stone lean-to cow house against the rear wall was added in the later 19th or earlier 20th century (OS 1889, 1907). Later modifications have seen the interior features removed and a wide opening inserted in the south gable wall for vehicular access.</p> <p>The upper stable part of the range has a doorway flanked by two wide windows and a further wide window to the left, with wooden lintels, facing onto the yard. None of the original stall partitions, hayracks or mangers survive inside to indicate the pattern of tethering. The windows are modern in origin, of “hopper” type in two sections with four fixed lower lights and four upper lights hinged on metal brackets. An earlier doorway and two smaller flanking windows with stone lintels in the rear wall are now blocked.</p> <p>Two doorways with stone lintels facing onto the yard in the downslope end indicate a former cow house. The lower door forms a through passage with a doorway with stone lintel in the rear wall suggesting transverse tethering. The only other openings are two narrow ventilation slits in the rear wall. Sawn off joist slots indicate that at least part of the cow house was formerly lofted.</p> <p>The lean-to cow house abuts the middle part of the range to the rear. A lengthways stalling platform and the positions of the doorways in either end wall suggest an arrangement where cattle were stalled in a long line facing the front wall (ie east wall of main range) with a drainage passage behind. There are two enlarged square window openings with concrete lintels in the rear (west) wall and an arrangement of door then small window mirrored in each end wall. Abutting the northern end of the cow house is a modern garage of breeze block construction. The cow house was modified when the front wall was built up with two courses of breeze blocks.</p> <p>The stables cow house range is currently in a derelict and deteriorating condition with little of the roof surviving but walls which remain substantially intact. Surviving trusses within the stables, cow house part are of king post truss construction with raking struts on wooden wall plates. No trace of the lean-to cow house roof survives and the original historic covering (slate or corrugated tin) is not known.</p>

Facing north towards the interior of the cow house/ stables

The possibility of restoring the building, which is currently derelict was discussed as a potential Tir Gofal capital works option. The intention is to return the building to a stable and weatherproof condition, thereby ensuring its continued future use.

- Repair the gabled roof on the main cow house/ stables range. Take care to retain the original detail of the roof such as ceramic ridge tiles and keep the same method of slating.

- Repair original roof trusses where possible. Where replacement or reinstatement is required take care to match the original style of construction: in this instance king post truss construction with raking struts on wooden wall plates.

- Replace the missing lean-to roof. This is a single pitch roof which was raised in the past when the front wall was built up by two courses with breeze blocks. Remove breeze blocks to reinstate the original pitch.

- Rebuilding the missing south gable end of the main cow house/ stables range taking care to match the type of stone and method of laying found elsewhere.

- Plastering the inside of the building is a non-traditional characteristic. It is recommended that the interior of the building should be limewashed. Suitable surfaces should be brushed down and existing layers of loose limewash removed. It should not be necessary to remove all previous layers of limewash before applying new coats.
