## **TIR GOFAL MANAGEMENT PLAN: HERITAGE MANAGEMENT INFORMATION (HE2)**

**Prepared for:  
Bwlchyrhiw**

**Tir Gofal Reference No  
W/12/6255**

**DAT Report No. 2009/88  
Project Record No. 65012**

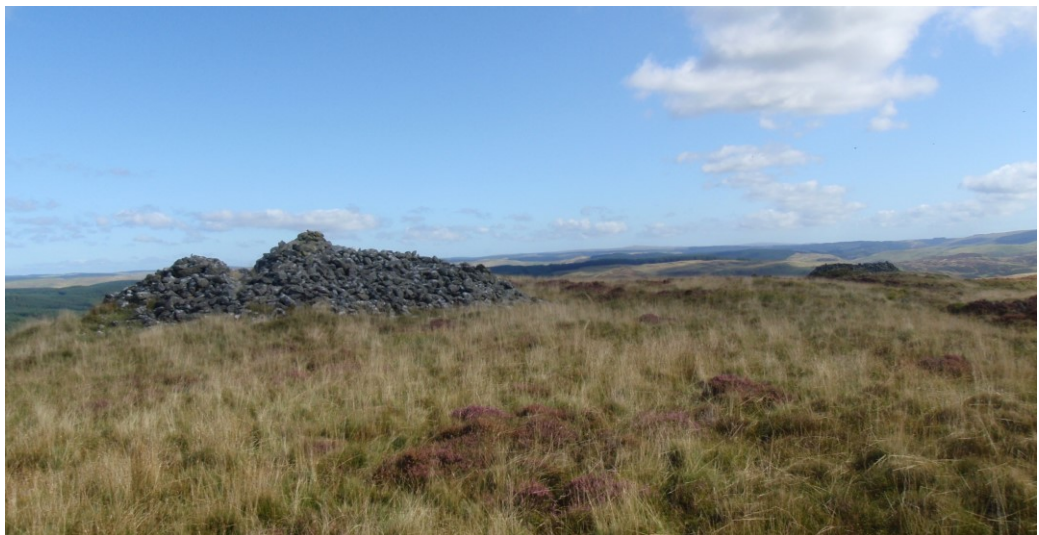
The two large stone-constructed cairns, set about 100 metres apart, known as the Crugiau Merched are the most prominent structures at the northern end of the Mynydd Mallaen upland common. Standing at the highest point of the Mynydd Mallaen at 459 metres OD, they dominate the skyline when viewed from the south or east but are not particularly visible from the north since they are set away from a steep slope, which obscures them from view. The western cairn PRN 4096 is substantially intact apart from a channel cut through it (apparently by Ordnance Surveyors for trigonometrical observations).

*Looking east, Cairn PRN 4096 in foreground (with channel cut through it) and second cairn PRN 4097 beyond.*

Fortunately it only affects the upper levels of the cairn. The cairn measures over 25 metres in diameter and is approximately 3 metres high (although a later walker's cairn on top increases this to 3.5 metres or more). The main body of the cairn is comprised of medium to large sized stones which have been heaped on top of a natural hillock on the ridge top. A walkers' cairn of stones stands on the southern side of this trench, about 1 metre in height. On the southern side there is a 'hole' measuring 2 metres square and extending to a depth of 0.7 metres. Again, there are no indications that this has continued any deeper into the fabric of the cairn. This has probably been created to act as a shelter. There are no signs of a kerb around the outside of the cairn

It is recommended that there is sufficient grazing on the mountain to prevent the tussock grass from getting too thick and long.

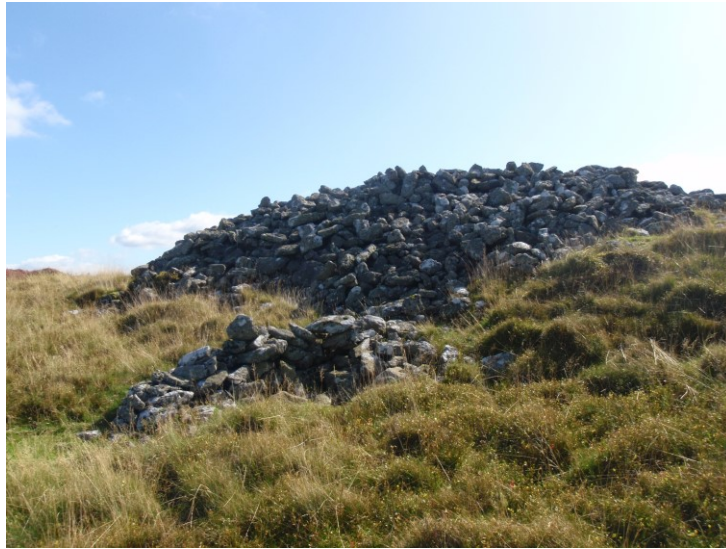
*Looking south, showing shelter built to the north of cairn PRN 4096*

It is on this side that a small shelter has been built in the lee protection of the cairn and probably using stones removed from the cairn. This takes the form of a semi-circular rubble stone wall about 1.5 metres long which serves to protect a small area of ground beside the cairn (CADW, 1999). The site was visited during the 2009 Tir Gofal archaeological farm visit. It is located within upland moorland and marsh which is under low-intensity grazing. The cairn remains the same as described by CADW in 1999, with a channel cleared through the east-west axis, a later cairn formed in the centre and a length of wall to the north. No subsequent damage appears to have occurred and there were no apparent immediate threats to the monument.

PRN 4096 is a Scheduled Ancient Monument (SAM CM302) and is monitored by the Cadw Field Monument Warden. On the last visit to the site (2003) it was found to be in a stable condition with no specific management issues.

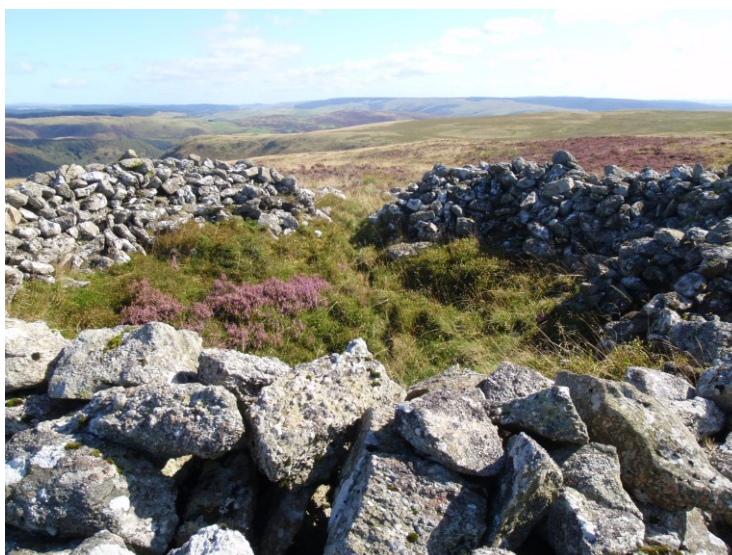
One of two cairns, the other being PRN 4096, known as the Crugiau Merched. Located on the Mynydd Mallaen upland common, about 100 metres apart on a ridge. This easterly cairn measures approximately 25 metres in diameter and stands up to 4-4.5 metres high. The interior of the cairn has been hollowed out, with an entrance on the eastern side, to form a shelter or a pen with an entrance on the eastern side. The cairn was excavated in the 1930s by J.F.Jones, the curator of Carmarthen Museum, but no burial remains were apparently recovered, suggesting that one could still remain undiscovered and undisturbed. The excavation opened the centre of the cairn which has been subsequently used as a shelter. However, this leaves quite large areas of cairn material and ground still undisturbed around the periphery.

*Looking east across the hollowed-out interior of cairn PRN 4097*

A circular shelter some 2 metres x 1.5 metres in size has been built within the cairn on the southern side, probably a shepherd's shelter. This will have used stones taken from the fabric of the cairn. The cairn still has much of archaeological interest. No burial was reported to have been discovered during the excavations suggesting that one could still remain undiscovered and undisturbed. There is also a strong likelihood that a buried Bronze Age land surface may have been preserved beneath the remaining areas of the cairn (CADW, 1999)

It is recommended that there is sufficient grazing on the mountain to prevent the tussock grass from getting too thick and long.

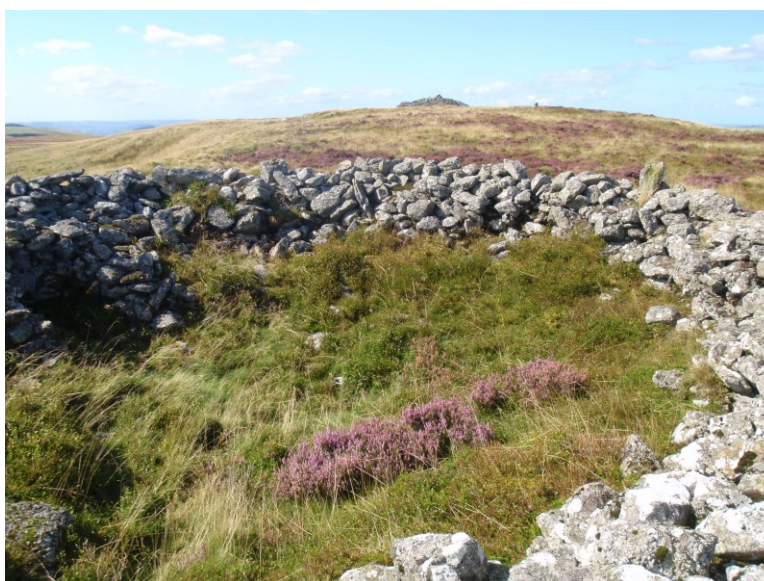
*Looking west across cairn PRN 4097 towards cairn PRN 4096. Shelter built within the monument is visible on left of picture.*

The site was visited during the Tir Gofal archaeological farm visit of 2009. It is located within upland moorland and marsh which is under low-intensity grazing. The cairn remains the same as described by CADW in 1999, hollowed out after excavation and a shelter built against the south side of the interior. No subsequent damage appears to have occurred and there were no apparent immediate threats to the monument.

PRN 4097 is a Scheduled Ancient Monument (SAM CM302) and is monitored by the Cadw Field Monument Warden. On the last visit to the site (2003) it was found to be in a stable condition with no specific management issues.

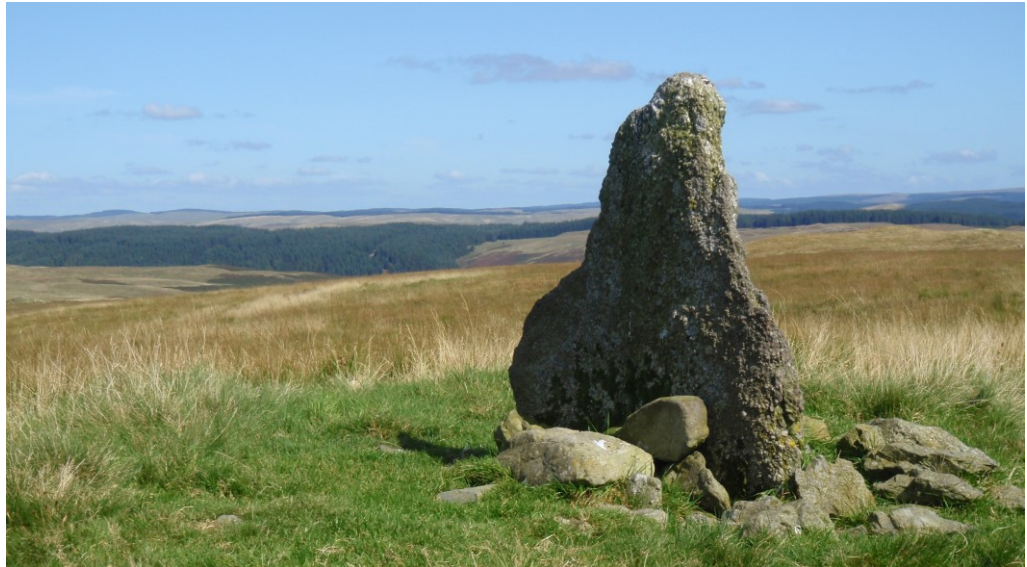
particularly prominent position visible from long distances in several directions. In particular, it forms part of a sight-line extending from the Crugiau Merched to a second standing stone further to the southeast. The triangular stone measures 1 metre x 0.3 metre x 1.3 metre high and stands on top of a grass covered stone cairn, 6 metres in diameter and some 0.3 metres high.

*Looking northeast, standing stone Maen Bach (PRN 4102)*

The stone is held upright by packing stones, including one particularly large one packed flat against the base of the stone on its southern side (CADW, 1999). The site was seen during the 2009 Tir Gofal archaeological farm visit. A possible waymarker, it stands on a upland moorland plateau in an area of low intensity grazing. The stone remains the same as when recorded by CADW in 1999. The only apparent potential threat to the monument was what appeared to be the well-worn track of a quad-bike running within two metres of, the west of the stone, which had caused poaching in places.

The trackway appears to be well-established but it is recommended that motorised vehicles take a wider course past the monument, at least five metres away, to help prevent further erosion.

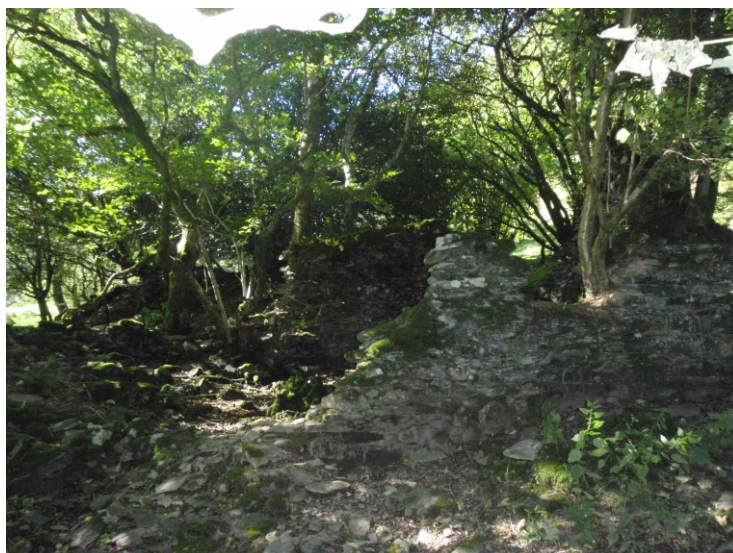
*Ruins of Melin y Coed (PRN 21849), looking west*

Mill complex recorded on the 1888 1st edition Ordnance Survey map, named 'Melin y coed Woollen Factory'. Marked as disused on the 1905 2nd edition OS map. The site was seen during the Tir Gofal archaeological farm visit of 2009. It is located on the edge of broadleaf woodland by the side of the Nant Melyn. The rectangular building is now roofless and ruinous, measuring approximately 11 metres north-

south by 6 metres east-west. The layout of the structure was difficult to determine, with no internal features discernable, but there were possibly two doorways and a central window in the east facing wall - presumably the facade - and one doorway in the northwest corner of the west-facing wall. The north-facing wall is the best preserved, standing to possible full height in part, but the other walls vary from partial survival to rubble spreads.

The building has lost its roof and some stretches of the walling have collapsed. The ruins are now under threat from encroaching vegetation and some control would be advised. The remaining wall tops might also benefit from consolidation.

Consider cutting back vegetation on the walls, leaving the roots in situ. Spot treat to prevent re-growth.

Consider consolidating areas of loose masonry using a traditional lime mortar mix, trying to follow the original mix and appearance as far as possible.

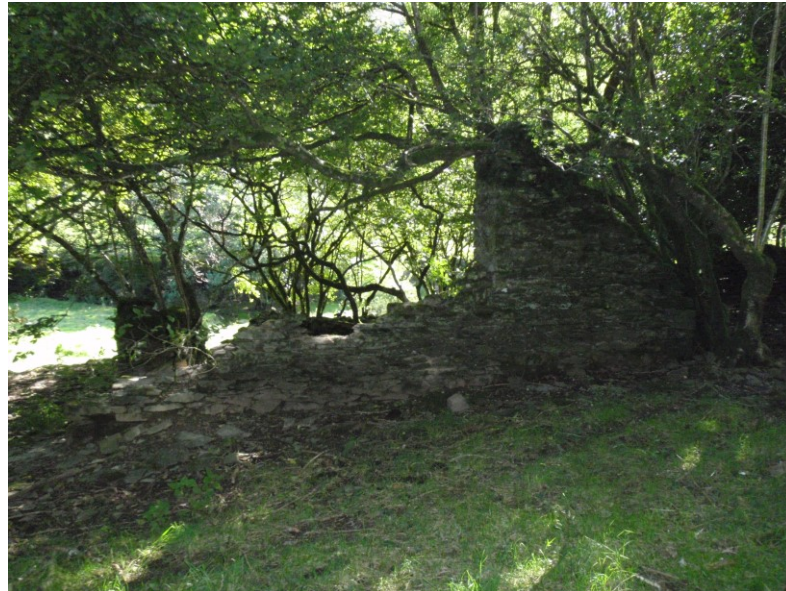
*Looking south, north-facing wall of Melin y Coed (PRN 21849)*
