THE TYTHE BARN, CASTLE ROAD, KIDWELLY CARMARTHENSHIRE ARCHAEOLOGICAL EVALUATION

Prepared
by
Dyfed Archaeological Trust
for
Mr Norman Aubery

REPORT NO.2008/77
PROJECT RECORD NO.93843

July 2008

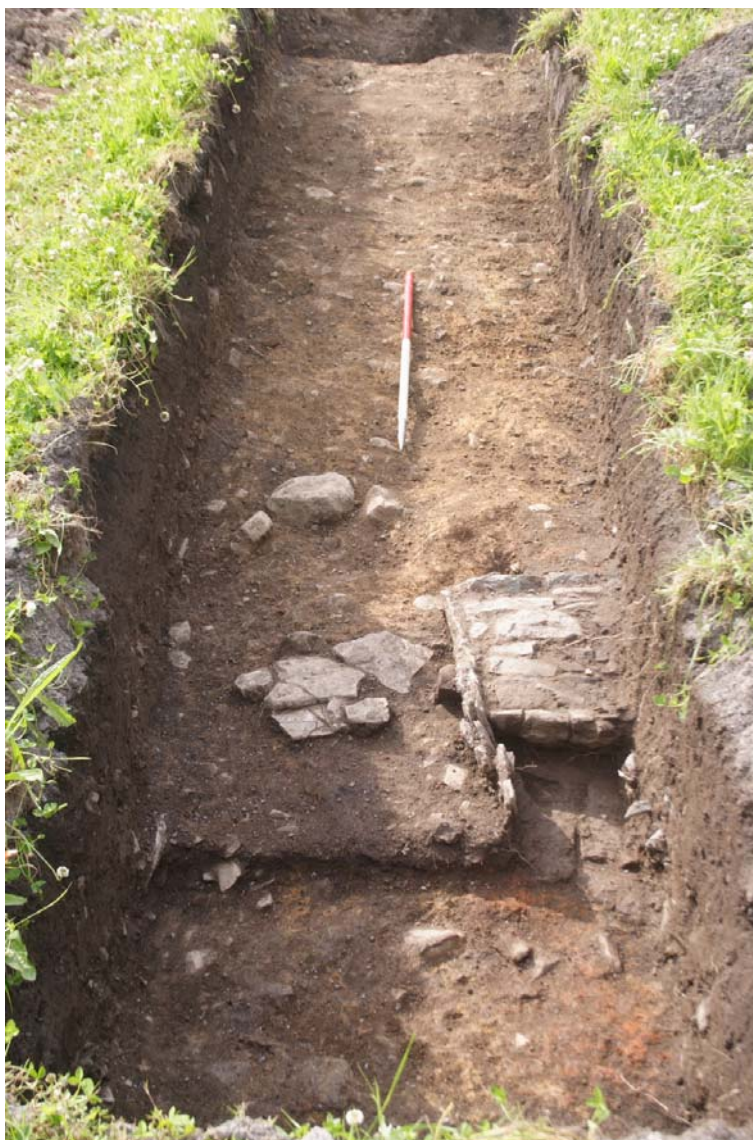
Plate 1: General view southeast along the trench showing Hearth 1012 and heat affected clay 1020.

The northeast end of a stone-built structure was uncovered at the northwest end of the trench. The exposed section of the structure measured c.1m northwest - southeast x c.0.4m northeast - southwest and consisted of seven rows of pitched stones surrounded by thin slabs, which were also pitched to give a thin edging to the structure. The pitched stones had been removed from the northwest half of the interior revealing a surface of flat-laid stones. The remaining interior stones appeared to have been bonded with clay.

Hearth 1012 had been constructed over a pit (1015/1021) filled with orange heat-affected clay (1013/1020). The pit extended beyond the southwest edge of the trench, but the exposed section measured 2m northwest – southeast x 0.4m x 0.12m deep. The pit sides were gently sloped towards a flattish base. The fill was stiff dark orange clay containing small sub-angular stones and a small fragment of a copper alloy object that might be either part of a pin or a piece of wire.

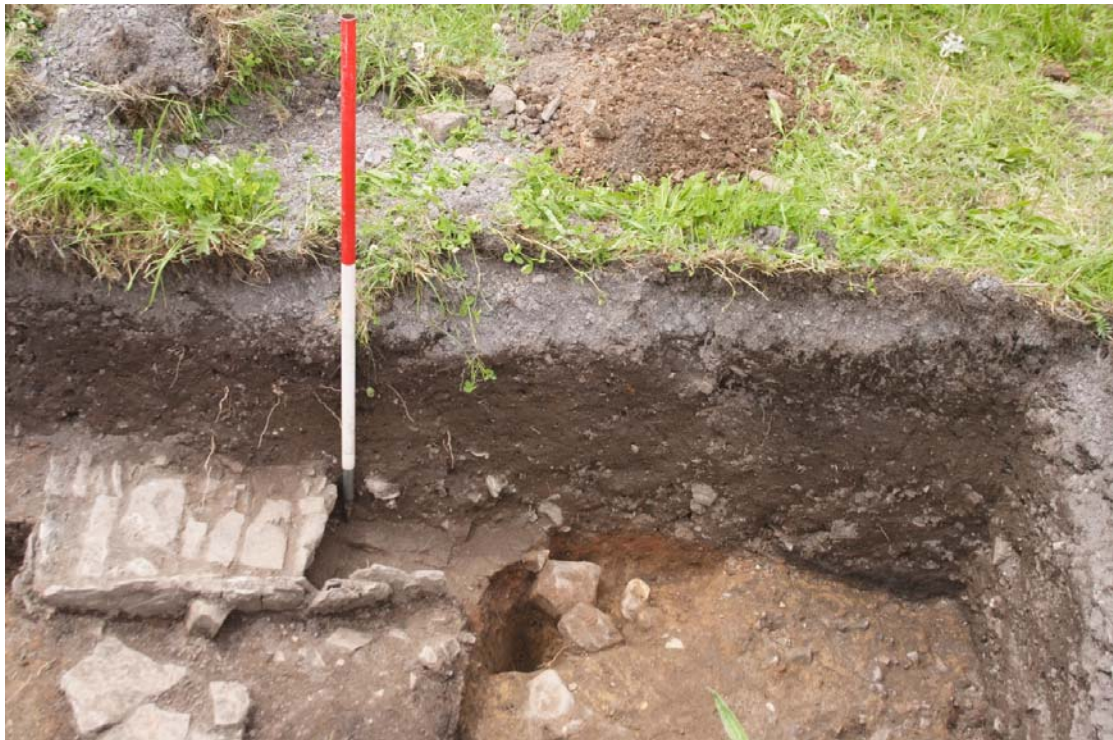
Plate 2: Shot Northwest of Hearth 1012. Also showing heat affected clay 1020 in section and pit 1017 in the corner of the trench.

3.2.6 Pit 1017 and fill 1016 (Fig. 3: Plate 2)

natural (1003) and had very shallow sloping sides, which extended beyond the trench edges. It had a single fill of charcoal rich silty clay, which contained fragments of burnt bone and shell (1016). Too little of this feature was exposed to make any assumptions regarding its function or form. A sample of the fill has been retained for possible radiocarbon dating.

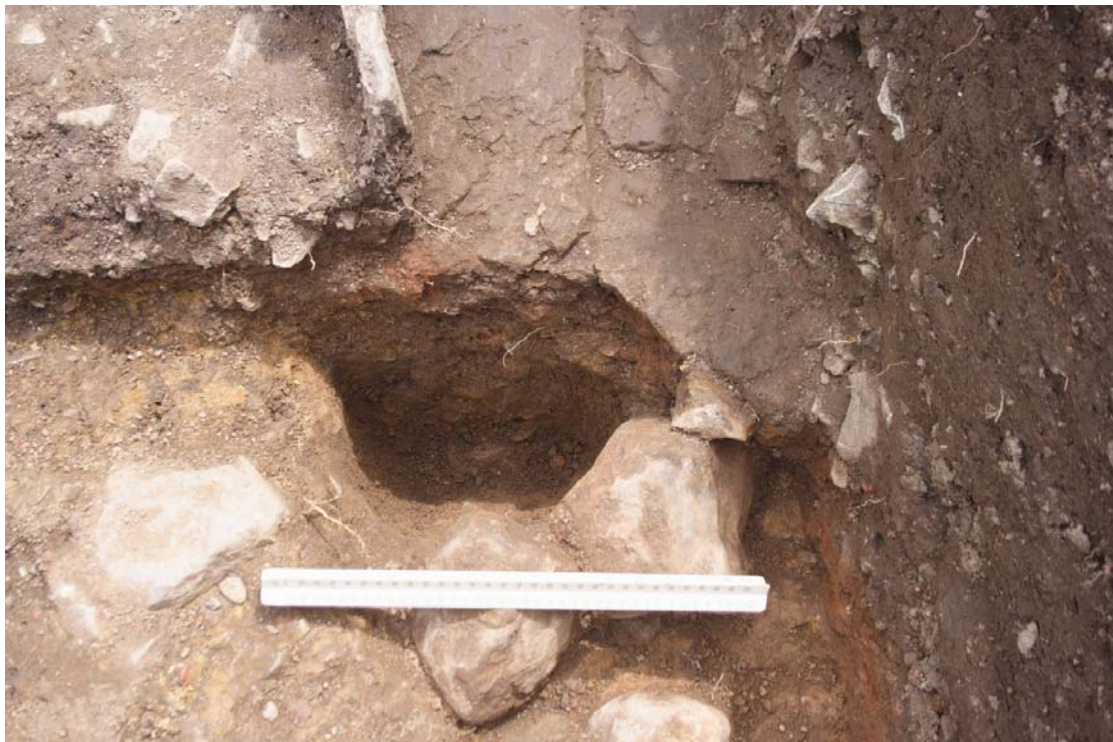
Plate 3: Vertical shot of posthole 1019 and flat-laid stones in hearth 1012.

The northwest side of hearth 1012 had been cut by a circular posthole, c.0.27m diameter x 0.23m deep. The posthole had vertical sides, except for the northwest side that was slightly sloped. It was filled with black/brown silty clay containing a small amount of charcoal flecks (1018).

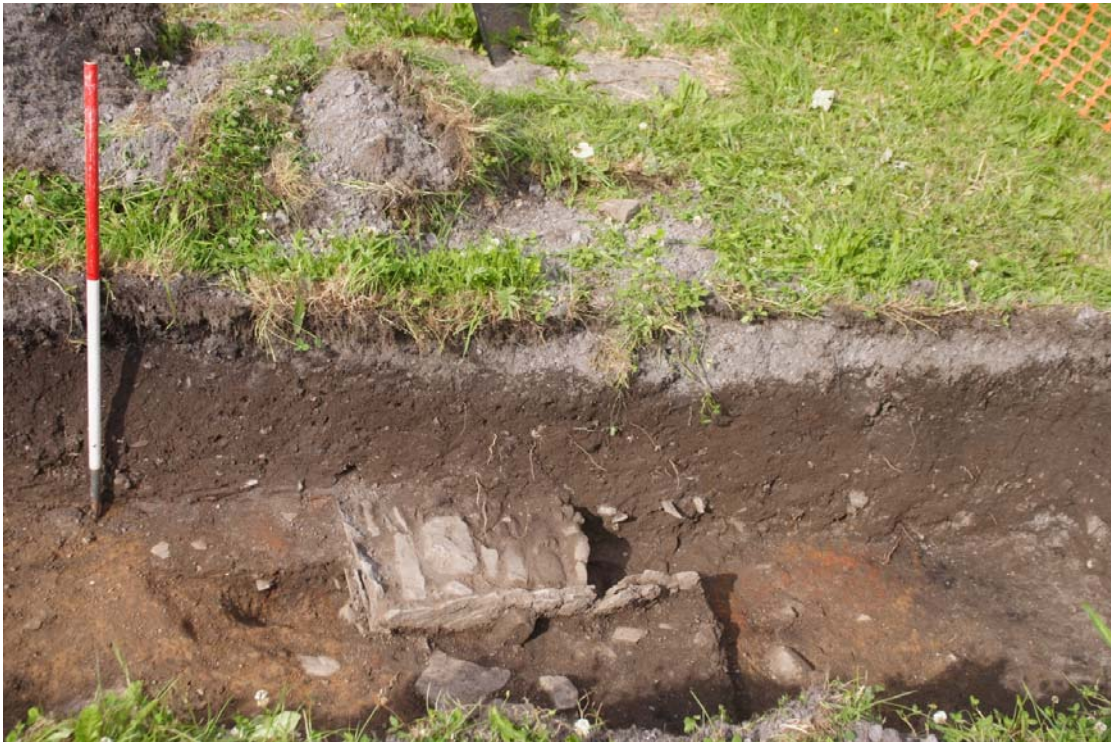
Plate 4: Shot northwest of hearth 1012 and heat affected clay 1013 and 1020.

The clay fill had been heavily heat affected, but interestingly there was no charcoal suggesting that the clay had not been in direct contact with a fire. With such a small section exposed it is not possible to be certain about a function for this pit, but the heavily heat affected fill suggests that it may have been industrial rather than domestic in origin.

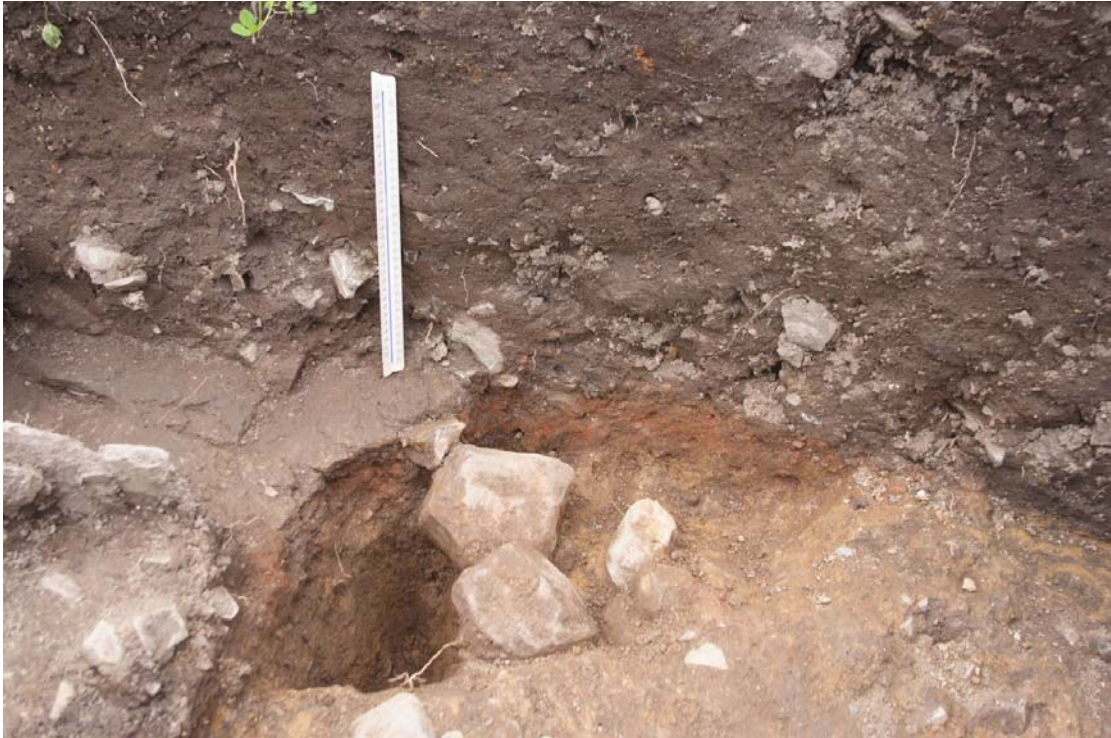
Plate 5: Shot northwest of posthole 1019 and heat affected fill 1020.

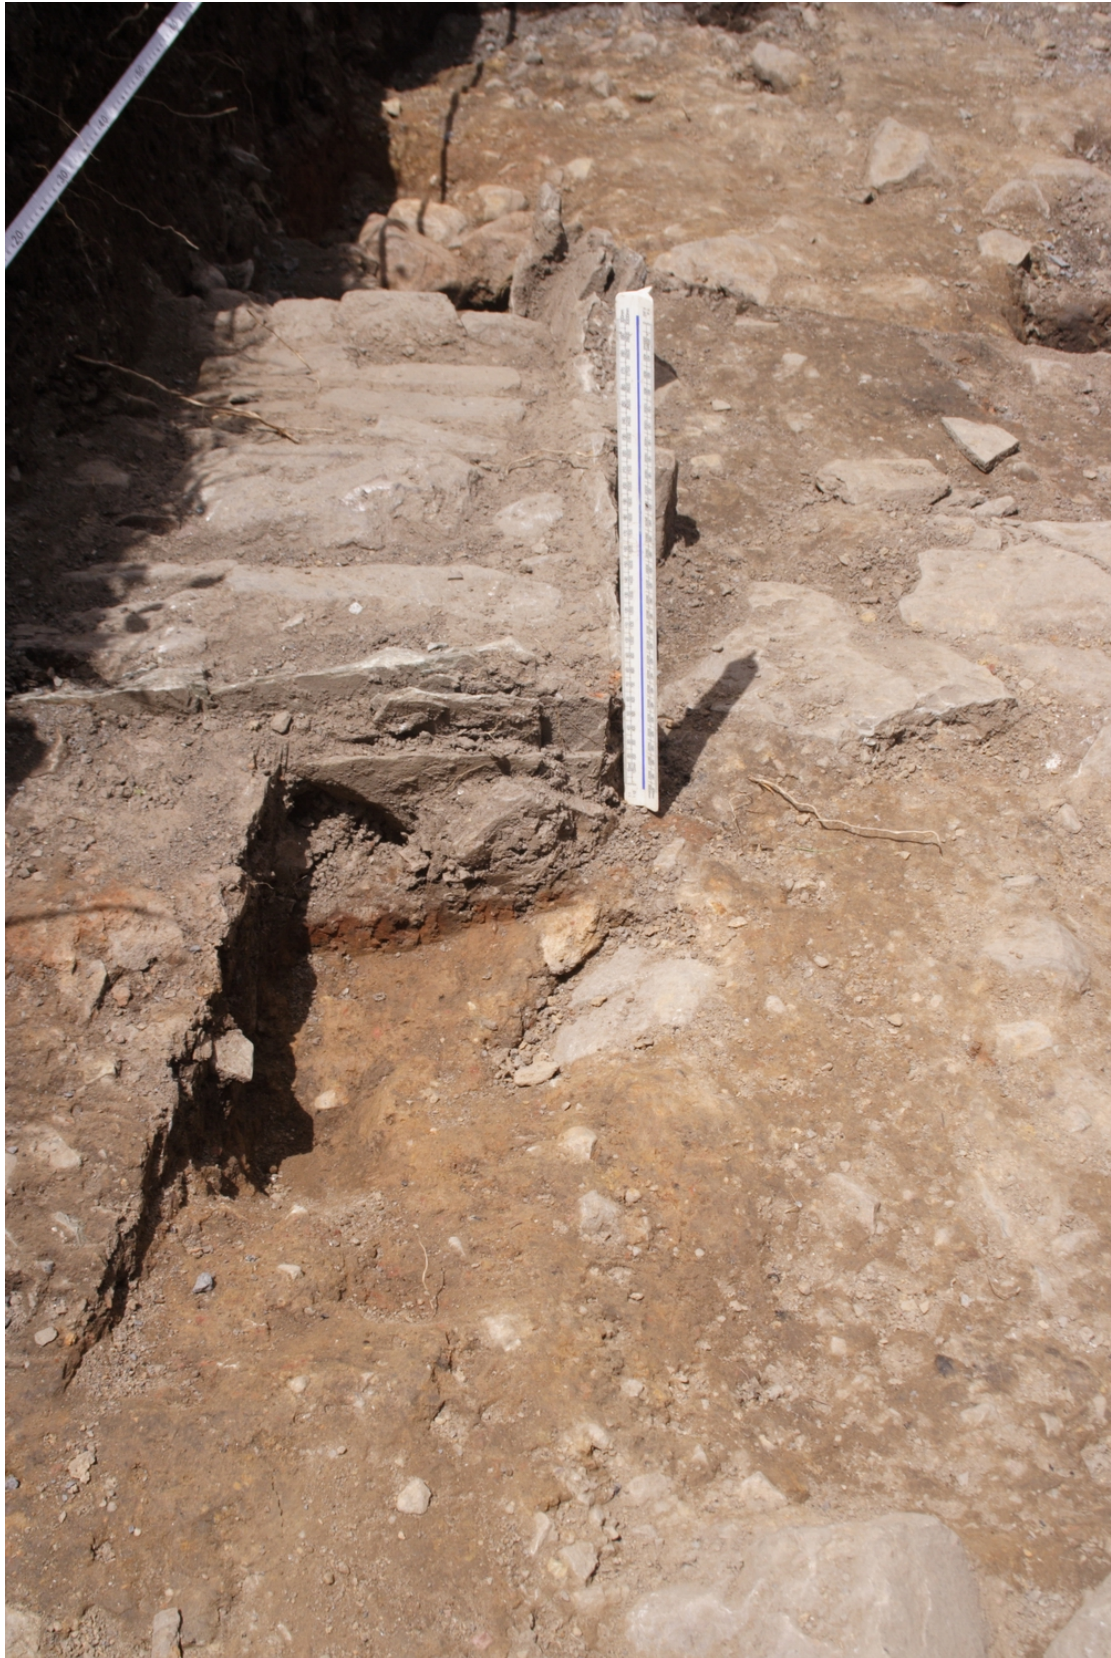
Plate 6: Shot northwest of Hearth 1012 and heat affected fill 1013.

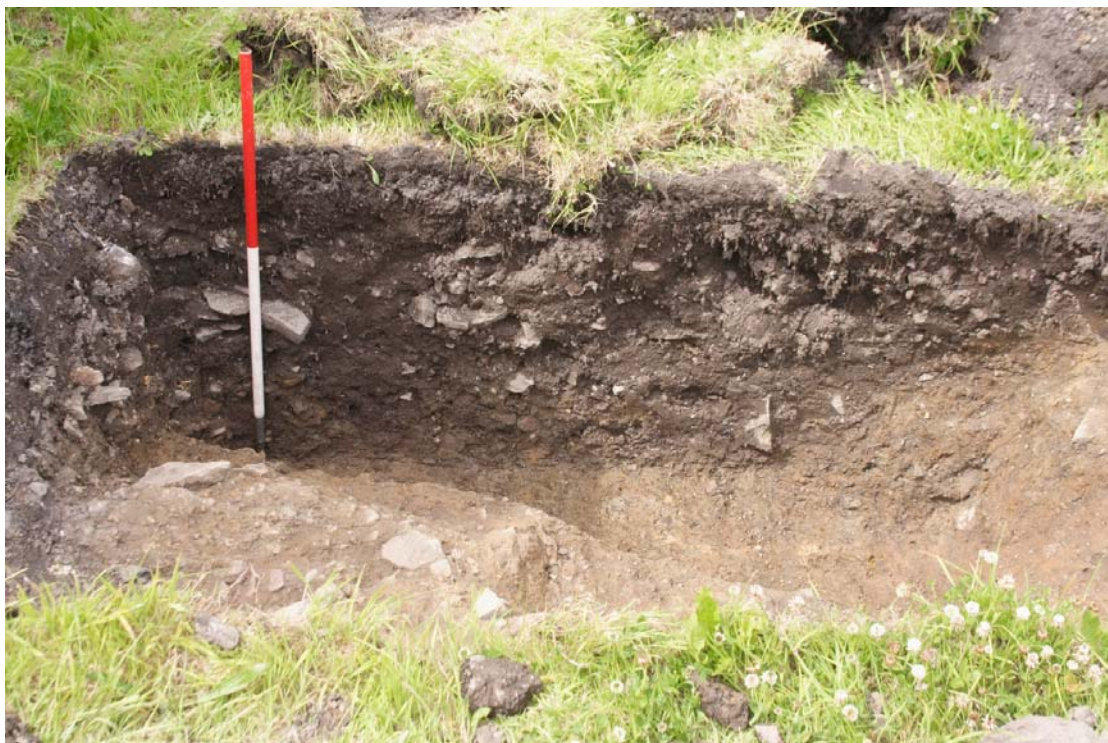
Plate 7: Shot south west of curvilinear ditch 1005.

A large ditch or pit (1005) curved from northeast to south across the southeast end of the trench. The ditch was up to 1.2m wide and 0.7m deep at its deepest

point. The form of *1005* changed from its northeast - southwest length, where it had a vertical northern side and a very shallow-sloping south side a rounded base and was c.0.25m deep, to its north - south length, which was up to c.0.7m deep and had a flat base and steeply sloping east side. This difference suggests that it had been recut at least once, or that the larger north - south length was a later feature cutting an earlier shallow ditch or gully.

It was filled with a single deposit of black brown humic soil containing abundant stone (which increased with depth), animal bones, post-medieval and modern pottery and coal fragments (*1004*).

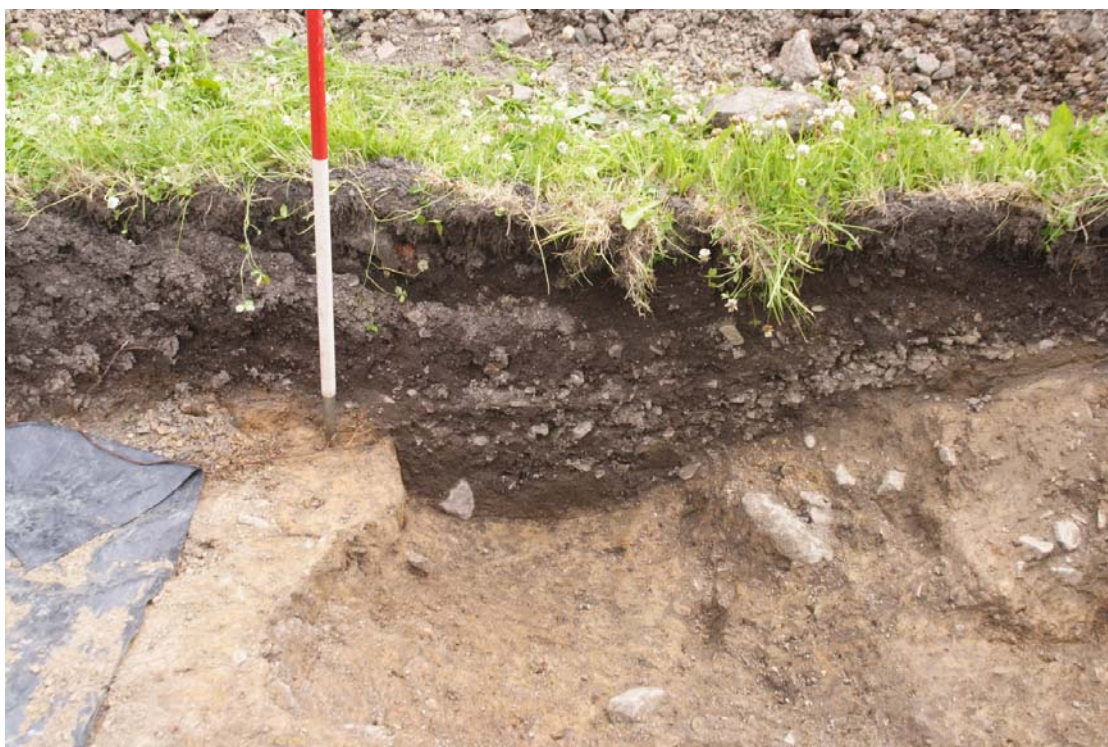
Plate 8: Shot northeast of ditch 1005

There was nothing in the form of the feature, or its fill, to suggest a former function, nor was its full extent established. The fill *1004* contained domestic rubbish and this suggests that it was, at least in its later phases, used as a rubbish pit.

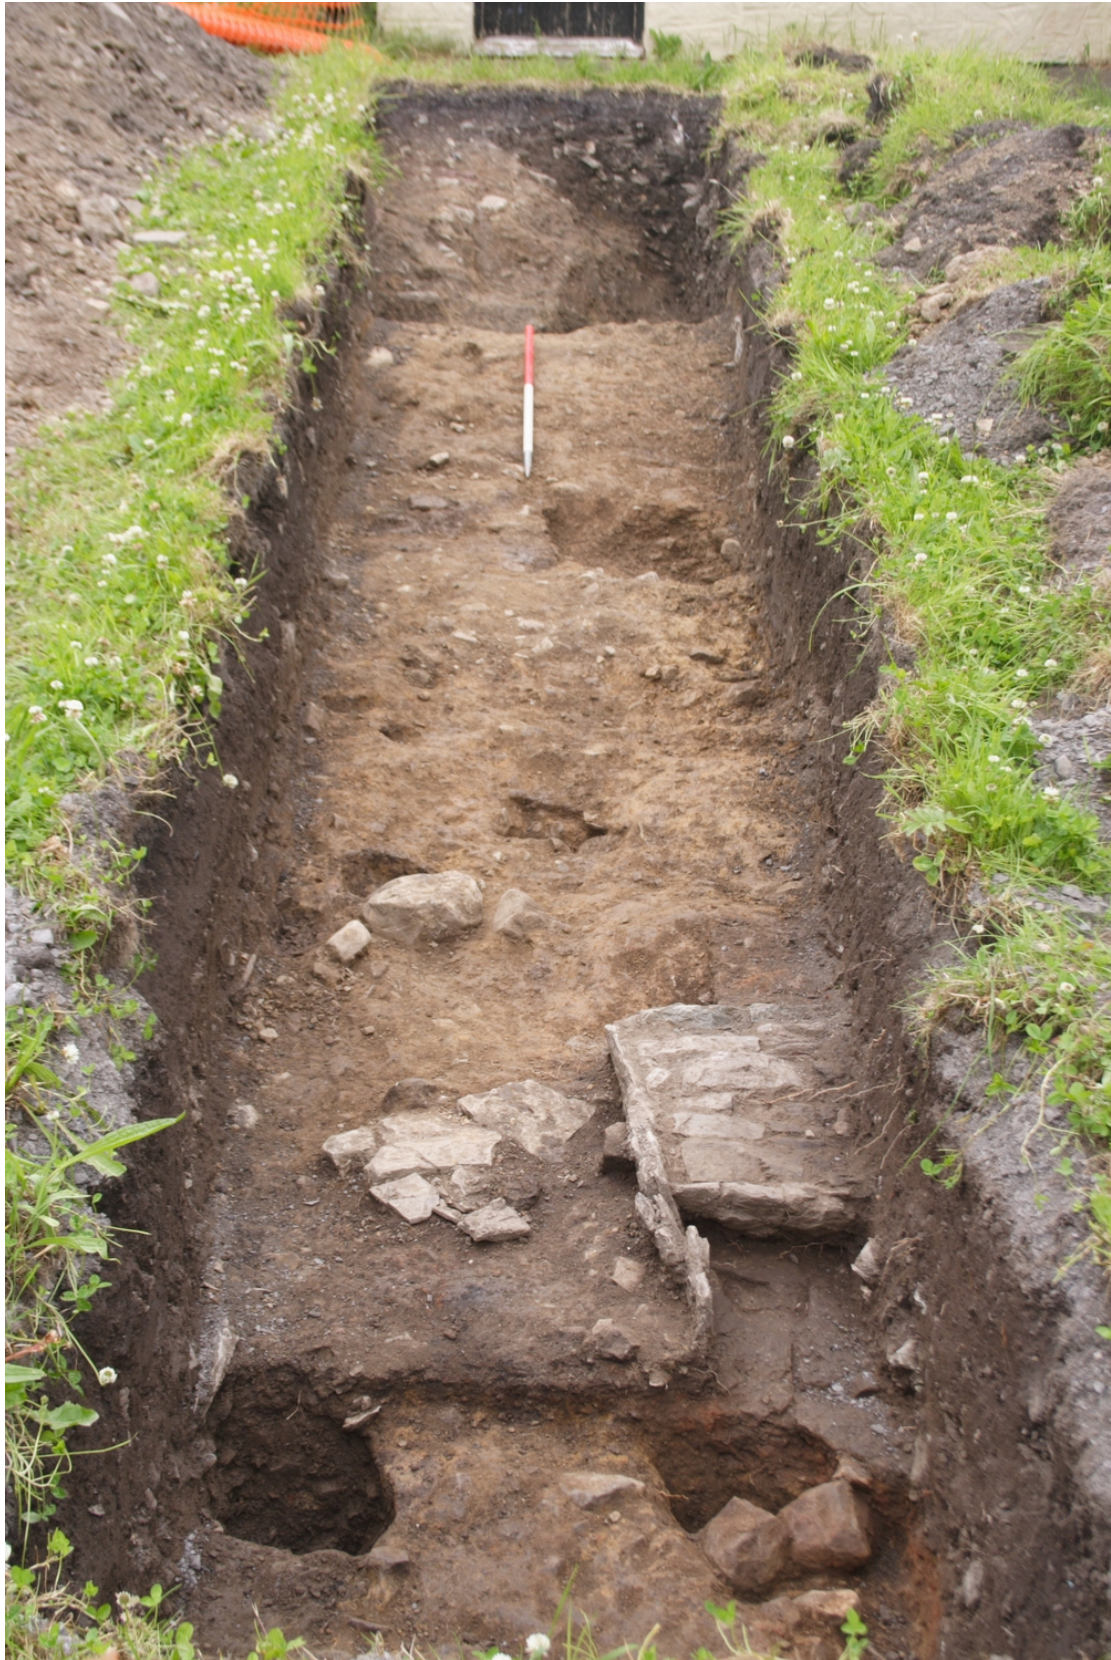
Plate 9: Shot south east of excavated trench.

Two very ephemeral dark stripes in the middle of the trench were investigated as possible gullies (*1007* and *1009*). Excavation showed them to be irregular and in places difficult to trace. Gully *1007* ran northeast - southwest across the trench and was c.0.3m wide x 0.1m deep, although its southern edge was not certain. It was filled with light yellowish brown silty clay containing a few charcoal flecks.

Part of a curving linear cut feature (*1011*) was recorded in the north corner of the trench. The exposed portion was roughly aligned northwest - southeast and it extended beyond the northeast edge of the trench. This feature was only partially excavated, which revealed a sloping side that continued beyond the trench edge and despite a shallowing of the slope it was not clear if the base was reached. The excavated section, 0.3m deep, was filled with black/brown silty clay with occasional flecks of charcoal, some burnt daub and brick (*1010*). One sherd of late medieval or early post-medieval pottery was recovered from the fill.
