DAN Y BANC, CARMARTHEN ARCHAEOLOGICAL RECORDING AND WATCHING BRIEF

RHIF YR ADRODDIAD / REPORT NO. 2008/78
RHIF Y PROSIECT / PROJECT RECORD NO. 93844

Dan y Banc, Carmarthen Archaeological Recording and Watching Brief

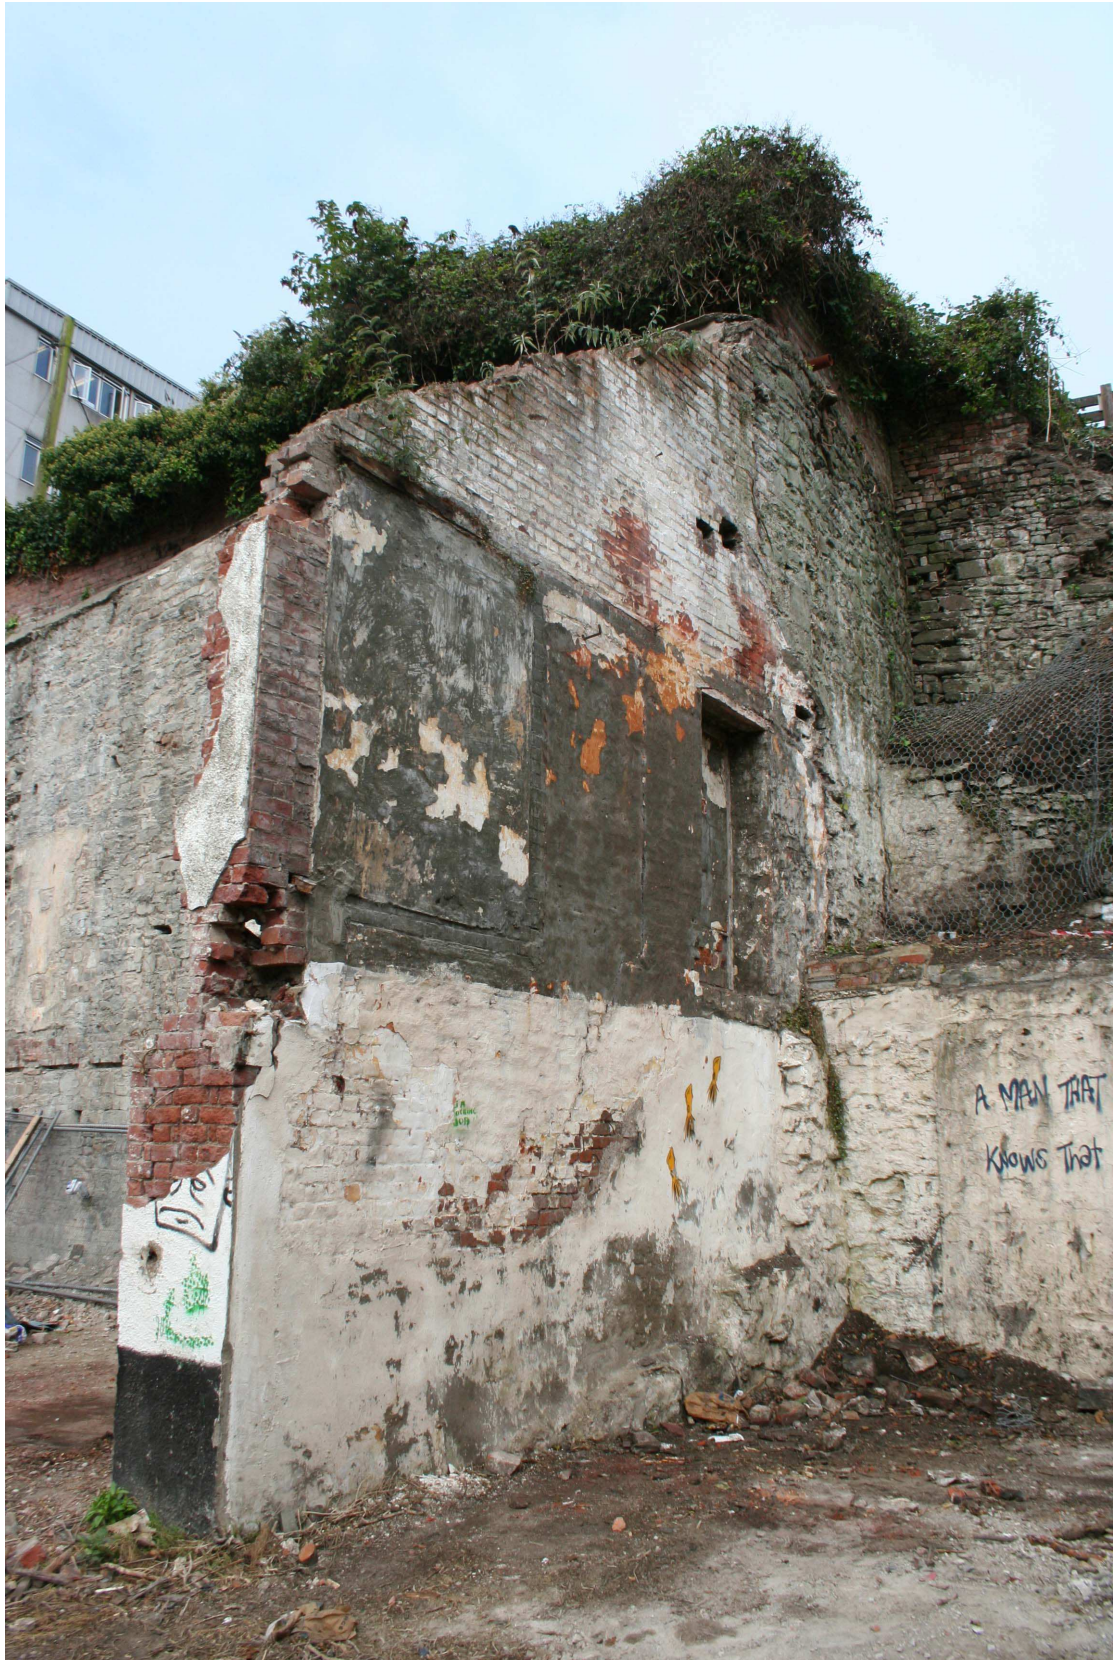
Plate 3: North east gable wall of former cottage prior to demolition.

It was noted that the section of cottage wall to be demolished was constructed of rough stone and mortar that contained coal and ash fragments, which suggests a post medieval date. A further rough stone wall was also recorded prior to its demolition that appeared to have been constructed in a 1m wide cut, which was also filled by a dark brown silty clay of loose compaction.

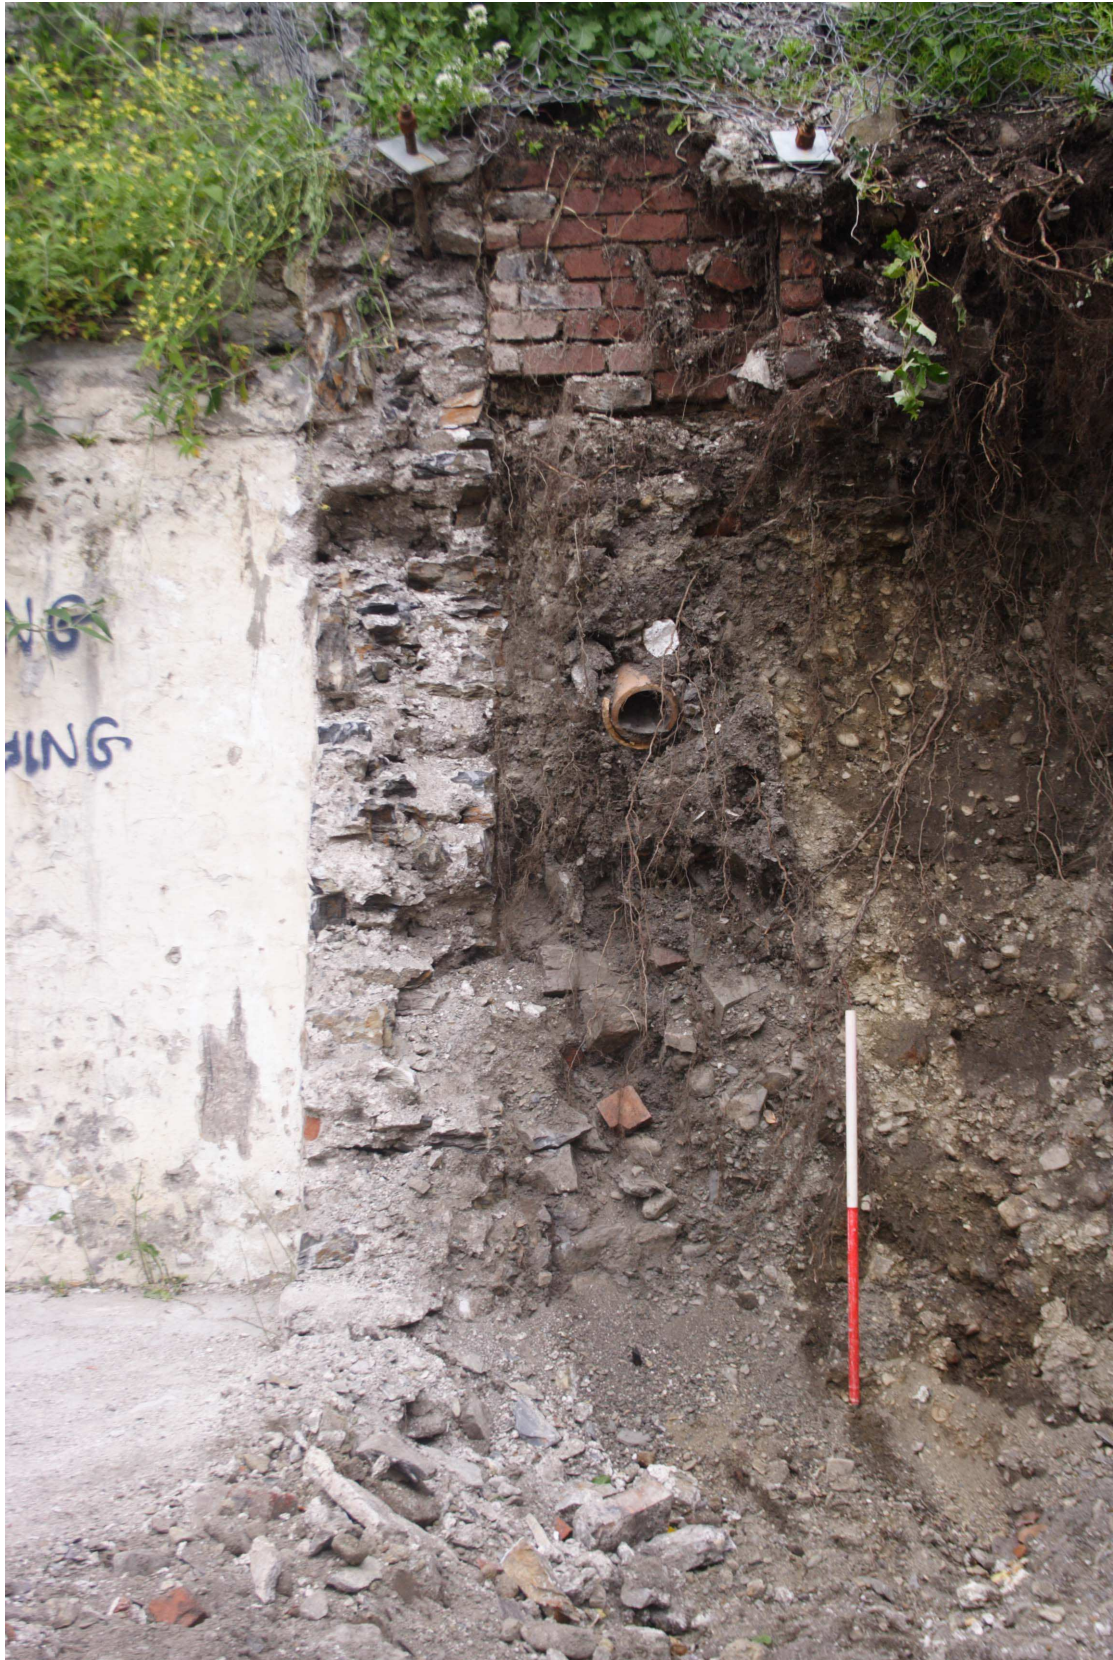
Plate 4: Former cottage wall showing prior to demolition.

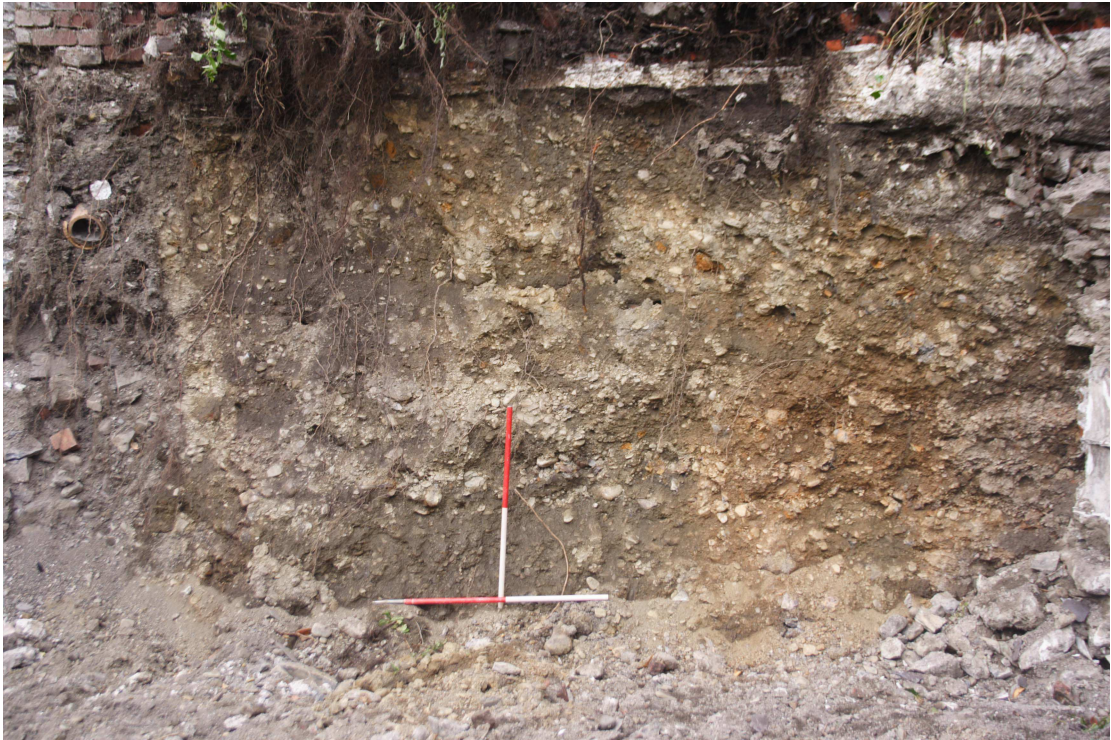
Plate 5: Section through bank from southeast.

The stratigraphic sequence revealed in the bank during the excavations consisted of a dark greyish brown silty clay topsoil of moderate compaction containing much modern debris. This overlay a 0.4m deep moderately compacted mid orange brown sandy clay subsoil horizon containing c.15% small sub-rounded stone. The natural horizon was a mid grey sandy clay of firm compaction containing c.40% sub-rounded pebbles.

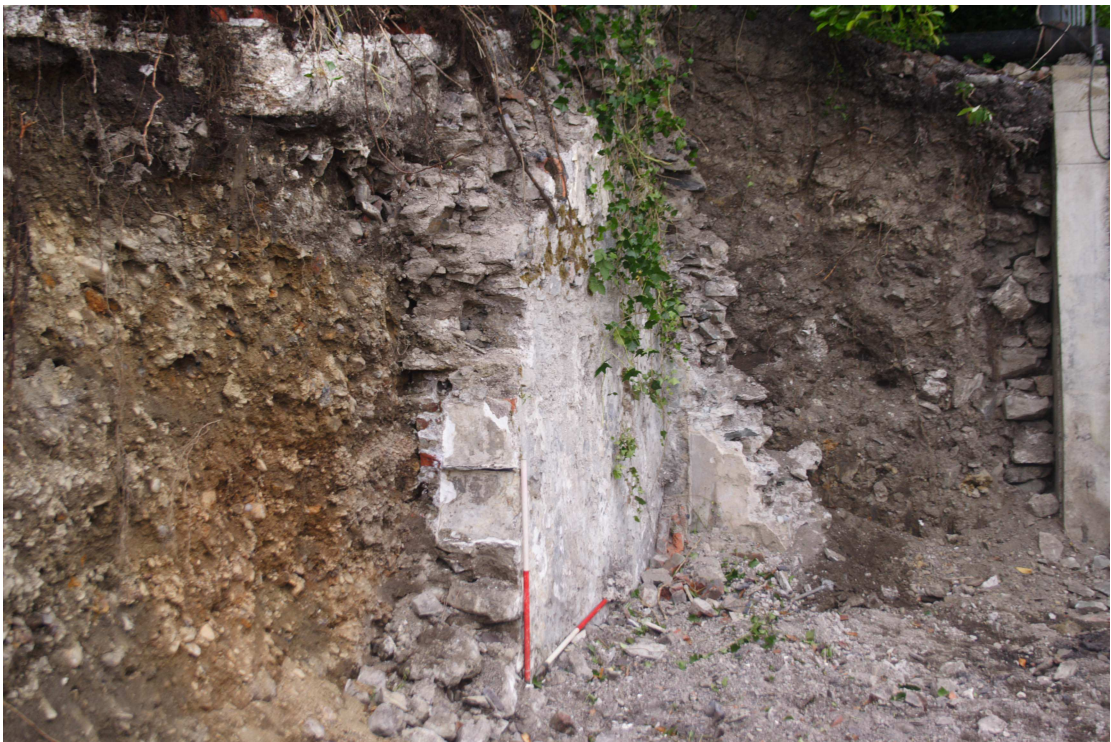
Plate 6: Rear and side walls of former cottage prior to demolition.

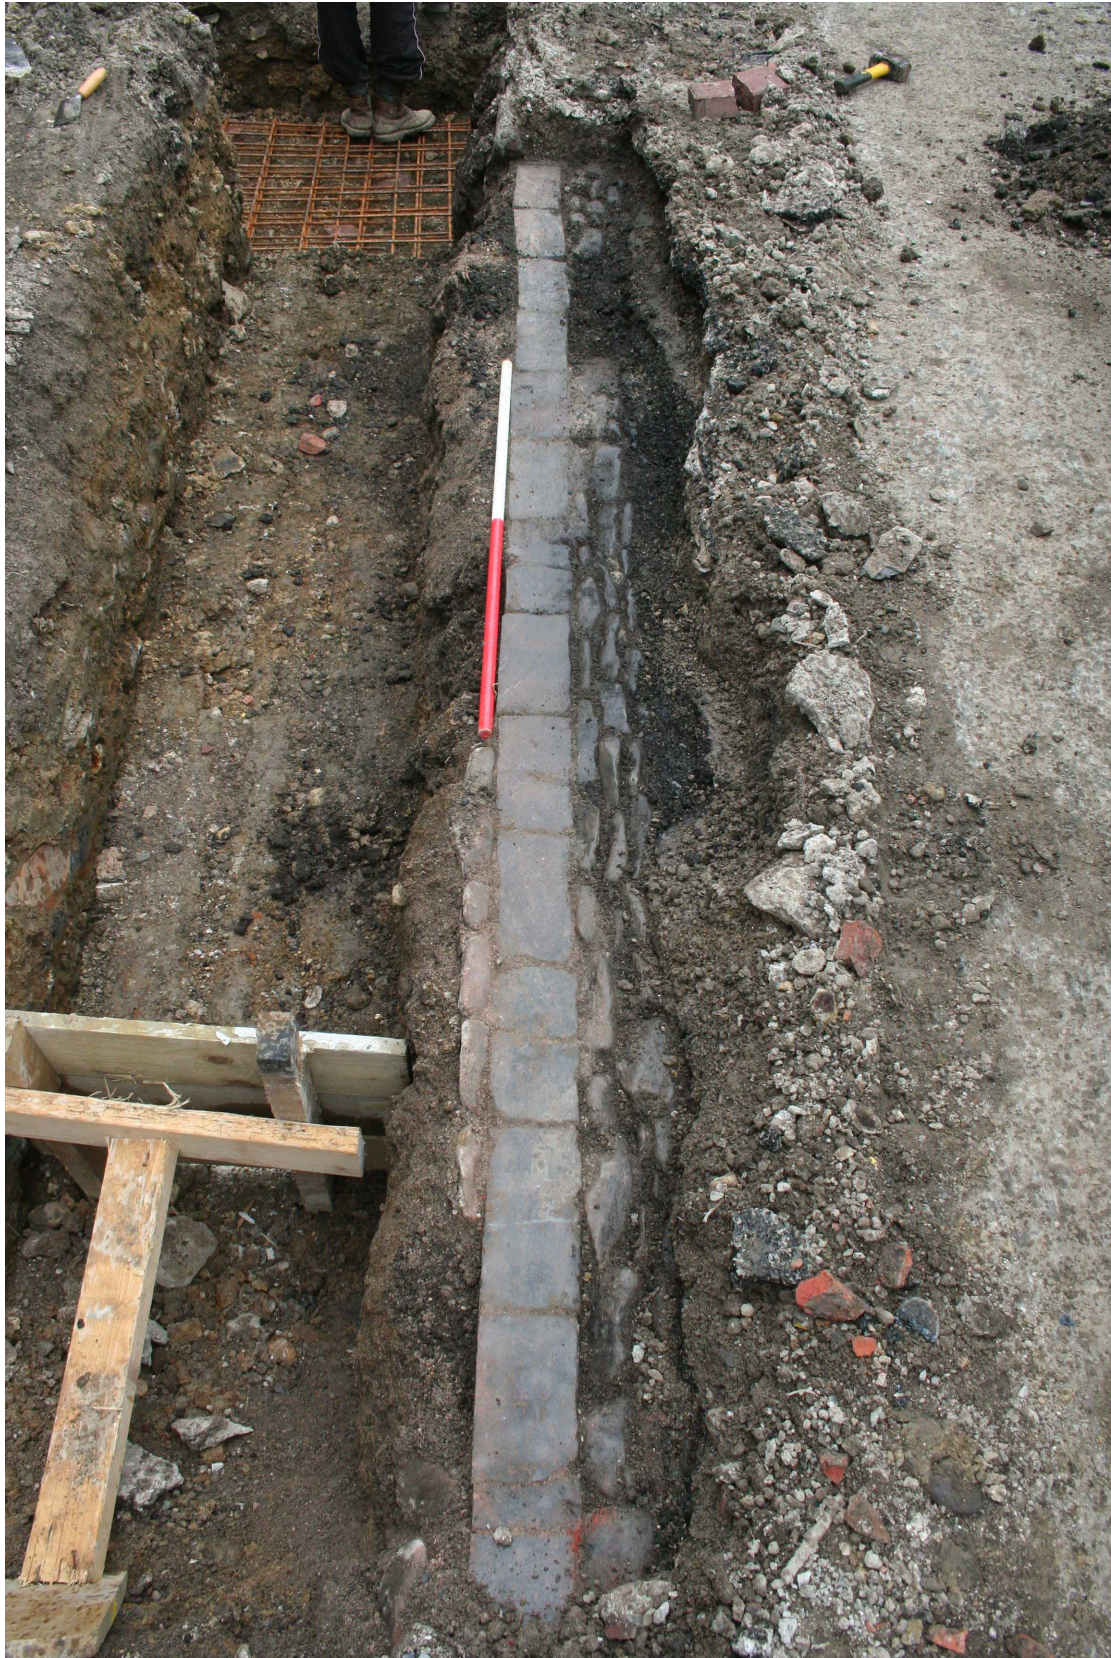
Plate 7: Cobbled surface with brick kerbing.

The excavations along the frontage of the site revealed much modern disturbance. However, a 3.1m long x 0.3m wide area of cobbled road surface was revealed beneath the modern tarmac of the existing lane which runs along the front of the development site. Along the edge of the cobbled surface grey brick kerbing was noted. The bricks used to construct this kerbing were of a dense engineering type with high crushing strength and it was noted that they were produced by Doulton and CB. It is unknown what the initials CB denote but a brickworks was once located to the south-east of Dan y Banc and it is possible that they were produced there.

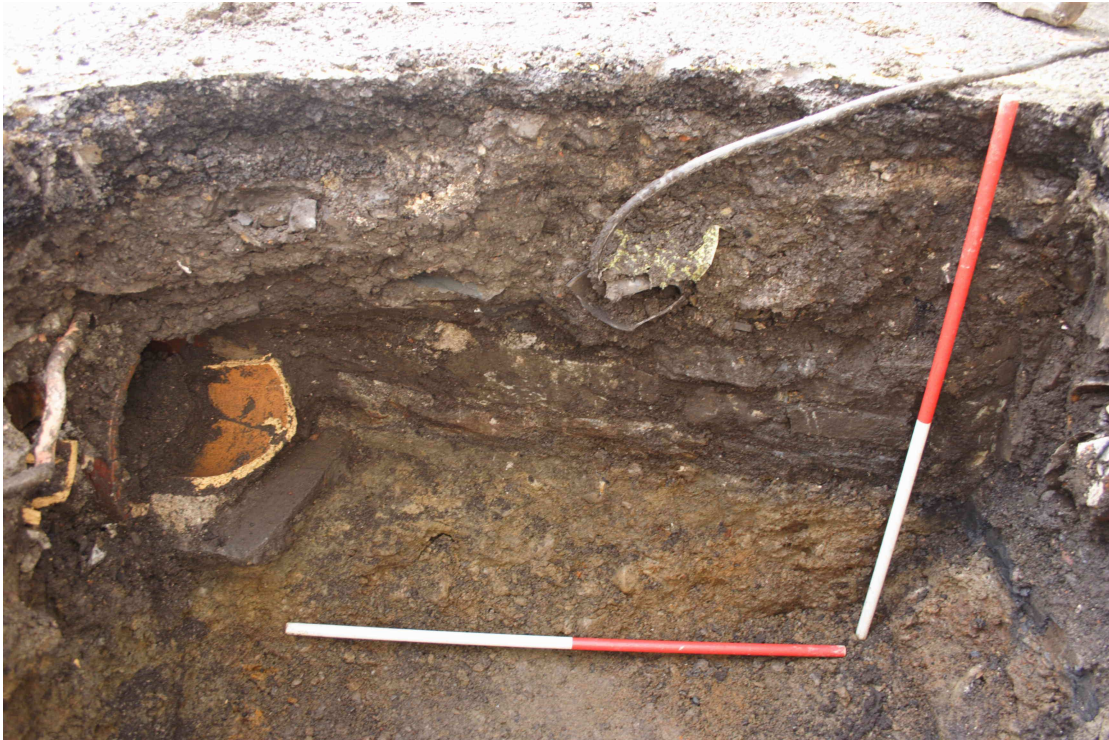
Plate 8: Stone built former drain showing later stoneware pipe.

A pit excavated in the south-west corner of the development plot frontage revealed a 1.4m x 0.3 high length of probable drain beneath heavily disturbed modern deposits. This had a 0.18m x 0.04m deep slate base *in situ* and would probably have originally been capped with slate. However, the whole structure was much disturbed by the insertion of later stoneware pipes.

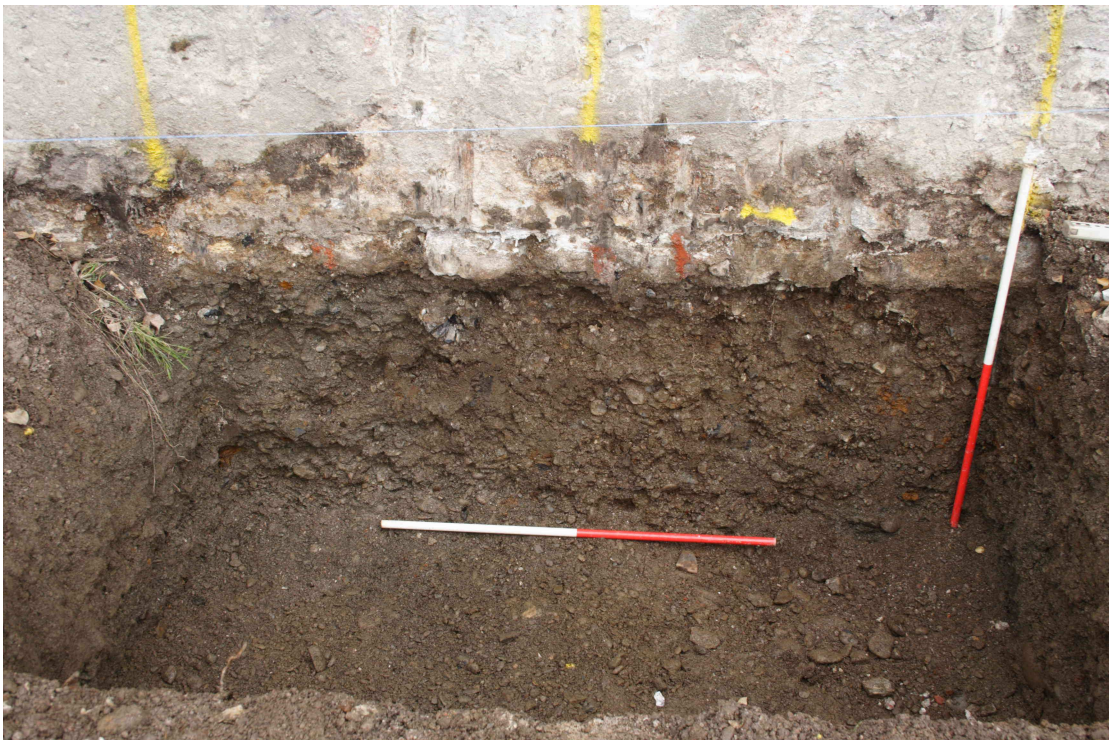
Plate 9: Section beneath possible town wall.

Three pits excavated along the base of the possible town wall revealed no evidence for a ditch although it was possible to discern that the wall had been constructed on the natural horizon comprising a firm mid grey brown sandy clay containing c.40% small to medium sized pebbles.

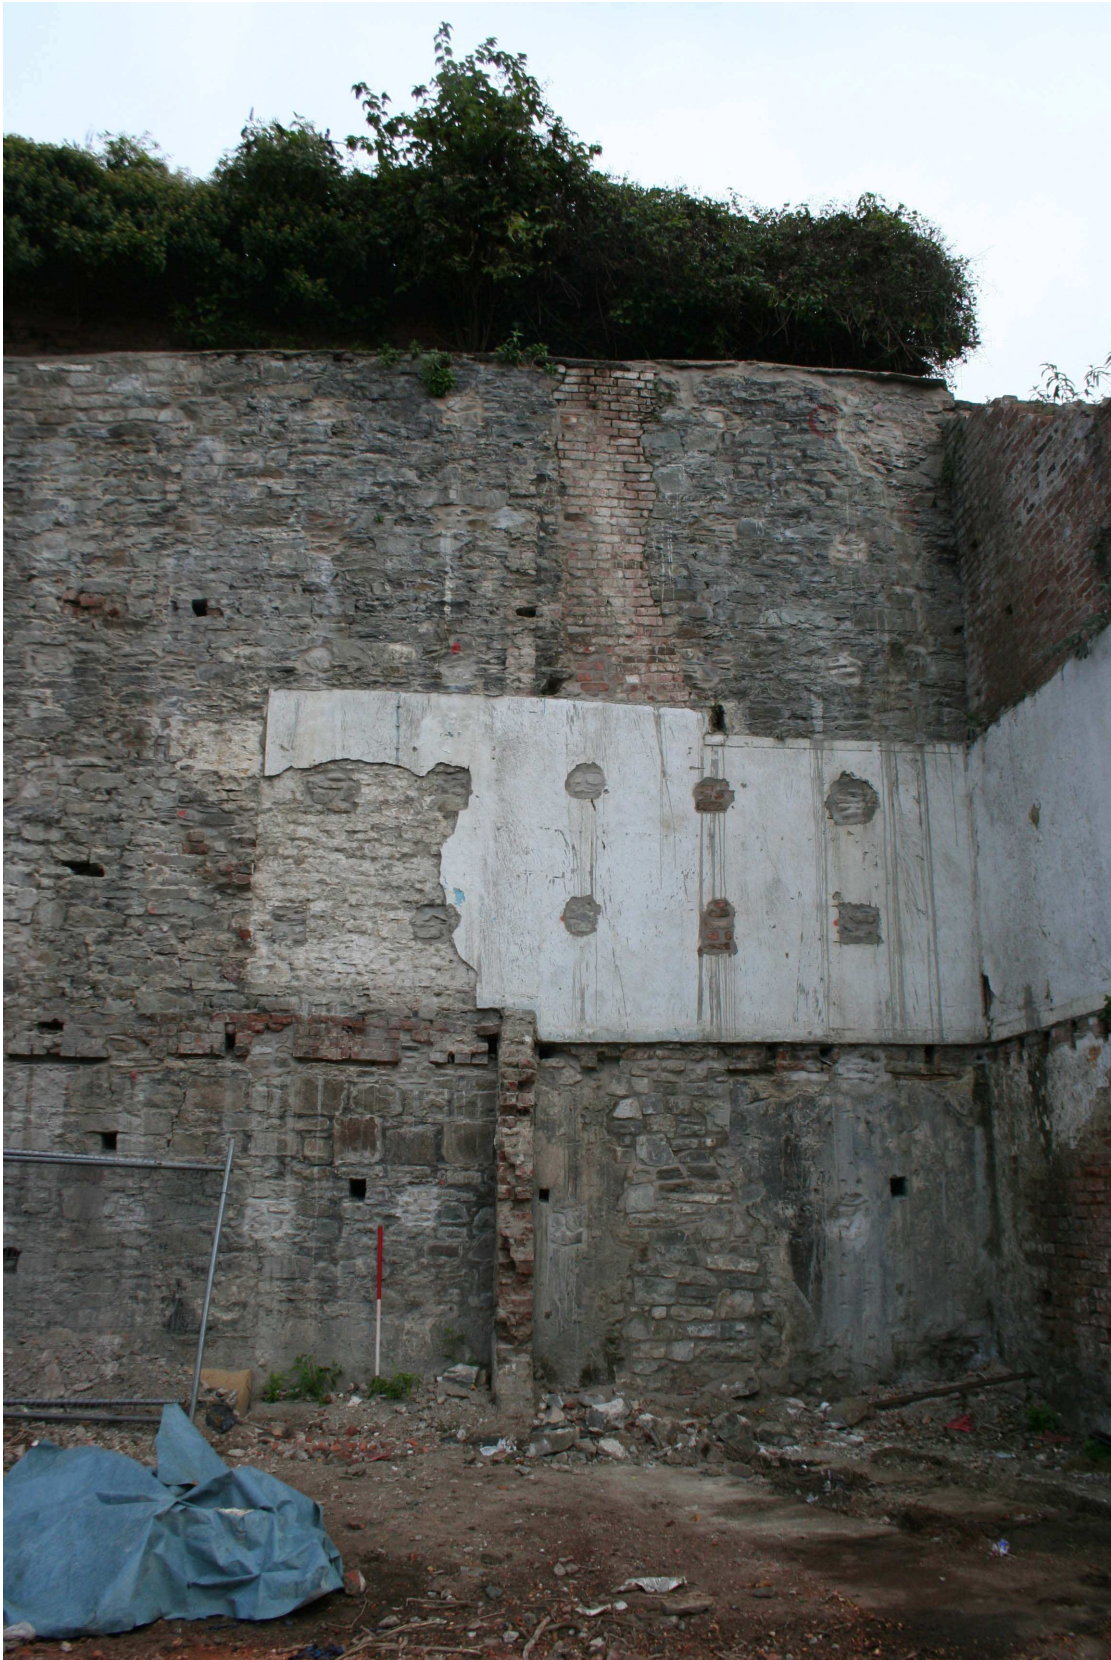
Plate 11: Showing full height of northeast end of retaining wall.

The section of retaining wall (see figure 4) recorded at the proposed development site stands to a height of c.10m and is constructed predominantly of sandstone. The presence of putlog holes, which once housed the wooden scaffolding used during construction, suggests that the lower portion of the wall may be of medieval date and form part of the town walls. Within the central portion of the wall a band of larger squared stone blocks was noted. A series of five later walls abut the possible medieval wall, these probably relate to the cottages that once occupied the site. The upper levels of the wall appear to have been the subject of much later work, with a band of brickwork being present along with slots for floor beams and joists, and with further brick insertions further up. Substantial areas of concrete rendering were also noted, these probably dating to the 1960s as the name Gerald Davies with the date 1963 was noted scratched into cement where an area of rendering had been removed. It is also known that the wall has been stabilised by means of pinning this being evident from scarring along much of its face.

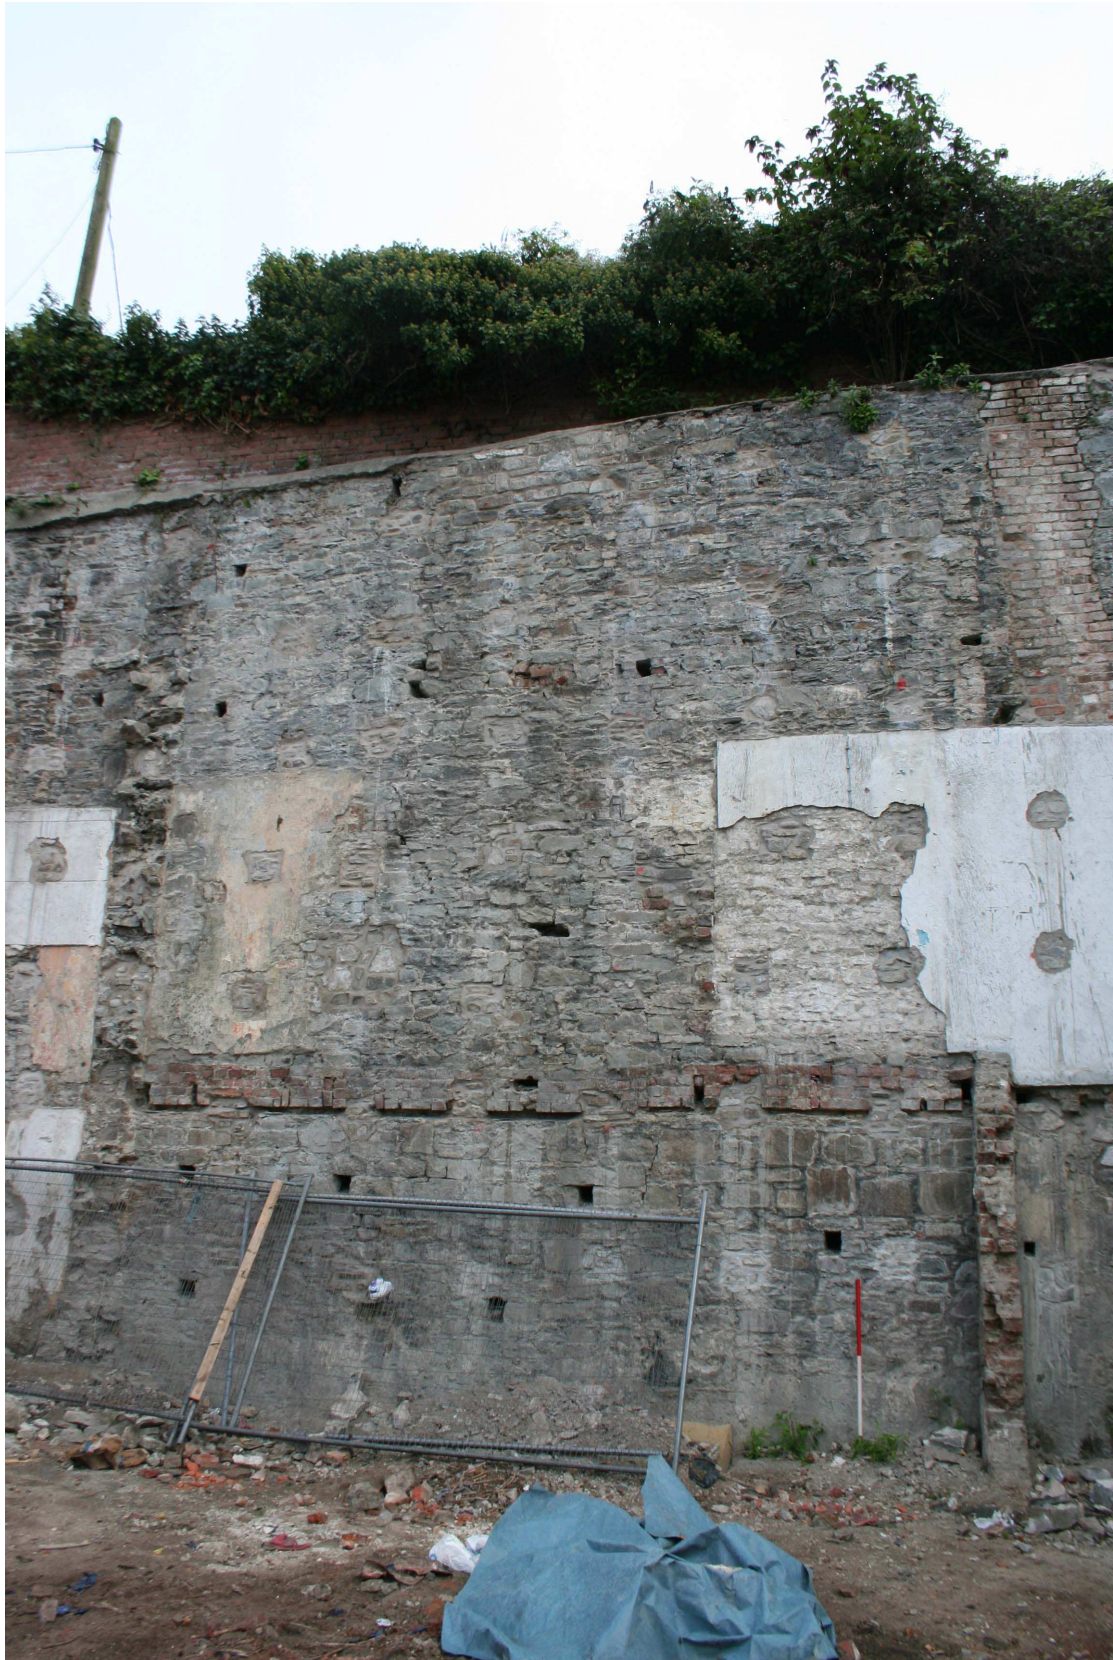
Plate 12: Showing full height of mid section of retaining wall.

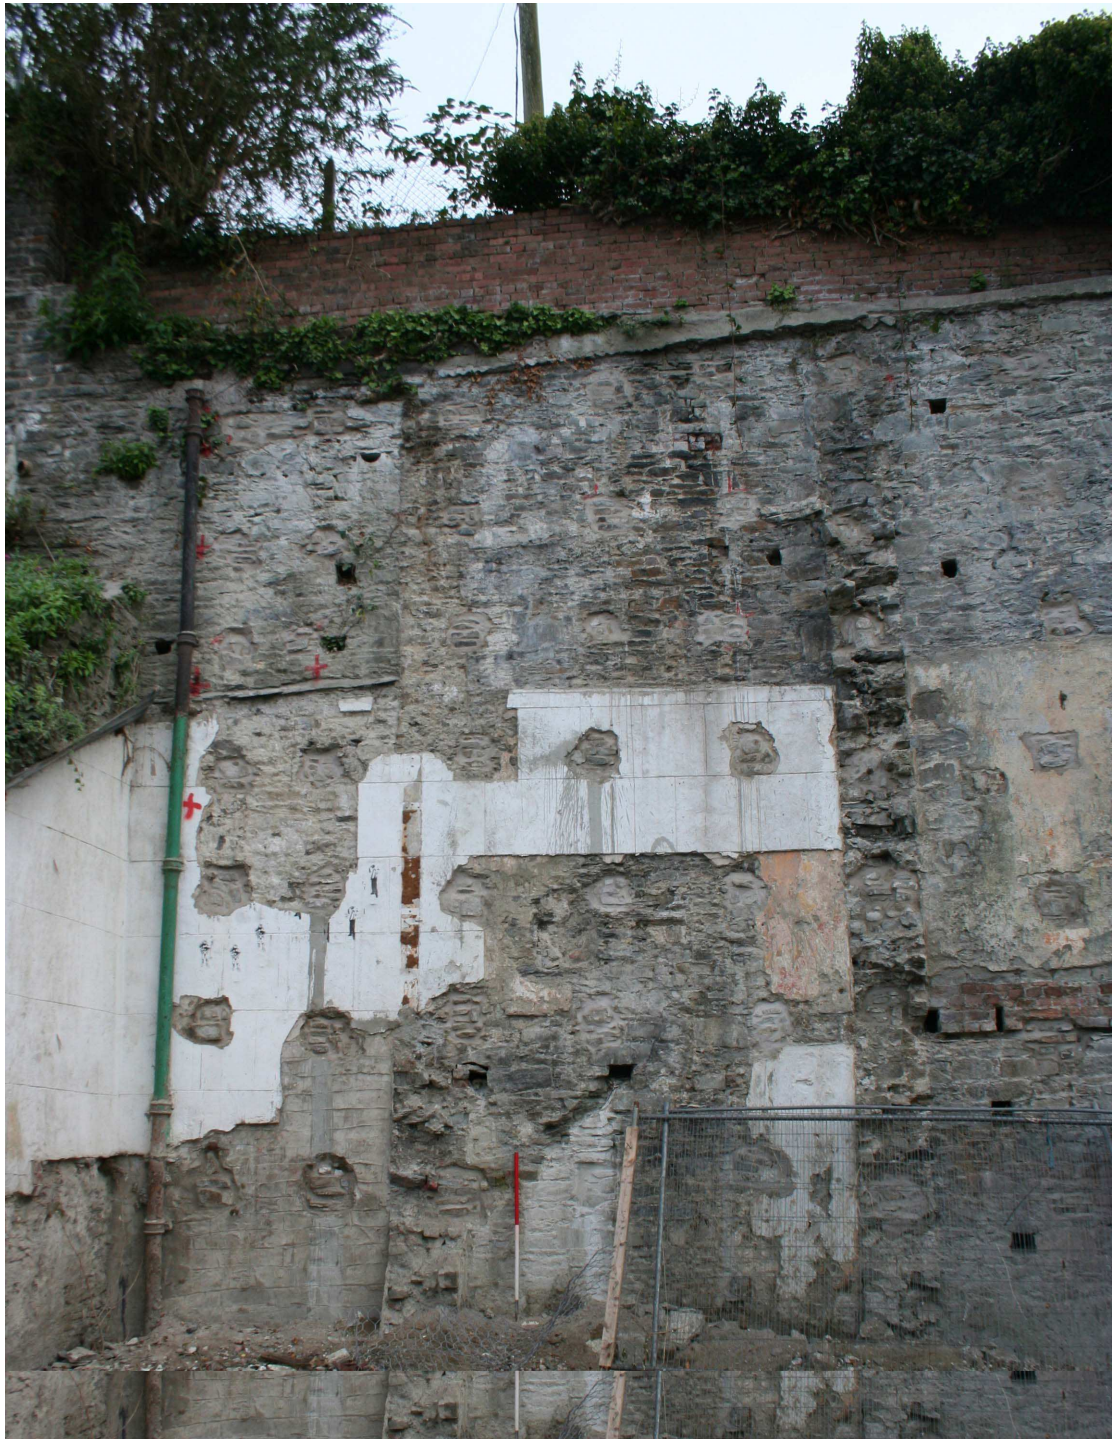
Plate 13: Showing full height of southwest end of retaining wall.

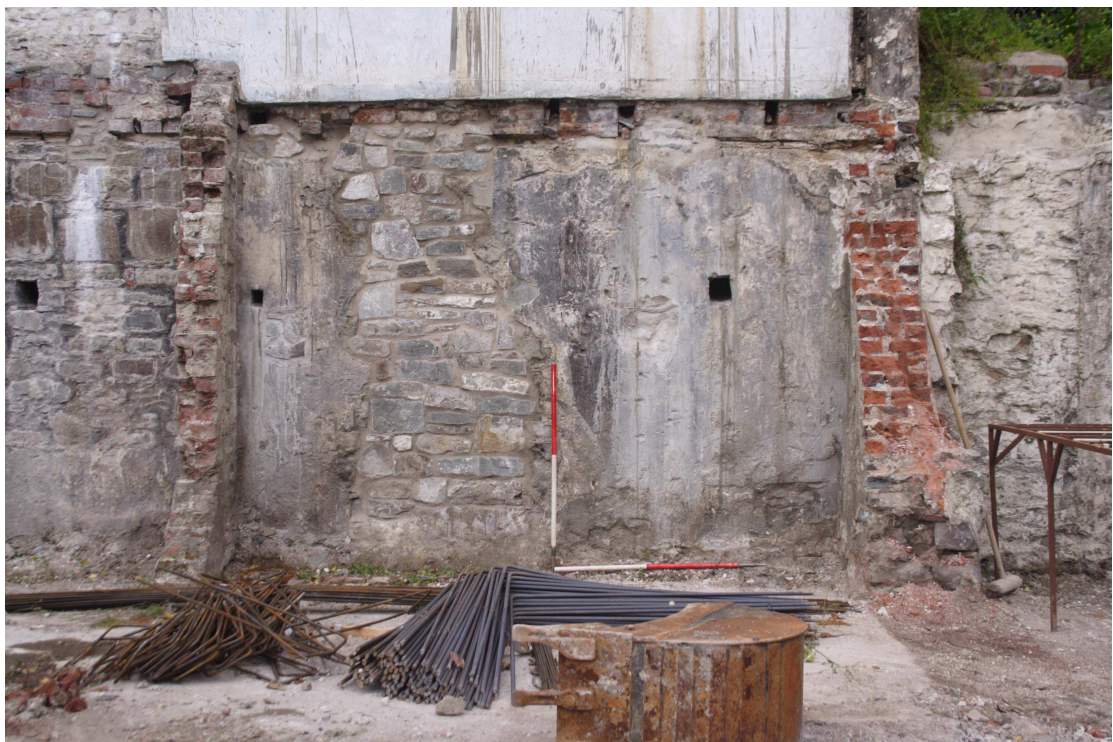
Plate 19: Lower section of northeast end of retaining wall showing former gable end to right and internal cottage wall to left. Shot 1

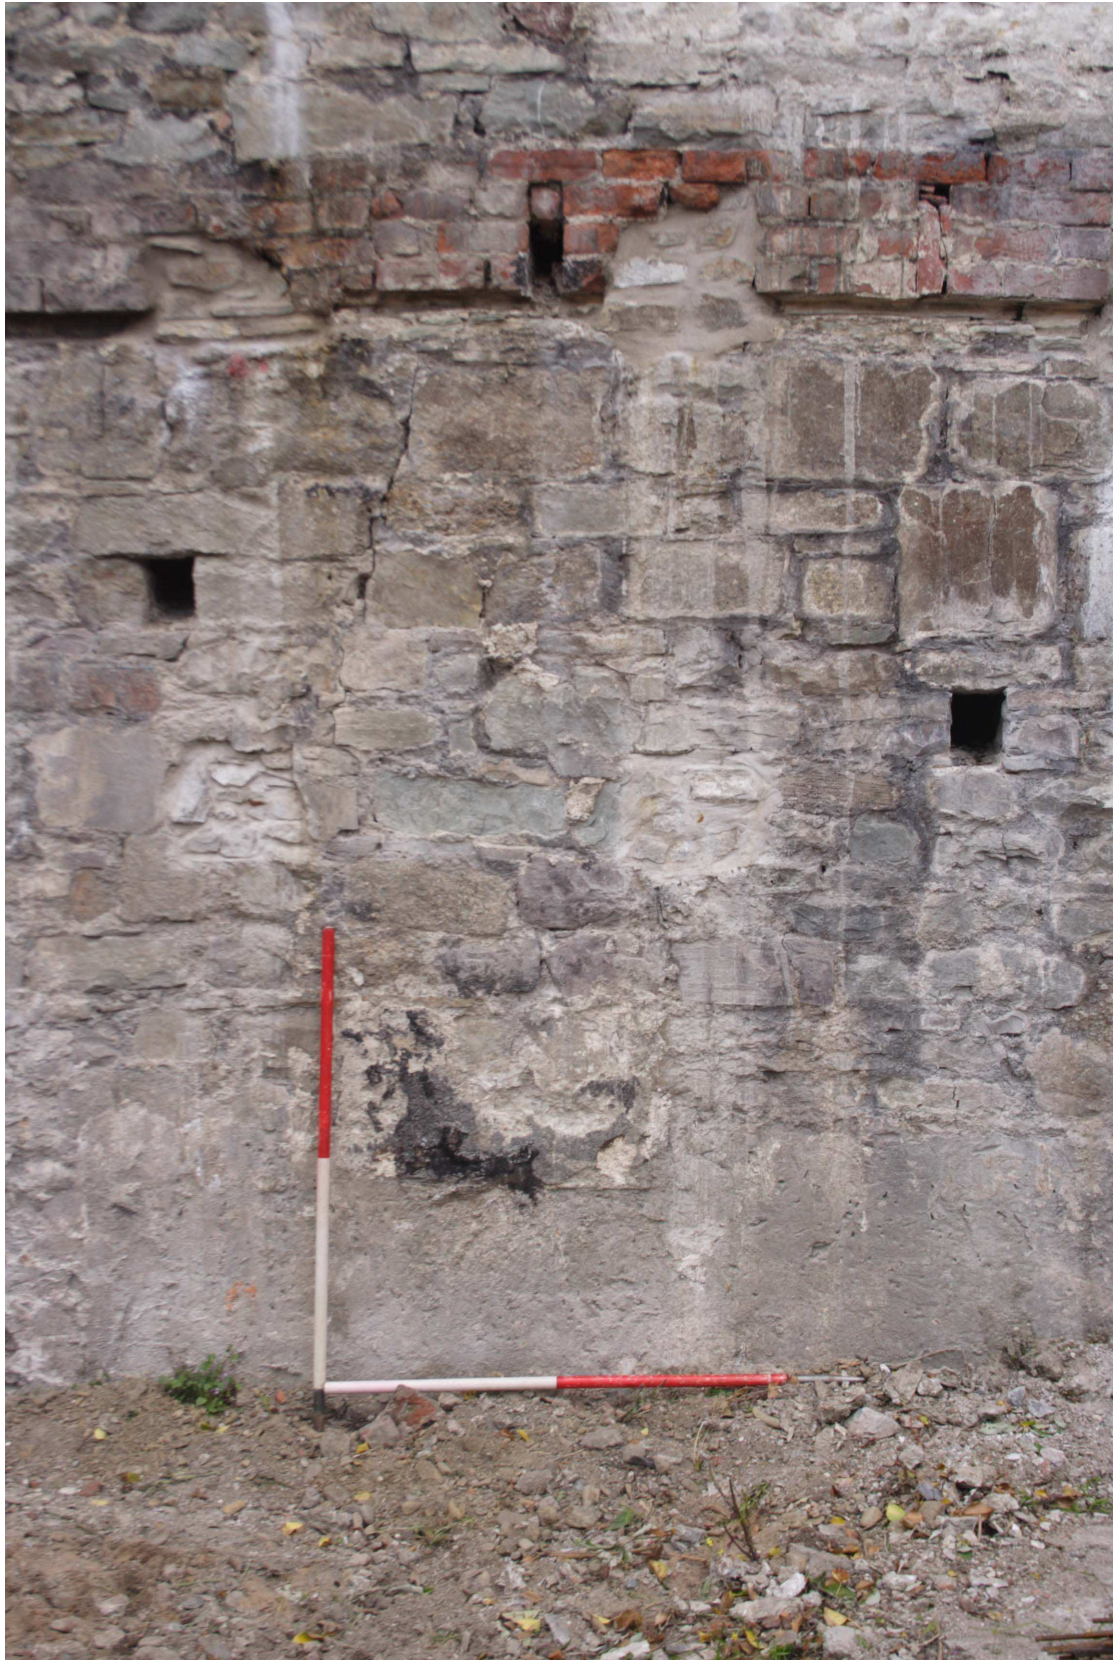
Plate 21: Lower section of retaining wall with putlogs visible. Floor joist slots of former cottage visible in upper image shot 3.

Given the presence of putlogs it is likely that the lower section of the retaining wall recorded at Dan y Banc represents a section of the original town wall of Carmarthen. However, much of the upper levels have been the subject of much later work as evidenced by the presence of brick additions. Whilst the upper levels contain brickwork much of the stone used in construction appears to be geologically the same as that found in the lower levels, but without any putlogs which may point to a later date. It is possible that the upper levels of the wall have been rebuilt, possibly reusing the original town wall material, although it is not possible to be certain.

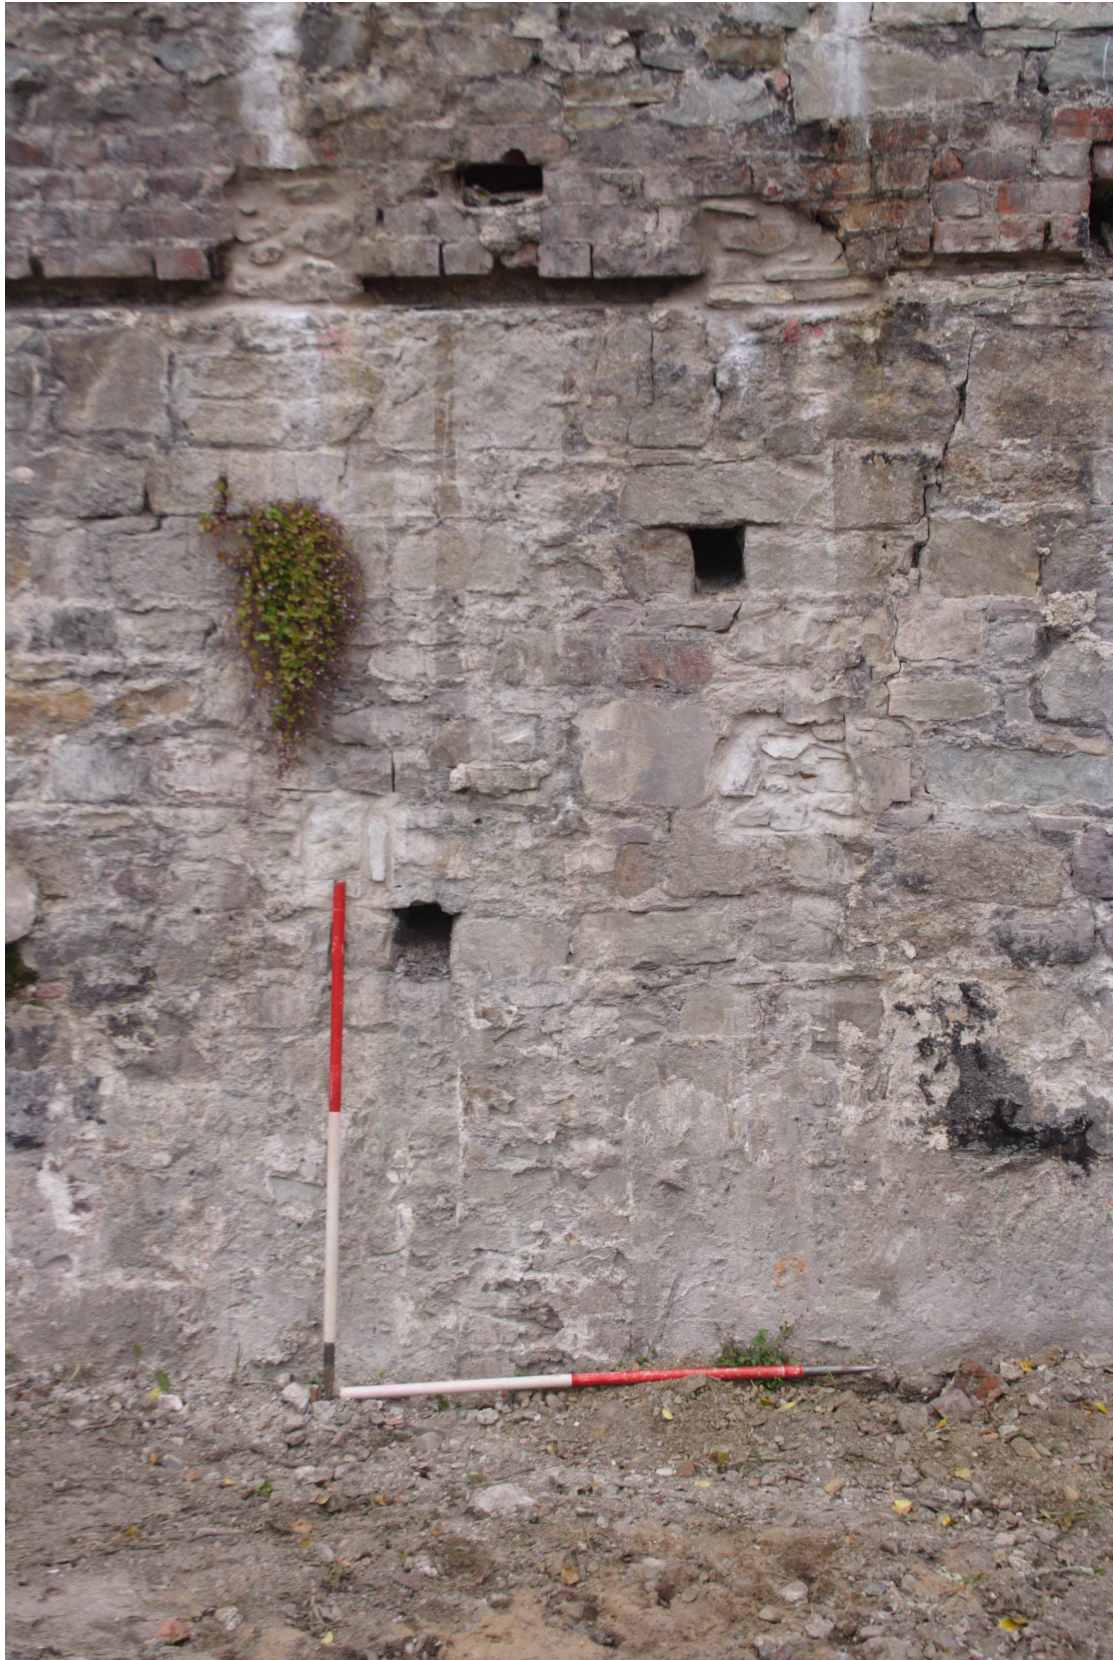
Plate 22: Lower section of retaining wall with putlogs visible. Floor joist slots of former cottage visible in upper image shot 4

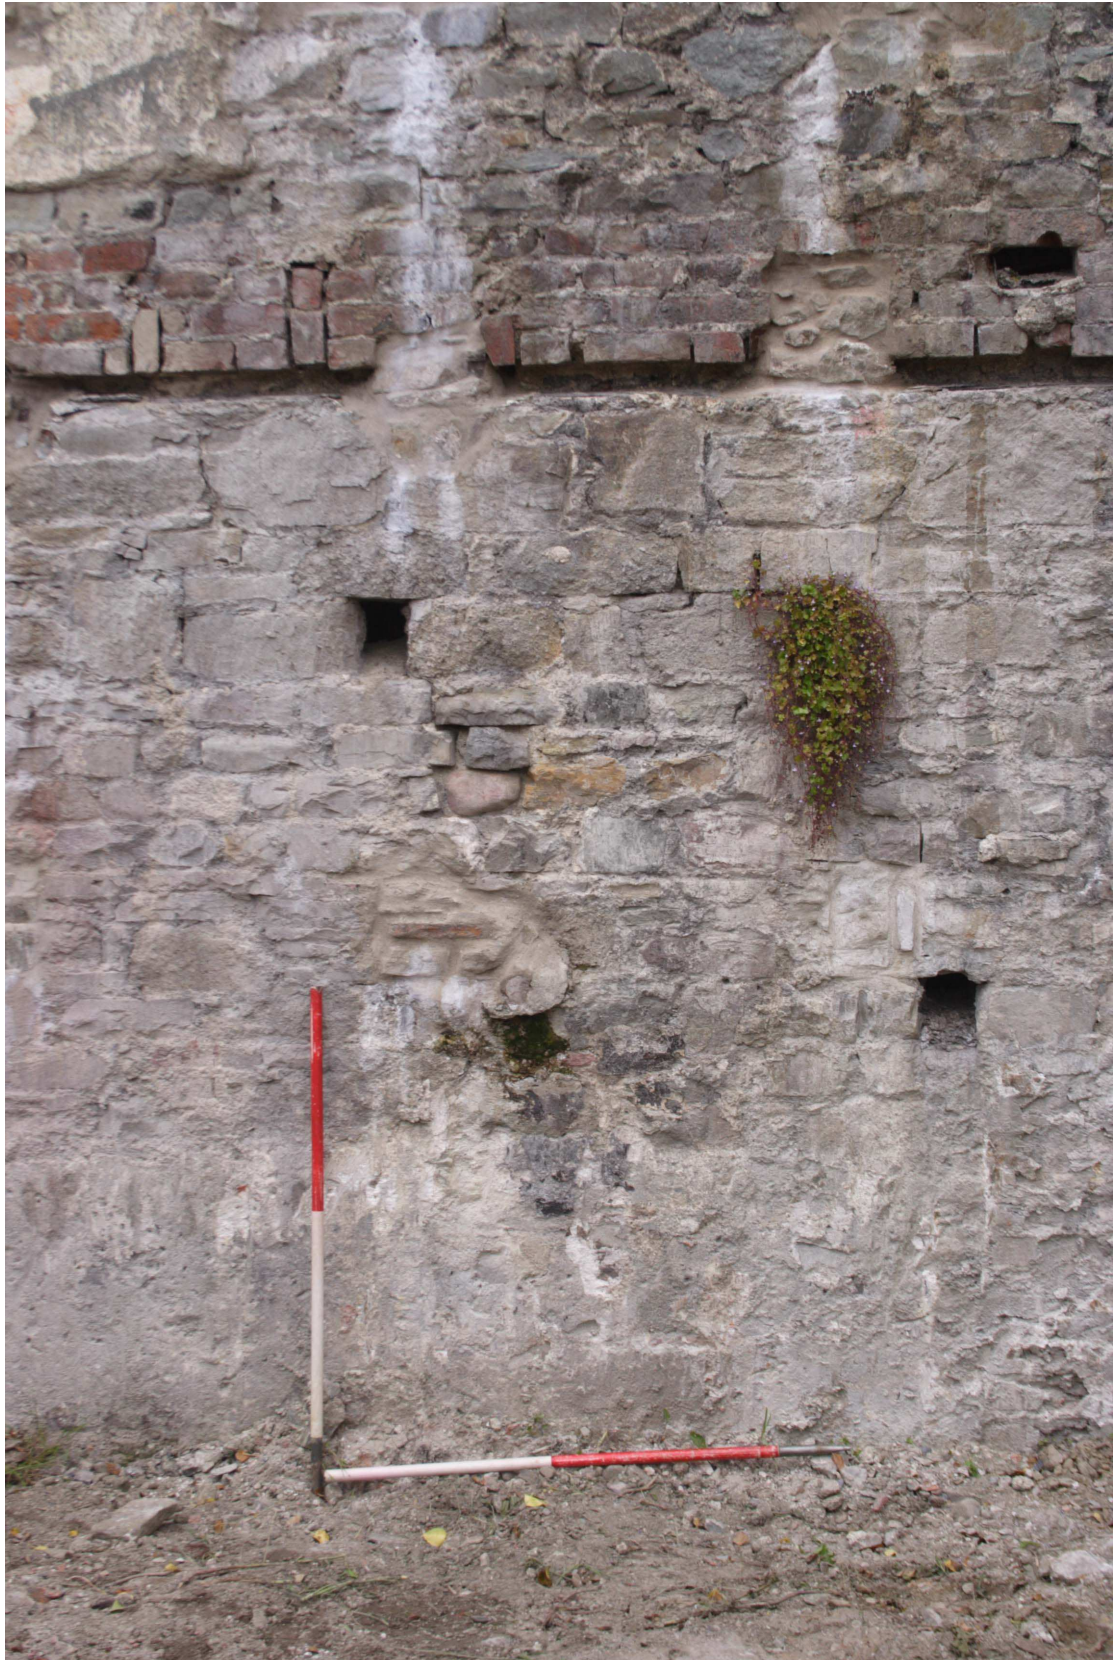
Plate 23: Lower section of retaining wall with putlogs visible shot 5.
