DAN Y BANC, CARMARTHEN ARCHAEOLOGICAL RECORDING AND WATCHING BRIEF

RHIF YR ADRODDIAD / REPORT NO. 2008/78
RHIF Y PROSIECT / PROJECT RECORD NO. 93844

Dan y Banc, Carmarthen Archaeological Recording and Watching Brief

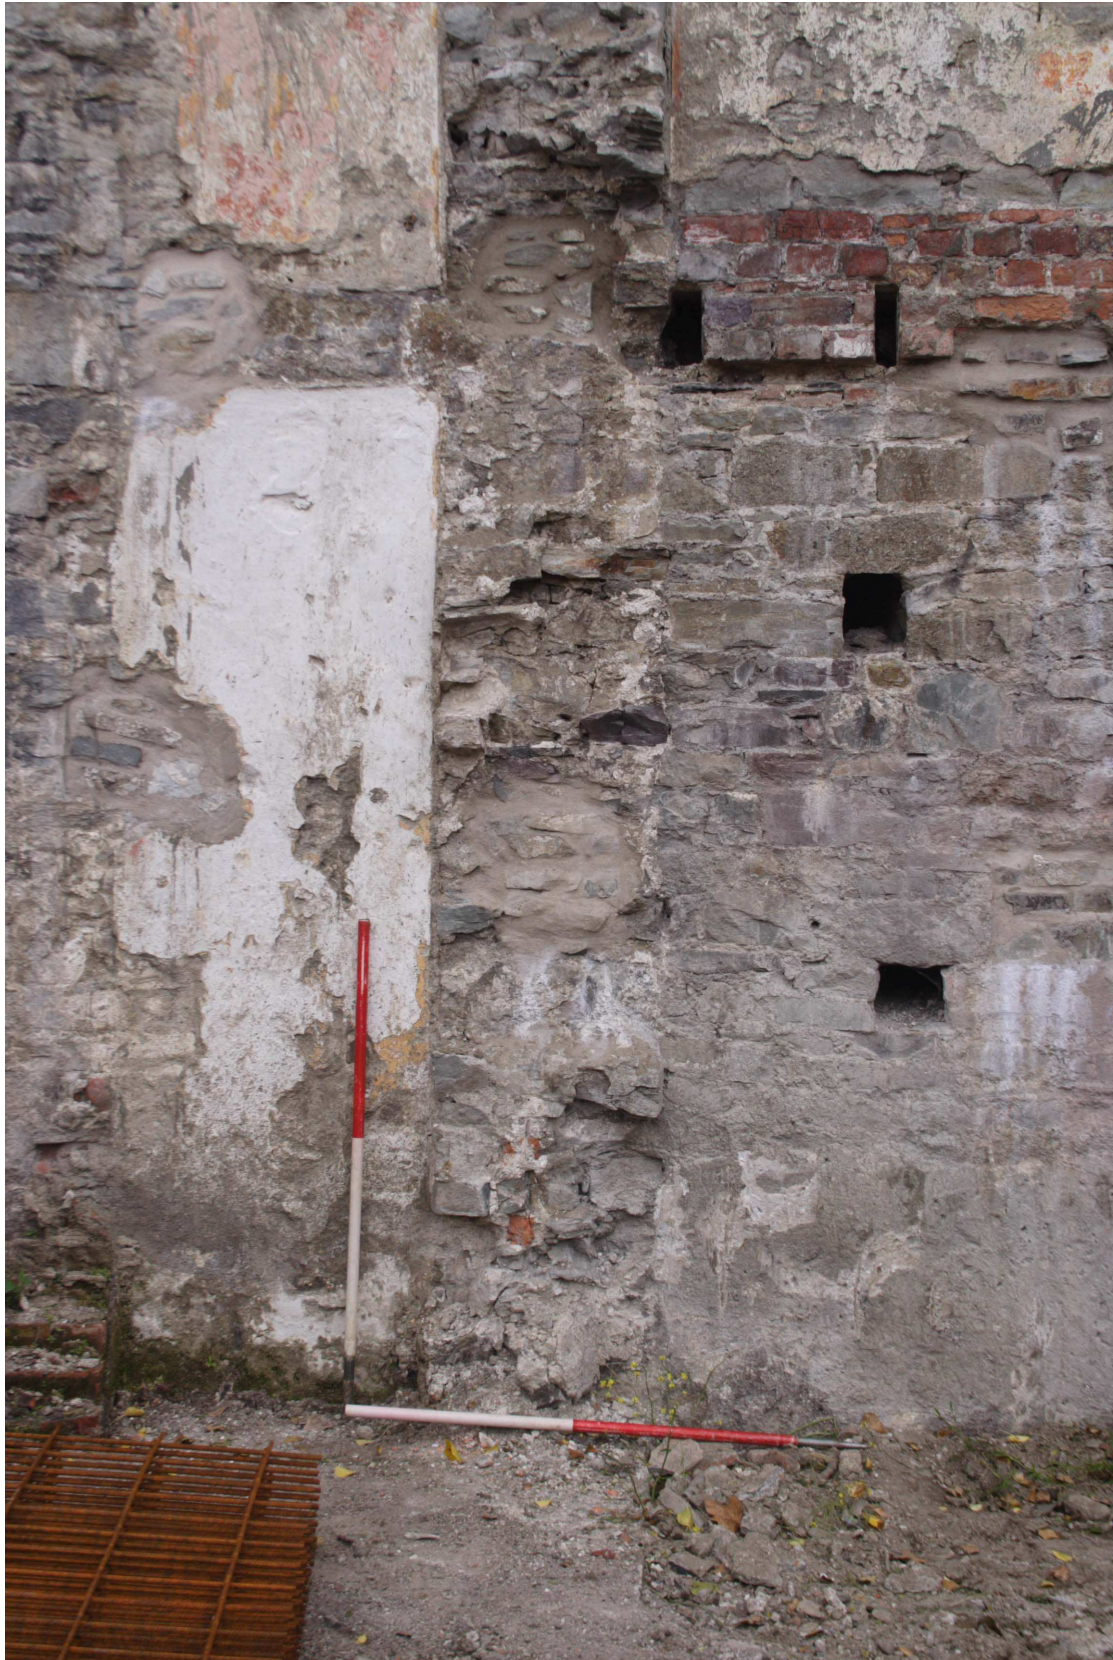
Plate 25: Lower section of retaining wall showing former gable end of cottage. Put logs visible to right along with floor joist slots of former cottage, shot 7.

The section of retaining wall (see figure 4) recorded at the proposed development site stands to a height of c.10m and is constructed predominantly of sandstone. The presence of putlog holes, which once housed the wooden scaffolding used during construction, suggests that the lower portion of the wall may be of medieval date and form part of the town walls. Within the central portion of the wall a band of larger squared stone blocks was noted. A series of five later walls abut the possible medieval wall, these probably relate to the cottages that once occupied the site. The upper levels of the wall appear to have been the subject of much later work, with a band of brickwork being present along with slots for floor beams and joists, and with further brick insertions further up. Substantial areas of concrete rendering were also noted, these probably dating to the 1960s as the name Gerald Davies with the date 1963 was noted scratched into cement where an area of rendering had been removed. It is also known that the wall has been stabilised by means of pinning this being evident from scarring along much of its face.

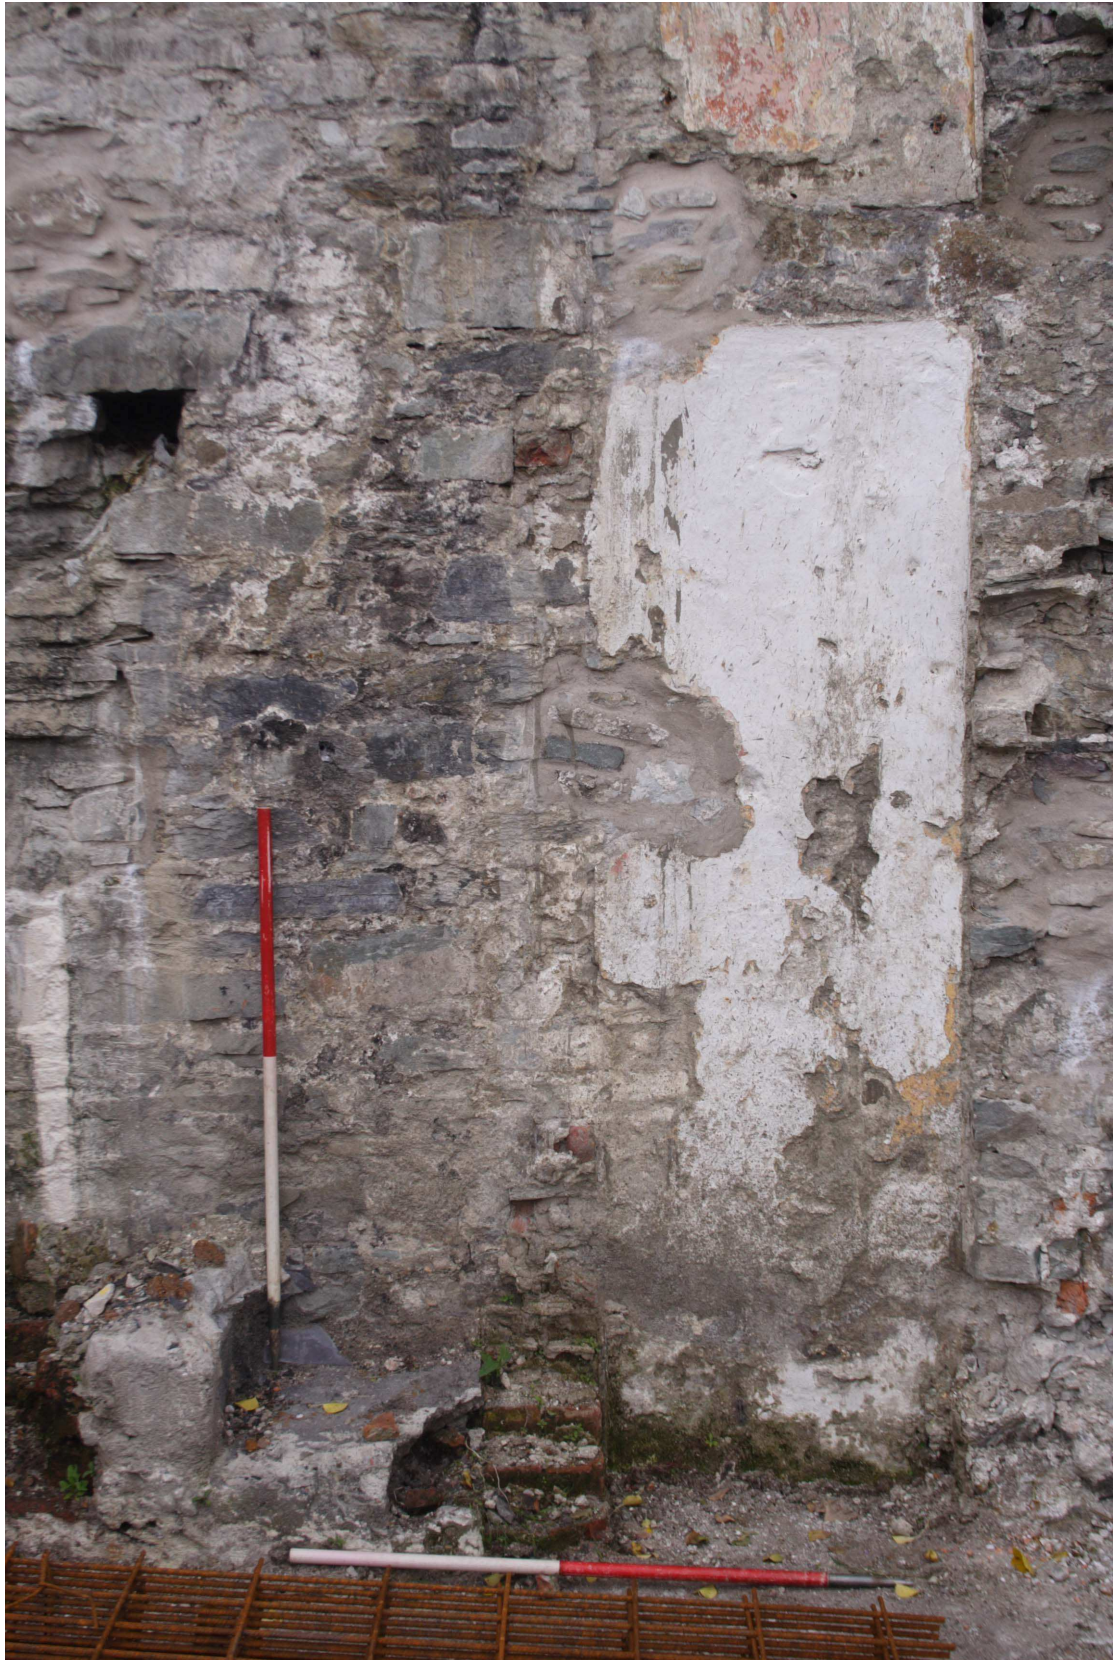
Plate 26: Lower section of retaining wall showing concrete render and unknown feature relating to cottage. Damaged put log in upper left hand edge of image, shot 8.

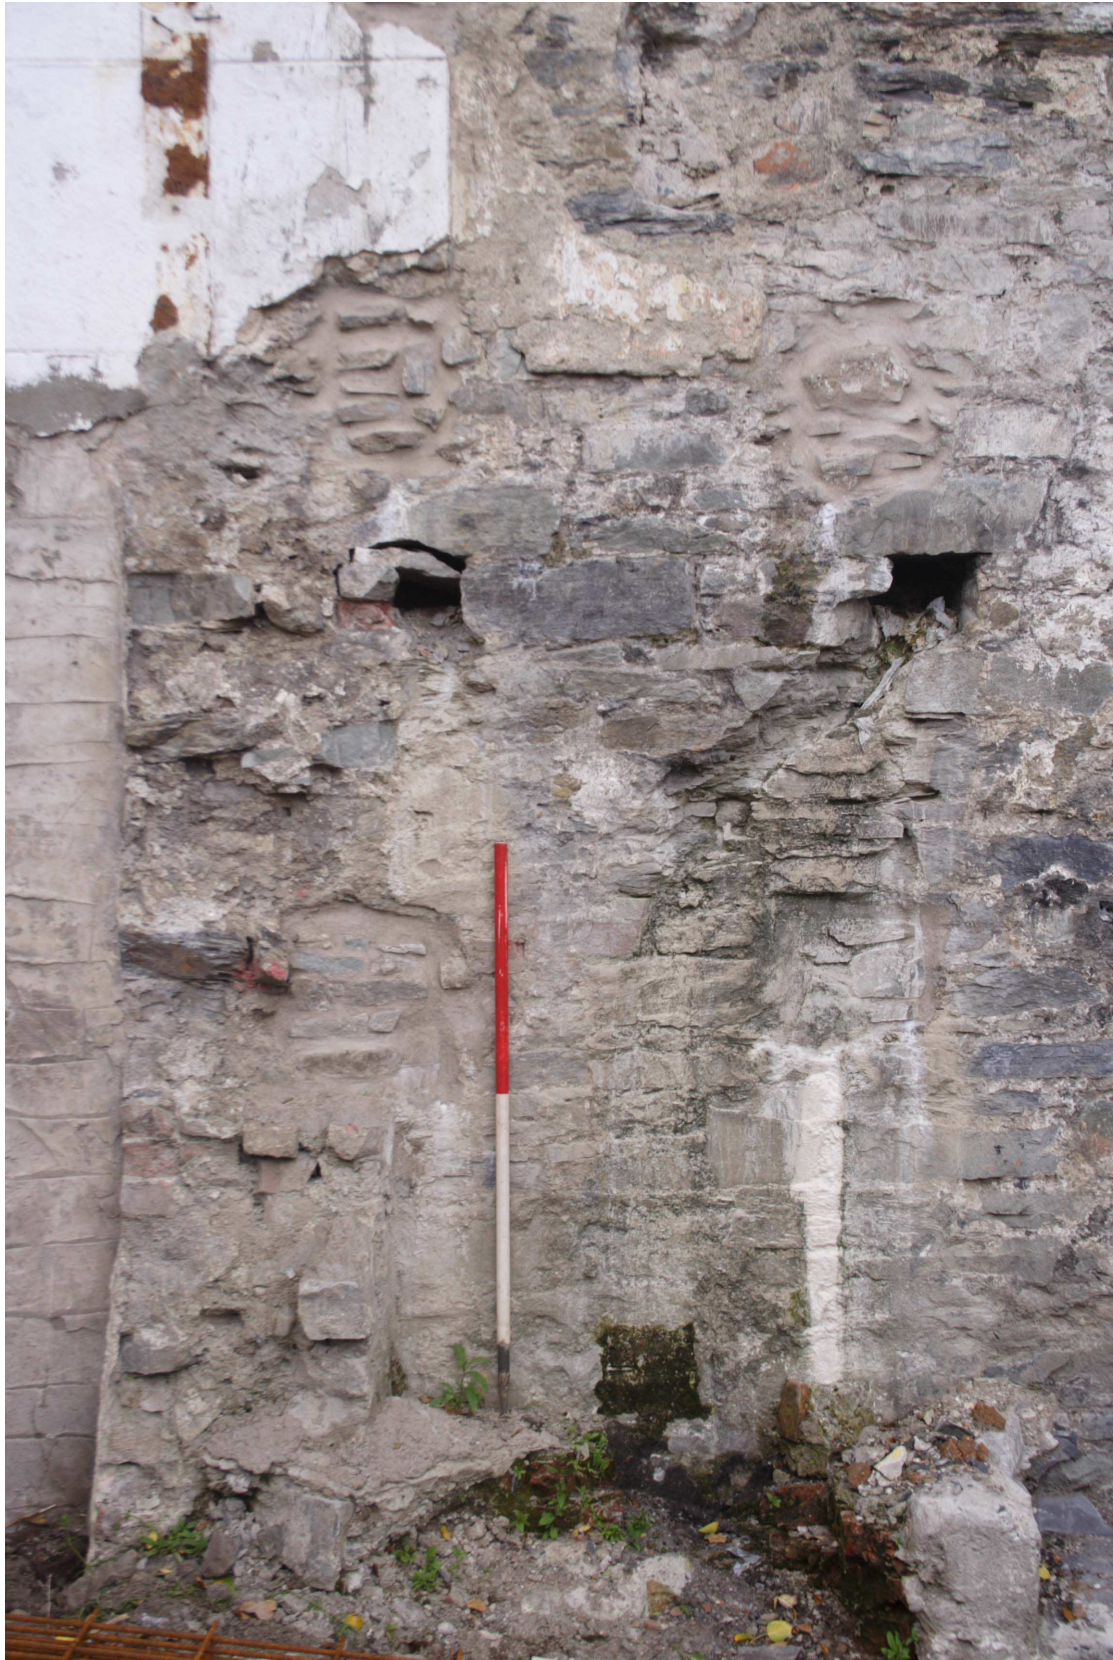
Plate 27: Lower section of retaining wall showing damaged putlogs. Former cottage wall to left of centre. Concrete render visible in upper left, shot 9.

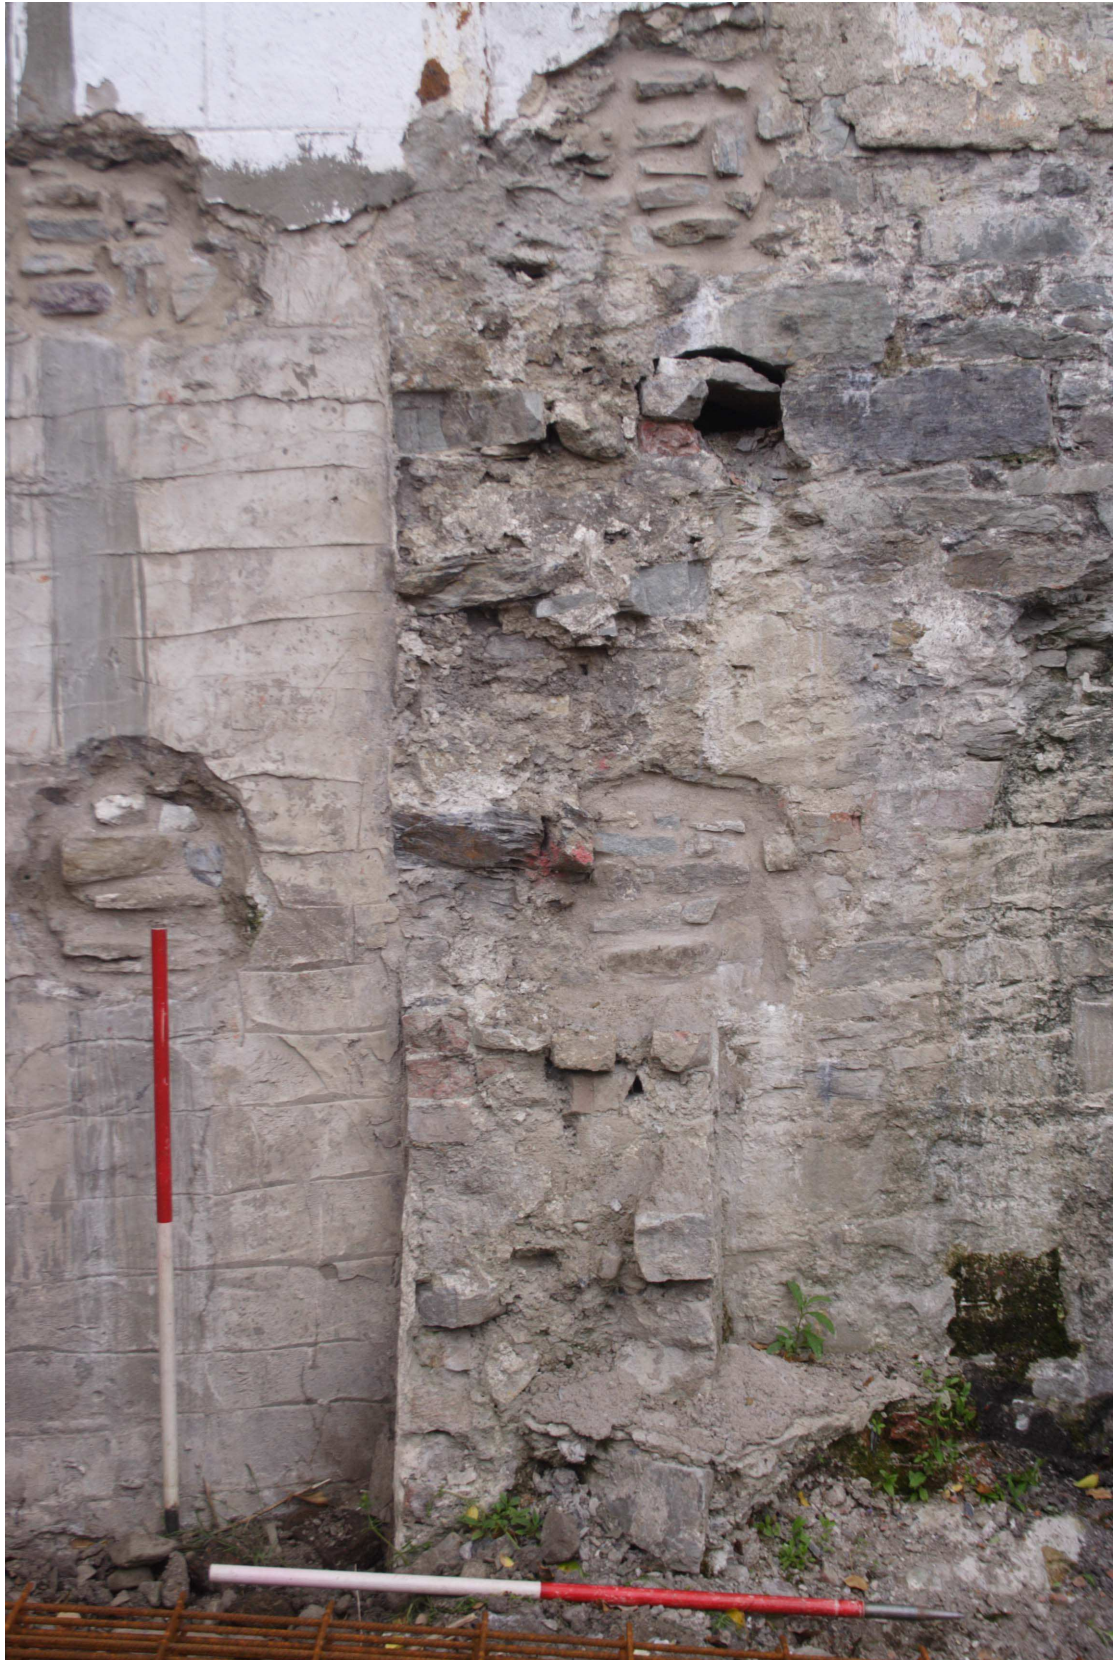
Plate 28: Lower section of retaining wall. Former cottage wall to centre. Concrete render to left. Pinning scar visible above vertical scale, shot 10.

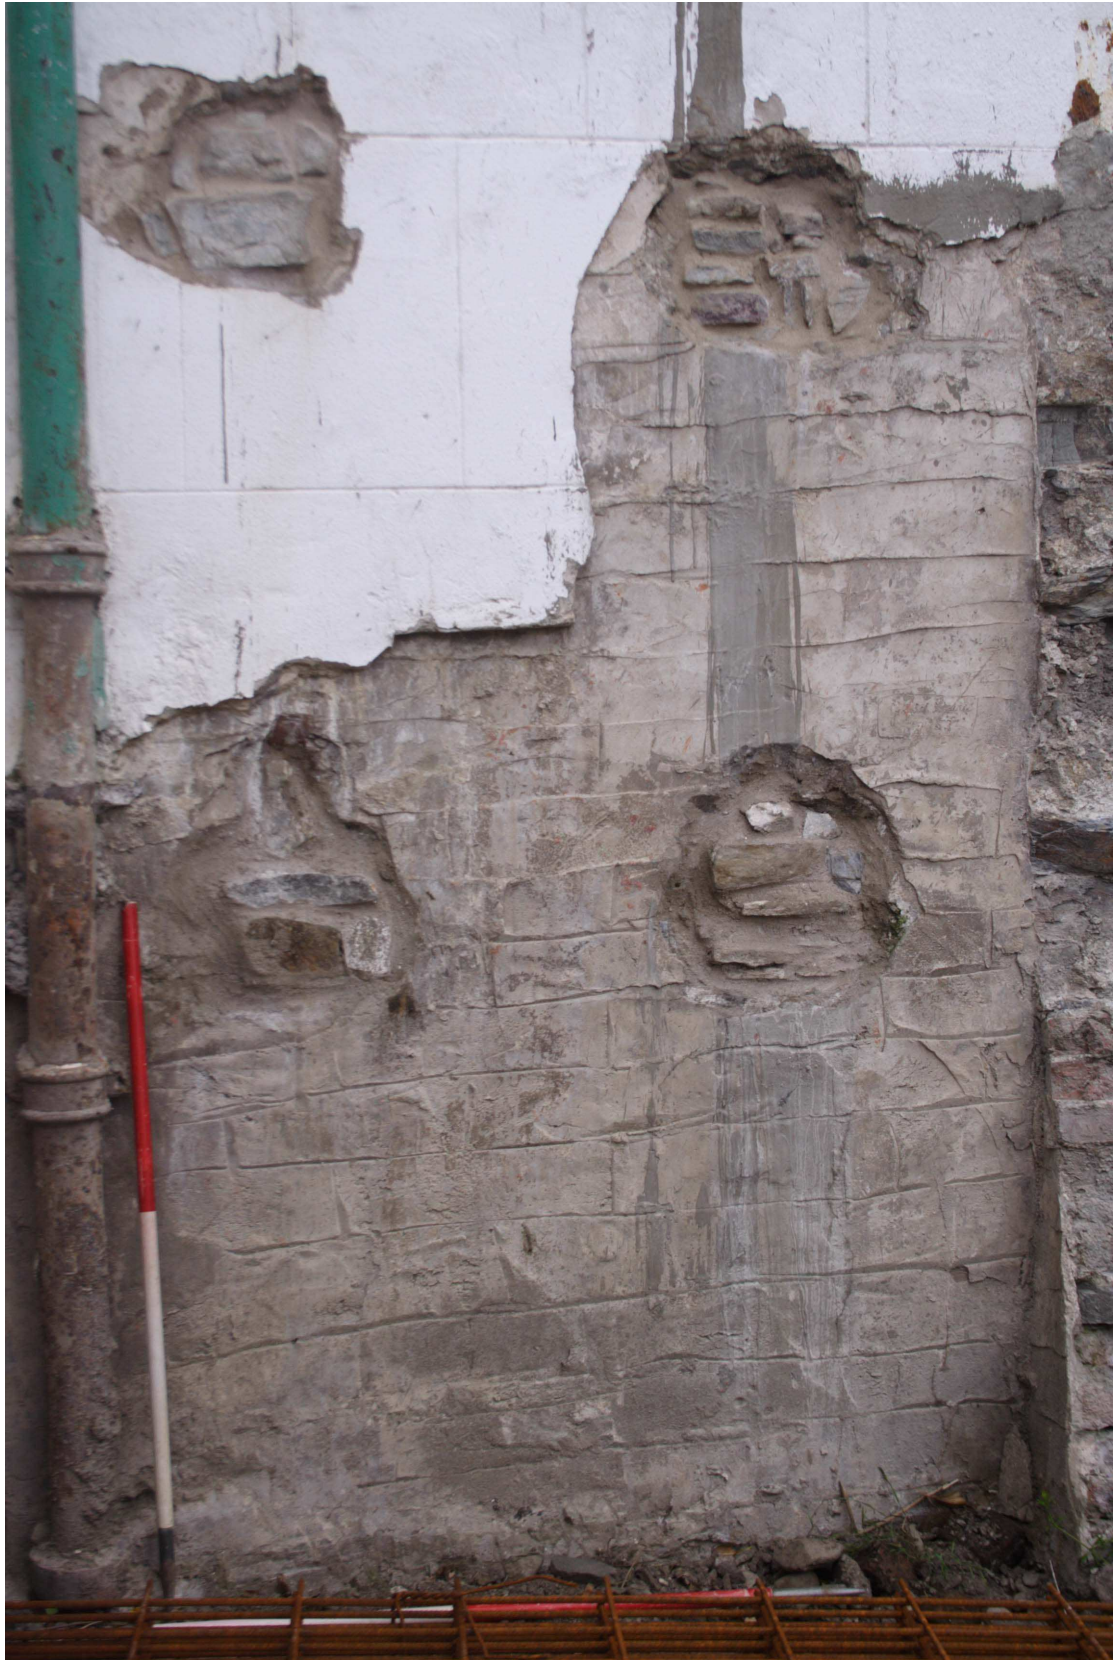
Plate 29: Lower section of southwest end of retaining wall showing concrete render and pinning scars, shot 11.
