# LYRIC THEATRE, KING STREET, CARMARTHEN ARCHAEOLOGICAL WATCHING BRIEF

MARCH 2009

RHIF YR ADRODDIAD / REPORT NO. 2008/85  
RHIF Y PROSIECT / PROJECT RECORD NO. 93999

### ARCHAEOLOGICAL WATCHING BRIEF

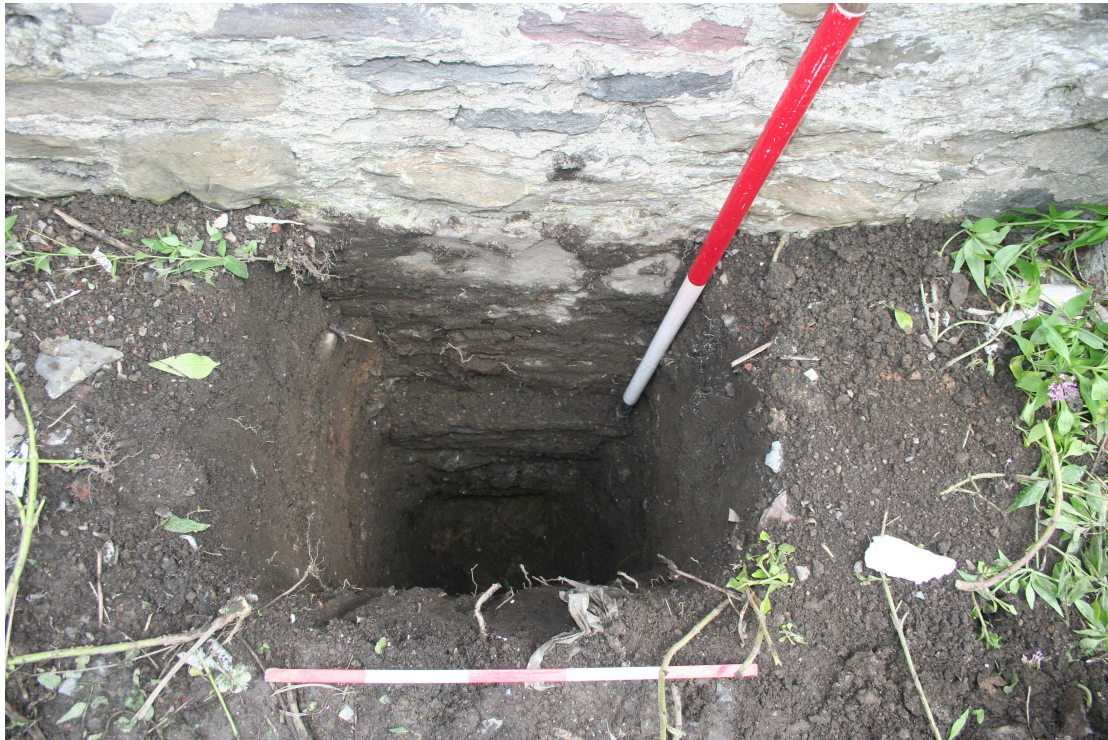
Test Pit 1 was located on the north side of the Bank Lane entrance. The pit measured 0.45m by 0.65m wide and was dug up against the boundary wall to a maximum depth of 1.35m. The test pit revealed the footing of the boundary wall at a depth of 0.75m.

Other than the boundary wall footing no further archaeological features or deposits were revealed.

**Photo 1:** Test Pit 1 showing boundary wall footing (102).

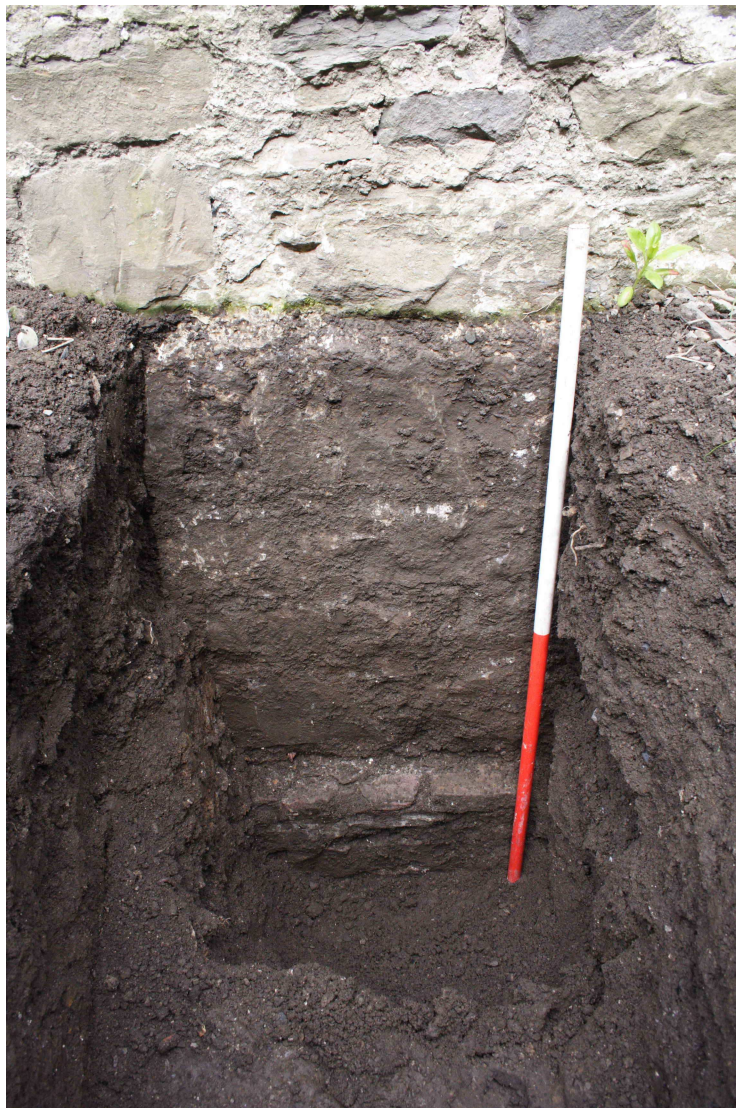
Test Pit 2 was located adjacent to the southwest face of the existing boundary wall and measured 0.9m x 0.7m originally with a depth of 0.6m. A 0.25 wide sondage was excavated to a depth of 0.4m against the face of the boundary wall that revealed the footing of the wall at a depth of 0.74m. Modern ceramic and brick material was recorded within the test pit, but not retained.

No further archaeological features or deposits were present in Test Pit 2.

**Photo 2:** Test Pit 2 southwest facing section.

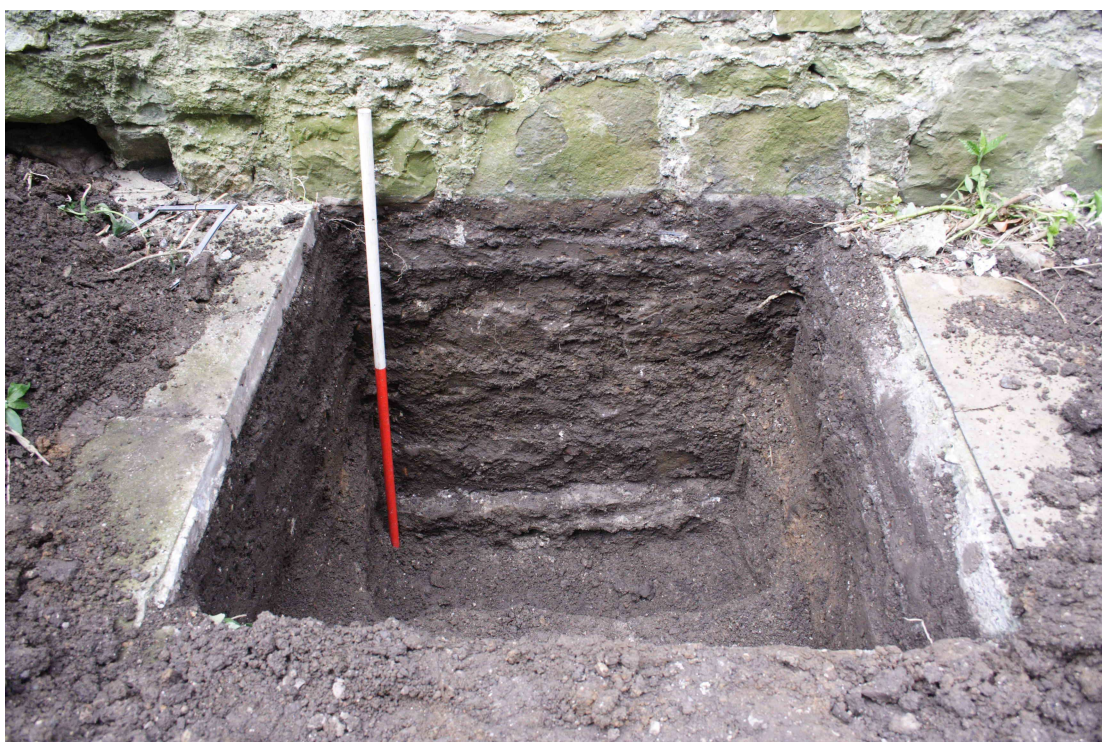
Excavated to a depth of 0.84m and measuring 0.94 x 0.6m, Test Pit 3 was located adjacent to the southwest face of the existing boundary wall. As with Test Pit 2 the footing of the boundary wall was revealed. An unstratified single piece of green glazed pottery of possible medieval date was recovered and retained. Modern ceramic material was also recorded from within the test pit, but not retained.

No further archaeological features or deposits were revealed in Test Pit 3.

**Photo 3:** Test Pit 3 facing northwest. Boundary wall footing (301) visible in base.

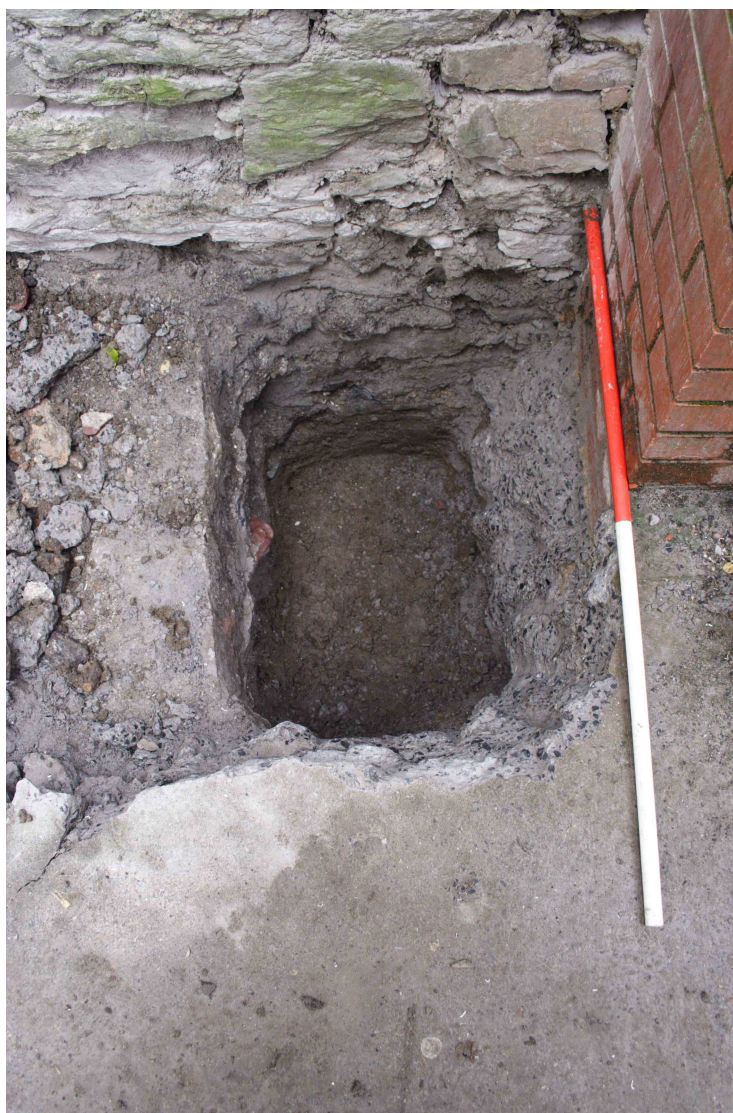
Located at the southeast corner of the existing fire exit opening onto Bank Lane, Test Pit 4 measured 0.8 x 0.64m and was excavated to a depth of 0.8m. Modern disturbance in the form of a 0.8m deep engineering brick pier and concrete were noted but not deemed to be of archaeological significance. However, in the southwest section of the test pit at a depth of 0.3m a compact layer of large flat angular stone was revealed. This may represent the former surface of Bank Lane.

With the exception of the possible lane surface and modern disturbance no further archaeological features or deposits were revealed in Test Pit 4.

**Photo 4:** Test Pit 4 facing southeast.

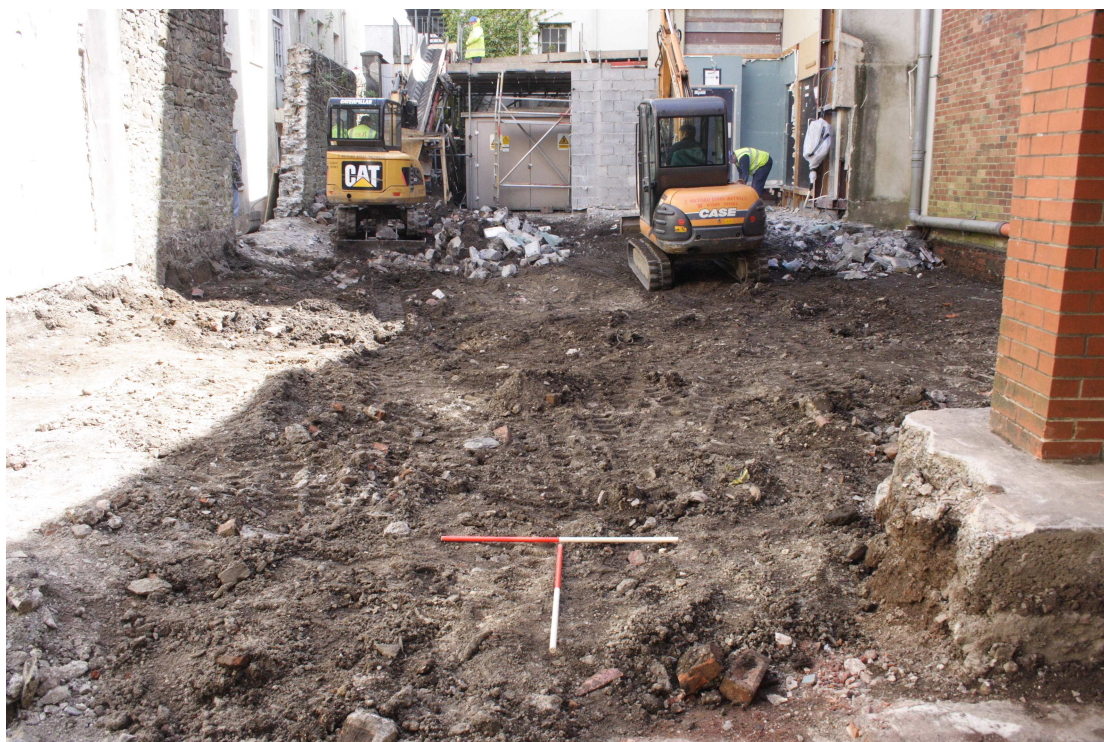
Following site clearance excavations commenced to reduce the ground level of the development site by an average depth of 0.5m. Initial excavations revealed much modern disturbance by services and modern drains. A single hand made early 19<sup>th</sup> century brick, along with a number of broken early 20<sup>th</sup> century Trimsaran engineering bricks were recovered but not retained. In addition to the brick finds the base of a free blown wine bottle was recovered. The considered date for the bottle is mid to late 18<sup>th</sup> century and would probably been of squat cylinder form. Finds of 19<sup>th</sup> and 20<sup>th</sup> century ceramic material were made but these were not retained.

The depth of the ground reduction works was designed to avoid impacting into the likely depth of archaeological deposits at the site. No significant archaeological features or deposits were identified during site clearance and level reduction works, and therefore this part of the watching brief confirmed that the ground reduction works did not truncate into any significant underlying archaeological deposits.

**Photo 8:** Development site following ground level reduction.

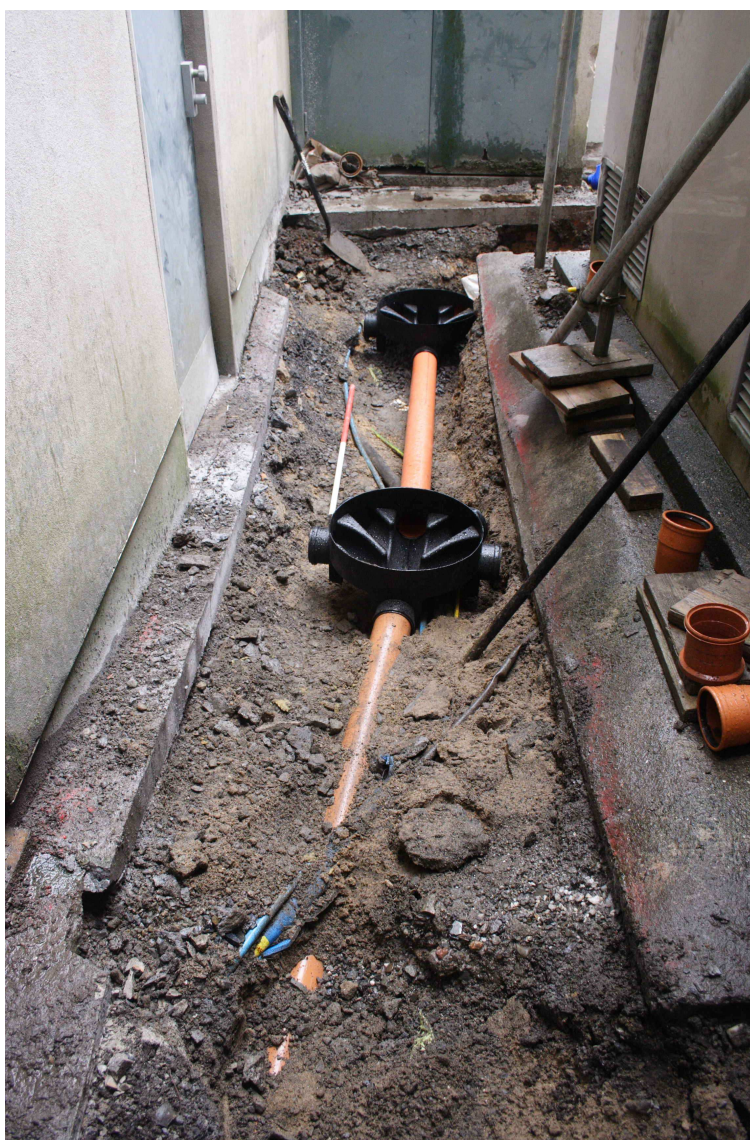
Archaeological monitoring was undertaken during the excavation of a 6m x 0.84m x 0.61m deep drainage trench running from the rear of the Carmarthenshire County Council offices at 41 Spilman Street and terminating at an existing

manhole. The excavations revealed modern debris in the form of red brick fragments, coal ash and a single complete Swansea red brick, none of which were retained.

No significant archaeological features or deposits were revealed during the drainage trench excavations. Again the watching brief demonstrated that the groundworks did not truncate any significant underlying archaeological remains.

**Photo 10:** Southeast view of drainage trench.

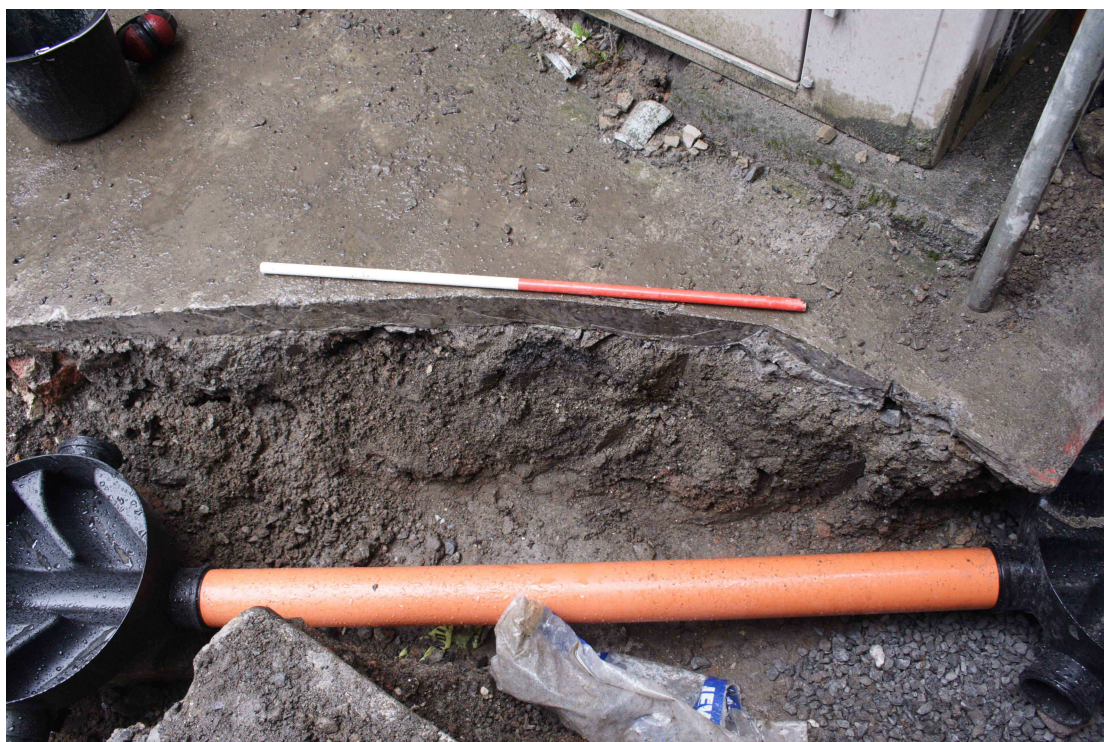
**Photo 11:** North facing section of drainage trench.

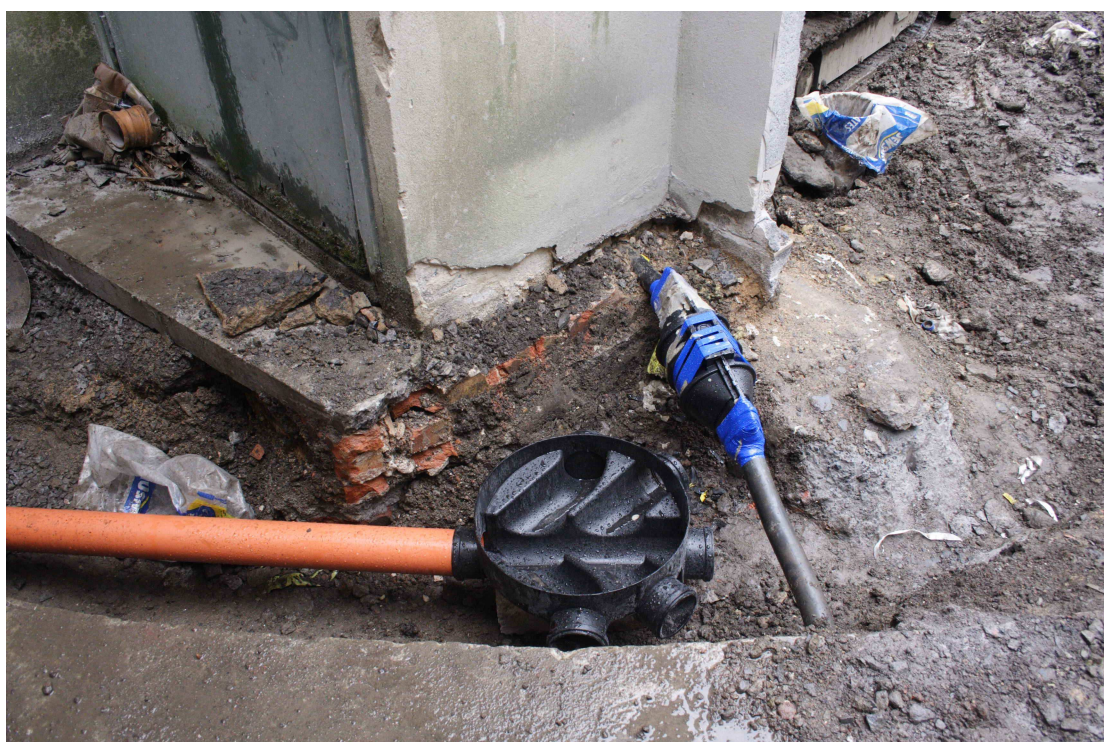
**Photo 12:** Brick foundation of modern stage building.

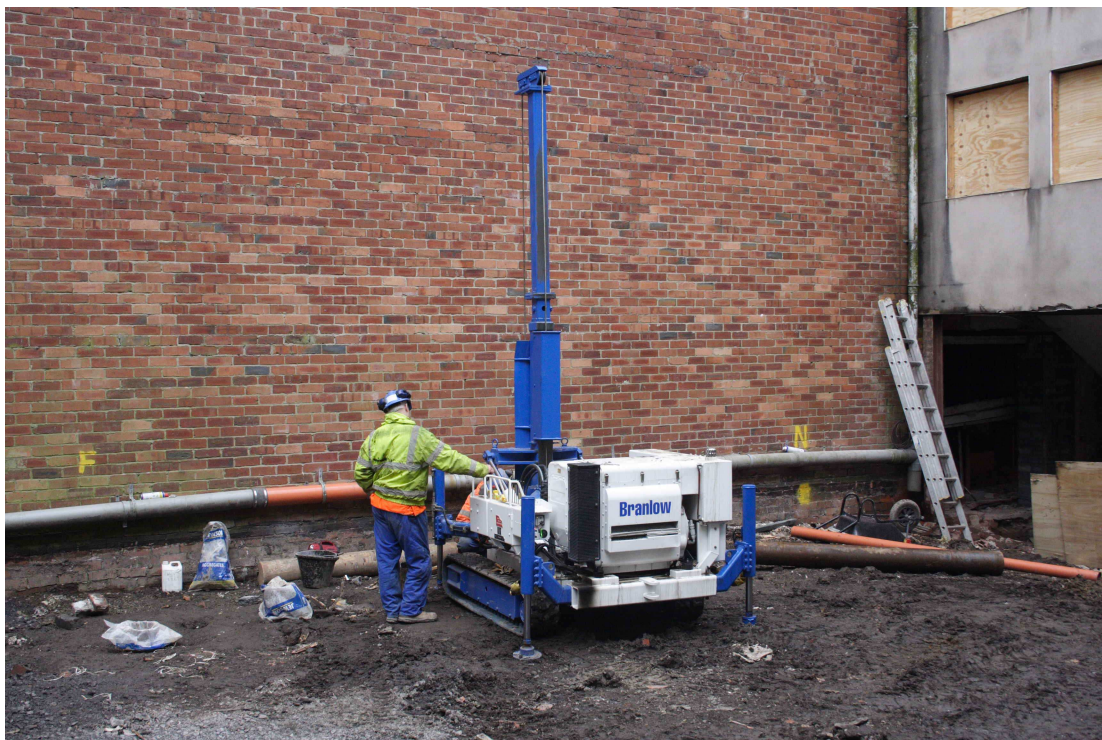
Following excavation of the development site to the required level the final phase of the ground-works consisted of the installation of fifty steel piles. An archaeological presence was maintained during this phase in order to monitor the works. The piling layout had been designed to allow small changes in the locations of the piles in the event that they encountered underlying obstructions which prevented the pile from penetrating further into the ground. The locations of such obstructions could indicate the presence of archaeological remains, such as walls, compacted surfaces or other stone built features. In the event that piles needed to be moved, the watching brief would record during the removal and relocation of the piles (it had been agreed at an early stage of the design that it would not be acceptable to excavate and remove any underlying obstructions, as this could cause substantial disturbance to any underlying archaeological remains).

The piling at the Lyric theatre encountered substantial resistance at the northwest end of the development site, whilst towards the centre of the site one pile bent after encountering an obstruction at a depth of c.2m. Neither the piles at the northwest end of the site, or the damaged one in the centre were required to be moved and were successfully driven into their required locations. Although obstructions were encountered, it is not possible to substantiate whether they encountered buried archaeological features or natural geological deposits.

**Photo 13:** General working shot of piling in progress.
