THE OLD MILL, HOREB, LLANELLI, CARMARTHENSHIRE: STANDING BUILDING RECORDING AND ARCHAEOLOGICAL WATCHING BRIEF

Prepared by Dyfed Archaeological Trust
For: Mr and Mrs Mark Evans

RHIF YR ADRODDIAD / REPORT NO. 2008/106
RHIF Y PROSIECT / PROJECT RECORD NO. 94421
Watching Brief 94422
Standing Building Recording 94423

November 2008

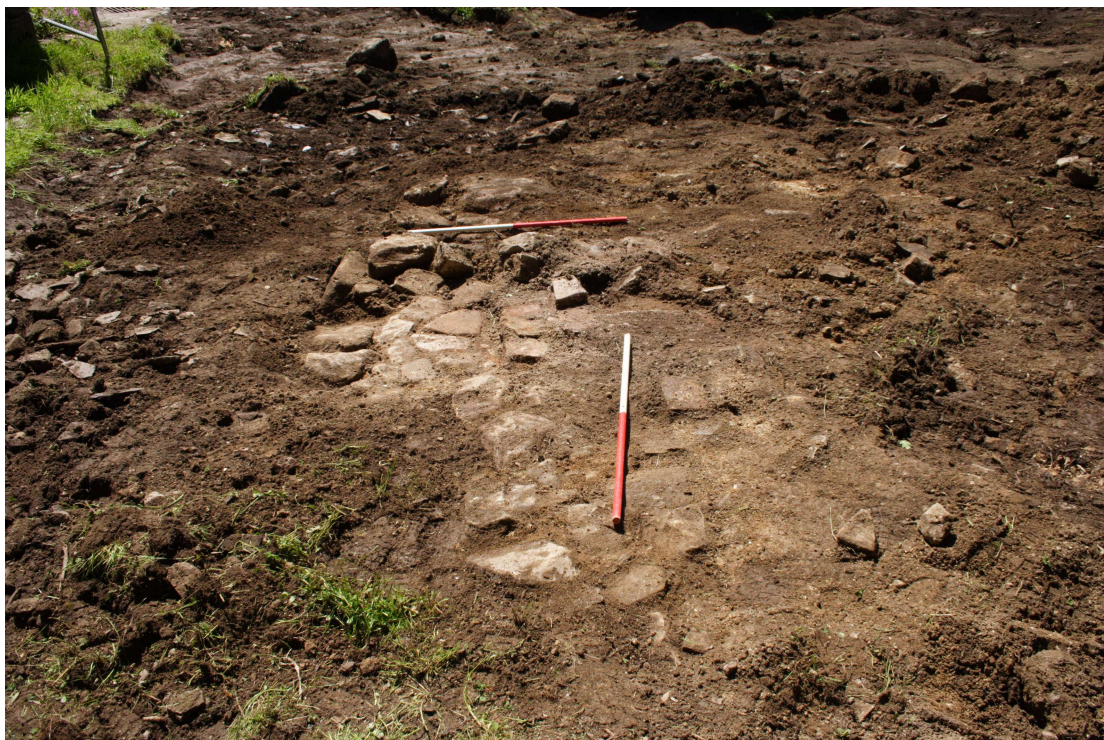
Plate 1: Metalled possible yard surface.

Two archaeological features were revealed and recorded during the clearance and topsoil stripping of the site. The first was a 3.3m x 1.6m metal surface of large subangular stone that may have been part of a yard surface. Post medieval willow pattern stoneware fragments were recovered along with late 19th – early 20th century glass but these were not retained.

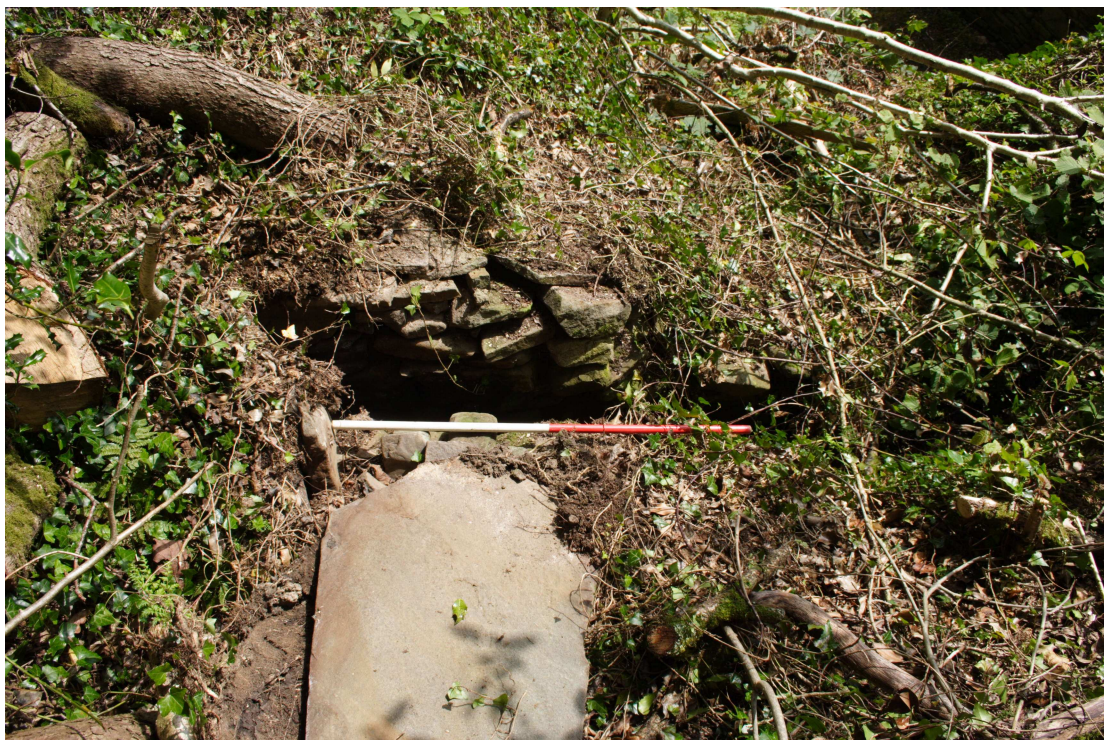
Plate 2: Stone water channel from west.

Clearance works to the northeast of the head race wall revealed a 3.75m long 0.9m wide, 1.4m deep stone channel that supplied water to power the water wheel. The full extent of the channel was unknown as it continued beneath the unexcavated area. The channel was capped with stone slabs, one of these was disturbed during the clearance works and was found to be 1.2m long, 0.5m wide with a thickness of 0.04m.

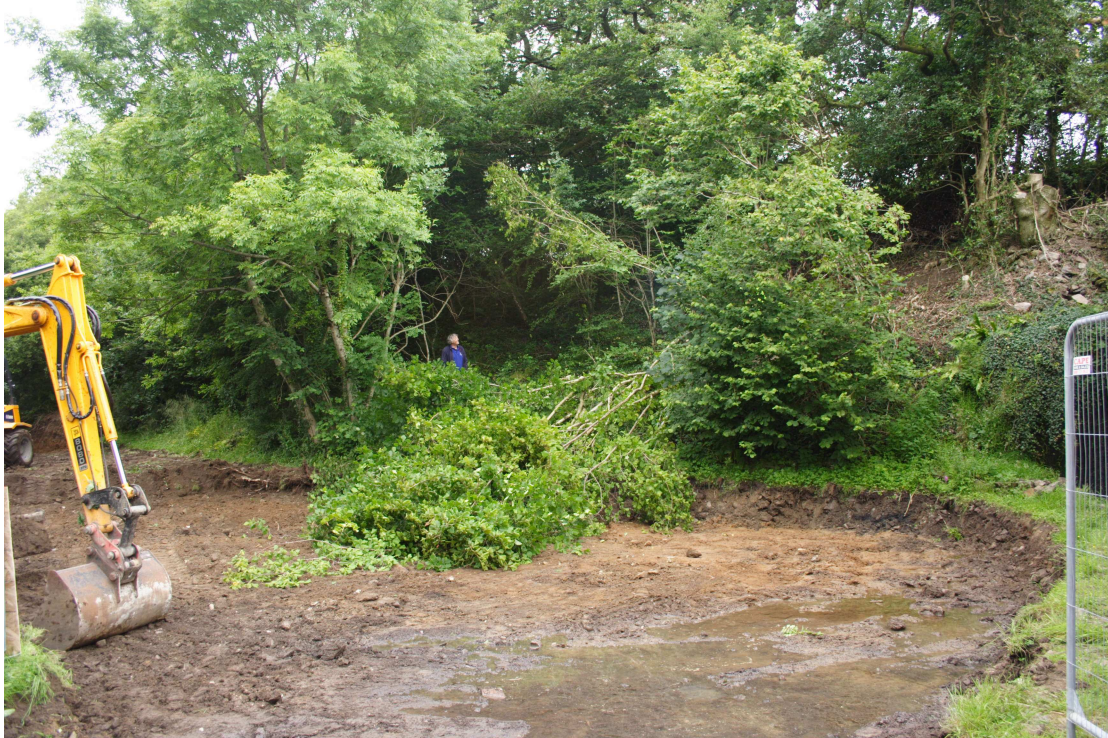
Plate 4: View of site from southeast following topsoil stripping.

Topsoil stripping of the site revealed that the stratigraphic sequence was broadly uniform across the site with a 0.4m deep dark grey brown clay silt topsoil of moderate compaction and containing c.40% large subangular stone and c.10% roofing slate brick and mortar overlying a mid orange brown clay of firm compaction. The presence of a high proportion of large stone, roofing slate and mortar within this layer suggests it was building debris derived from the mill. However, the presence of brick suggests that material had been deposited from elsewhere as the mill structure contained no substantial brick elements. The bricks noted appeared to have been of relatively modern date with one bearing the name Glynea Co Bynea. The Glynea Brick Works operated between 1893 and 1931 and manufactured brick from clay from Glynea Colliery and shale from its waste tips (Craig *et al*, 2002, 331).

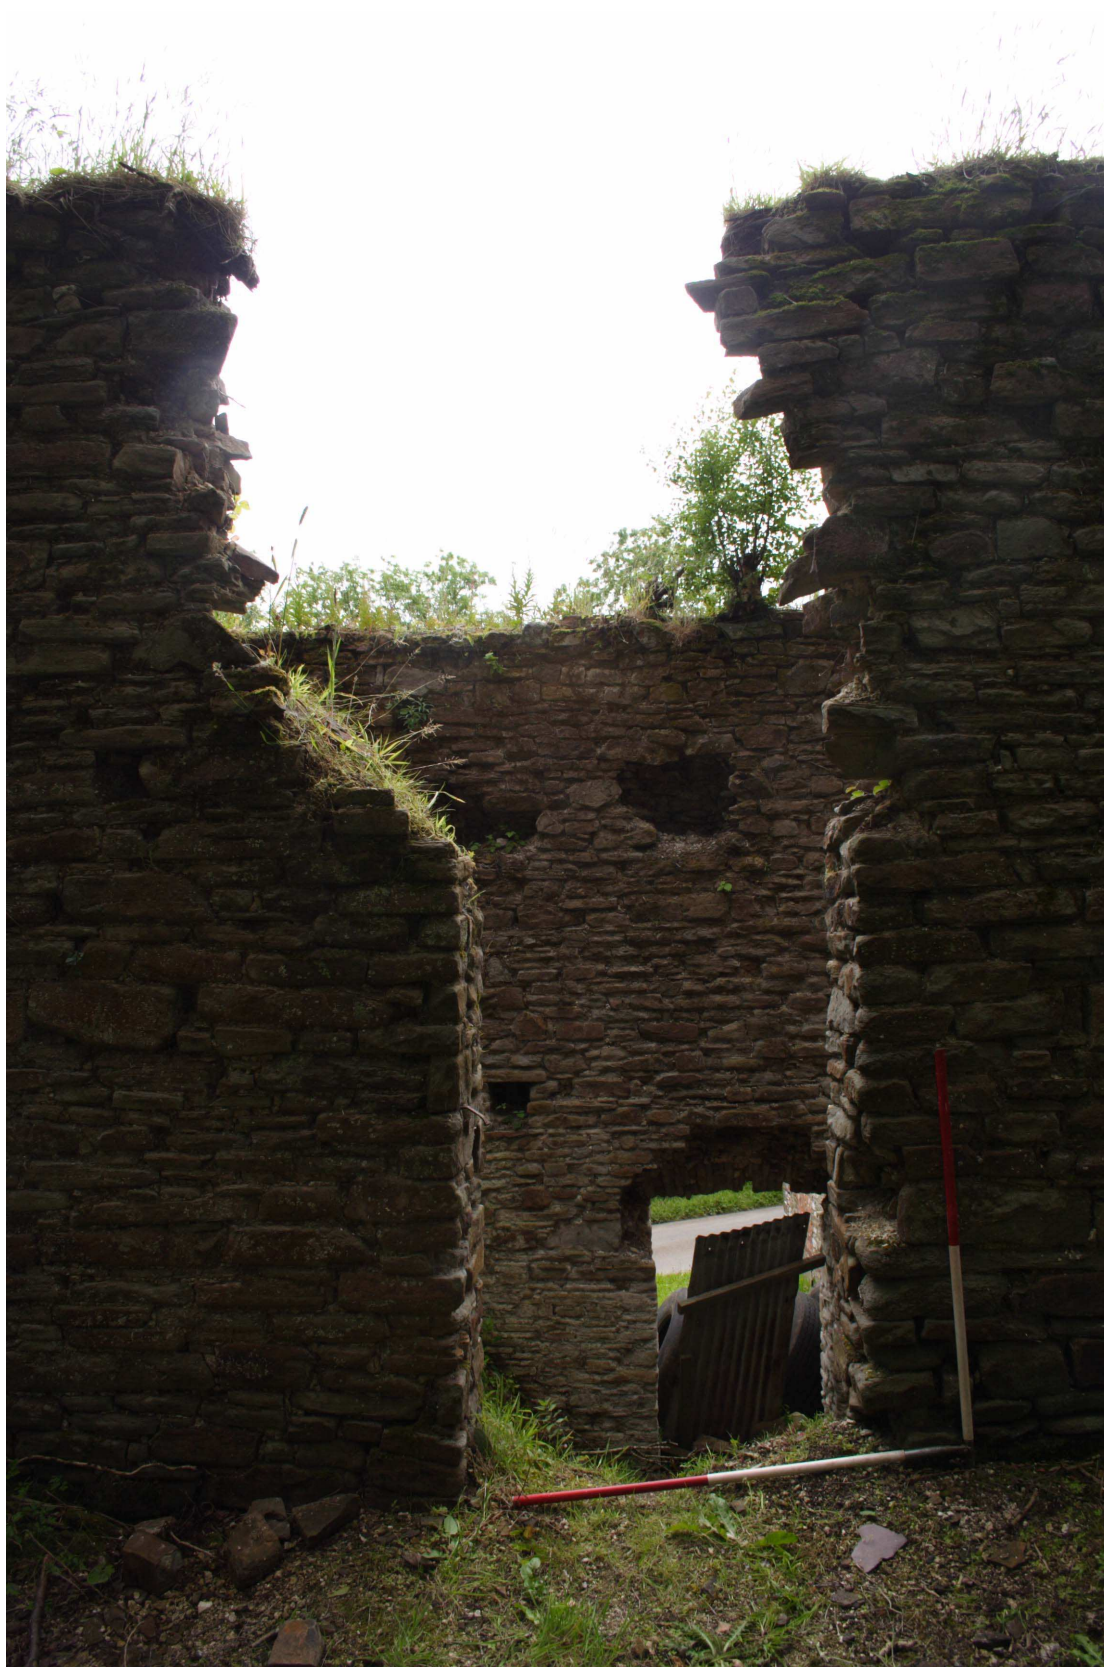
Plate 11: Mill rear wall from northeast showing doorway. Shot 6.

The earliest phase of construction appeared to be the larger northwest to southeast aligned structure of mortared rubble coursework. Access to the structure was originally through doorways piercing the northeast and southwest side walls. The door in the northeast wall was at a higher level to that in the southwest suggesting that it provided access to a now destroyed first floor. This doorway was likely to have been the entry point for corn to be ground. The doorway in the southwest wall was likely to have provided access to a basement level and originally have been where the flour would have been taken from the mill.

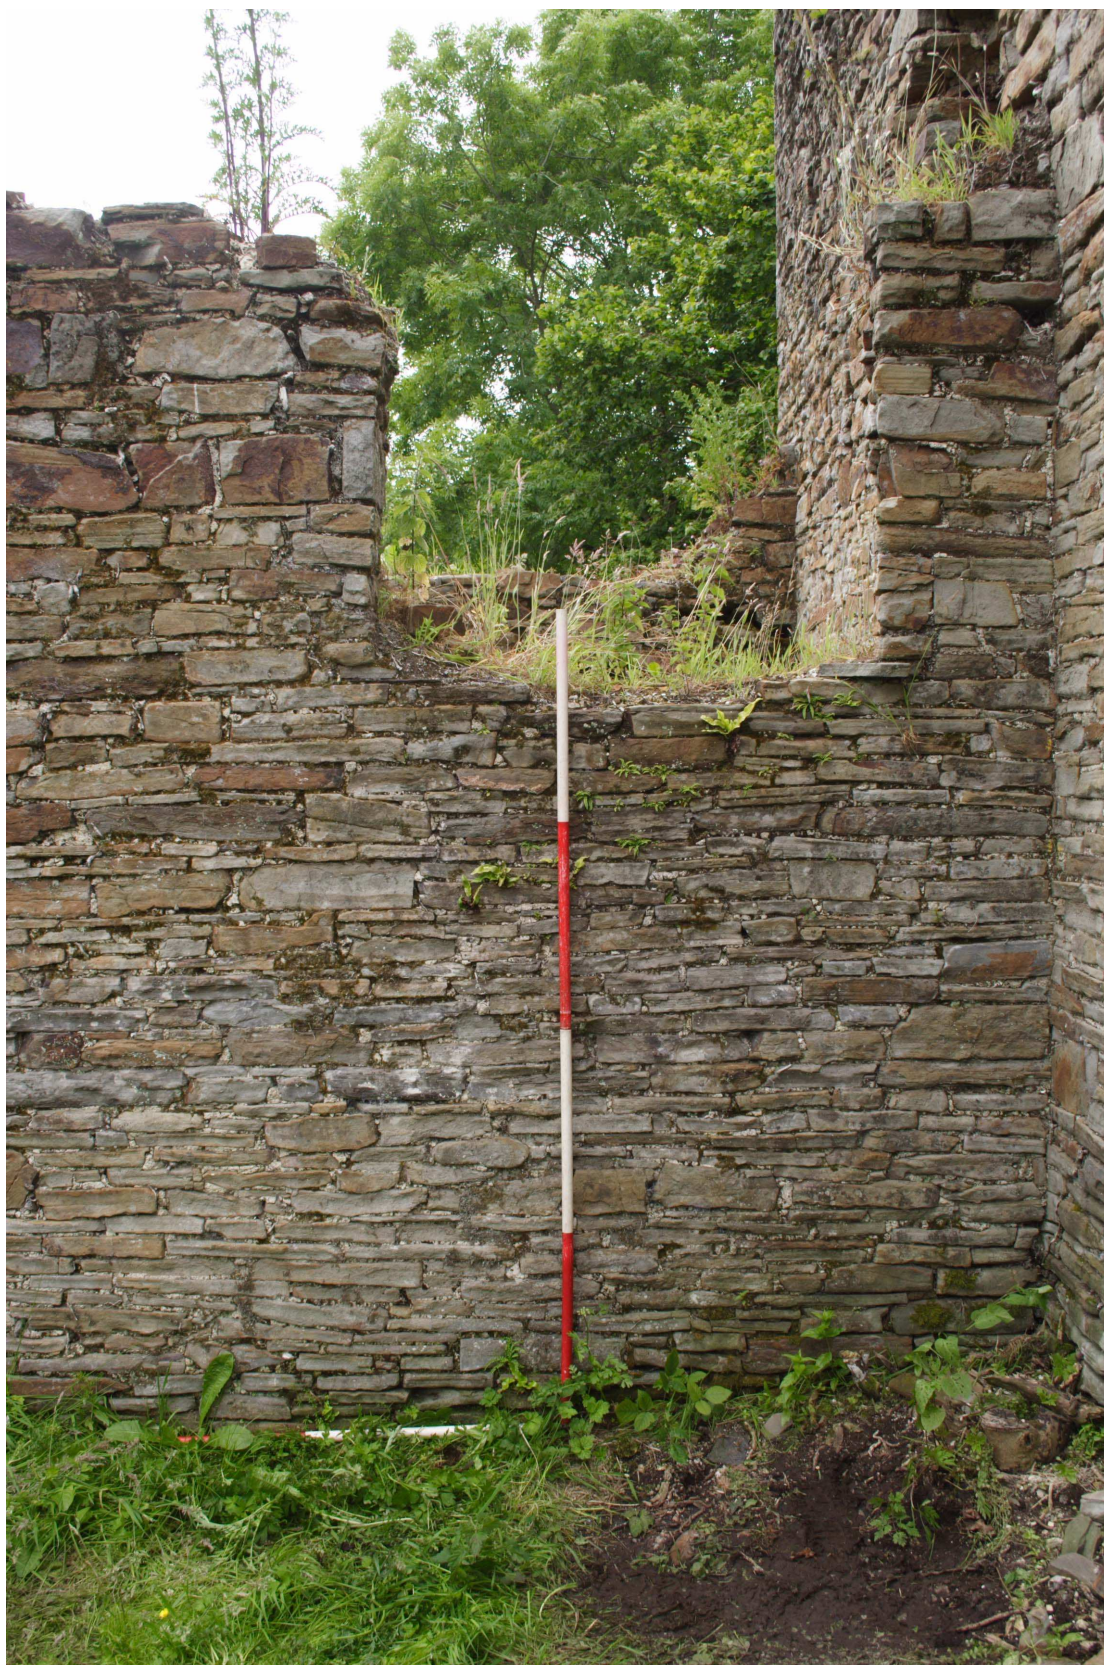
Plate 30: Extension wall from southeast window visible. Shot 2.

Aligned northeast to southwest a rubble coursed possible later addition to the original mill was noted. It was not possible to record the internal space of the structure due to it being unsafe to enter. However, the structure appeared to have been originally of two storeys and lit by windows in the side and gable wall although much of the upper storey had been destroyed. The upper storey provided access to the original mill via a doorway in the northeast wall. The means of access between the ground and first floor of the structure were unclear although it is possible that it may have been by ladder.

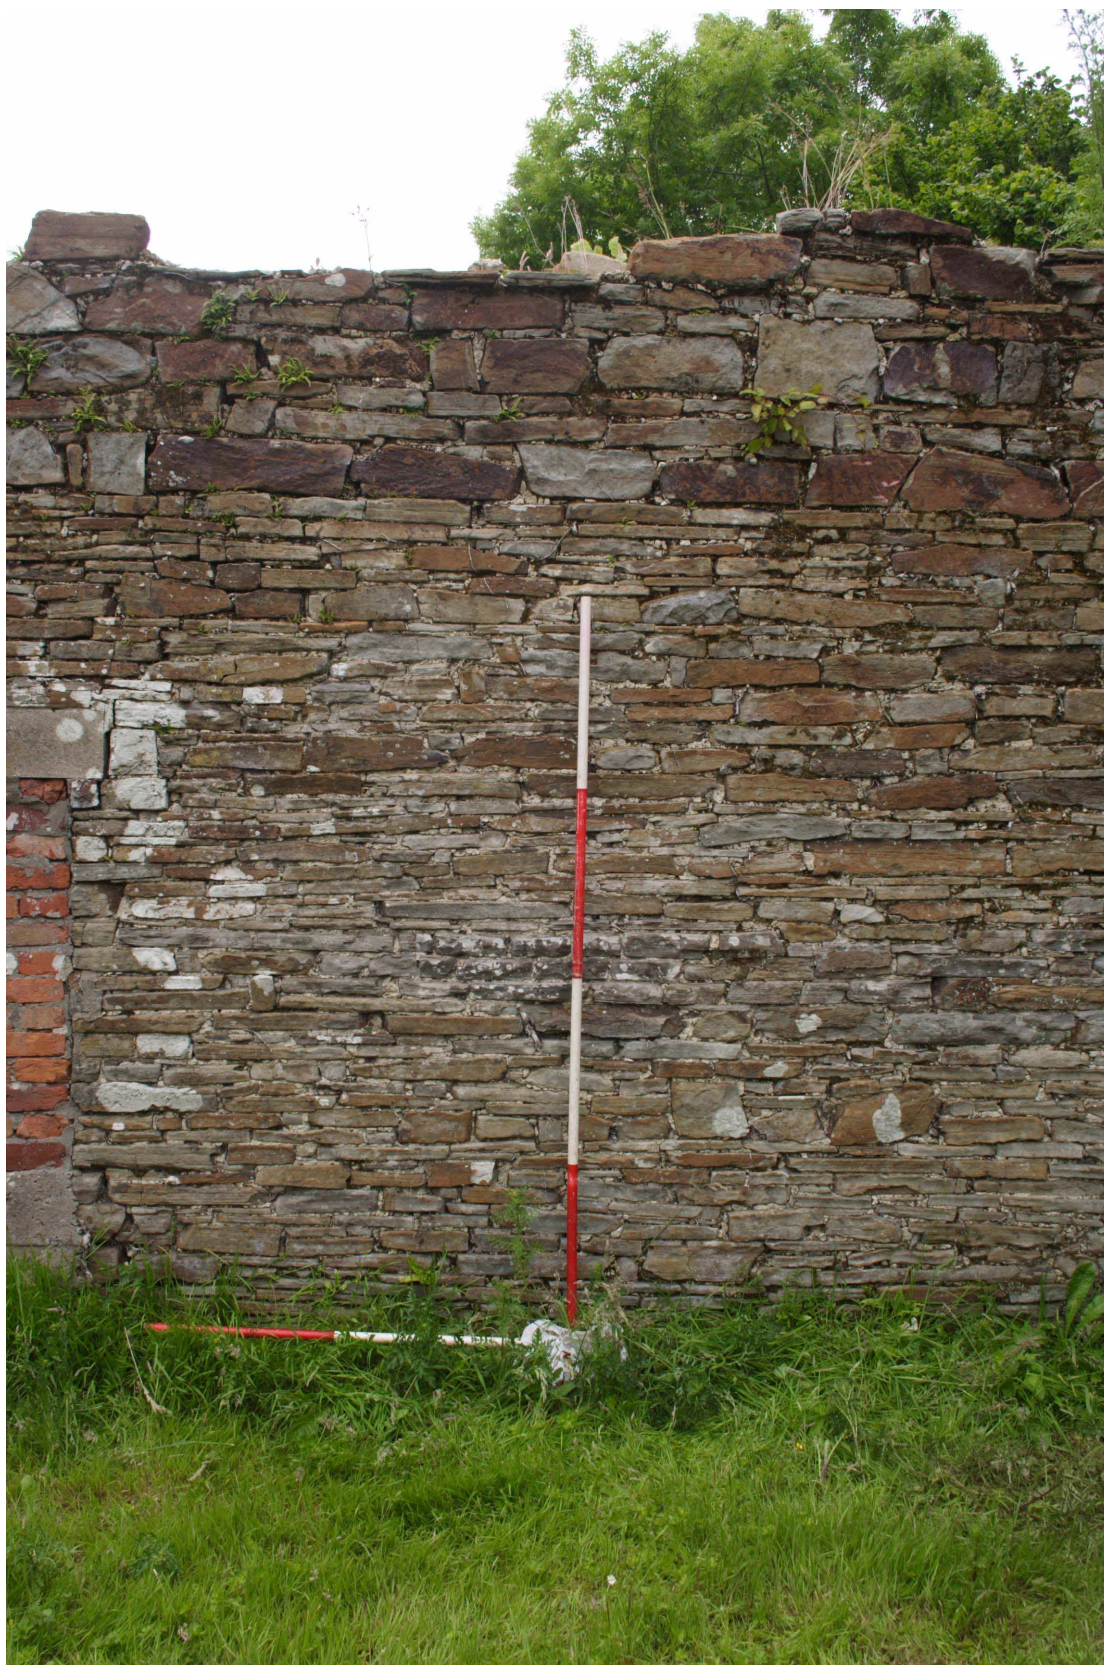
Plate 32: Extension wall from southeast area of larger stone visible above vertical scale. Shot 4.

It was noted that the upper level of the southeast side wall was constructed of larger stone than the rest of the addition. This may suggest that it had been rebuilt. However, it is equally likely that it may be evidence for a different stone source and may represent a wall lift whereby the rubble coursing was levelled to provide a good base for the continuation of construction.

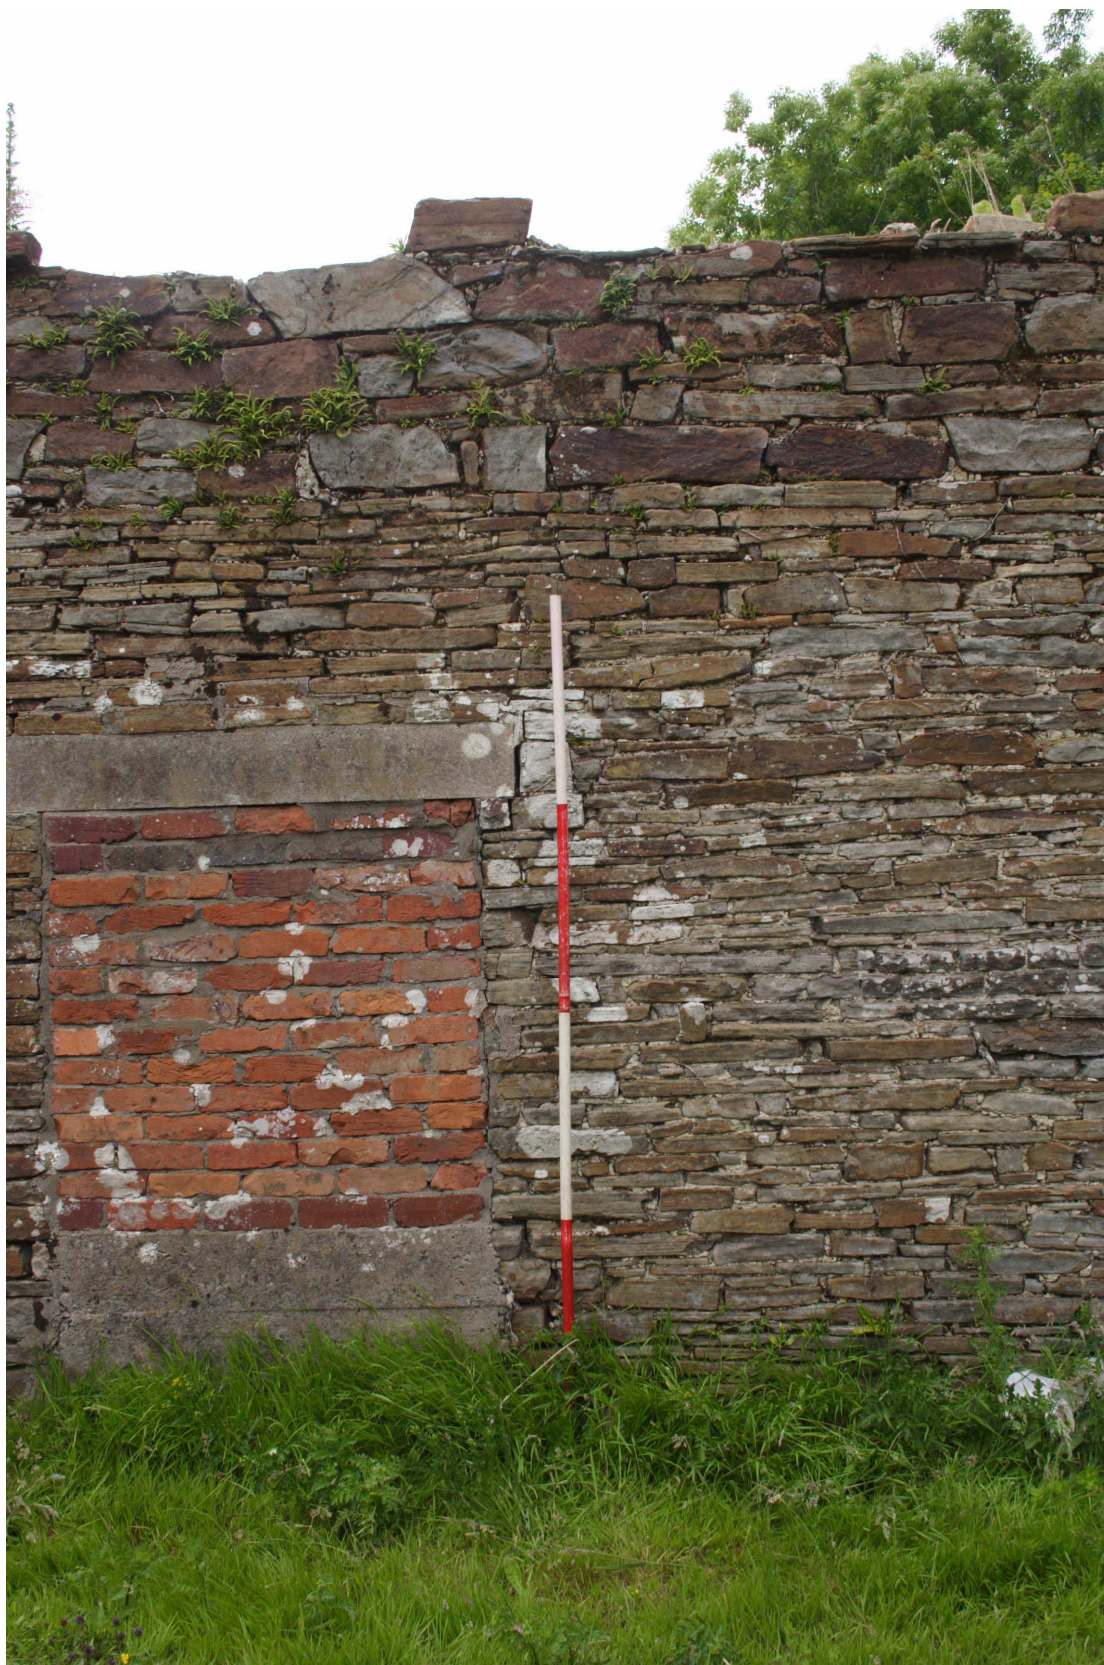
Plate 33: Extension wall from southeast blocked door/window to left. Shot 5.

The ground floor of the possible later addition to the mill was originally accessed through doors in the side and gable walls. No direct ground floor access was possible to the original mill. Of these three original doors only the one in the northwest side wall was still open. The door in the gable end had been blocked with rubble whilst that in the southeast side wall may have been converted to a window by the insertion of a concrete lintel and plinth. This possible window was completely blocked with red brick.

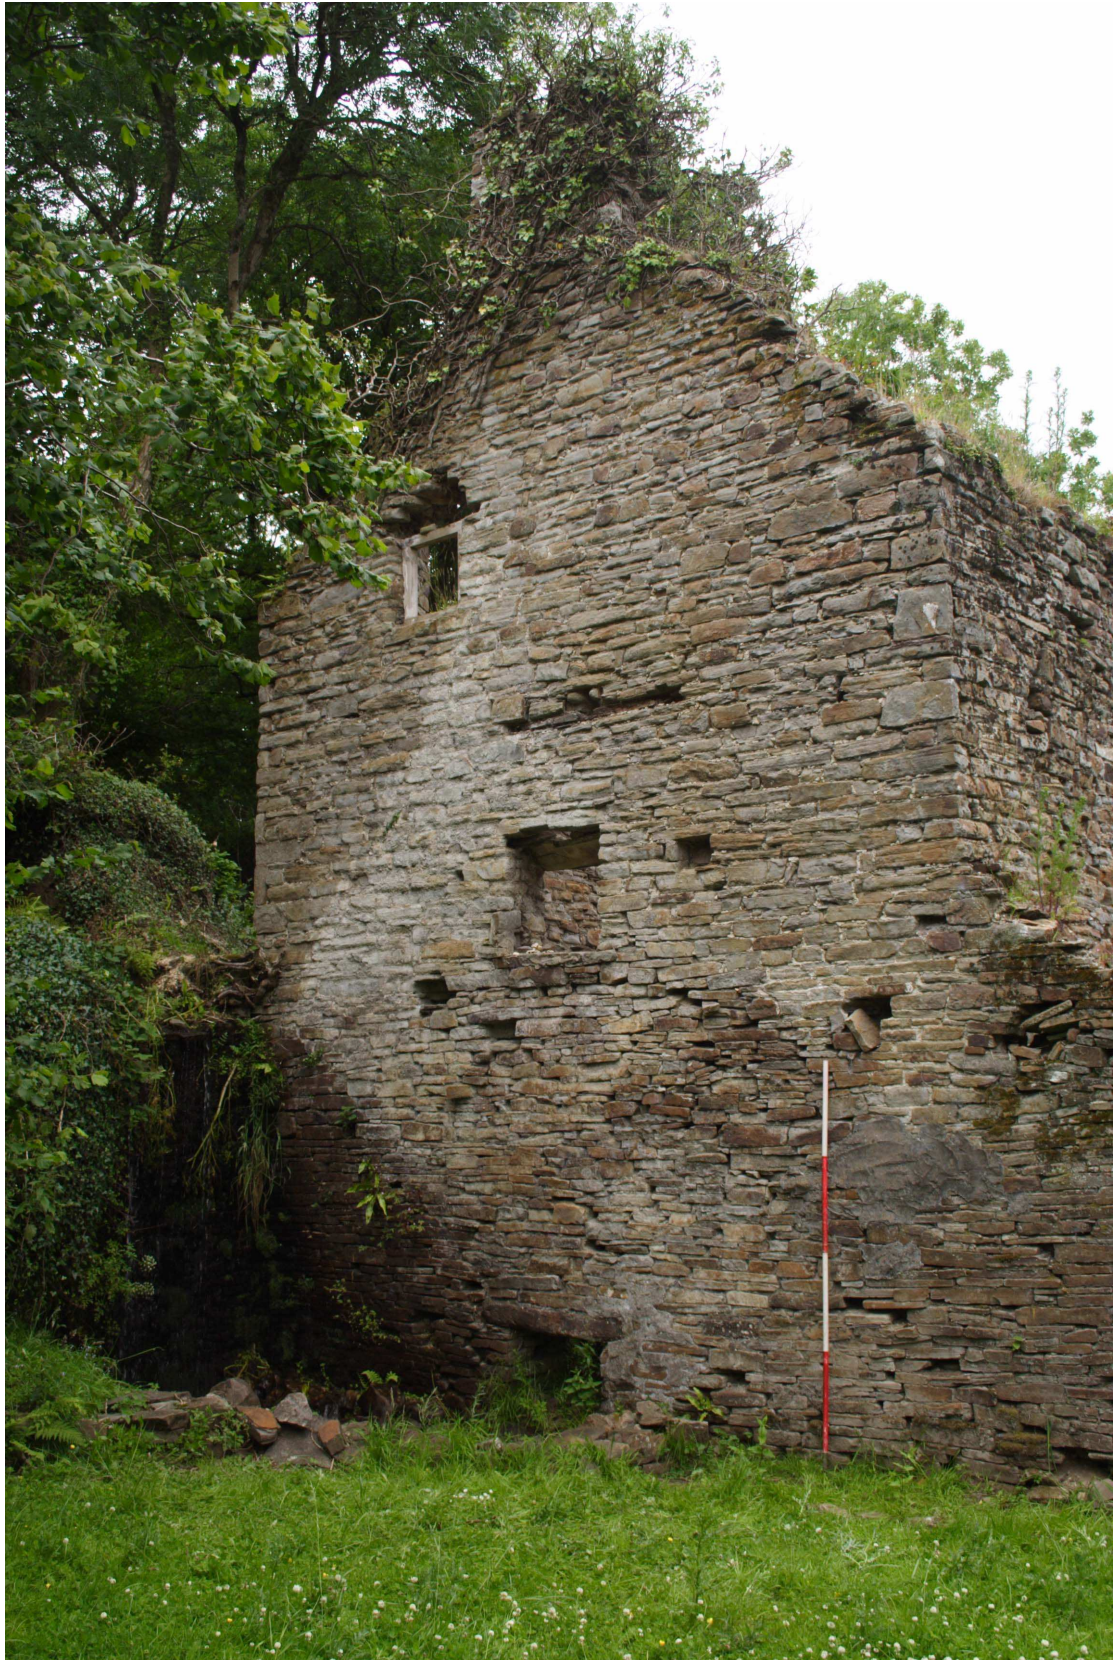
Plate 45: Gable end of mill from southwest.

Noted in the southwest gable wall were three rectangular openings. These may once have been windows to provide light and ventilation to the basement level. Alternatively, they may once have been used to accommodate substantial floor joists for supporting the first floor where the millstones for grinding may have been housed.

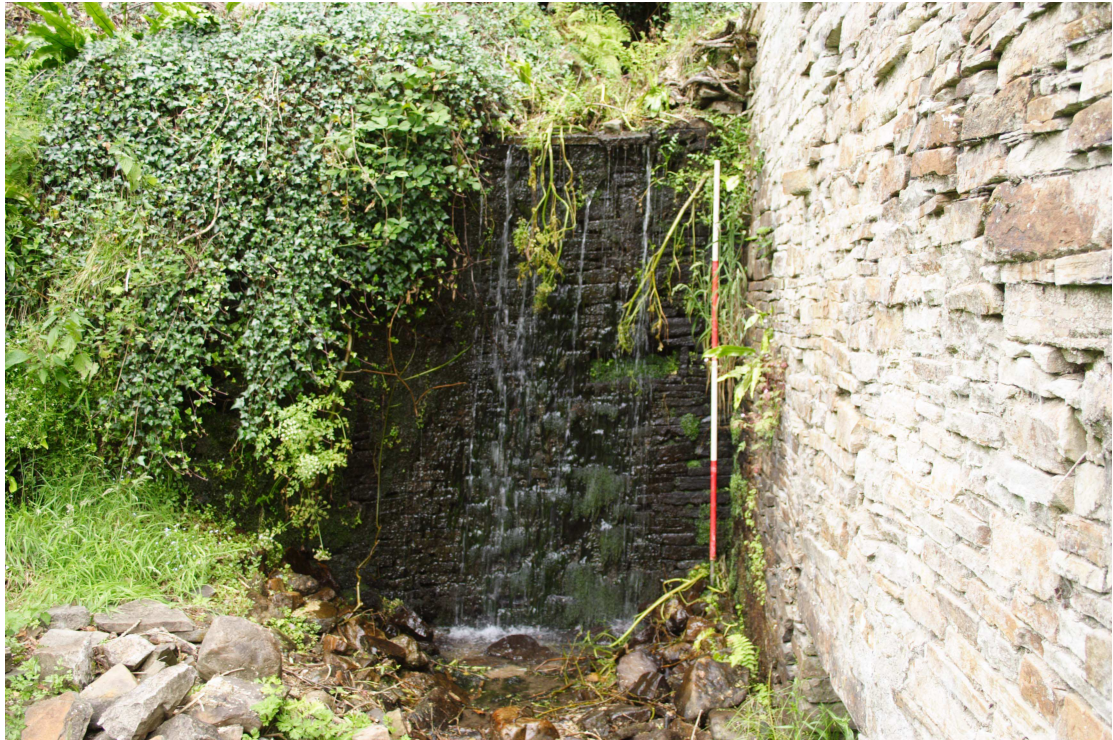
Plate 46: Head race wall from southwest.

Running along the northwest side wall, and continuing to the site of the former wheel pit, a covered over tail race was noted. To the northeast of the wheel pit a c.2m high wall was noted, this once functioned as the head of the head race. Within the head race wall was a c.0.4 x 0.2m recess that may suggest the original waterwheel was breastshot whereby water entered the wheel below the top. However, the presence of sockets in the north west gable wall of the mill may indicate that a breastshot wheel was replaced by either an overshot or pitchback wheel whereby water enters at the top of the wheel. Both these forms of wheel provide more power than the breast shot system. This upgraded power system may have been installed at the same time as the extension to the original mill was constructed.

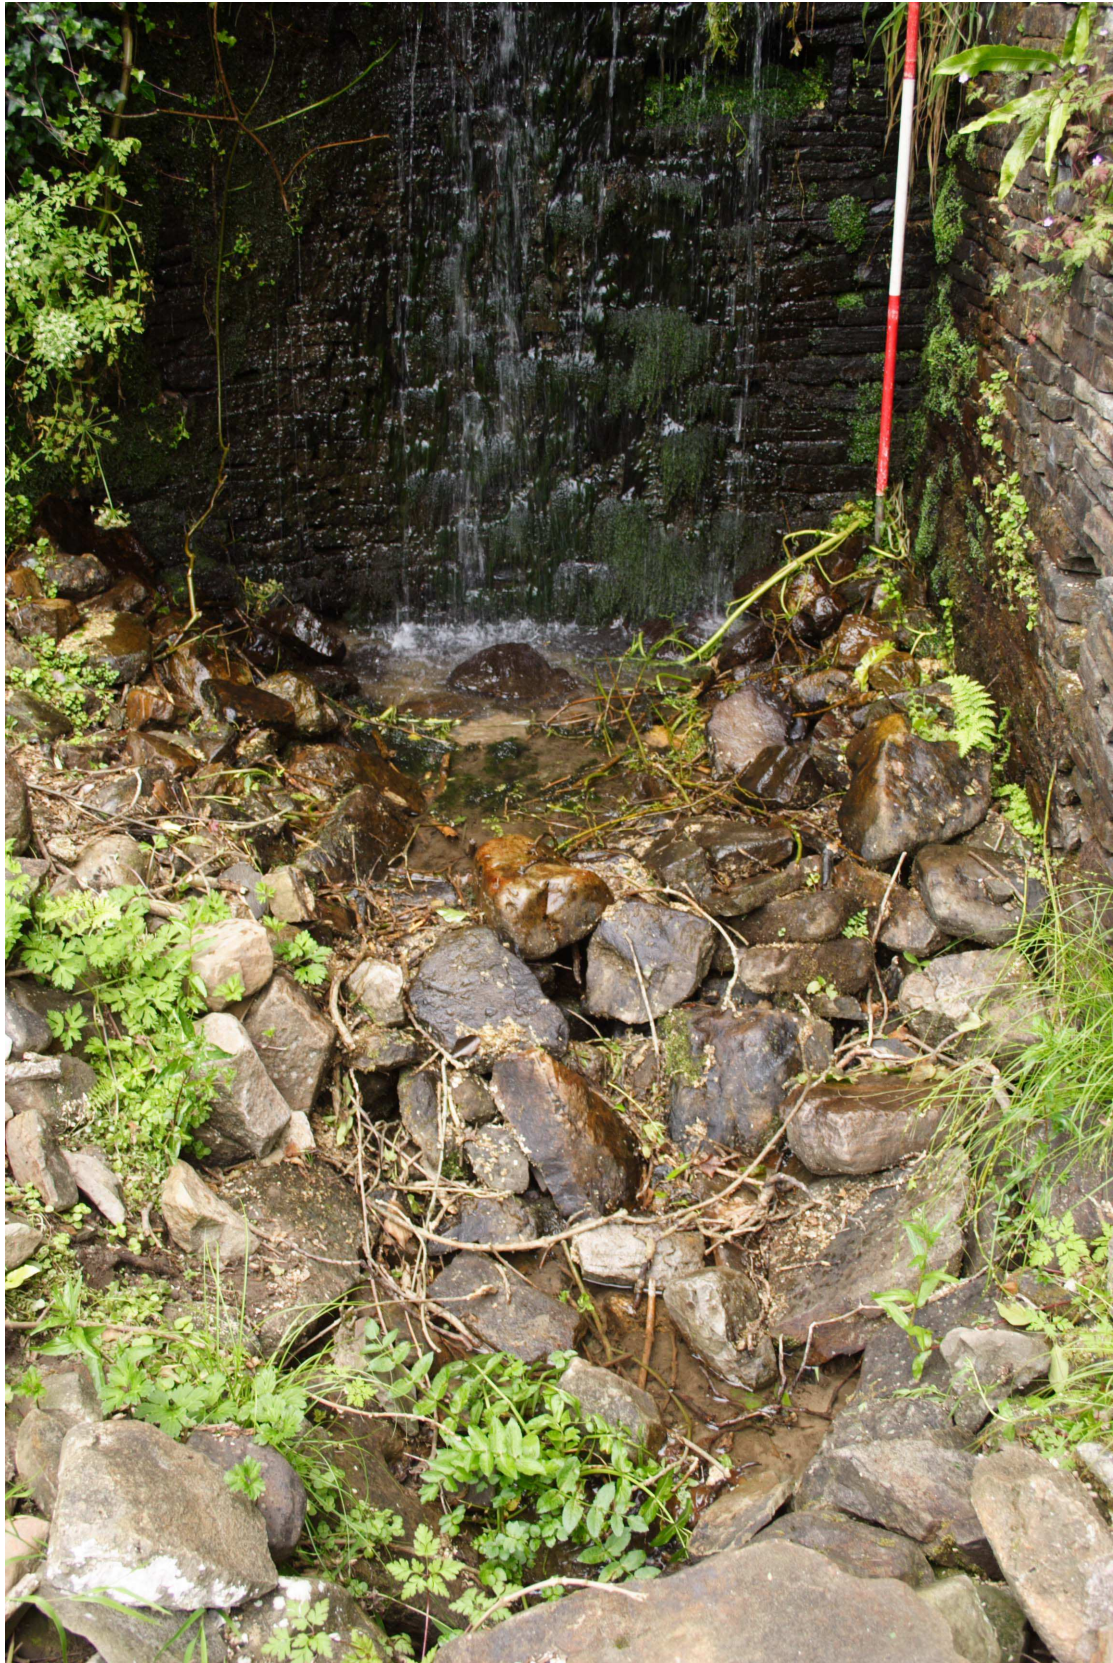
Plate 47: Former wheel pit.

The northeast gable wall was pierced by two broadly square window openings set at high level. It was also noted that the scars of floor joists were present, which suggests that the mill once had a second floor. No indication of floor joists were noted on the southwest gable wall at this level which may suggest that the floor did not continue across the whole length of the structure. An additional opening was noted at ground level, this is likely to have been where the axle of the waterwheel entered the mill. Externally at this point the remains of a silted up wheel pit were noted along with the mill head race and covered over tail race.

It is also likely that the water wheel powering the mill was upgraded from breast shot to either over shot or pitch back to provide more power. This was probably carried out at or around the same period as the extension was constructed.
