# PREHISTORIC DEFENDED ENCLOSURES: REMOTE SENSING 2008-2009

RHIF YR ADRODDIAD / REPORT NO. 2009/12  
RHIF Y PROSIECT / PROJECT RECORD NO. 94751

# PREHISTORIC DEFENDED ENCLOSURES REMOTE SENSING

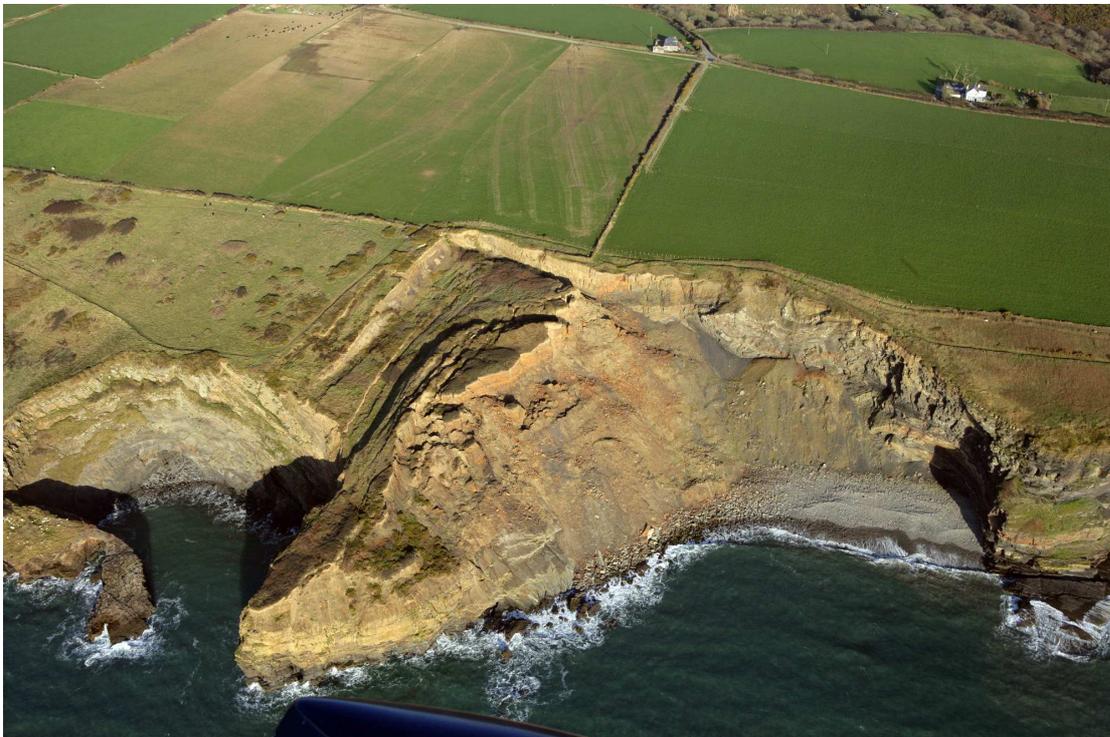
*Fig.8. 2008 RCAHMW aerial photograph*

As well as the deep north-south fissure shown on the modern vertical aerial photograph others running east-west are visible on the LiDAR image and 2008 RCAHMW photograph. Of all the available data sources this image (Fig. .) shows most clearly the extent of coastal erosion at this site.

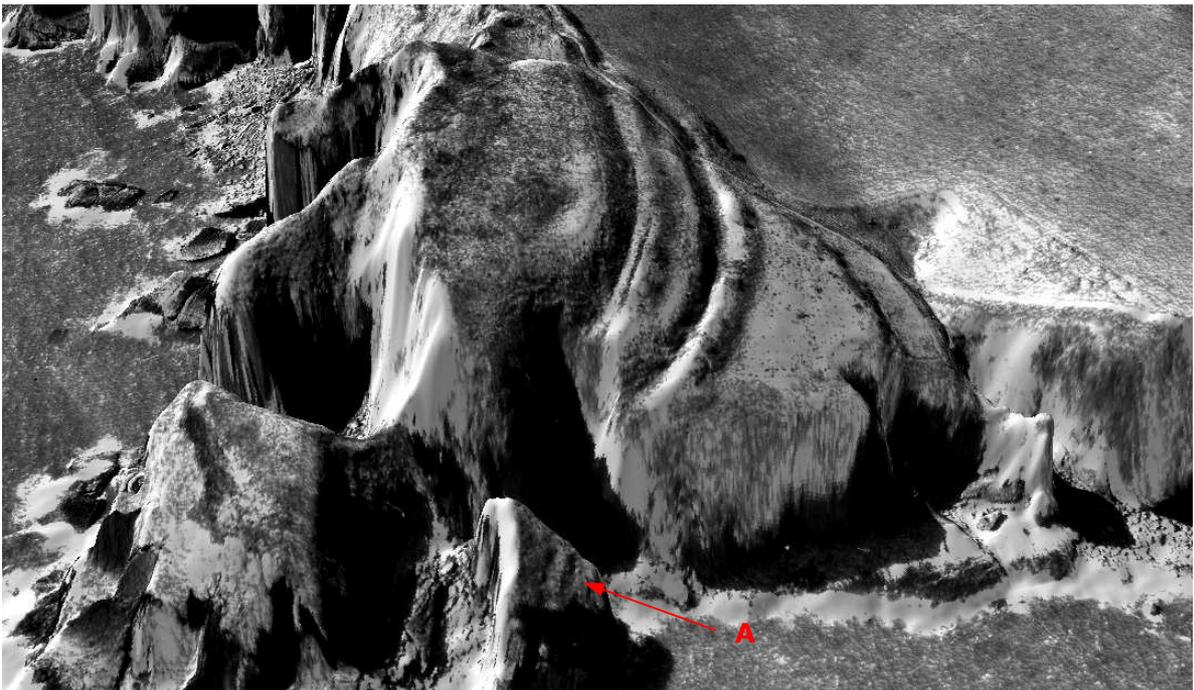
*Fig.14. Digital Elevation Model with AP overlay. Note the continuation of the ditches at 'A'.*

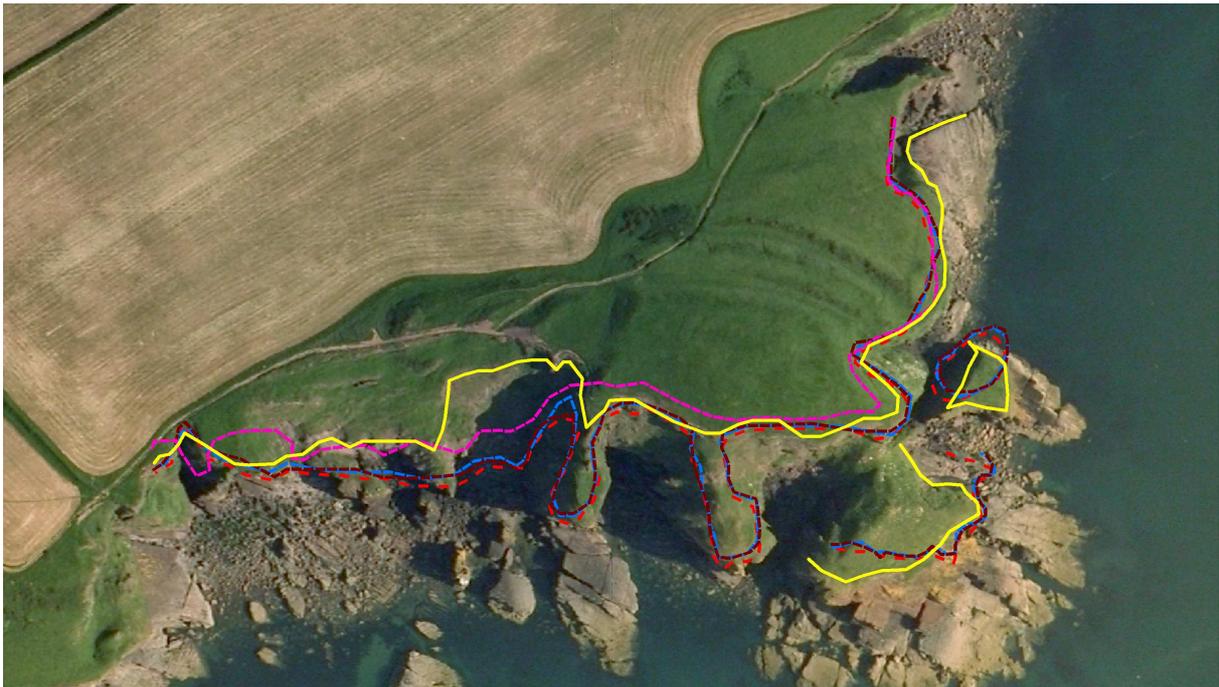
Fig.16. Map regression. Yellow line in this image shows edge of apparently stable vegetation.

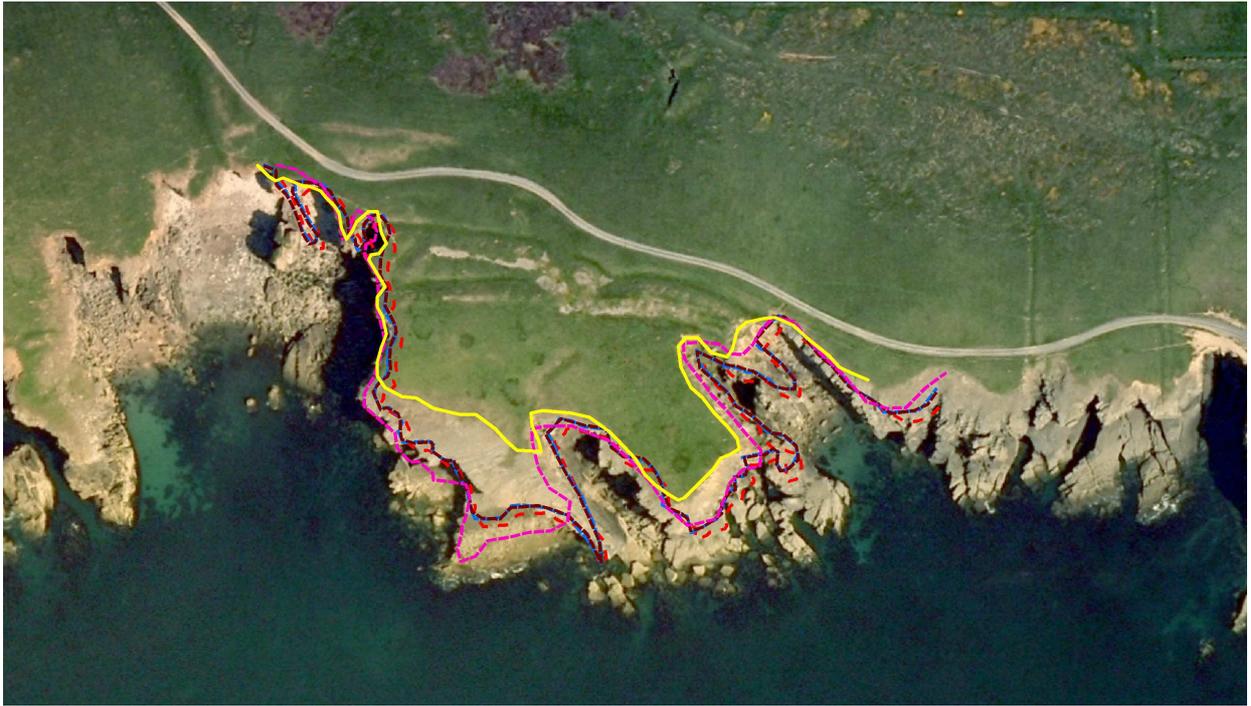
*Fig.24. Map regression*

- - - = 1<sup>st</sup> edition OS map
- - - = 2<sup>nd</sup> edition OS map
- - - = 3<sup>rd</sup> edition OS map
- - - = Black & white aerial photograph
- - - = NAW colour aerial photograph

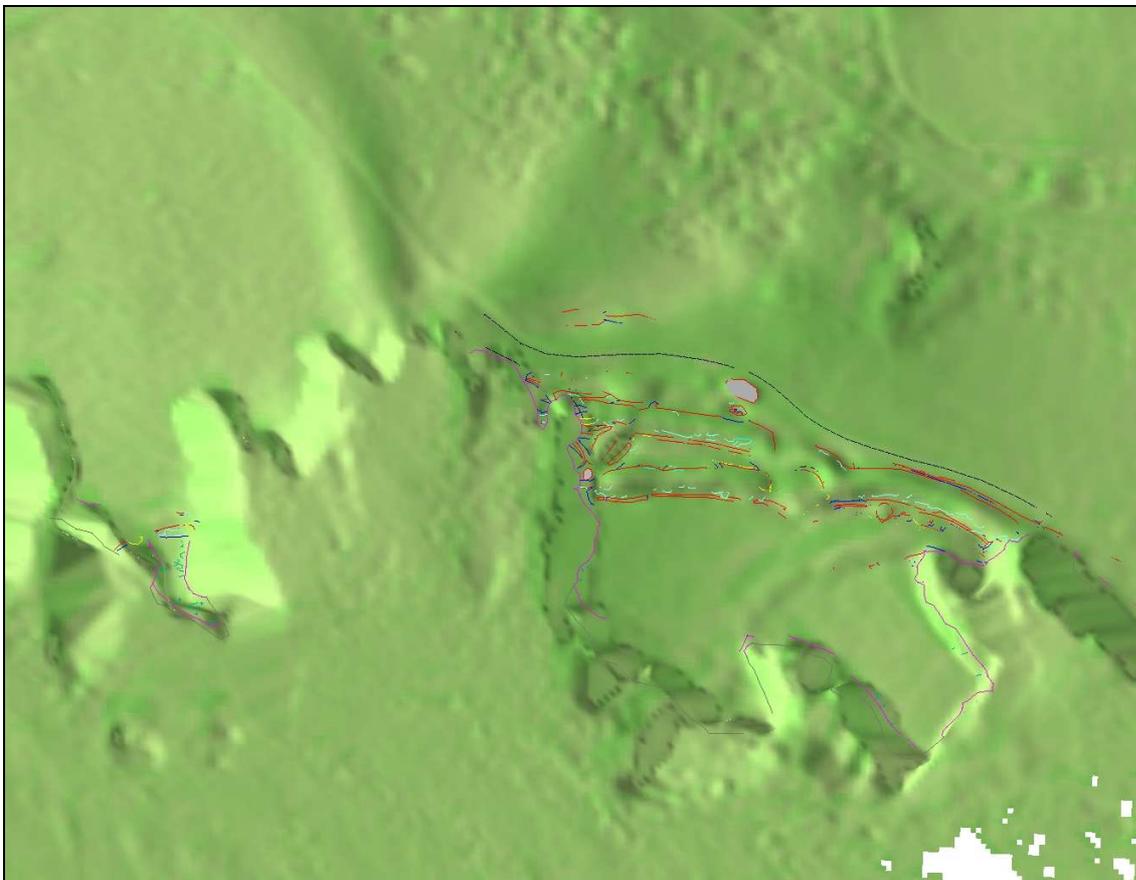
*Fig.28. GPS survey in plan over DEM. Despite the discrepancies in recorded cliff edge between the two datasets there is little variation in the location of archaeological features.*

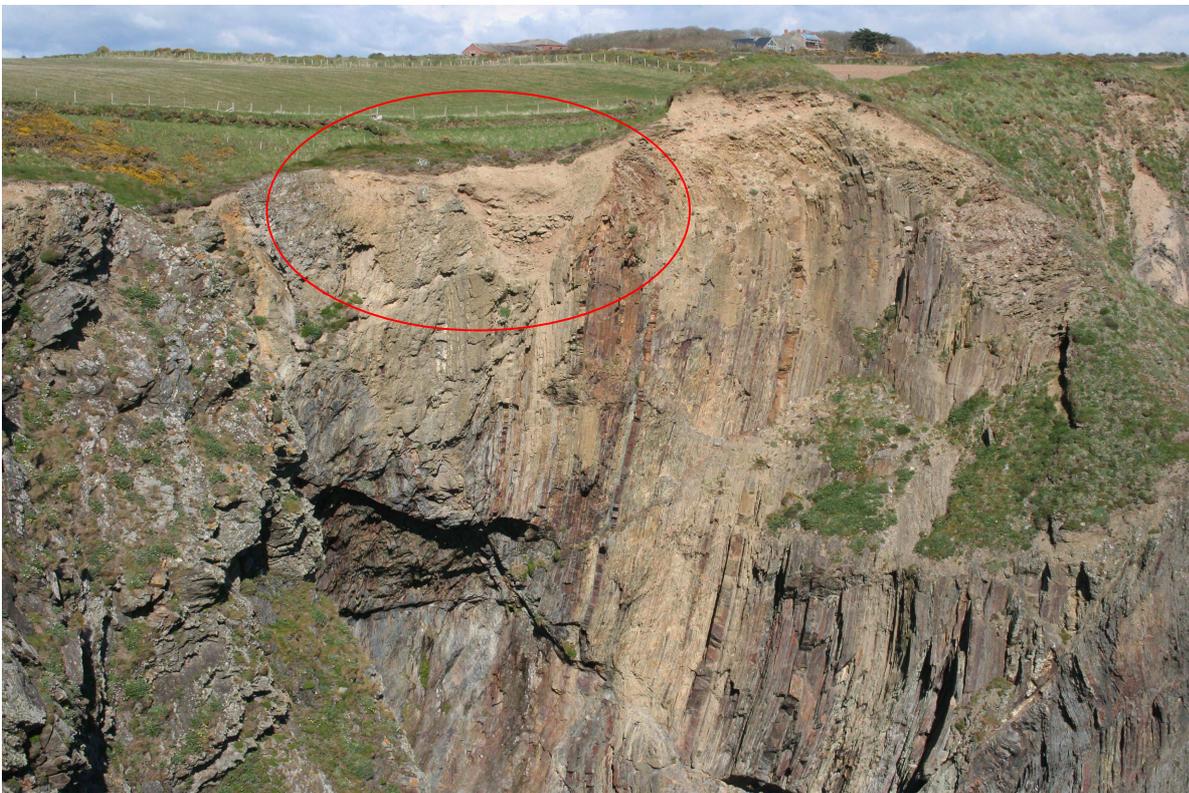
Fig. 33. 2009 DAT image taken from the south-western tip of the westernmost promontory and showing the ditches in section

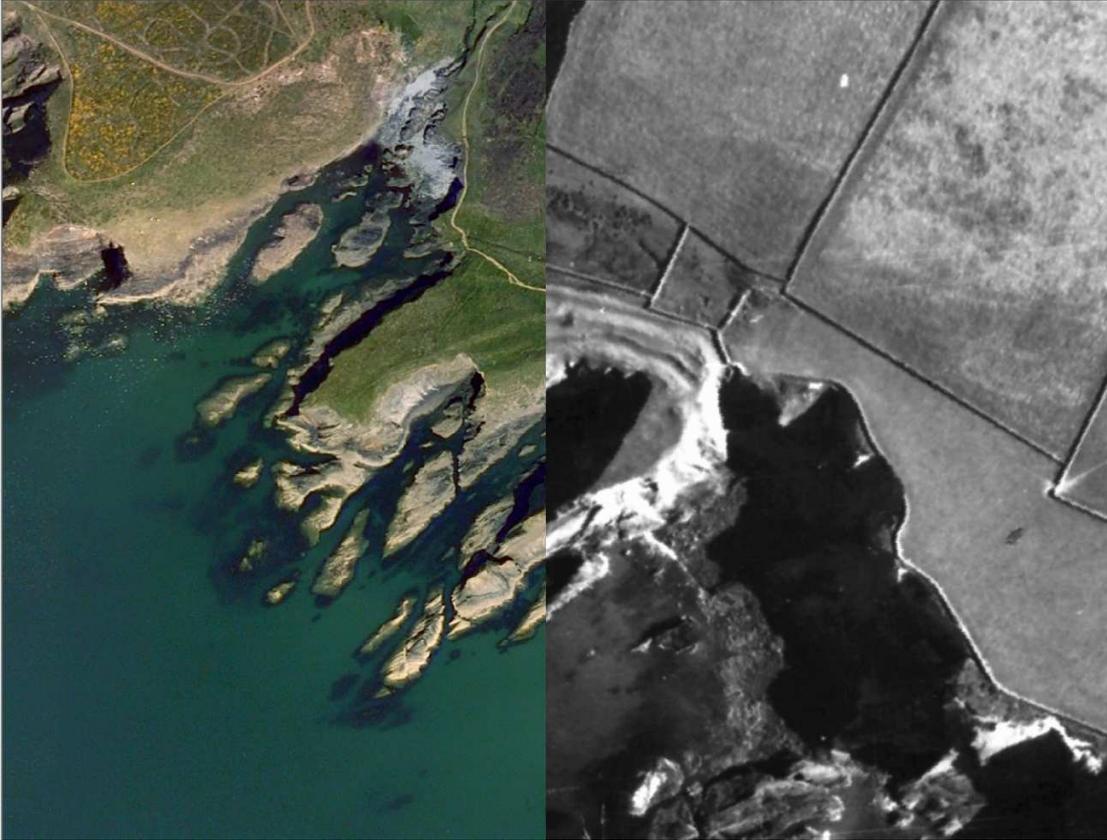
*Fig.34. Side by side comparison of historic and modern AP mapping.*

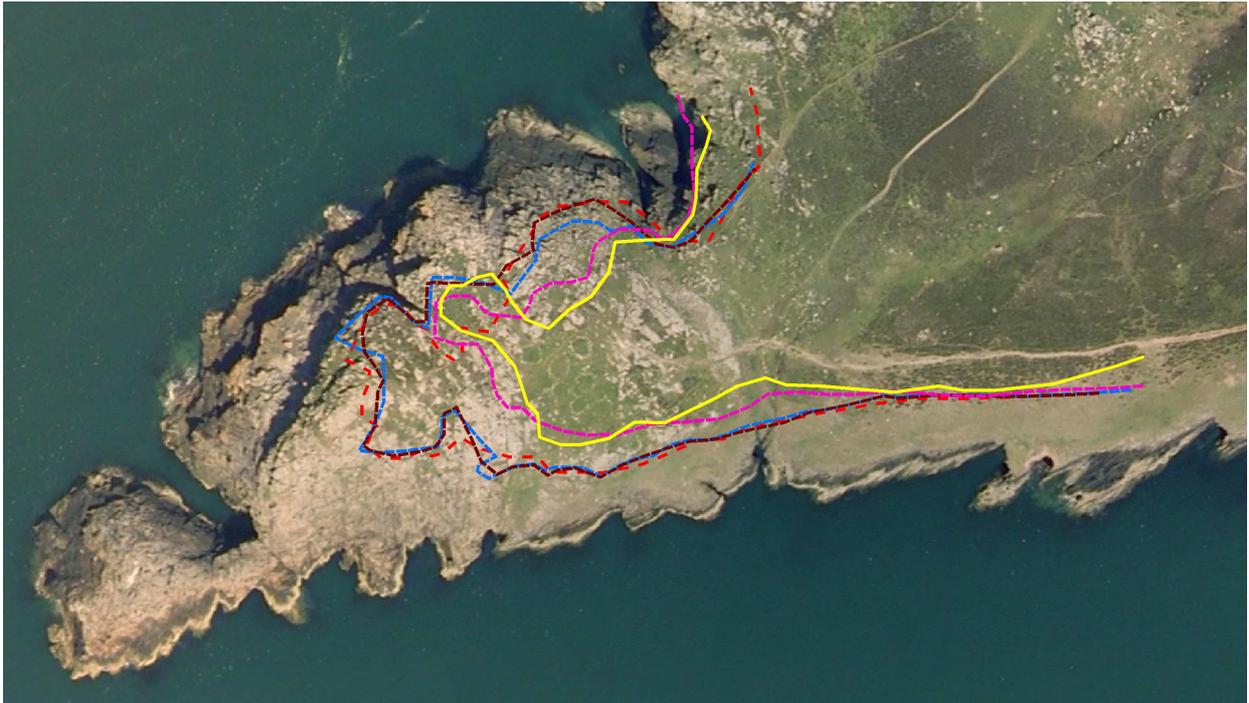
*Fig.39. Map regression.*

- - - - = 1<sup>st</sup> edition OS map
- - - - = 2<sup>nd</sup> edition OS map
- - - - = 3<sup>rd</sup> edition OS map
- - - - = 1972 aerial photograph
- - - - = NAW colour aerial photograph

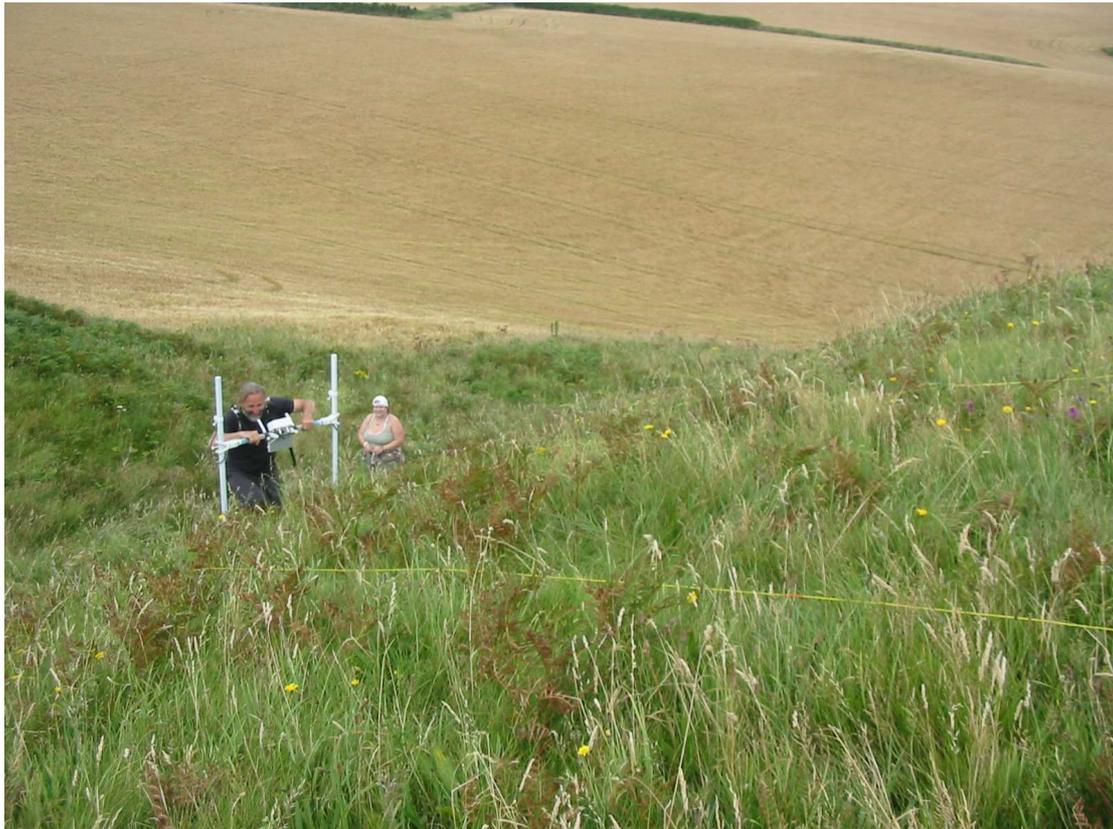
**Photo 1:** Steep bank south of inner entrance looking at entrance from inner annex. This caused problems with even data collection. View NW
