DŴR CYMRU, TROEDYRHIW PHASE 3 WATER MAINS REHABILITATION SCHEME: ARCHAEOLOGICAL WATCHING BRIEF

JANUARY to JUNE 2008

REPORT NO. 2009/18
PROJECT RECORD NO.94854

February 2009

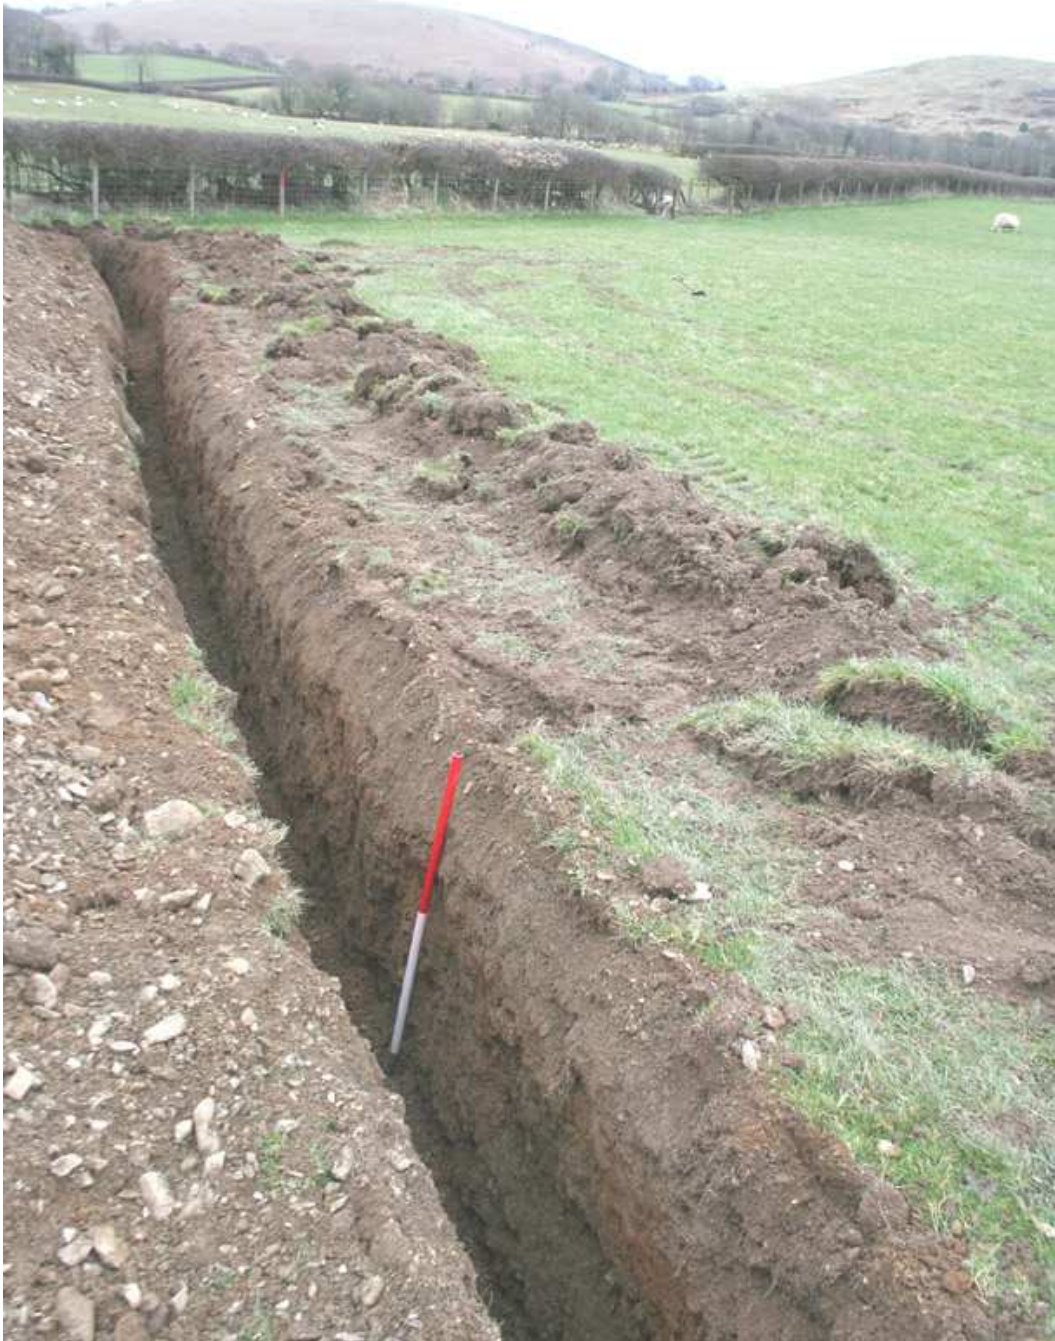
Photo. 1 View of open-cut trench looking east , 1m scale, showing natural deposits. The sheep, top right, is grazing on the *agger* of the Roman road.

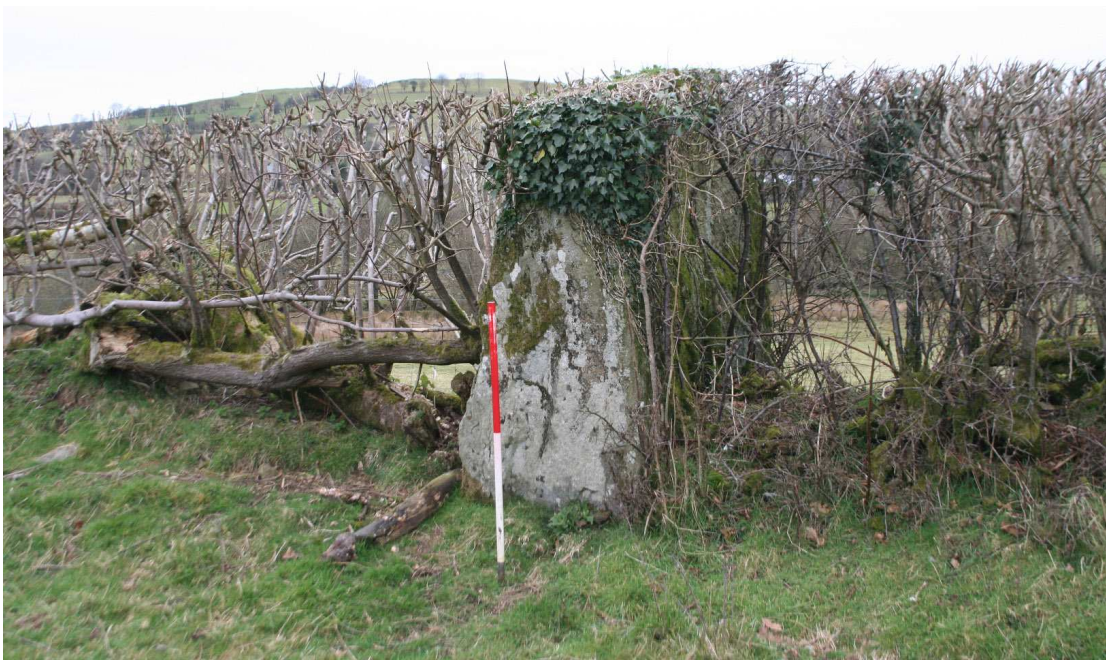
Photo. 2 Standing stone PRN 4069, looking northwest. Scale 1m.

A pair of standing stones (marked in yellow on Figure 2), one of which lies close to the route of the water main, are the reason for an archaeological watching brief being maintained in this map area. The stones, Scheduled together as an ancient monument (SAM number CM 182), date from the Bronze Age and are thought to be either ritual monuments or way markers. The site has been given the name Berrisbrook after the farm that lies close by to the southeast. Dŵr Cymru Welsh Water agreed to divert the water main to the west of the southernmost stone (PRN 4069 Photograph 2), however, sites such as this often have outlying below-ground features or deposits associated with them in reasonable proximity, so the potential for revealing archaeology is high.

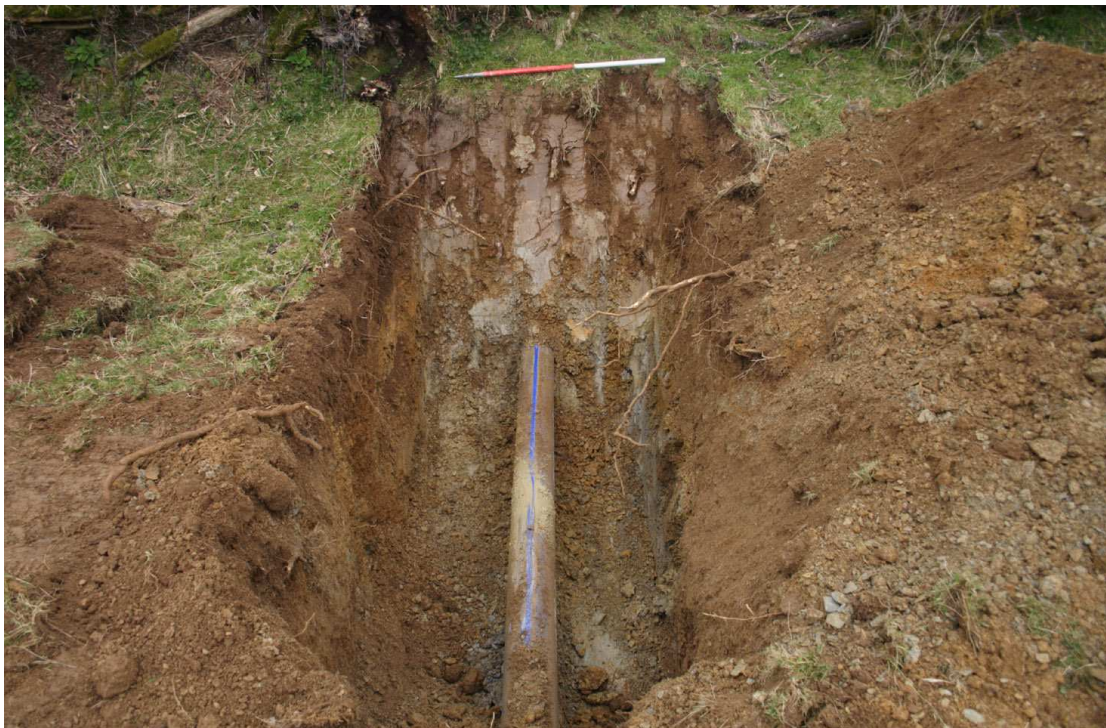
Photo. 3 Open-cut trench for air valve to the southwest of standing stone PRN 4069, showing natural deposits. Scale 1m.

An open-cut trench for the insertion of an air valve into the water main was excavated some 13m or so to the southwest of the standing stone (see Photograph 3). No archaeological features or deposits were revealed, with only natural deposits of ploughsoil, clays and gravels being represented in the trench.

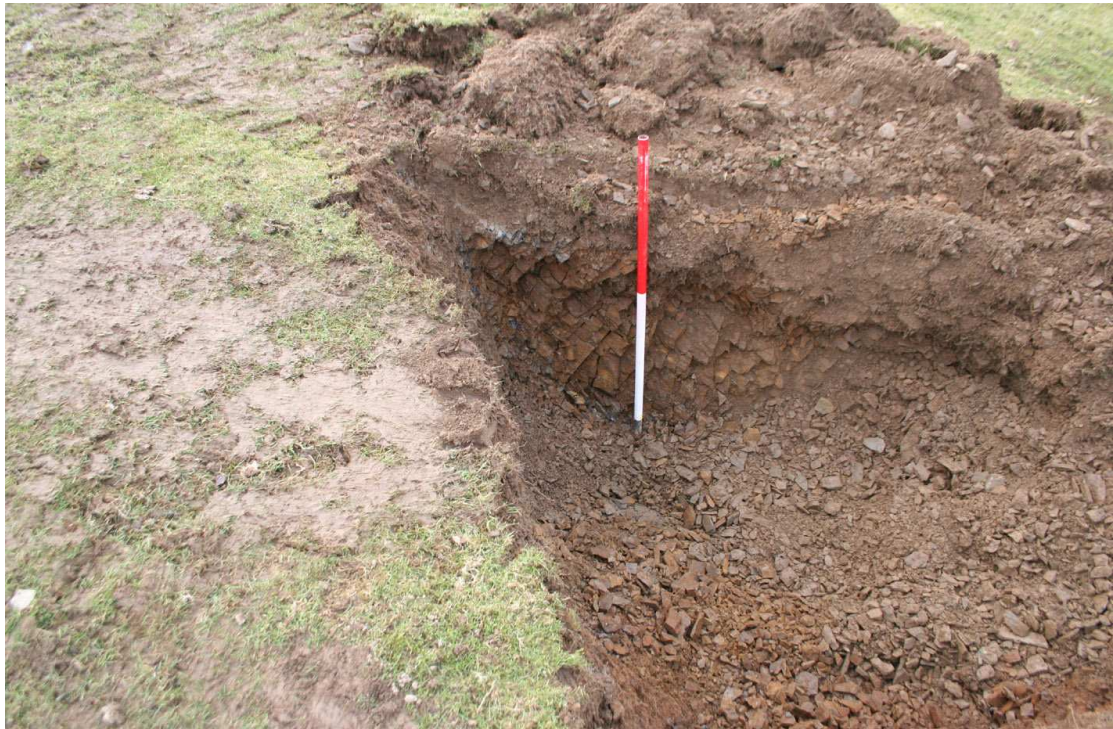
Photo. 4 View southwest showing natural deposits close to the Roman road at NGR SN74753845, 1m scale.

At the northern edge of map area 19 the watermain passes very close to the line of the known Roman road at NGR SN74753845 which is the easternmost extent of the *agger* PRN 33993. Open-cut excavation on the steep north facing slope just to the south of the agger at this location again revealed only natural deposits comprising ploughsoil of 0.2m depth overlying a 0.3m depth of orange brown shattered shale-rich subsoil underlain by shale bedrock (Photograph 4).

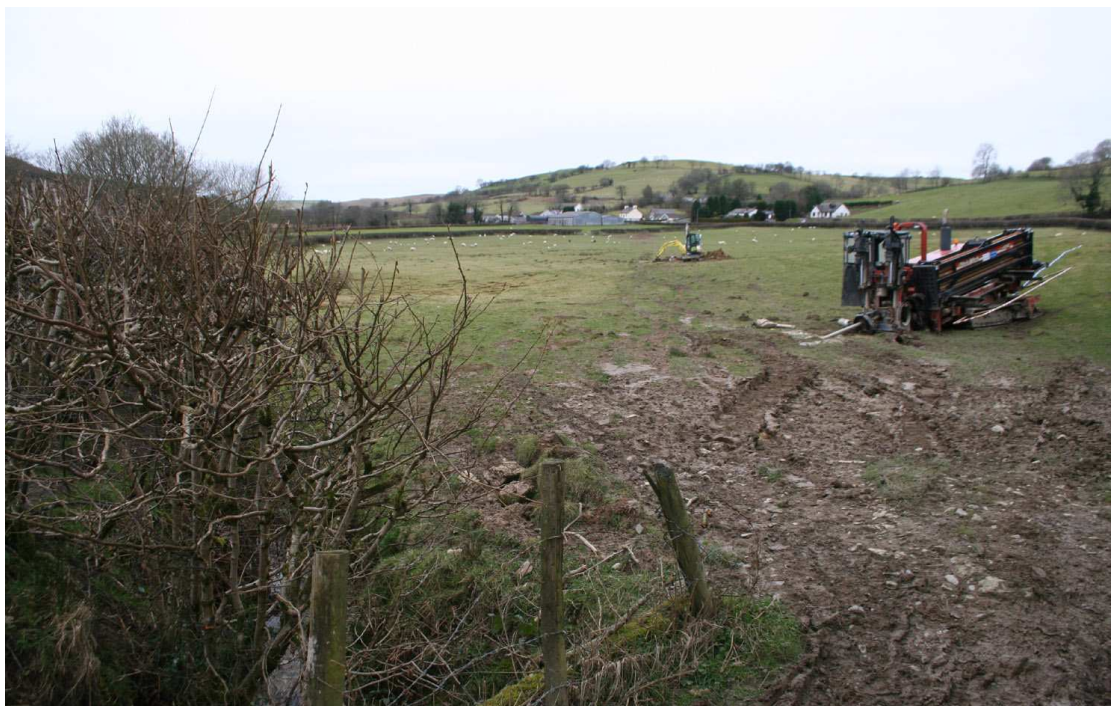
Photo. 5 Cover photograph showing drilling in action in Map Area 24. Looking northwest.
