FOLEY HOUSE CAR PARK, HAVERFORDWEST, PEMBROKESHIRE:

ARCHAEOLOGICAL WATCHING BRIEF and BUILDING RECORDING

APRIL - MAY 2009

RHIF YR ADRODDIAD / REPORT NO. 2009/90
RHIF Y PROSIECT / PROJECT RECORD NOS. 94870 & 94871

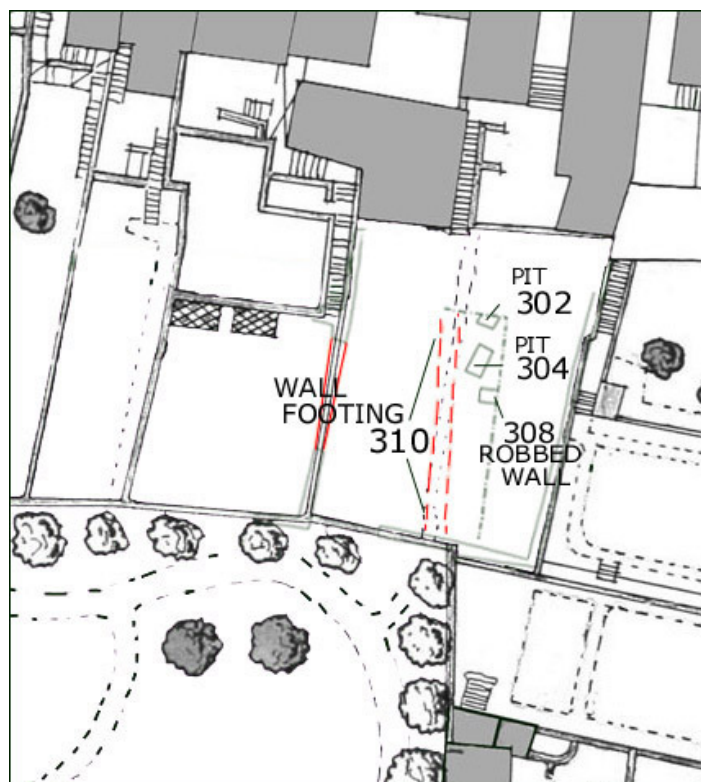
Figure 8: Schematic location of archaeological features revealed in Area F on an extract of Ordnance Survey 1:500 scale first edition map, north to top right.

Further removal of garden soil some 10m or so to the north of wall 108, and about 2m east of 310, revealed a 1m wide by 1.5m long rectangular feature (308) cut into the orange brown friable silty clay subsoil to an unknown depth. The feature lay beneath 0.25m of dark brown humic silty clay topsoil and continued beyond the eastern edge of the groundwork excavations (Photo D and Fig.8) for an unknown distance. Cut 308 contained a very stoney fill 307². The feature appeared to be the terminus of a wall foundation trench that had been robbed of its facing stone and back-filled with core work rubble. None of the available map evidence indicates the presence of a wall in this location, but its alignment, coincidentally or not, is the same as the east-west garden boundary wall between Nos. 20 and 22 Hill Lane to the east of the development area. The garden wall between the Hill Lane properties appears less substantial than that implied by 308, which might suggest that 308 is earlier and may possibly represent a former medieval burgrave boundary. Alternatively, it may represent a former boundary within the garden to the rear of the High Street properties (with a 2m wide entrance between it and the former north-south boundary wall 310)

About 1m to the north of the northwest corner of 308 a second rectangular feature (304) was revealed beneath 0.25m of garden soil, cut into the subsoil and measuring 2.10m long by 1.05m wide with its long axis aligned north to south (Photo H and Fig. 8). This feature contained a friable, dark brown, humic silty clay soil (303) that was very similar to the overlying garden soil. The fill contained frequent clay tobacco pipe bowl and stem fragments, glass shards from broken bottles, sherds of stoneware pottery and frequent blue ware ceramic sherds along with occasional small angular fragments of stone and slate. The clay tobacco pipes were datable to the late 19th century (Ayto 1994), as was the pottery. A few finds were retrieved from the upper fill of this feature, which was otherwise left undisturbed.

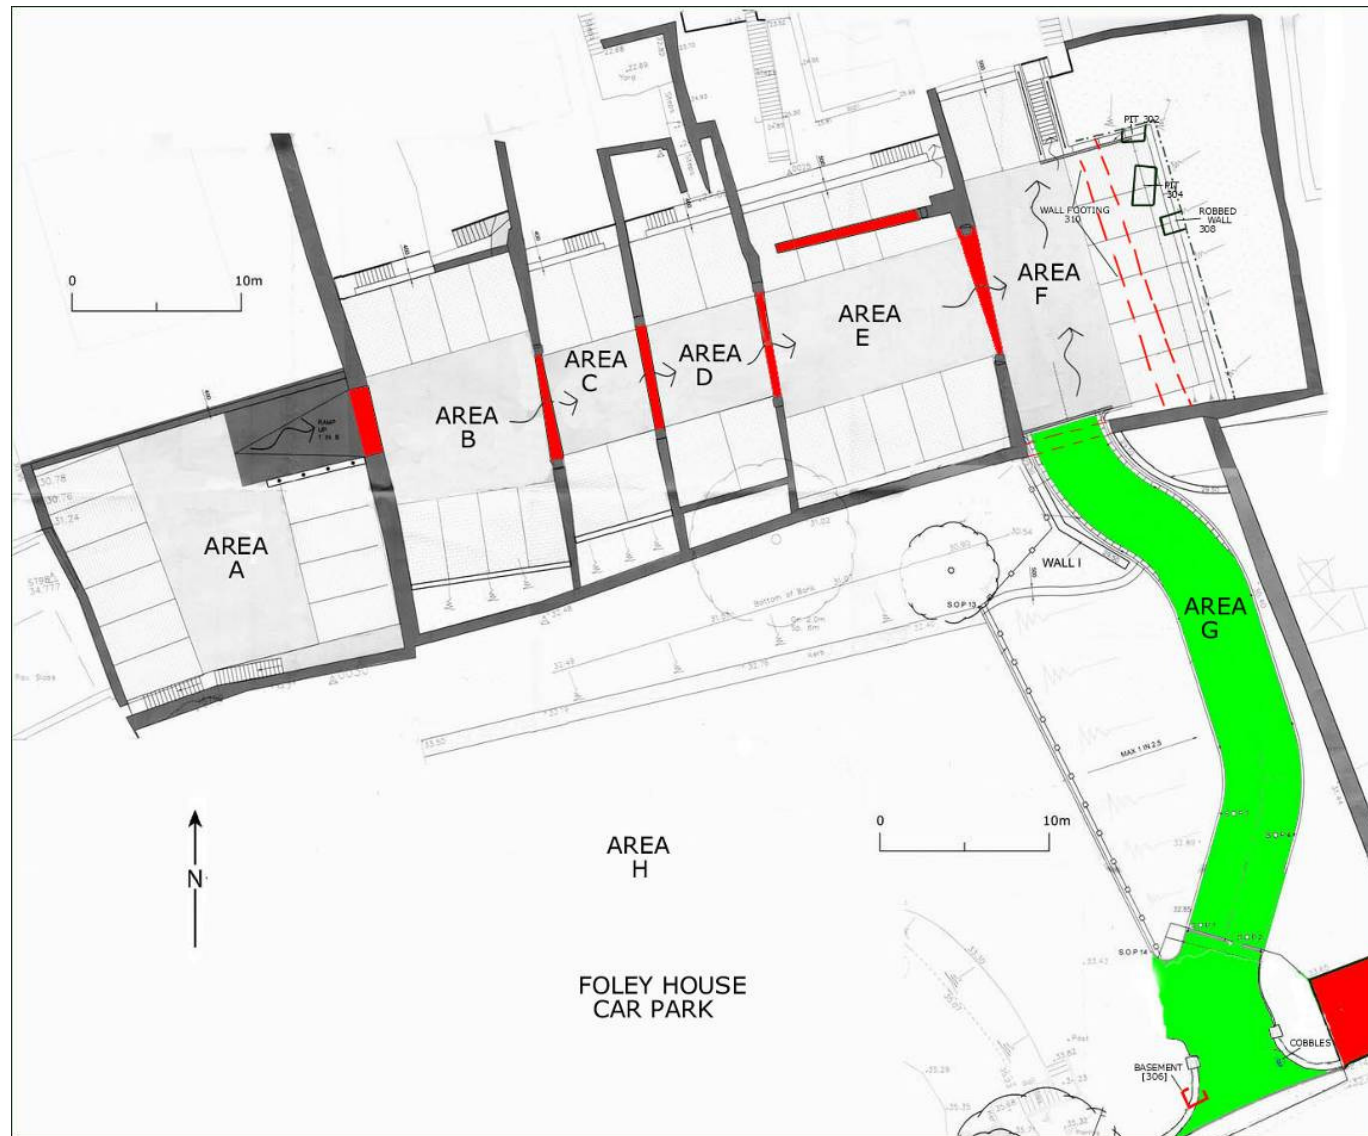
Figure 9: Adaptation of overall final site plan (see also Photos U and V) based on Atkins Ltd. original drawings, showing work Areas and schematic location of the revealed archaeological features.

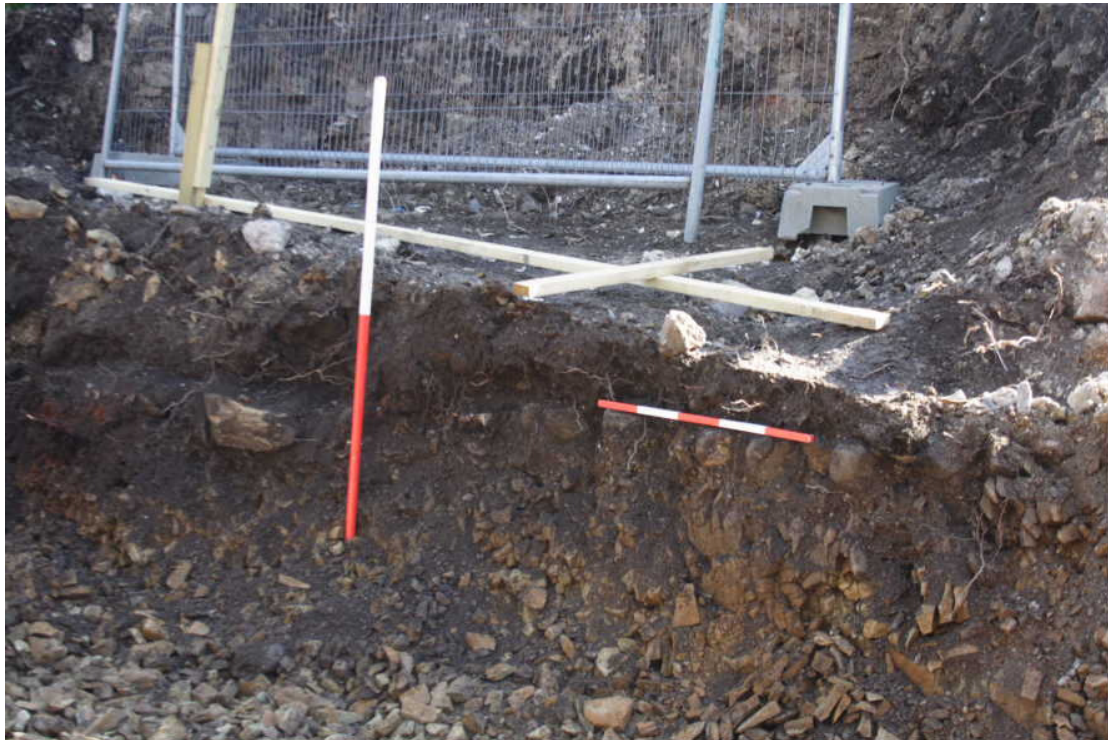
Photo A: Area of pitched cobbling exposed in the section close to wall 101 on Goat Street. View east, 1m and 0.5m scales.

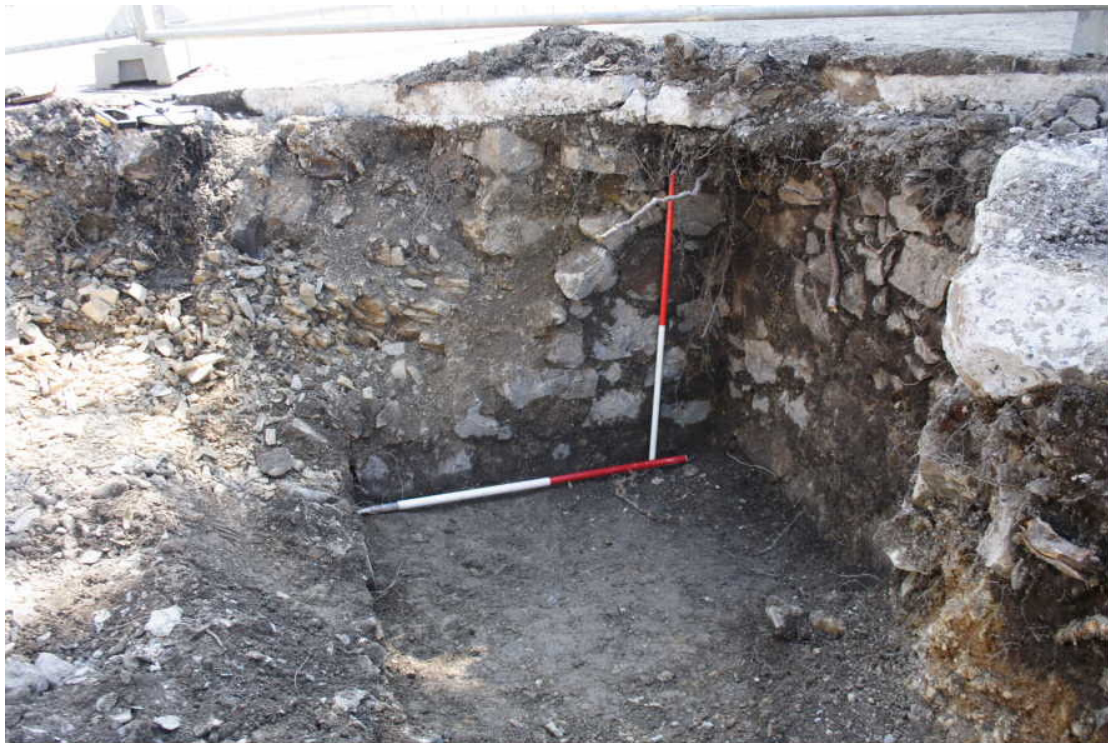
Photo B: Revealed basement structure 306, cut into the bedrock adjacent to Goat Street. View southwest, 2x1m scales.

The internal space of 306 was filled with a single homogeneous soil matrix (context 305¹). Hand-excavation of 305 revealed a flat level natural bedrock base or floor to the structure, and showed that the foundation on all four sides was cut into the natural shale bedrock to an average depth of 0.3m. Amongst the finds encountered in fill 305 were several post-medieval potsherds, two of which were sgraffito decorated slipware sherds dating to the late 17th century, a large ceramic roofing tile fragment, a clay tobacco pipe stem and a fragment of roofing slate. It is likely that the revealed structure represents part of the basement of a building that formerly fronted onto Goat Street. None of the early Ordnance Survey maps show a building in that location, which suggests that the building had been demolished prior to the construction of Foley House or that it may even have been demolished specifically to make way for the garden wall (101). The building debris contained in the fill of the structure was almost certainly demolition rubble, and its loose consistency suggested that the cleared area was not intended to take the weight of a new structure any heavier than a wall.

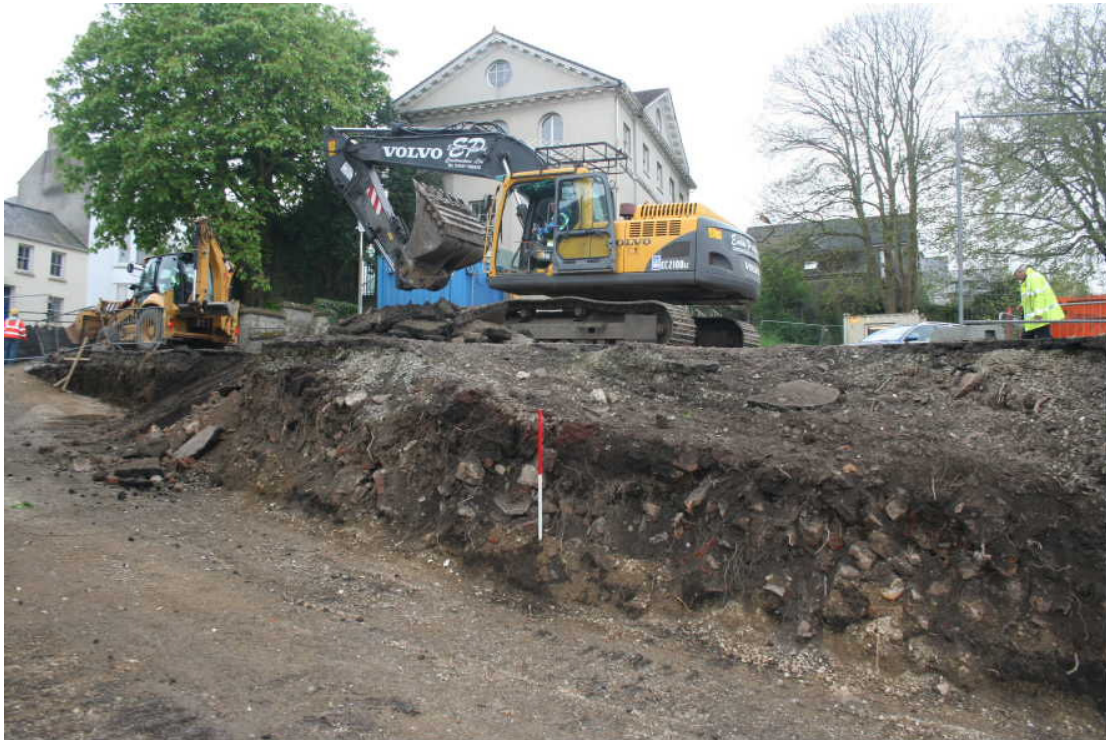
Photo C: View looking southwest, showing made ground deposits of the terrace upon which Foley house and garden were established, 1m scale.

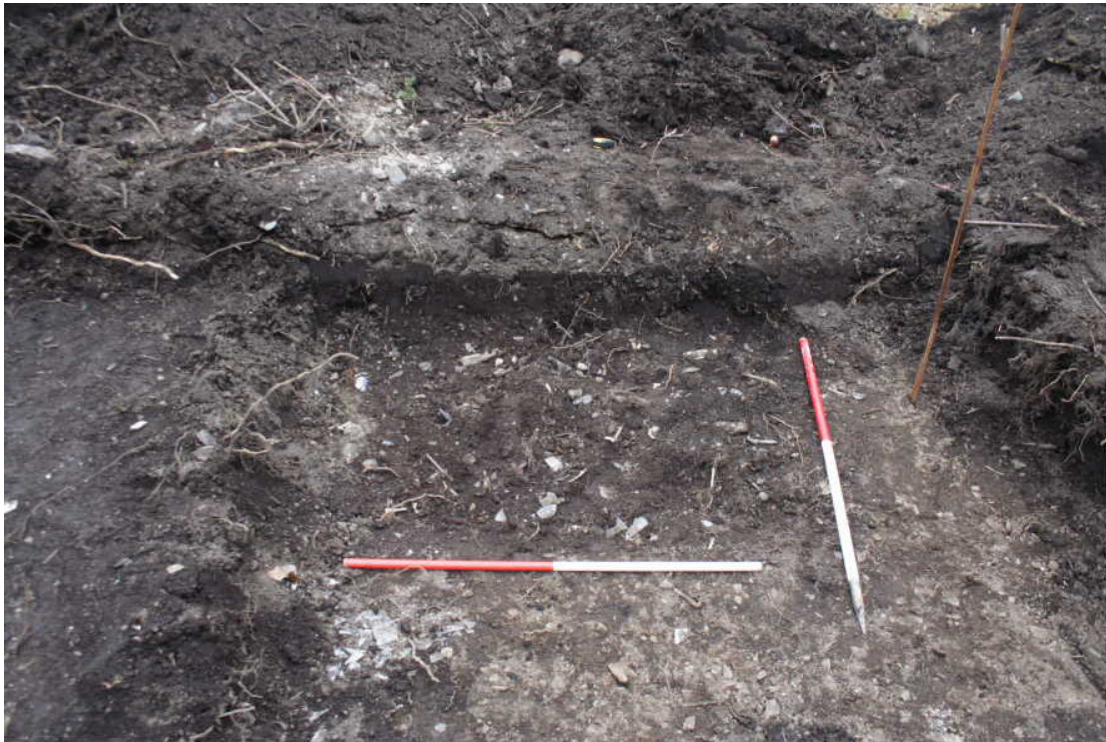
Photo E: View, looking north, of pit 302. 2 x 1m scales.

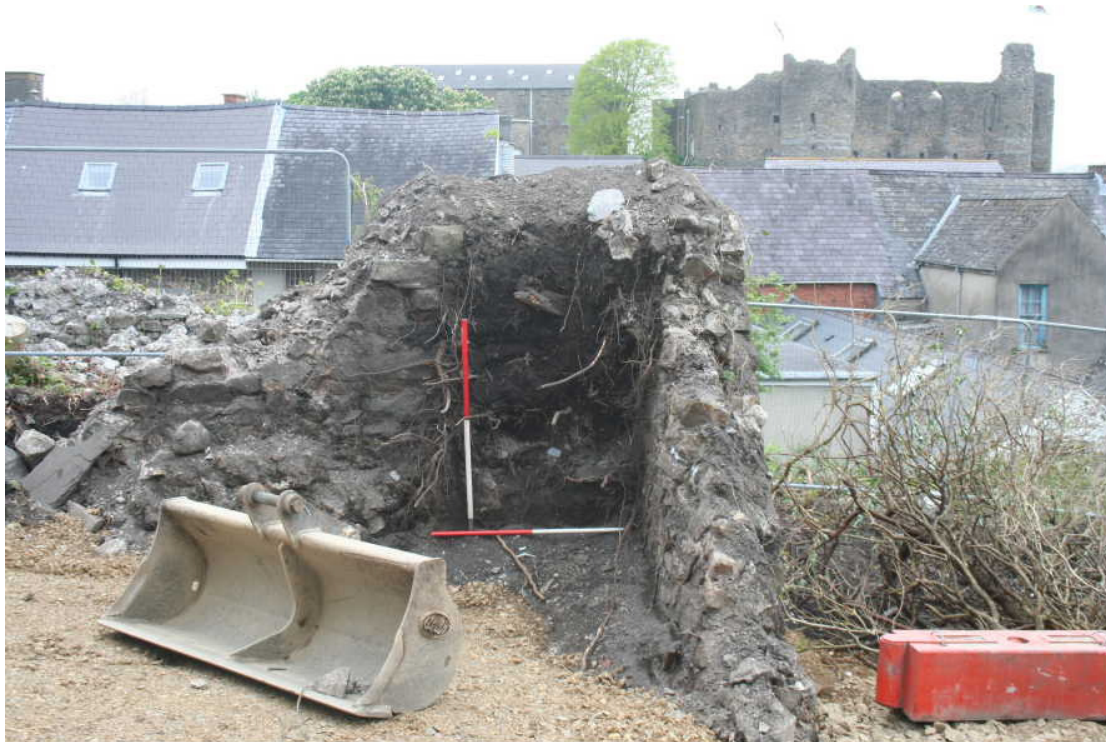
Photo F: View of the blocked access to the steps down to No. 29 High Street. Wall 102 is on the right, the east-west boundary wall is to the left. Looking north, 2 x 1m scales.

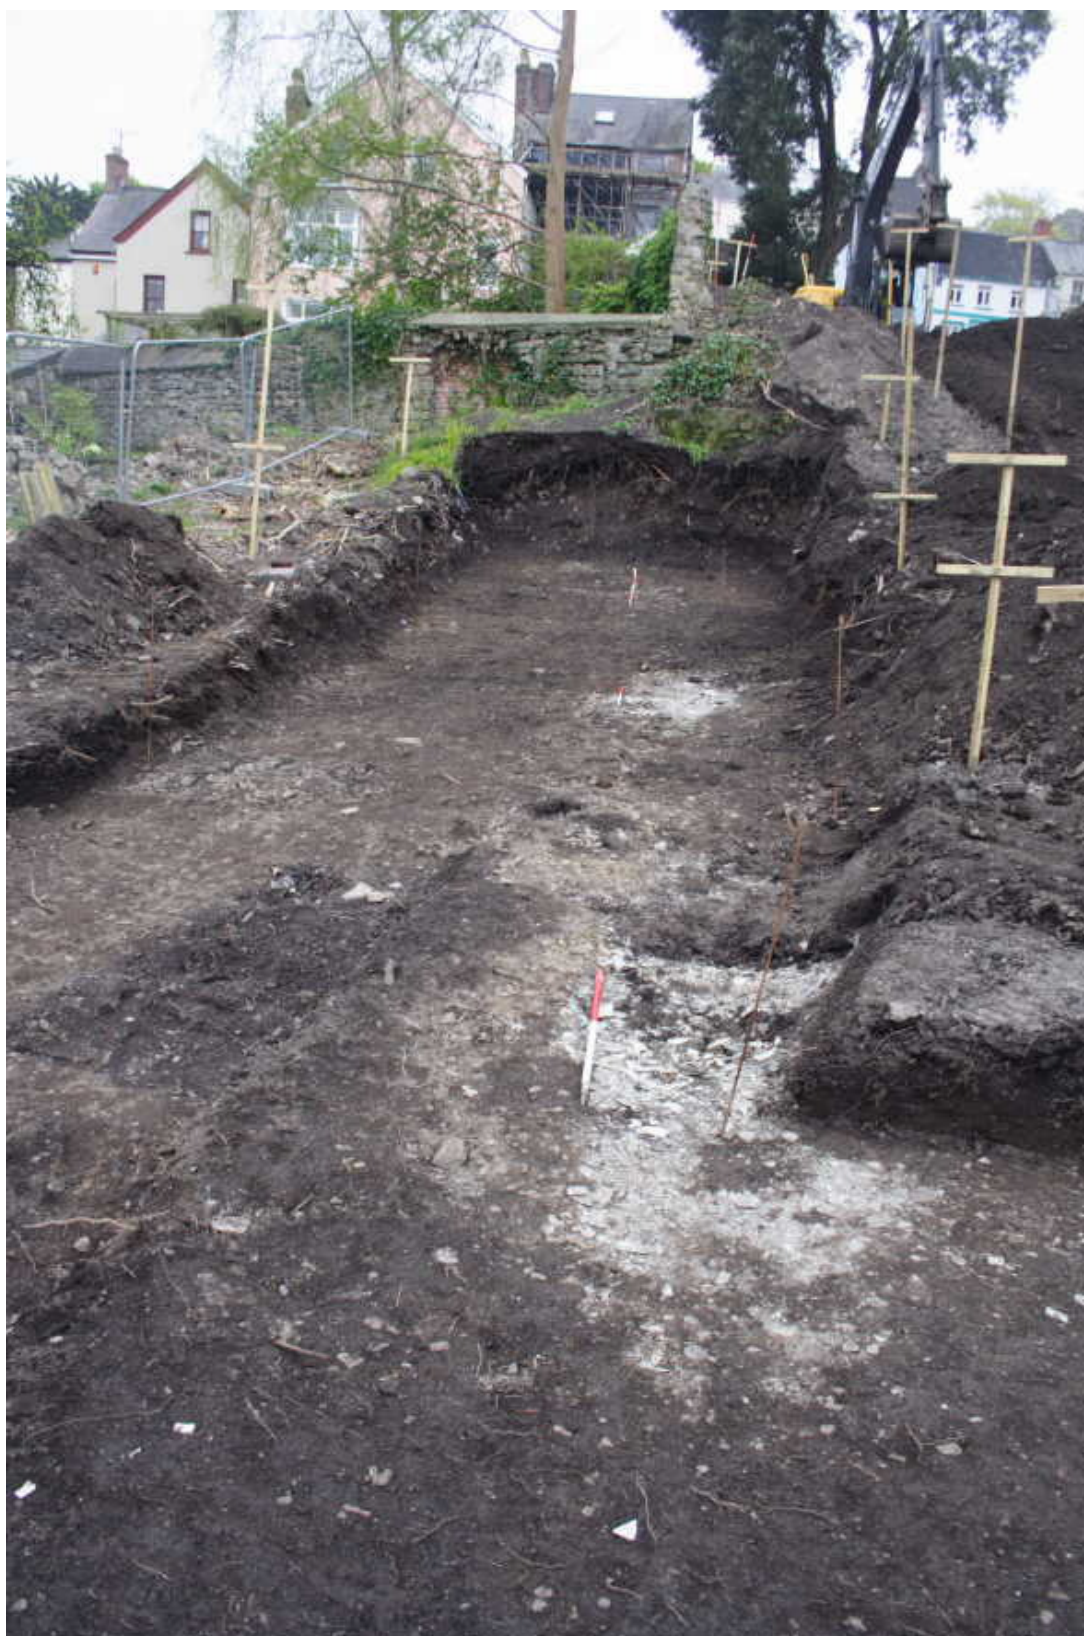
Photo G: The light areas next to the scales represent the revealed wall footing (310) of the former garden boundary in Area F. Looking south, 3 x 1m scales.

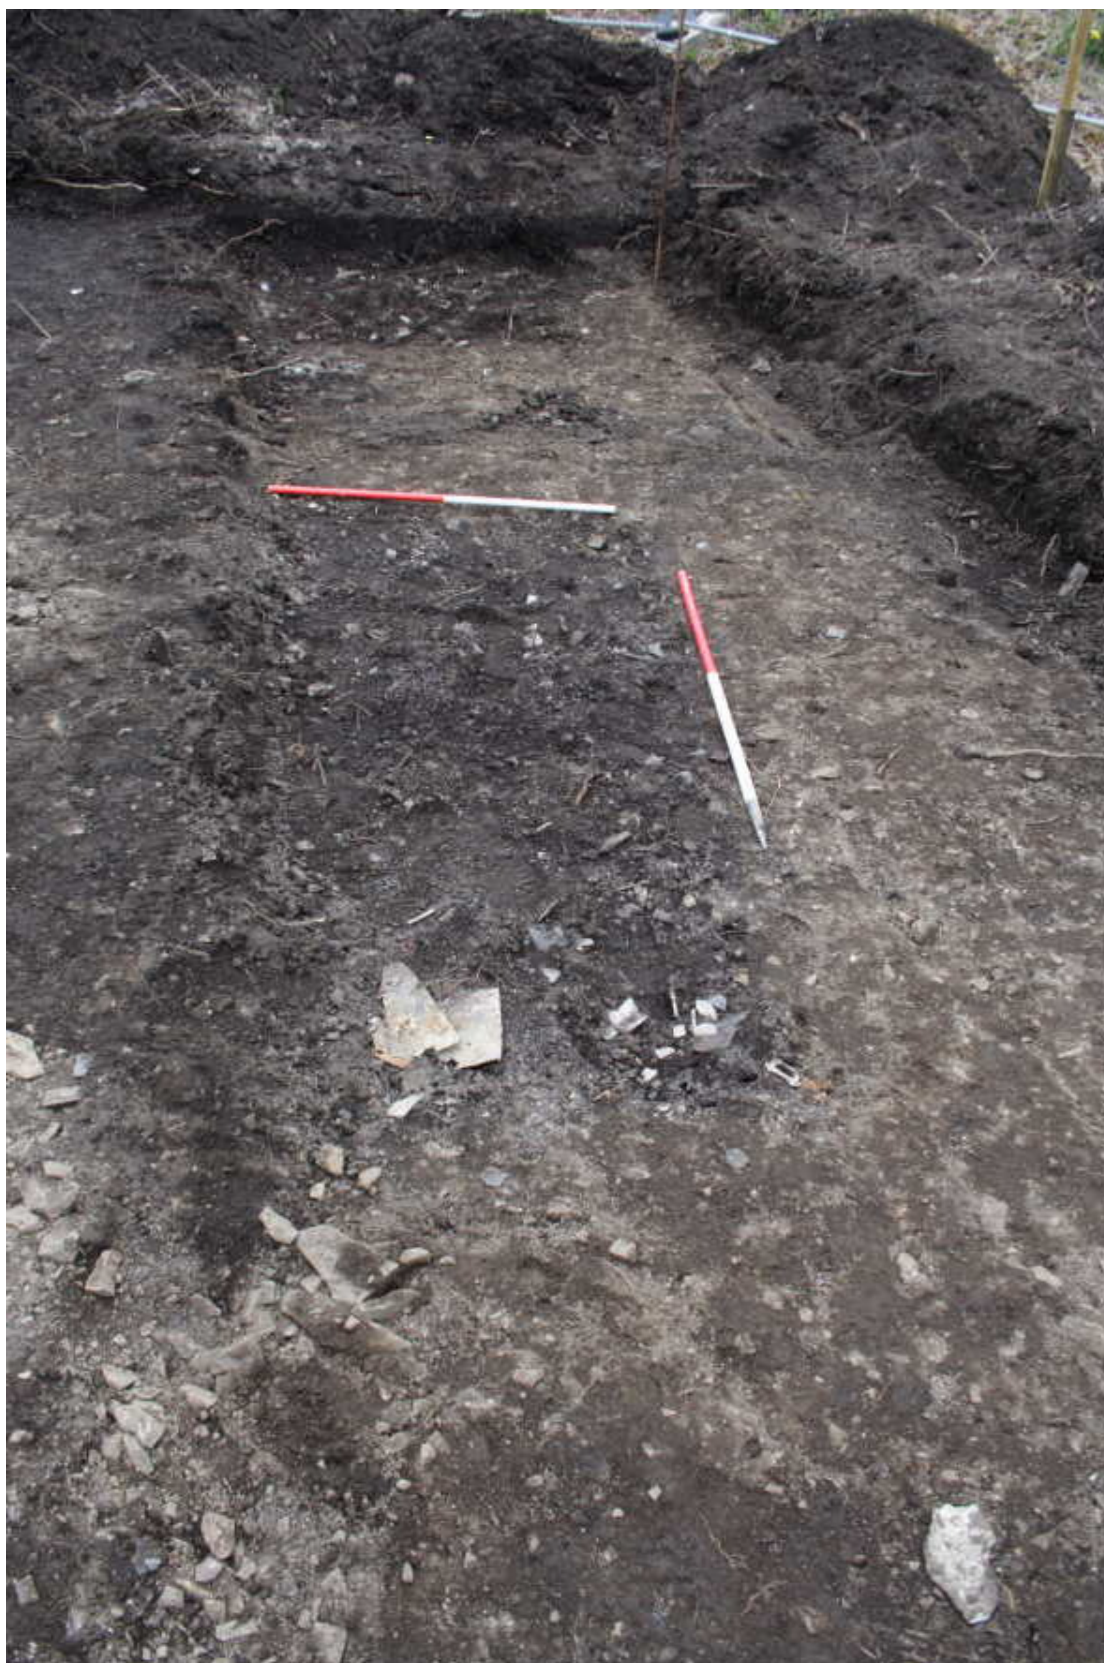
Photo H: View of rectangular pit 304 looking north, 2 x 1m scales.

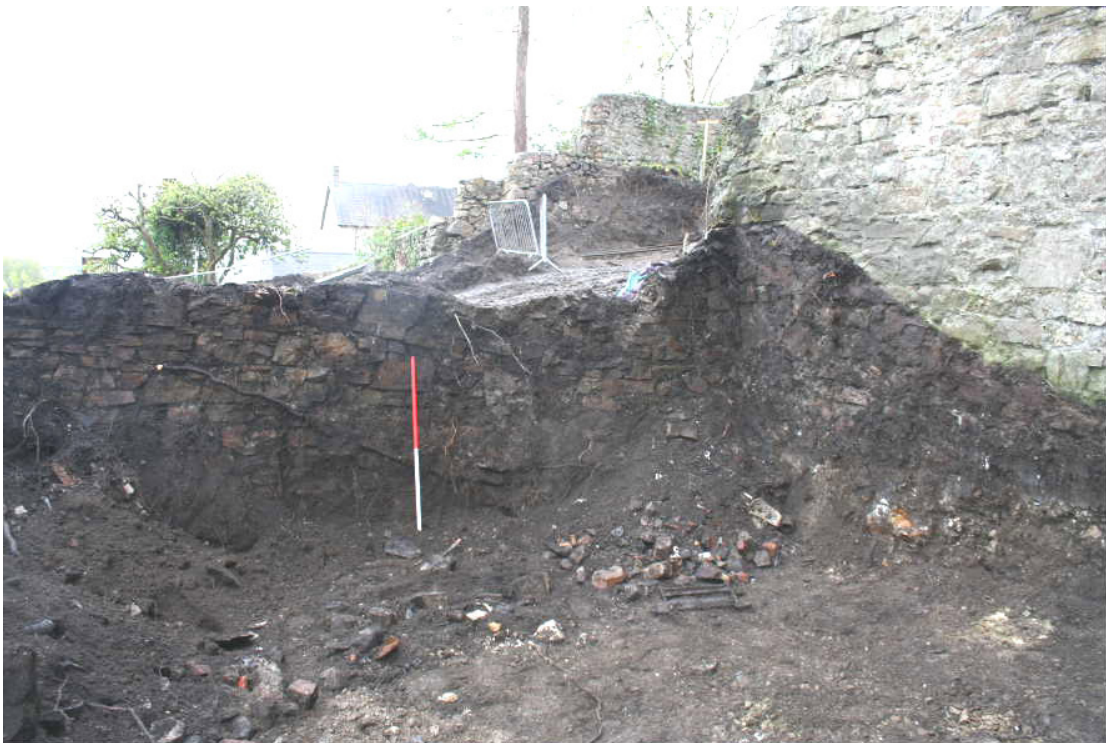
Photo J: Soil removal from the southeast corner of Area E. View southeast, wall 102 is behind the 1m scale.

At the south end of the area a 0.7m deep sloping accumulation of very dark brown garden soil mixed with dumped rubbish was removed from the corner formed at the abutment of wall 102 with retaining wall 108 (Photo J). Amongst the rubbish were numerous red brick fragments, pieces of cast iron, frequent broken bottles from the late 19th and early 20th centuries, cream ware potsherds, glass jar lids and frequent small and medium size stones tumbled from wall 102. Beneath this layer was a c.0.5m depth of dark brown garden soil containing far less rubbish material that continued across the site to the west and north at a nearly uniform depth, although sloping down to the south very gradually, following the natural topography. Removal of this soil layer revealed a c.0.45m depth of mid brown silty clay soil containing frequent fragments of mortar, 10% small and medium size angular stones, frequent coal fragments and occasional red brick fragments. Amongst the finds noted in this layer were several clay tobacco pipe fragments, broken glass bottles and glass jar lids, sherds of stoneware bottles and jars, and sherds of cream ware pottery; all were considered to date from the mid to late 19th century. Again, this layer followed the natural topography and was seen to overlie natural bedrock at the south end of the site and a compact, shale-rich natural subsoil elsewhere in Area E.

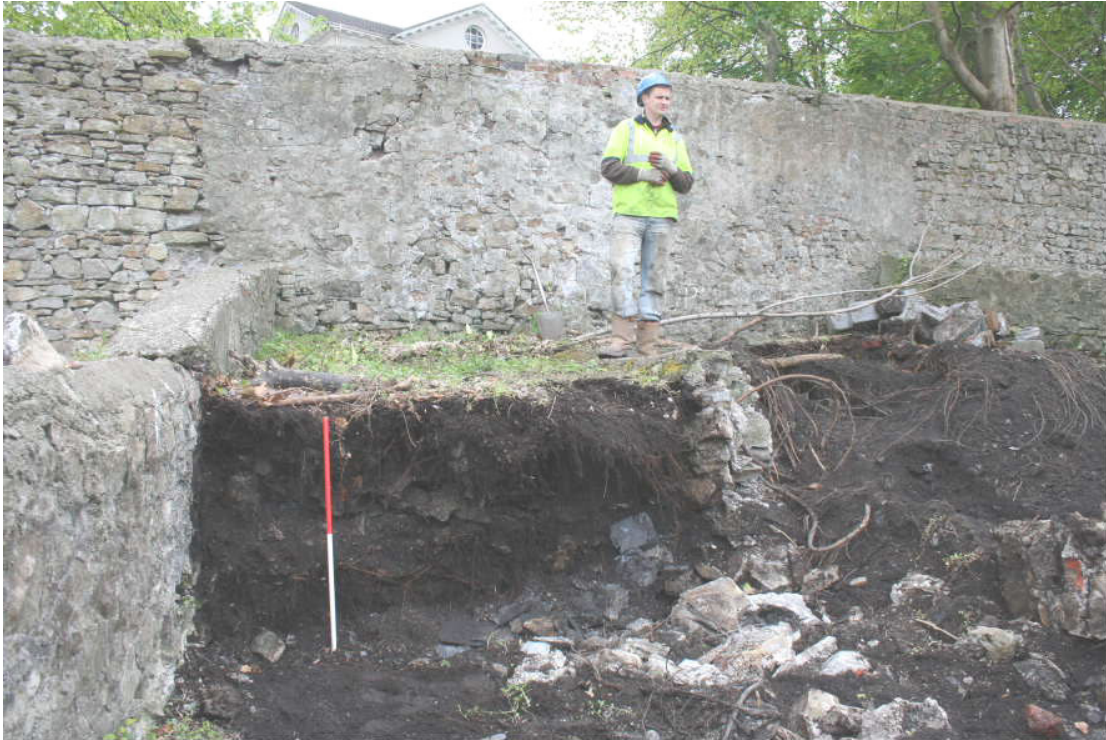
Photo K: During the demolition of the structure at the south end of Area D, showing the corework behind the 1m scale. View south.

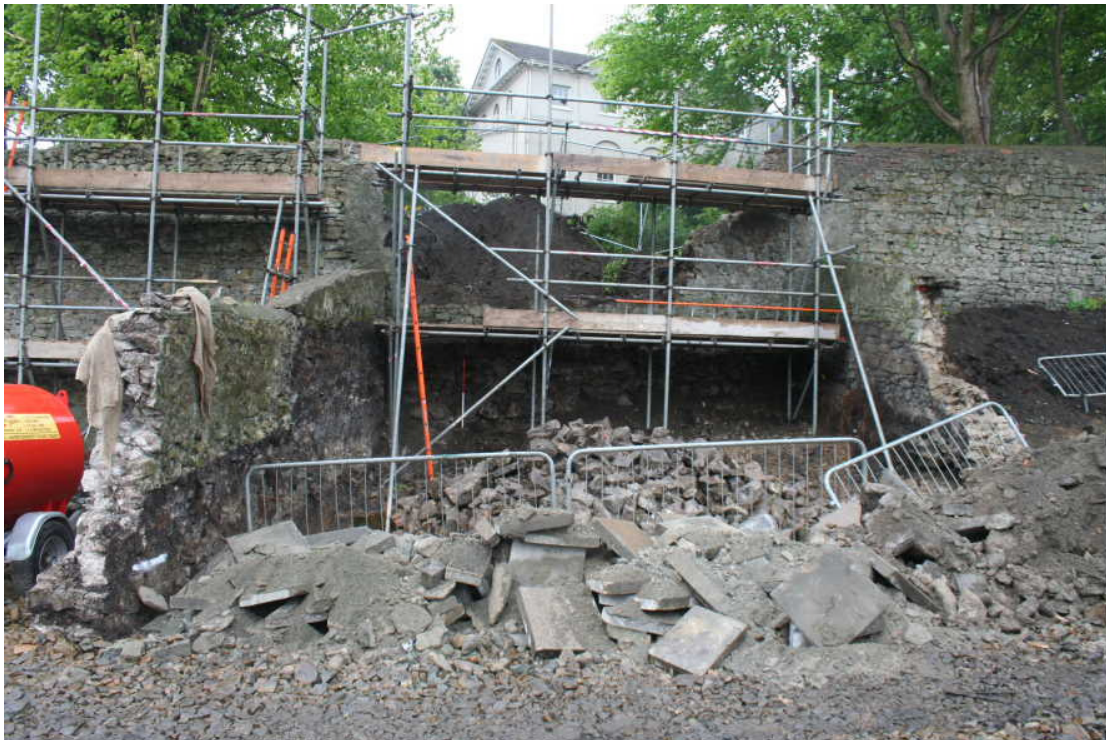
Photo L: During demolition and repair of wall 108 in Area D. View south.

The section of wall 108 forming the southern boundary to area D was deemed to be unsafe and was partly dismantled, re-built and consolidated (Photo L) during the development.

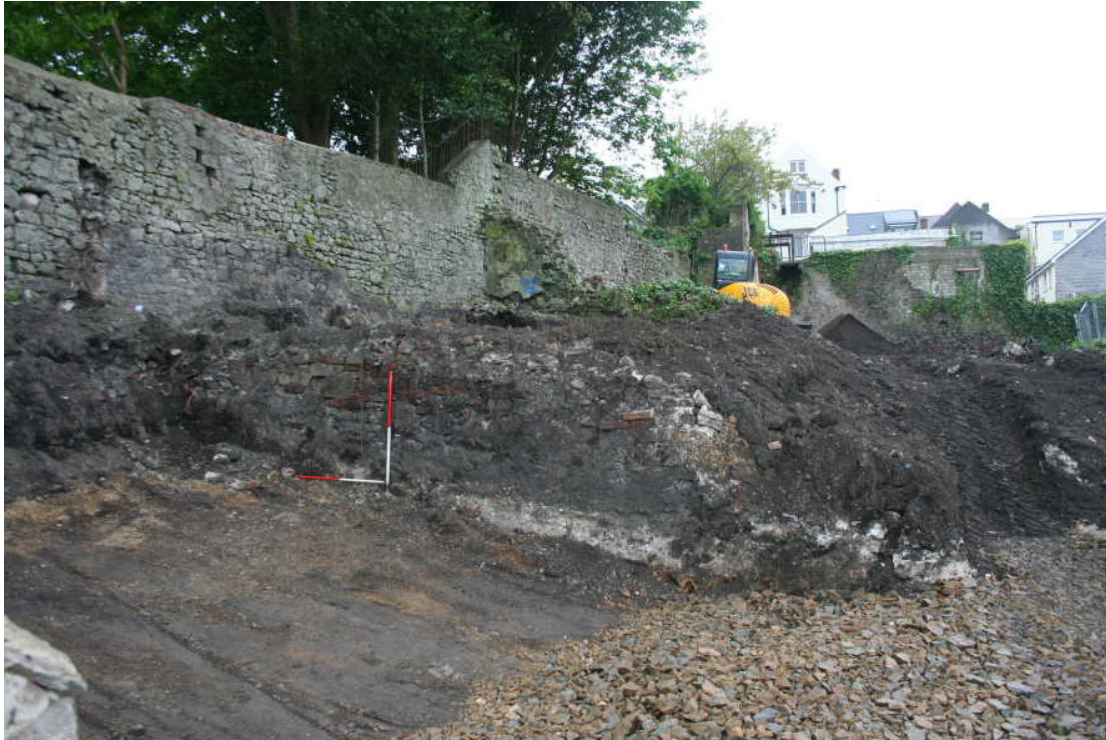
Photo M: Revealed face of wall 105 at the south end of Area C. View west-southwest, 2 x 1m scales.

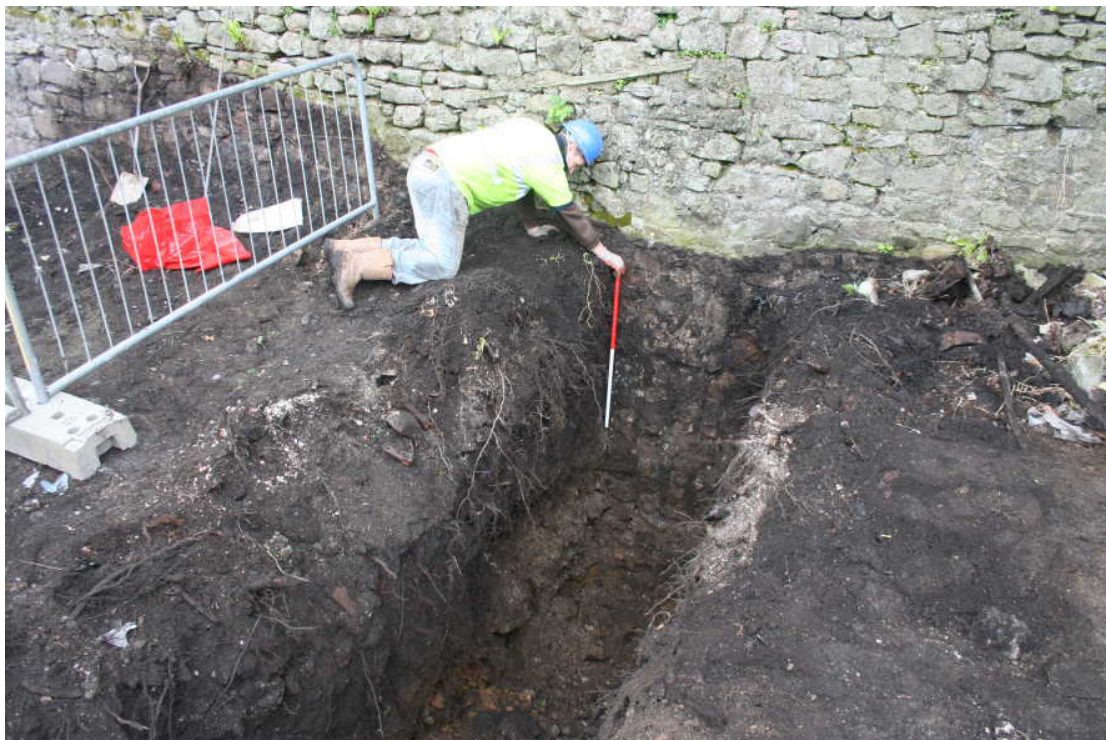
Photo N: View south showing test pit excavation in Area B, note sloping mortar line on wall 108 above the blue helmet on the person holding the 1m scale.

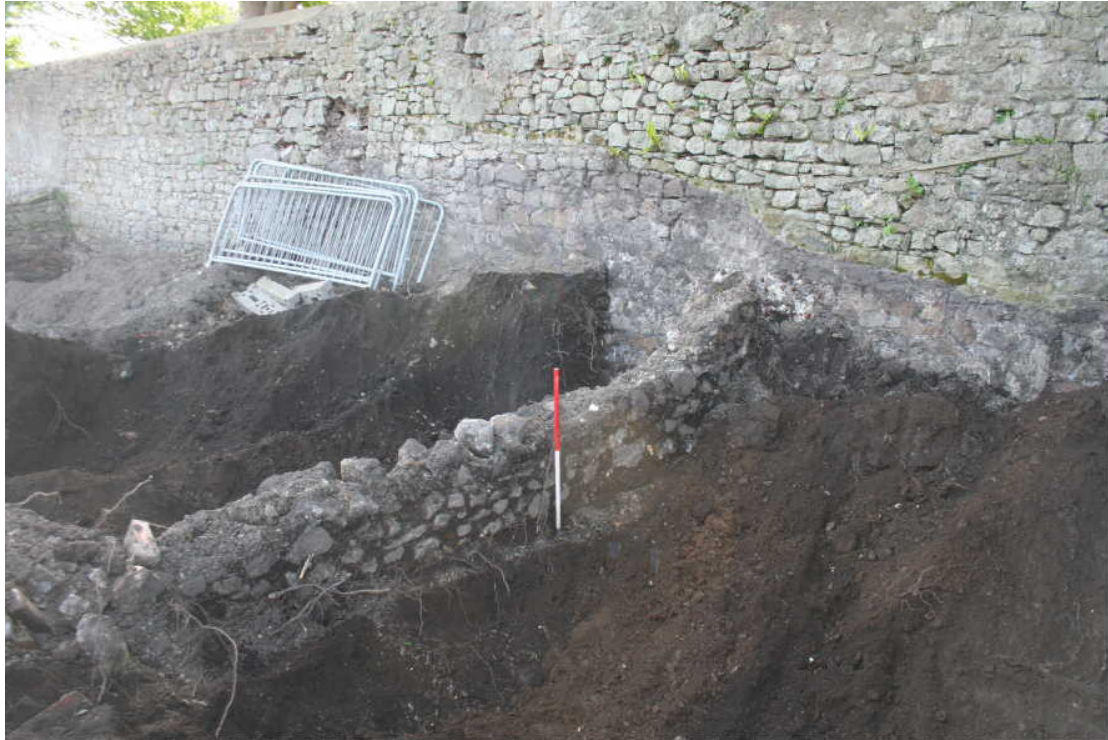
Photo O: View southeast, showing revealed section of wall 106 abutting wall 108 during excavation. 1m scale.

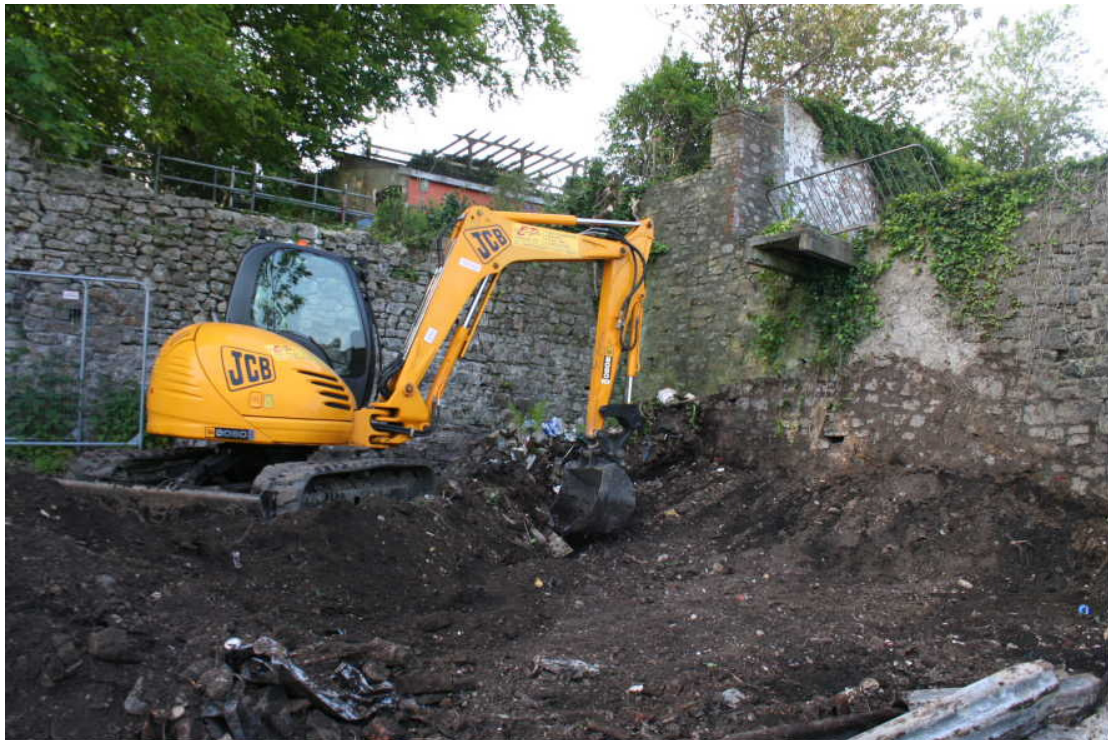
Photo P: View looking southwest in Area A, showing the corner formed by wall 108 and the boundary wall to the rear of Market St. The possible access 'jetty' can be seen protruding from the top of the Market St. wall amongst the ivy.

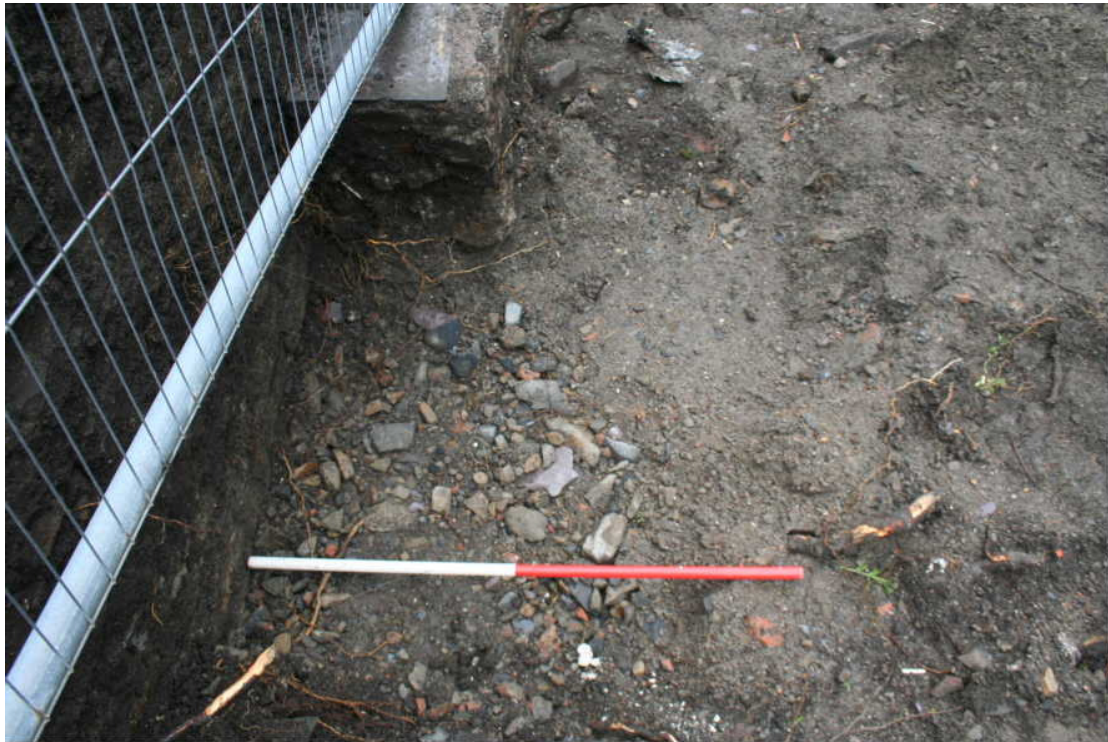
Photo Q: Construction trench for the northern boundary wall in Area A, filled with river gravel. View east, 1m scale.

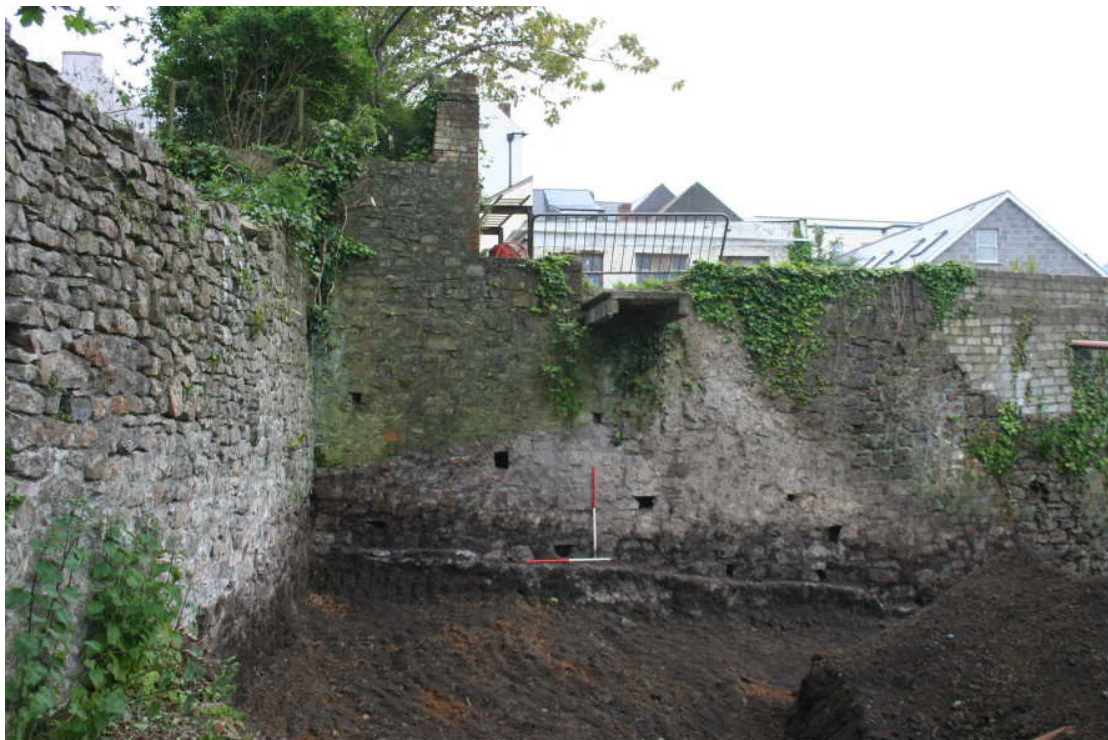
Photo R: The western boundary wall to the rear of No.18 Market Street, in Area A, showing its concrete footing. Wall 108 is on the left. View west, 2 x 1m scales.

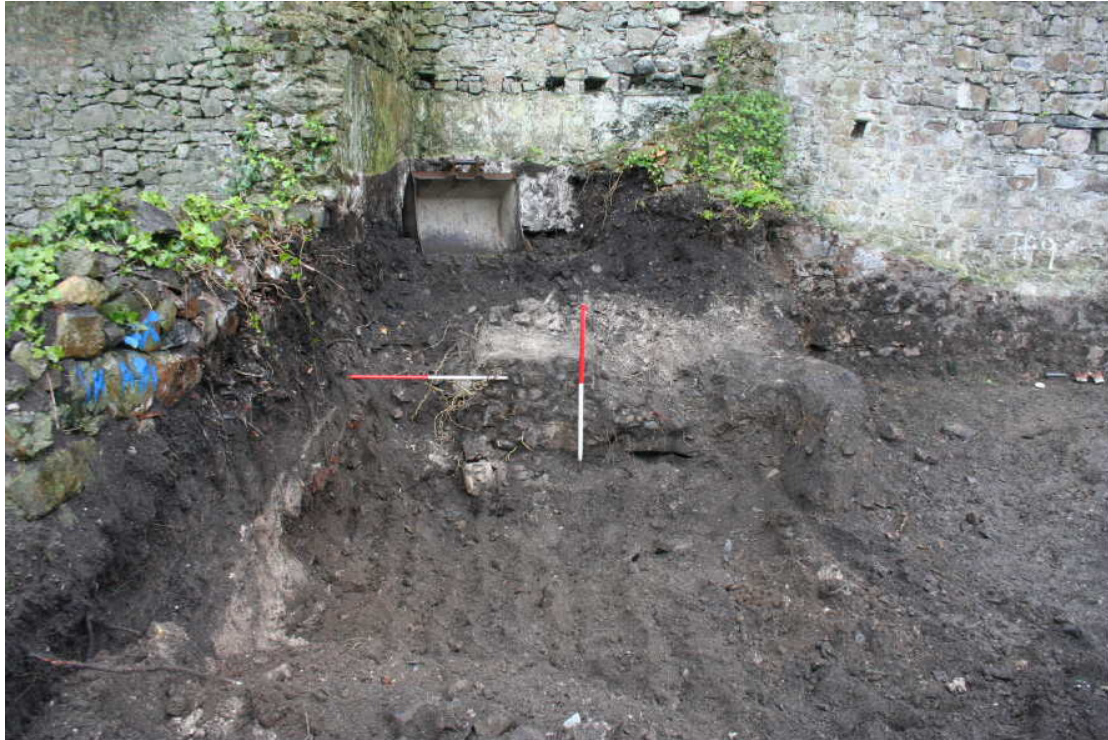
Photo S: South view of the building in the southwest corner of Area A. The remnant partition wall is in the foreground behind the 2 x 1m scales.

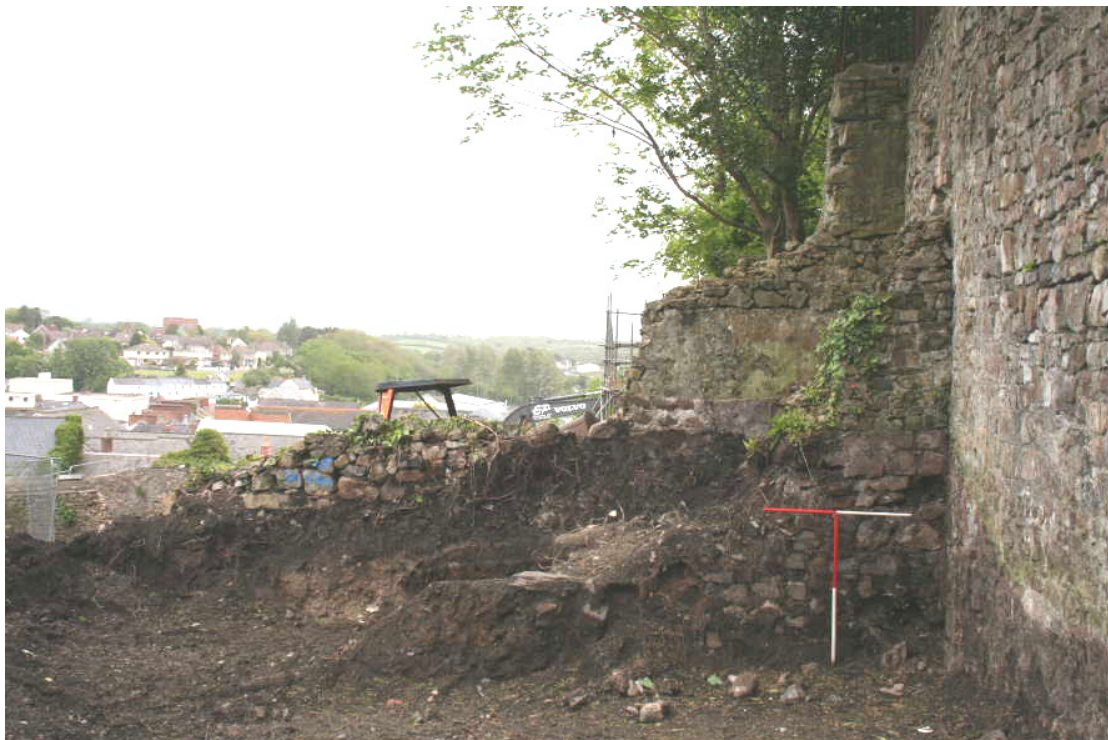
Photo T: View east of the building in Area A, showing its west wall in the foreground abutting wall 108 and the more substantial east wall (incorporated into wall 107) behind. Scales are 2 x 1m.

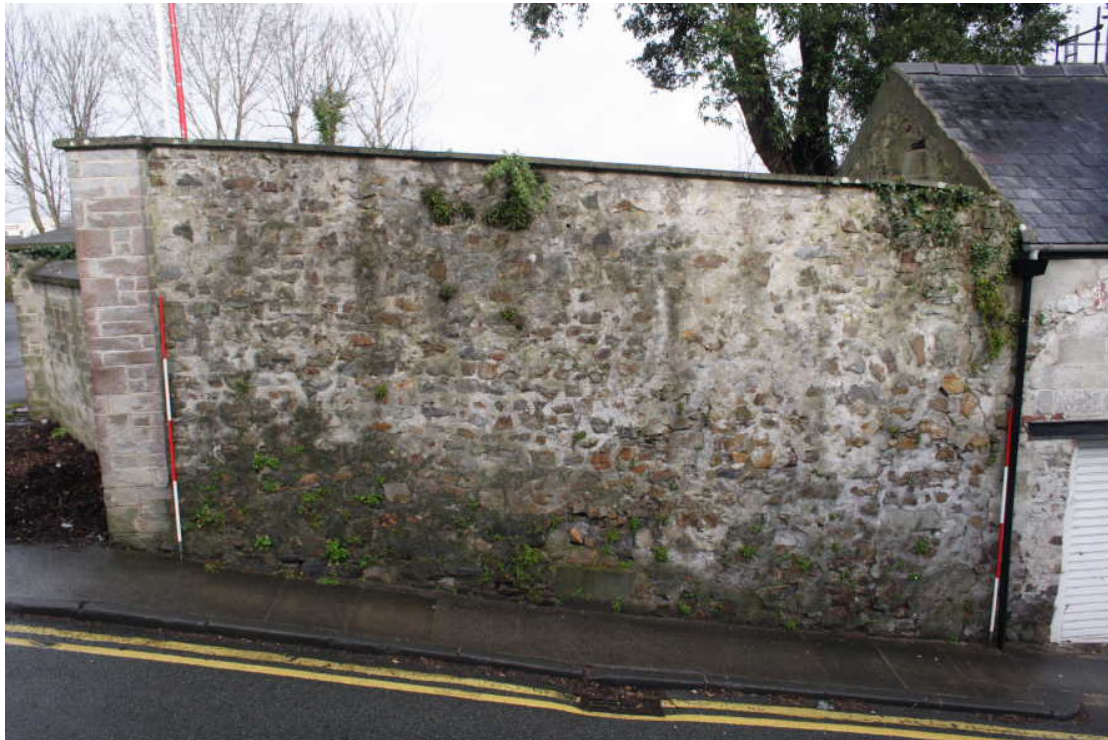
Photo 3: Wall (101), 2 x 2m scales. Note arch of blocked entrance just visible at east end of wall. View north (IMG_9932).

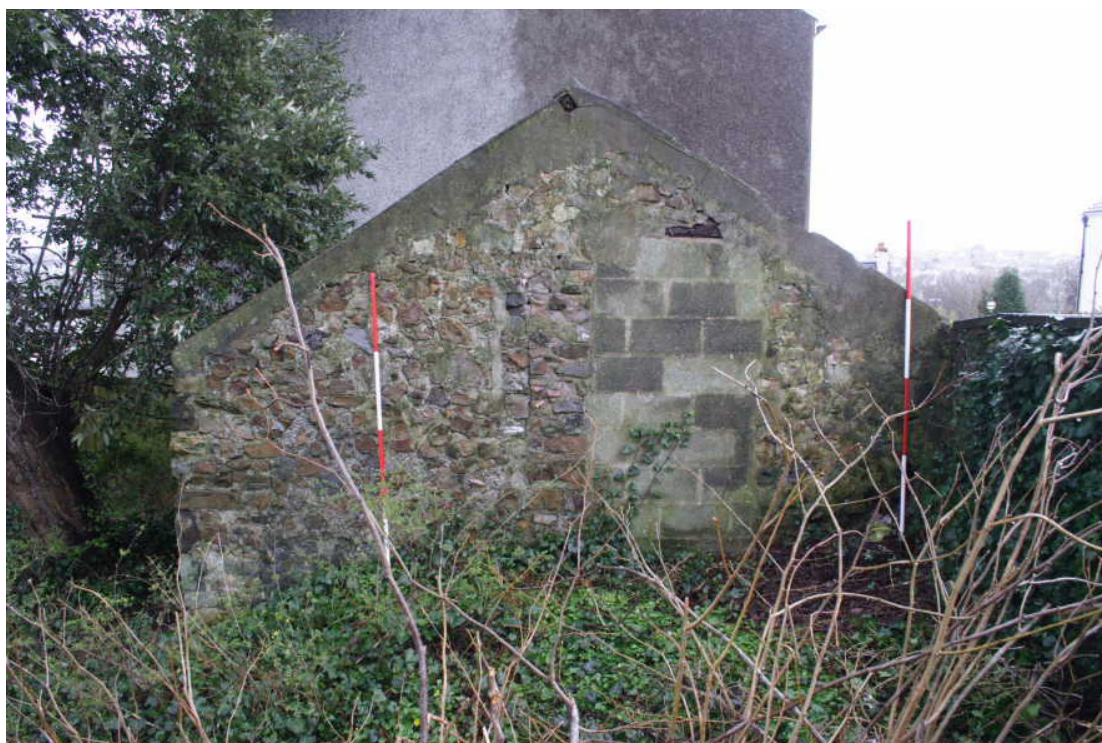
Photo 6: Gable end of 'garage' building at east end of wall (101) showing blocked original opening. View east (IMG_9937).
