FOLEY HOUSE CAR PARK, HAVERFORDWEST, PEMBROKESHIRE:

ARCHAEOLOGICAL WATCHING BRIEF and BUILDING RECORDING

APRIL - MAY 2009

RHIF YR ADRODDIAD / REPORT NO. 2009/90
RHIF Y PROSIECT / PROJECT RECORD NOS. 94870 & 94871

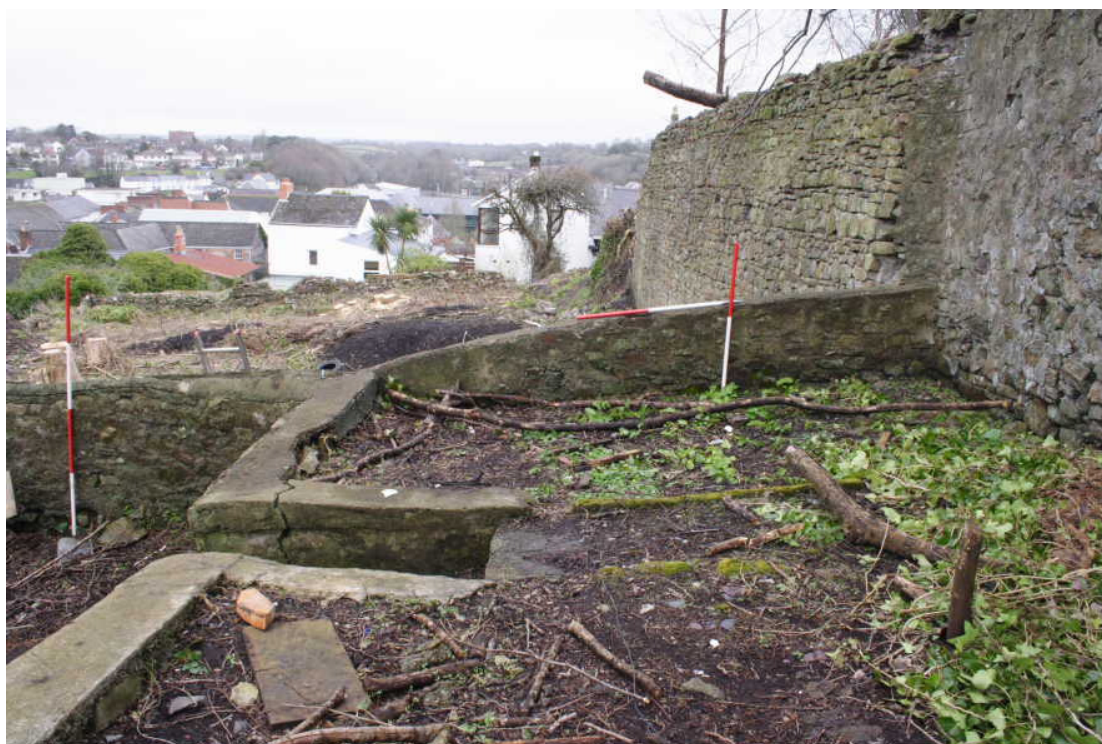
Photo 11: South end of wall (103) at abutment with wall (108), 2 x 1m scales and 1 x 2m scale. View east (IMG_9942).

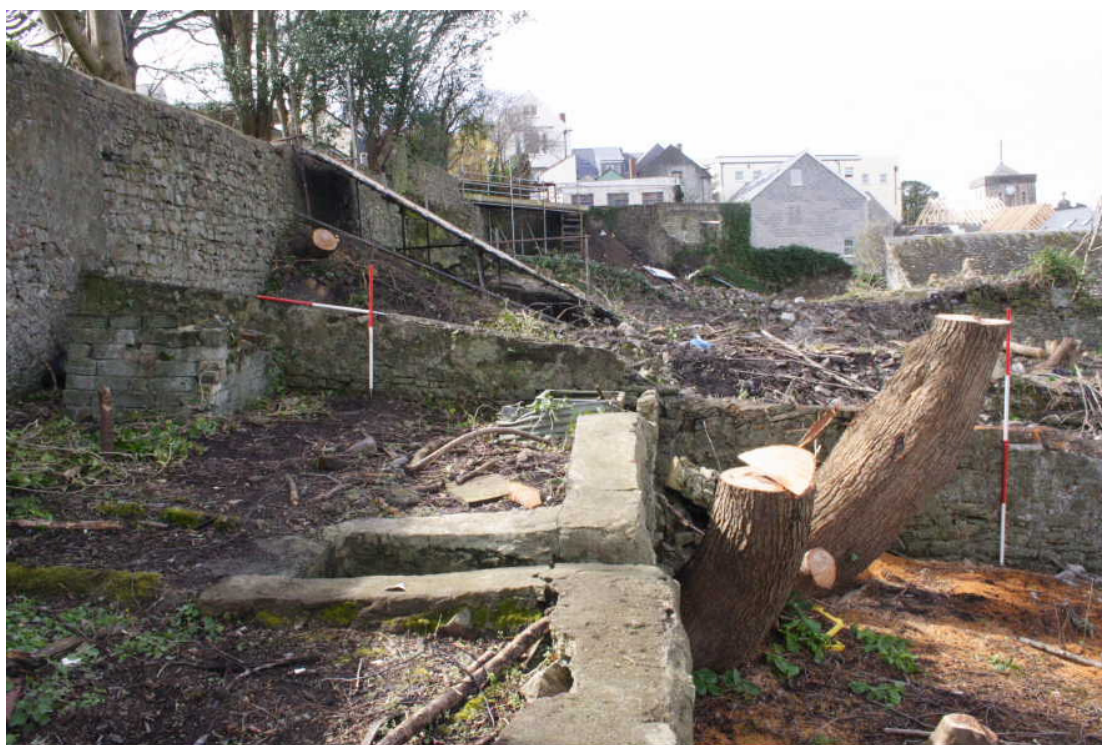
Photo 15: South end of wall (104) at abutment with wall (108), 2 x 1m scales and 1 x 2m scale. View west (IMG_9949).

This wall (Photos 15 to 21, 44 to 46) measured 32m long by 0.5m wide and reached an average height of 1.3m above the then present garden surface. The fabric of the wall was of coursed random rubble, bonded by an off-white lime mortar containing frequent coal and small angular stone fragments; the upper courses had been repaired using a grey cement mortar. Much of the east face of the wall had been rendered with grey mortar, which had been heavily weathered revealing the coursed stone beneath. The west face was unrendered and exhibited fine coursing. The top of the wall was capped with concrete in generally good condition along the whole length save for a 3m or so stretch close to its southern end where the upper wall courses were damaged (Photo 19). Apart from this minimal damage, the wall was in very good condition from its abutment with wall 108 to the south as far as its northerly terminus to the rear of Nos. 23 and 25 High Street. As with wall 103, the first 3.25m length of this wall was slightly raised and displayed a distinct curving slope where it represented the western wall of the probable former greenhouse-type structure built up against wall 108 at the end of the garden of No. 25 High Street (Photos 15 and 39).

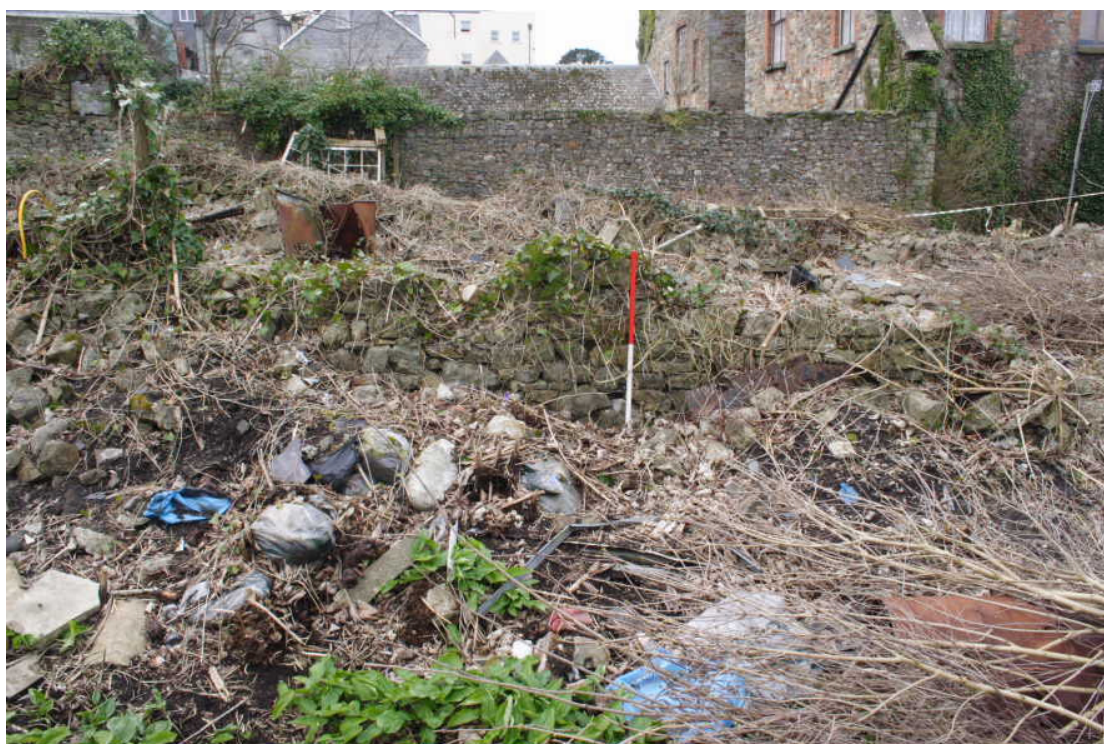
Photo 22: A rare above-ground surviving face of wall (105) towards its northern end. View west (IMG_9956).

Wall 105 (Photos 22 to 25, 44 & 45) was in a poor state of repair with only discrete stretches showing above the then present garden surface and a linear configuration of stone tumble following the wall line elsewhere. The original length of the wall was 27m, with the highest exposed section being 1m above the ground surface (Photo 22), and measured 0.45m wide. The wall fabric comprised coursed random rubble, bonded by a hard lime mortar containing frequent coal and small angular stone fragments. During the groundworks for the car park development removal of the stone tumble and garden soil revealed the wall intact to a height of about 1.2m and constructed on the underlying bedrock. The wall abutted wall 108 to the south and terminated at the east side of the rear of No. 21 High Street.

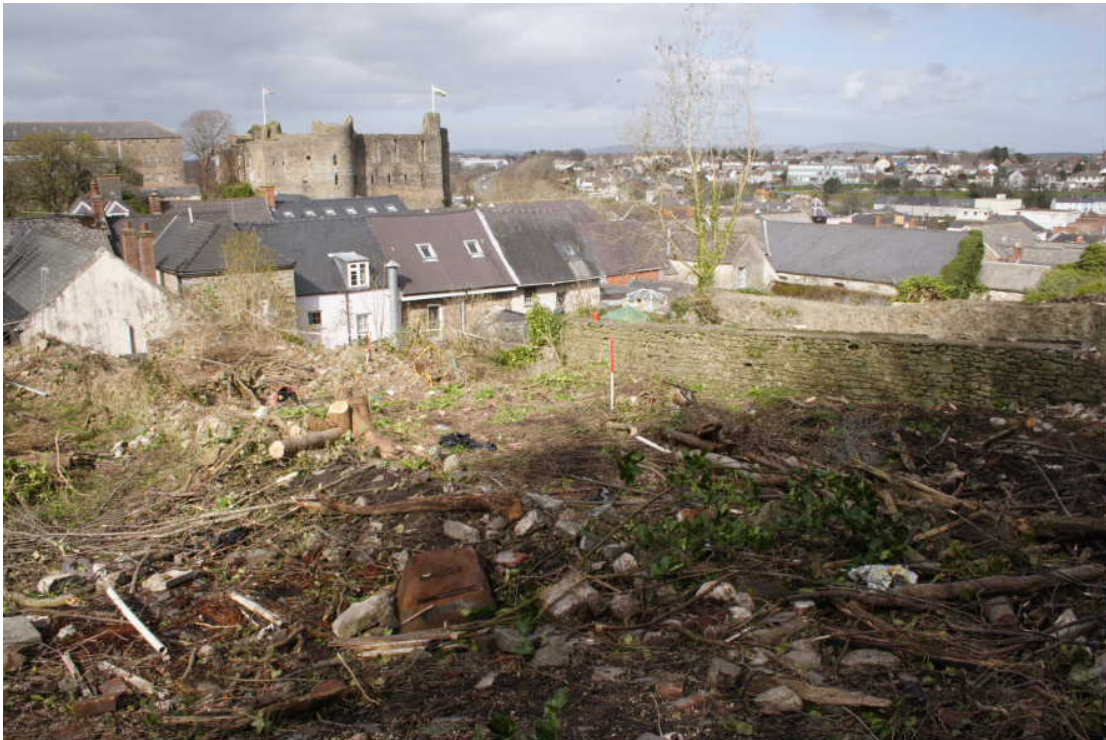
Photo 25: Wall (105) barely discernible just behind 1m scales. View northeast (IMG_9980).

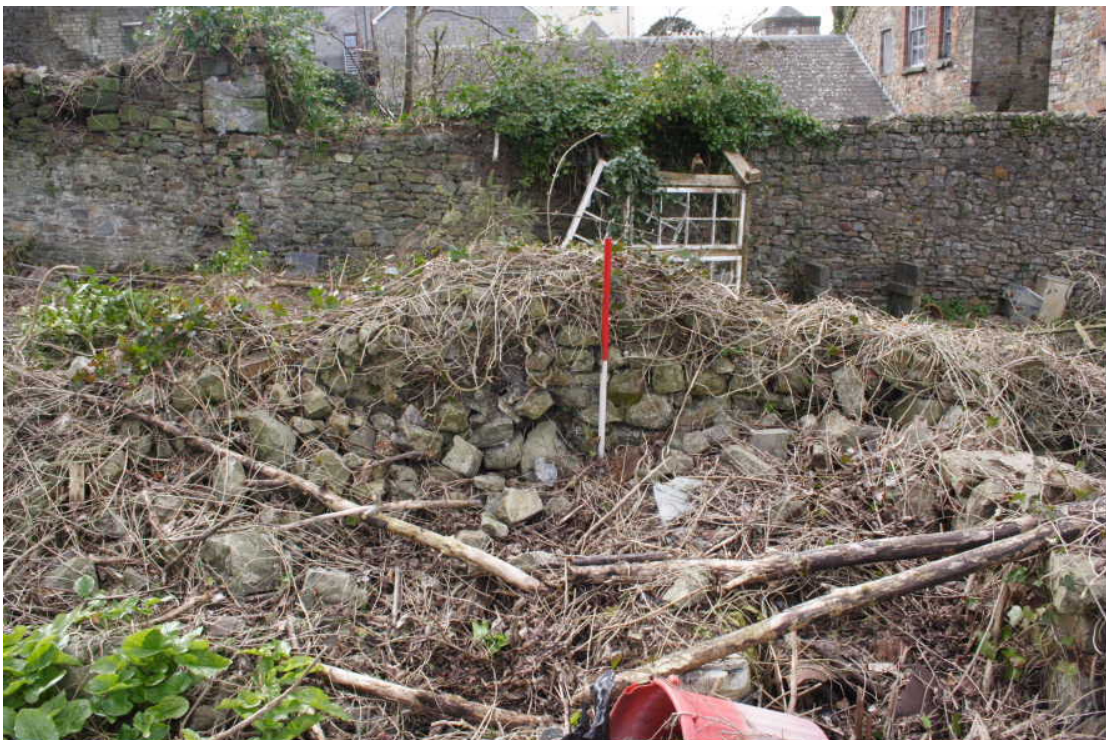
Photo 26: Best surviving face of wall (106) at its north end, 1m scale. View west (IMG_9981).

As with wall 105, this wall too was in a bad state of repair with very little but a linear spread of stone tumble showing on the garden surface (Photos 26 to 30, 44 & 45) and discrete lengths of standing masonry. The best-preserved section was at its northern end (Photo 29) where it was seen to be of off-white lime mortar bonded random rubble and roughly coursed. Removal of the garden soil down to the bedrock during the groundworks revealed the wall standing to an average

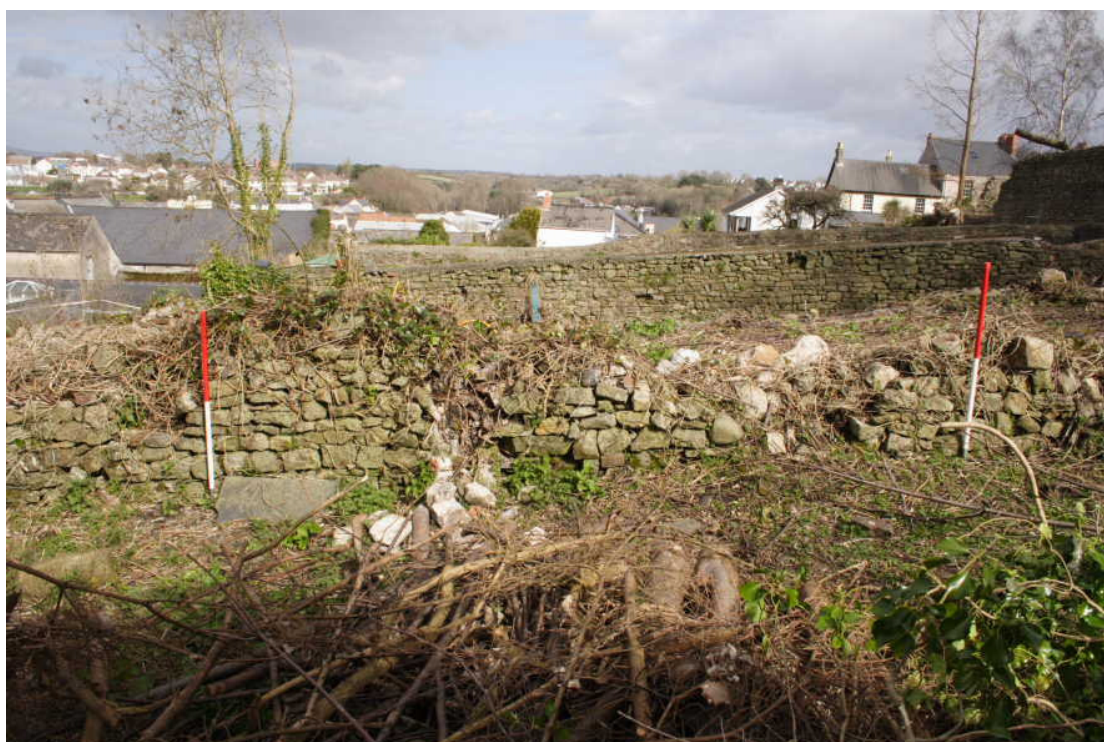
Photo 29: Best preserved section of wall (106) at its northern end, 2 x 1m scales. View east (IMG_9984).

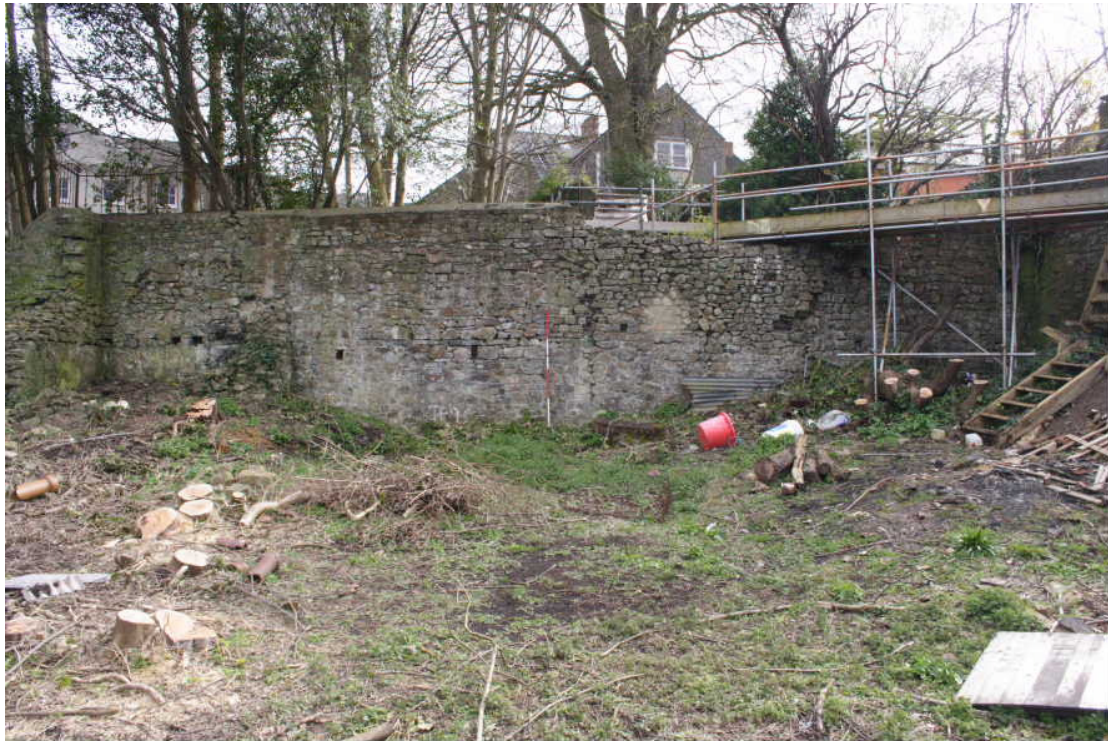
Photo 35: West end of retaining wall (108), 1 x 2m scale. Abutting wall (107) and building remains are visible centre left. Garden area at the back of No. 17 High Street. View south (IMG_9990).

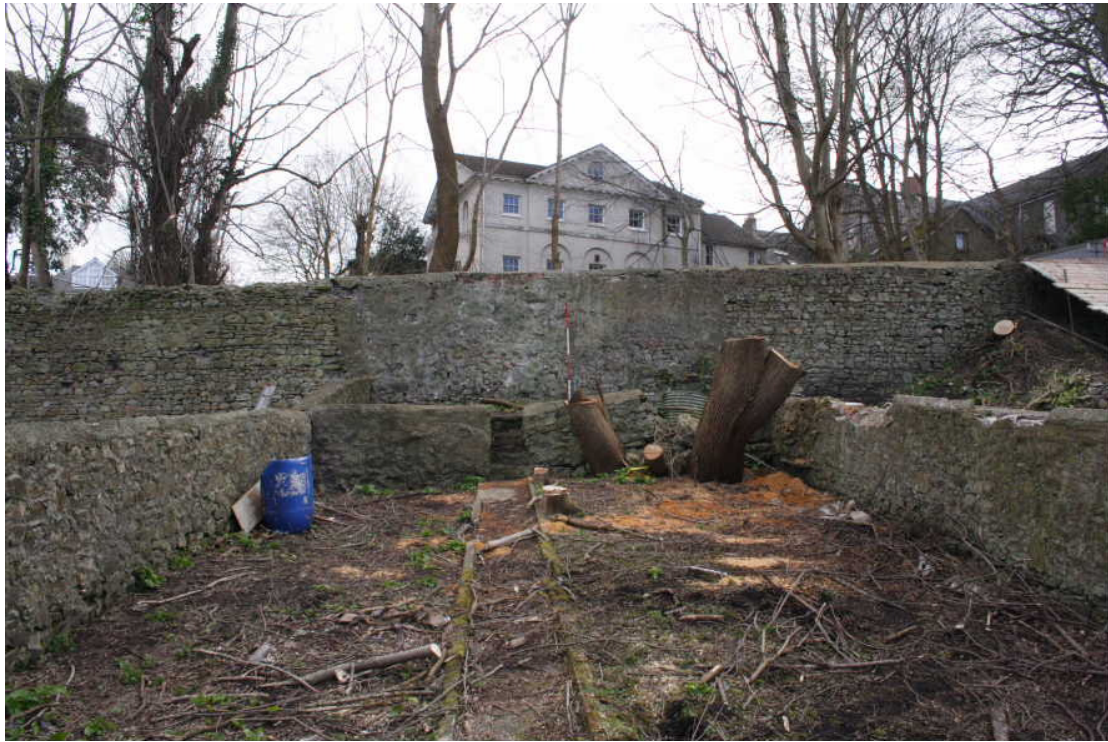
Photo 39: Retaining wall (108), 1 x 2m scale. Wall (103) is on the left, wall (104) on the right. Raised, stepped structure against (108); back garden of No. 25 High Street. View south (IMG_9993).
