SCHEDULING ENHANCEMENT PROJECT 2009: MEDIEVAL MINOR DEFENDED SITES

RHIF YR ADRODDIAD / REPORT NO.2009/37
RHIF Y PROSIECT / PROJECT RECORD NO.94895

**SCHEDULING ENHANCEMENT PROJECT 2009:
MEDIEVAL MINOR DEFENDED SITES**

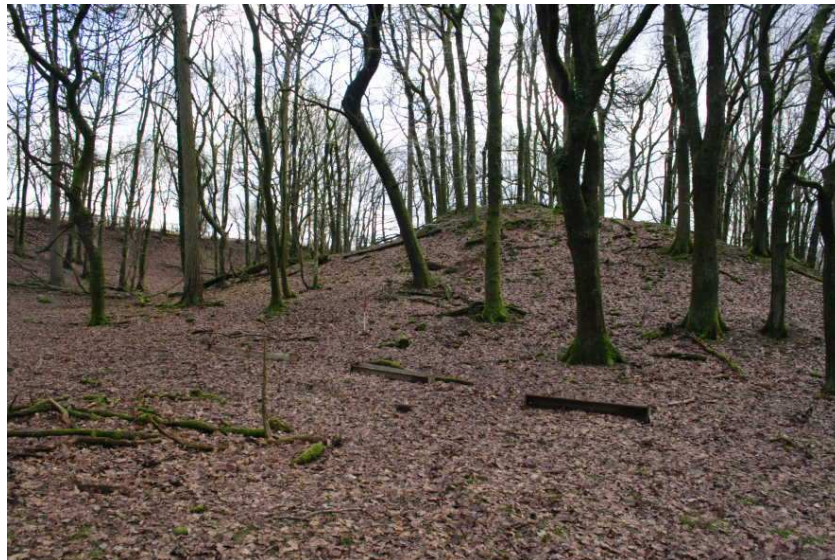
287 BAILY BEDW

Baily Bedw is a large rounded mound c. 42m diameter and c. 8m in height; it lies on a broad, flat, natural terrace on a steep west-facing slope within deciduous woodland. The mound is tree covered, several of which have fallen and exposed what appears to be natural bedrock. Although the mound is 'motte'-like in appearance it seems more likely to be a natural topographic feature, given the presence of the *in situ* bedrock.

View of Baily Bedw mound, looking south-southeast.

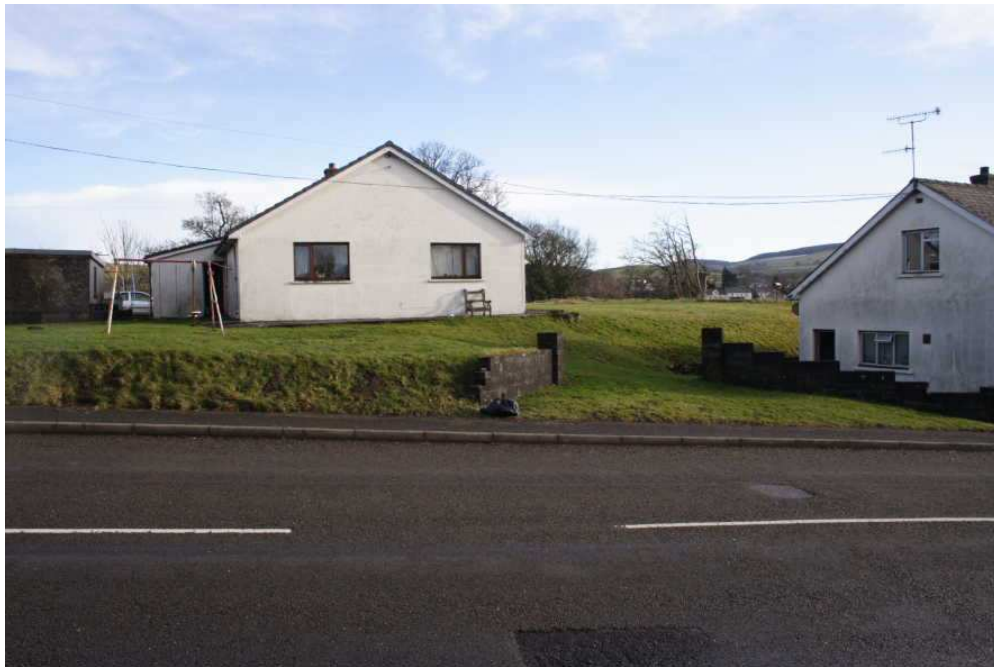
736 CASTELL DOLWLFF

Castell Dolwlff is situated on a scarp edged promontory overlooking the Afon Teifi at 99m above sea level. The steep fall of c. 9m down to the river on its eastern side afforded good natural defence to this former 24m diameter ringwork; the remaining defences comprised a strong bank and 6m wide ditch on the north and west sides. The site was formerly scheduled (SAM no. Cd 75) but became so mutilated by building development and landscaping that it was descheduled in 1990. Very little, if any, of the original defences are now evident save for the scarp to the east and south overlooking the river.

View of Castell Dolwlff, looking east. The building on the right has been dug into the exterior of the bank, the building on the left was erected in 1984.

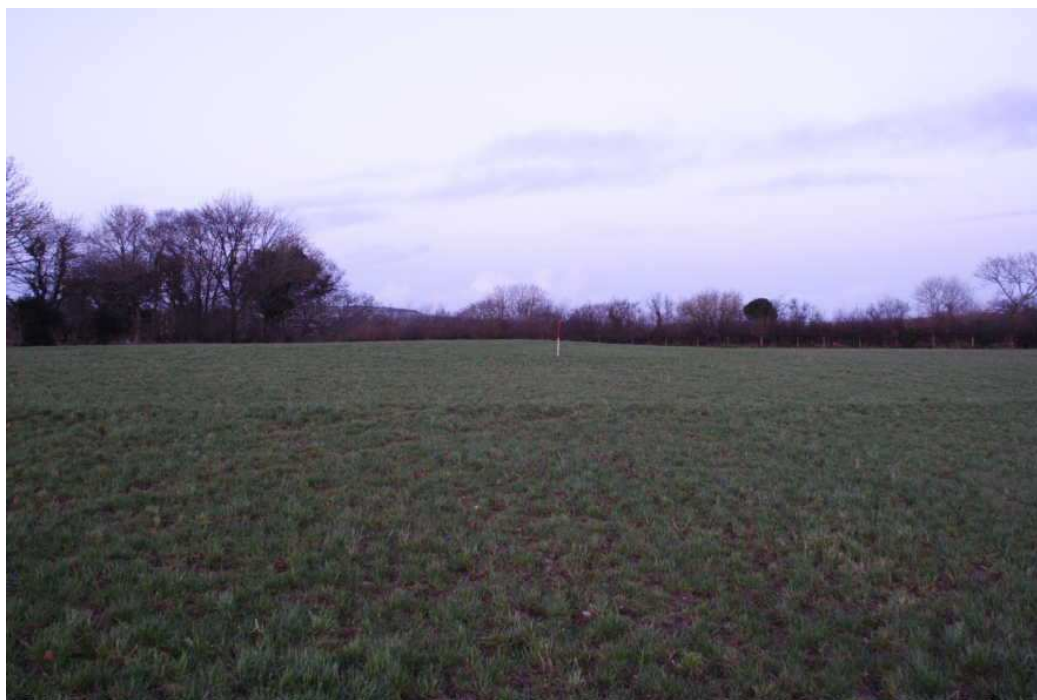
1148 CASTELL

Castell is a ploughed down circular earthwork mound c. 38m diameter and c. 0.4m in height with a centrally located smaller circular mound to a further height of c. 0.4m. There is a hint of a ditch just discernible on its eastern and south-eastern sides. The farmer ploughs the field every three years and says that the ground around and on the earthwork is very stony compared with the rest of the pasture field. The site lies in a field named Parc Castell, on a local highpoint at 115m above sea level.

View of Castell, looking north-northwest. The linear feature in the foreground represents a former field boundary

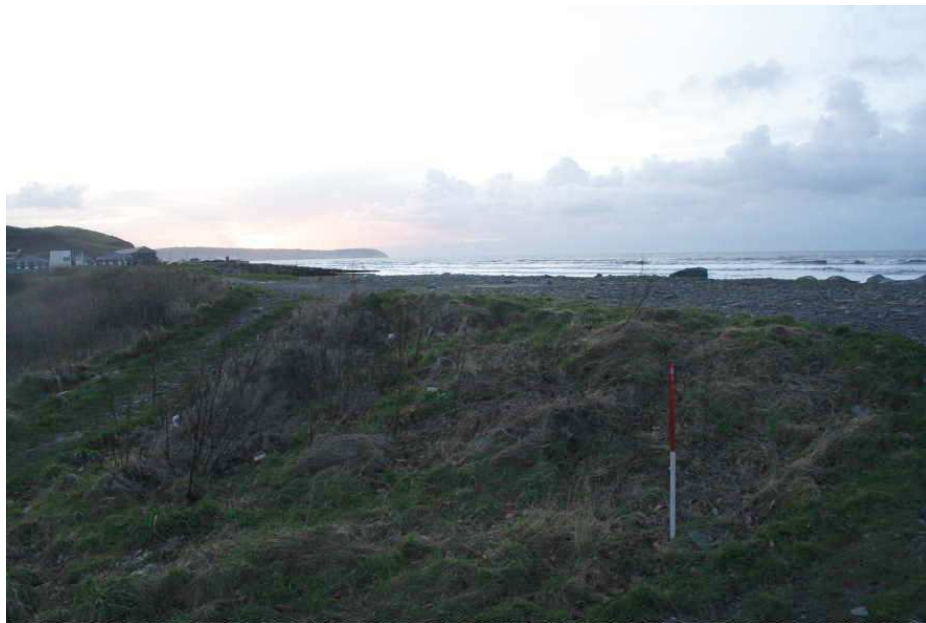
1867 CASTELL CADWGAN

Castell Cadwgan is shown on the first edition 25" Ordnance Survey map where it appears that much of its seaward fabric had suffered extensive erosion, leaving only the landward half of the monument as an approximately 60m long curving bank on the shoreline. By the time of the publication of the second edition Ordnance Survey map the earthwork is shown to have been further compromised by the construction of a breakwater. Nothing of the Castell bank can be seen at the site now; it has either been totally destroyed or has been incorporated into the high pebble bank sea defence that currently occupies the space.

View looking west across storm defence in former location of Castell Cadwgan bank.

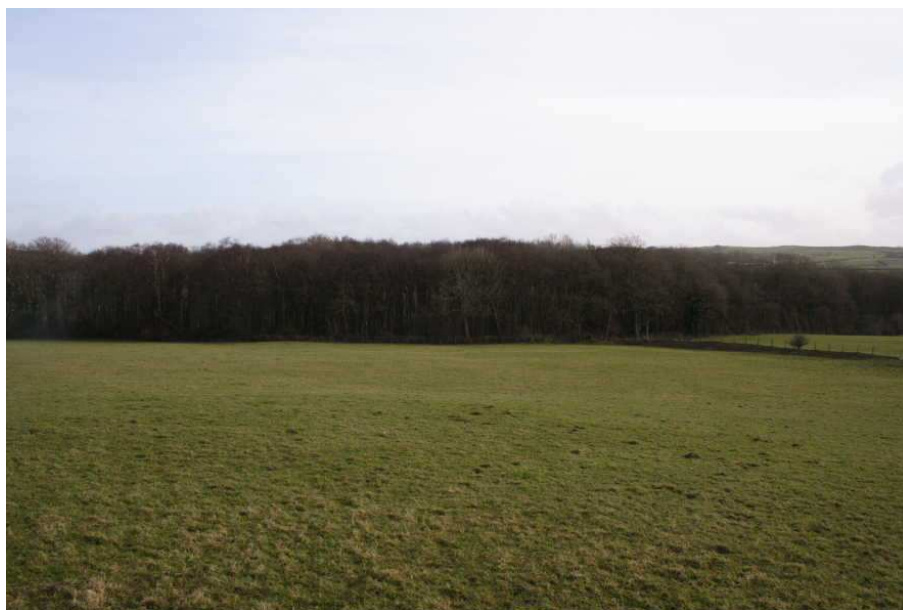
1998 COED LLYS

A rectangular moat, Coed Llys, was noted at this location by the RCAHM in 1970, and visited by the Ordnance Survey in 1974. At that time it was noted that the long axis of the moat measured 50m long, internally, and was aligned northeast to southwest with the shorter side being 30m long. The eastern side consisted of two fragmentary banks with a maximum height of 0.9m, which were in Coed Llys woods, the outer bank continued around the southern side where it was preserved under rough pasture. The northern and western extent of the moat ditch were observed to be "extremely spread", with a break of level ground in the southwest corner. At the time of the recent site visit Coed Llys woods were too overgrown with vegetation to enable an assessment of the current state of preservation of the two fragmentary banks. There is only a slight indication on the ground of the bank continuing around to the southern side. Elsewhere the monument is only barely discernible as nebulous linear hollows on very gently sloping, southwest facing, improved pasture at 122m above sea level.

View of Coed Llys, looking south.

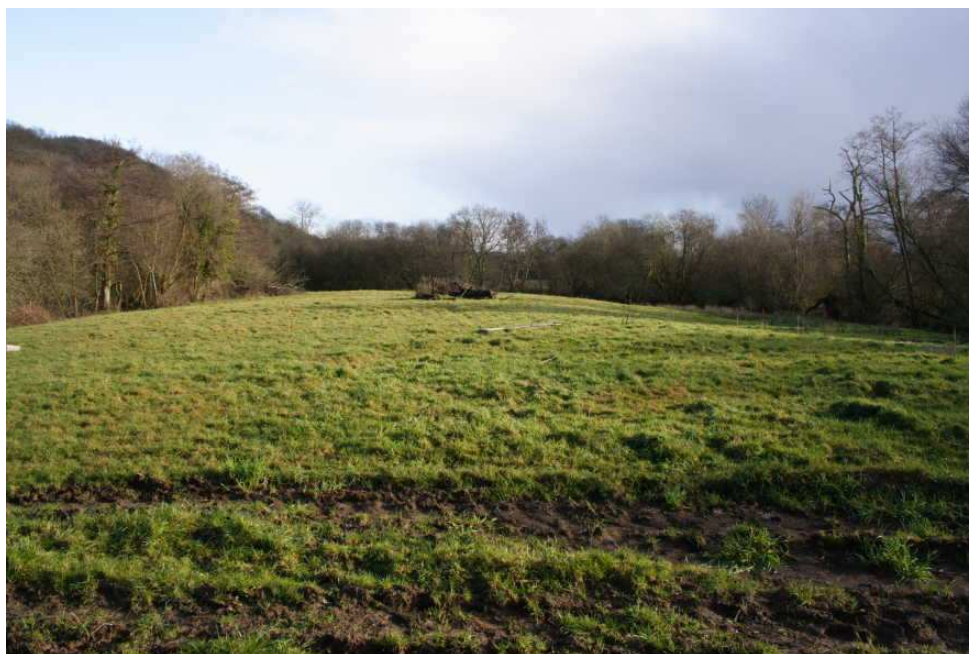
2334 CASTELL HENLLYS

Castell Henllys comprises a water filled ditch or moat, averaging 30m in width, which encloses a sub-rectangular area of slightly raised ground measuring c. 175m east to west by c. 90m north to south. The moat is weak at the western end where the outer bank is untraceable. The enclosed interior is on average some 1.2m higher than the surrounding Afon Teifi floodplain and is currently under pasture. A near rectangular hollow, measuring c. 30m east to west by c. 13m north to south, situated centrally along the southern edge of the interior may represent a building platform. Elsewhere the interior is generally featureless with a few undulations. The flooded moat contains a fairly dense growth of deciduous trees and shrubs throughout its length. As indicated by the Ordnance Survey, in 1971, it is possible that the site may have originally been an ox-bow lake that has been artificially modified to form an animal enclosure or, indeed, adapted as a defended moated site. The site lies on the north bank of the Afon Teifi at just under 30m above sea level.

View of the interior of Castell Henllys, looking east.

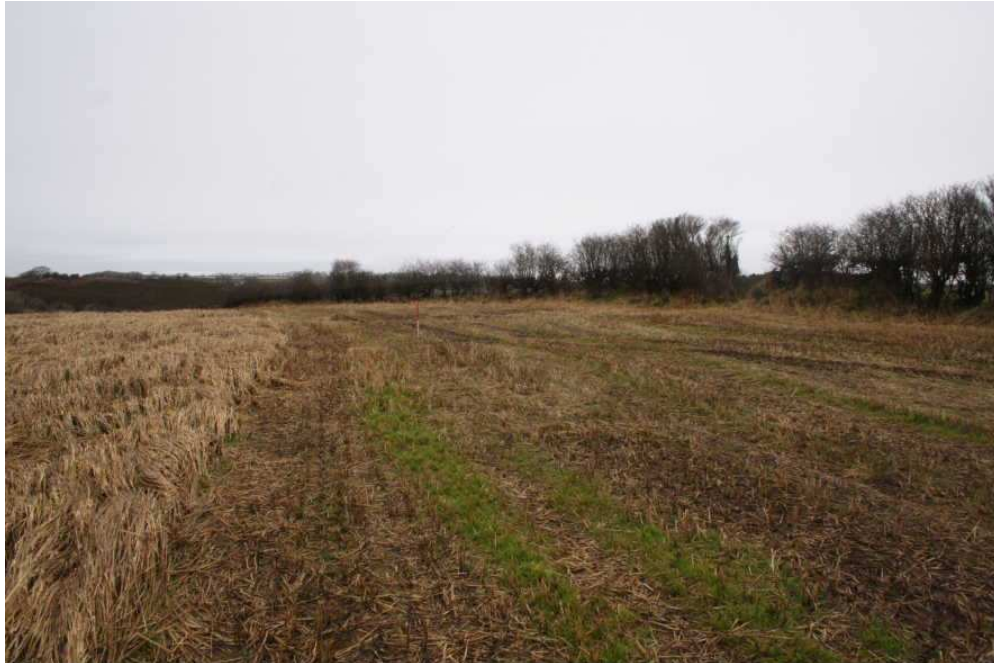
3632 TUMPED PARK

This site comprises a much ploughed down sub-rectangular earthwork, measuring c. 30m east to west by c. 25m north to south, just discernible as a low bank lying on a west facing gentle hillslope at 82m above sea level. The bank is best preserved on the north side, average height c. 0.3m, with an outer ditch clearly visible. There are indications of the presence of an outer bank on the southern side of the enclosure. The enclosed ground is crossed from north to south by a hedgebank field boundary, which places the eastern quarter of the earthwork in a field under pasture with the remaining three quarters lying in an arable field. It is possible that the field boundary overlies the eastern bank, possibly preserving it. At the time of the site visit the westerly field had recently been machine harvested, leaving deep wheel ruts that had severely damaged the earthwork banks and causing waterlogging of the enclosed interior. Small and medium size stones had been exposed and eroded out of the banks.

View of earthworks situated in the western field, looking north.

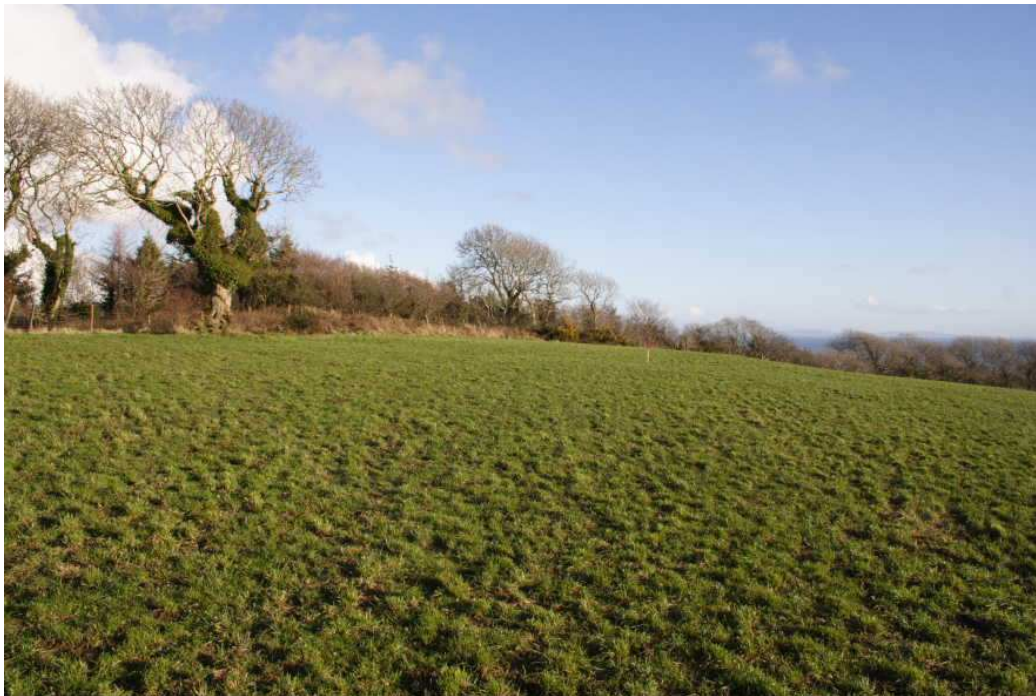
3657 LITTLE CASTLE PARK

Little Castle Park is a low circular earthwork c. 30m diameter by c. 1m high with a discernible outer ditch best preserved on the west side. A trackway has been cut through the eastern edge of this monument at the top edge of a steep natural, wooded, slope which acts as a natural defence on that side. Elsewhere the topography is a south facing gentle slope in an improved pasture field at 80m above sea level. The field name for the site is 'Little Castle Park'. The Royal Commission on the Ancient and Historic Monuments in 1925 noted that an earth mound in the vicinity is traditionally believed to be the site of Earwere Castle (later known as Amroth Castle), which was later replaced by a stone castle some 0.46km to the southeast. The land is currently owned by the National Trust.

View of Little Castle Park earthwork, looking east.

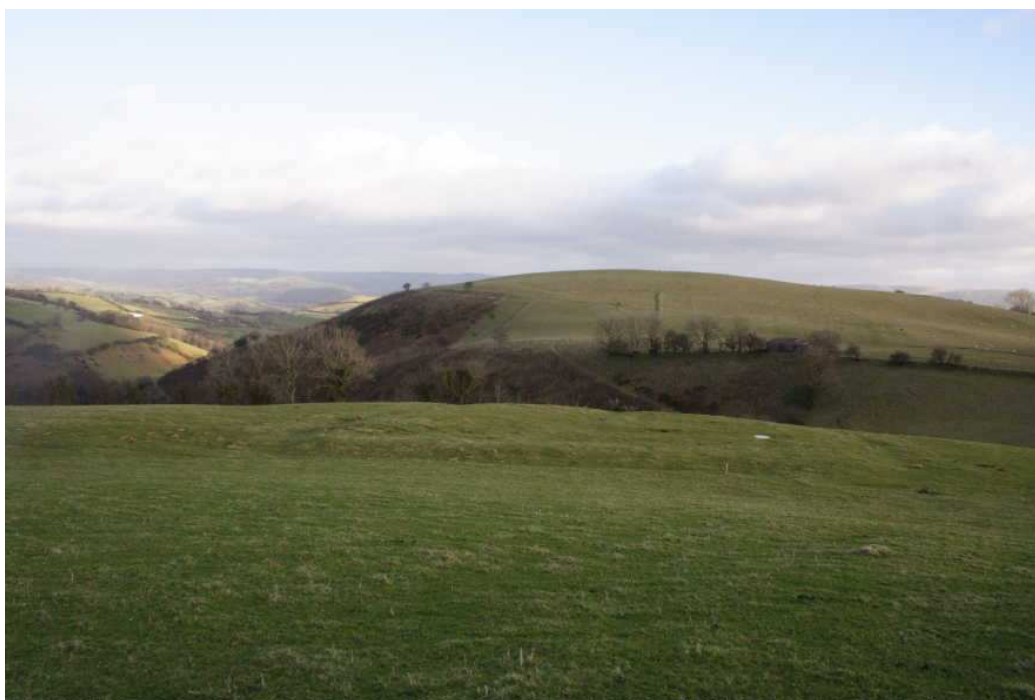
4081 LLANWRDA

View of Llanwrda earthwork PRN 4081, looking east.

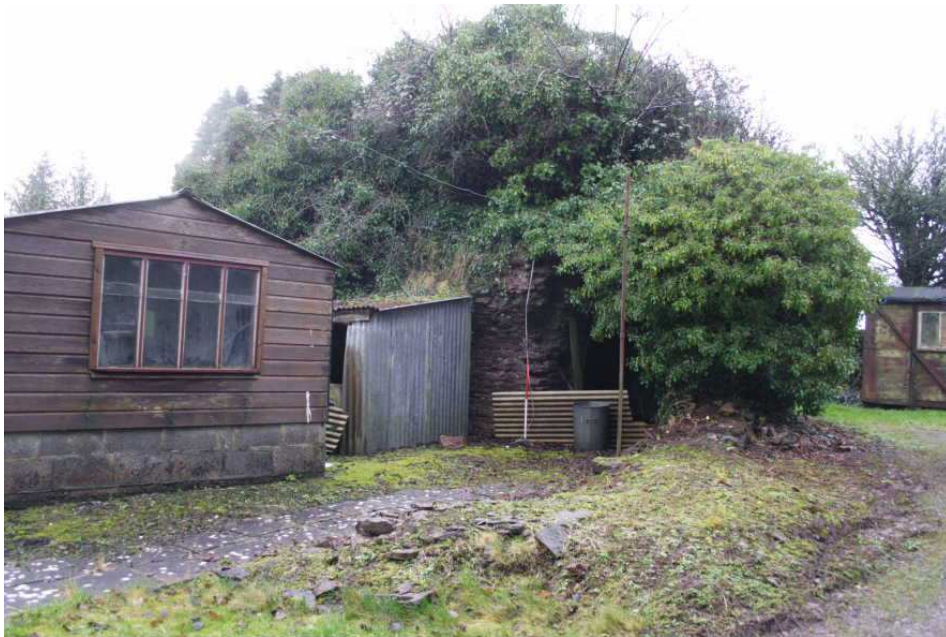
5070 ROCHE CASTLE

All that remains of Roche Castle today is a single stone tower with small stretches of abutting walls projecting from it to the northeast and southeast. The tower and walls were heavily covered with ivy at the time of the site visit but some architectural details were observable such as a fragment of arched vaulting and the chamber within the circular tower. The castle was in a ruinous state by the early 17th century when it is recorded as being robbed of stone for the construction of the nearby mansion at Broadway. The Ordnance Survey map of 1831 shows a wall linking two towers on the south-western side of a flat platform area. Subsequent building development on the site, especially during the 1960s, has presumably destroyed much of the fabric of the original castle and its foundations. The castle lies on a platform that is terraced into a gentle southeast facing slope, the platform is still recognisable despite the presence of modern buildings and the effects of later landscaping. The site lies on the 40m contour.

View of the ivy-clad tower of Roche Castle, looking south-southwest.

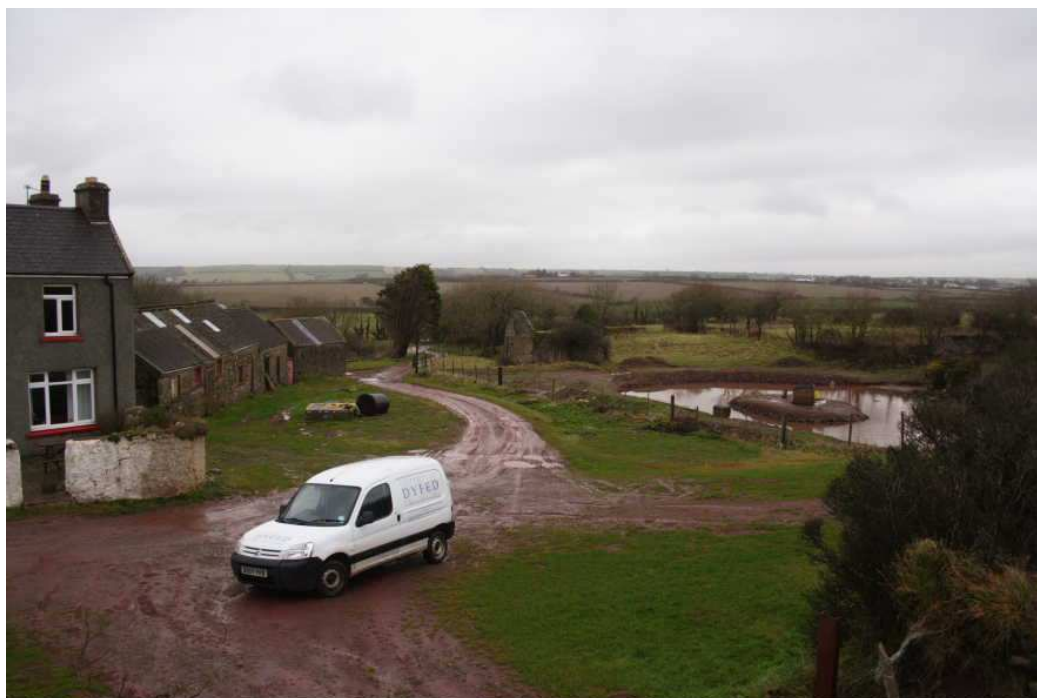
7287 EAST MOOR

Early map evidence and photographs show a range of buildings in what is now a pond area and farmyard to the east of the present day farm buildings. Richard Fenton mentions East Moor in his Tour of Pembrokeshire (1811) describing it as having been "one of the chief mansions in the district" some 200 years earlier. The site is known to have been the home of Sampson Lort, who was the second son of Henry Lort of Stackpole Court, in the 17th century. Of the buildings shown on the early maps only one small ruin, the most northeasterly of the group, now remains. Photographs of the demolished buildings, the last one was demolished in 2004, suggest that they were architecturally in keeping with the style of known medieval buildings still extant in the locality. Recent development of a pond area may have destroyed important archaeological evidence for the southern extent of the medieval farmstead. A rectangular walled garden, on higher ground to the east of the former building complex, and a circular parcel of land adjacent to its north side may represent an even earlier phase of occupation. There is no evidence for a moat. The farm lies on the 80m contour 250m northeast of the coast; the Pembrokeshire Coast National Park coast path skirts the farm's southern boundary.

View looking north-northeast across East Moor farmyard.

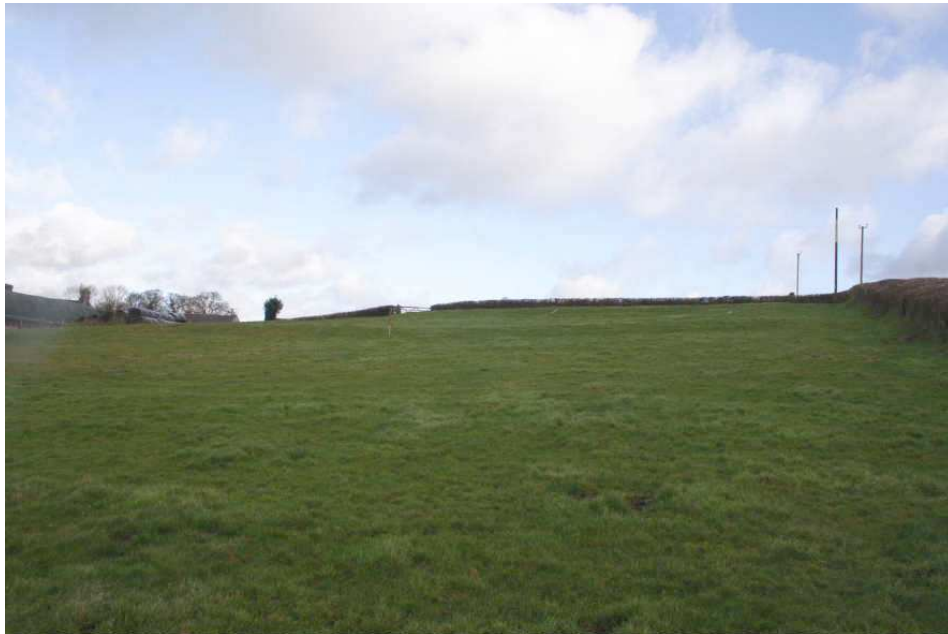
8783 CWM AGOL

This site was first detected as a rectangular cropmark during aerial reconnaissance in 1979 and its presence is confirmed on Meridian Airmaps from 1955. On the ground the enclosure survives as a low rectangular bank terraced into a west facing moderate hillslope at 50m above sea level. The long axis of the enclosure, at c. 40m long, is aligned approximately north to south, with the lesser sides measuring c.30m. The bank on the west side averages 0.4m high whilst the upslope eastern bank is lower and more spread. The southern bank may have been incorporated into the field boundary bank. There is no trace of a bank on the northern side where it may have been destroyed by a trackway. No ditch or moat is discernible. The site looks more like a typical Iron Age rectangular enclosure rather than a moated medieval site.

View of Cwm Agol enclosure looking northeast

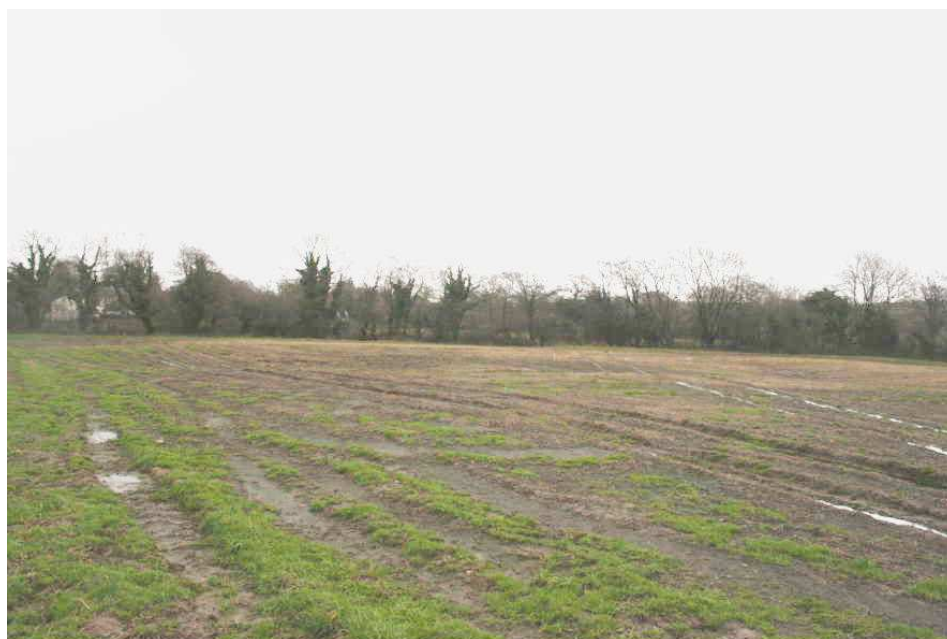
11809 CWRT MALLE

This site was discovered by aerial reconnaissance undertaken during the drought of 1984. Oblique aerial photographs taken at that time, and two years later, clearly show a square ditched enclosure situated in the field some 160m northeast of Cwrt Malle farm. Historical documents appear to confirm that the site is medieval, probably being the home of Robert de Malley in the early 12th century. On the ground the site is defined by a very low earthwork bank c. 60m by 60m with a discernible internal ditch surrounding an approximately square raised platform. The aerial photographs also appear to indicate a linear crop mark to the north of the site that may represent a leat that fed the moat, but nothing of this evident on the ground. The field is ploughed every two years and planted for silage. During the site visit the badly drained enclosure was seen to have suffered extensive damage from farm vehicles. The site lies on a very gentle south facing hillslope at 55m above sea level.

View across the site of Cwrt Malle enclosure, looking east. Note vehicular damage.

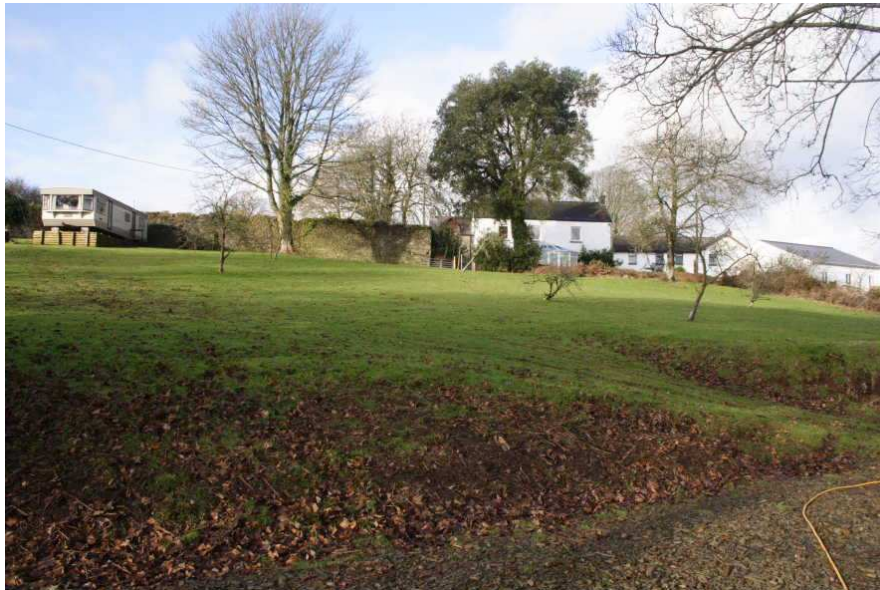
32475 WHITLEY FARM

This site was first recognised as being a potential medieval moated site during a topographic and historical survey of Narberth undertaken by Heather James in 1992 in which there is an unsourced reference to the 'Medieval manor of Whitley'. Early edition Ordnance Survey maps show the presence of a rectangular earthwork platform in front of (southeast side) the house, modern edition maps omit this detail. The main farmhouse and outbuildings of Whitley Farm have undergone much recent modernisation. A large walled garden survives to the southwest of the house, a drystone 'Ha-Ha' lies to the southeast, in front of the house and is obscured by vegetation. There is now no indication on the ground of the raised rectangular platform marked on the early Ordnance Survey maps, and there are no earthworks resembling a ditch or moat in the vicinity. The basement in the main farmhouse has architectural details that appear to be of some antiquity; the walls are of substantial stone masonry, the floor is of cut stone slabs, there are pointed arch stonework niches in at least one of the walls, and the ceiling is barrel vaulted. These features suggest medieval origins.

A view of Whitley Farm, looking northwest. Note walled garden to the left of the farmhouse.
