# OLD RECTORY, MANORDEIFI, LLECHRYD, PEMBROKESHIRE: ARCHAEOLOGICAL WATCHING BRIEF

RHIF YR ADRODDIAD / REPORT NO. 2009/45  
RHIF Y PROSIECT / PROJECT RECORD NO. 94950

Ebrill 2009

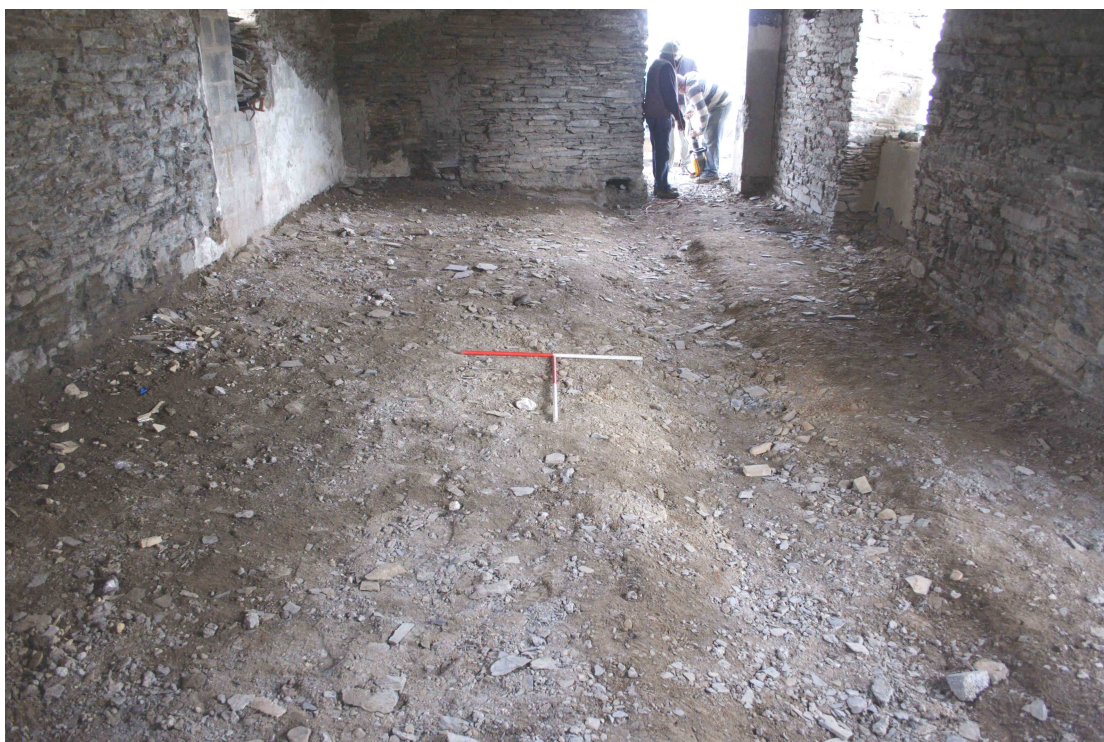
Prior to the archaeological watching brief the concrete floor of the building had been removed. Scarring left on the internal walls of the building indicated this floor was c.0.3m thick. A c.1m wide x c.0.15m deep northwest – southeast aligned former drain was present that ran the whole length of the cattle byre.

**Photo 1:** Northwest view of cattle byre with trough/drain to right.

The groundworks monitored during the course of the watching brief revealed a former drain through the length of the former cattle byre. The drain is likely to have been contemporary with the construction of the building, and thus of post-medieval date. Drains are integral parts of cattle byres with their primary function allowing animal waste products to exit the building as easily as possible. The feature is not considered to be of particular archaeological significance.

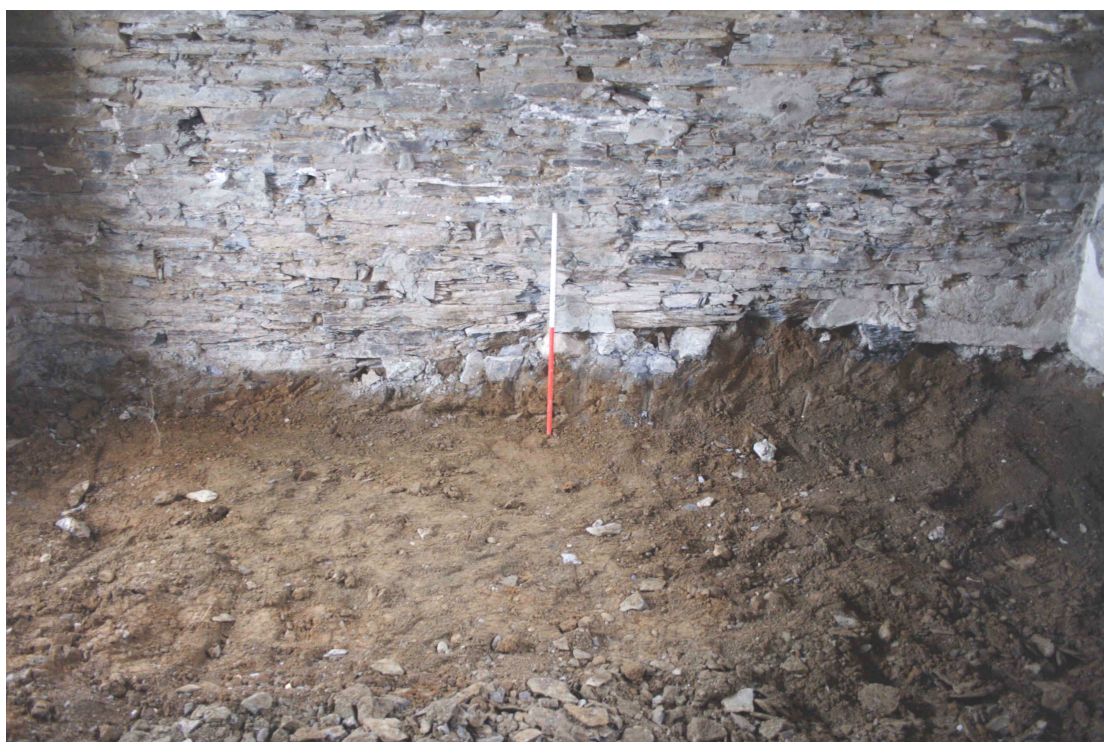
The groundworks revealed that the southwest part of the outbuilding had been constructed directly onto the shattered shale bedrock (001). This was visible as a c.3m wide band running the length of the room. To the northeast the building was constructed on the subsoil (002) with no sign of any foundations or footings.

**Photo 2:** Southeast end of cattle byre following groundworks.

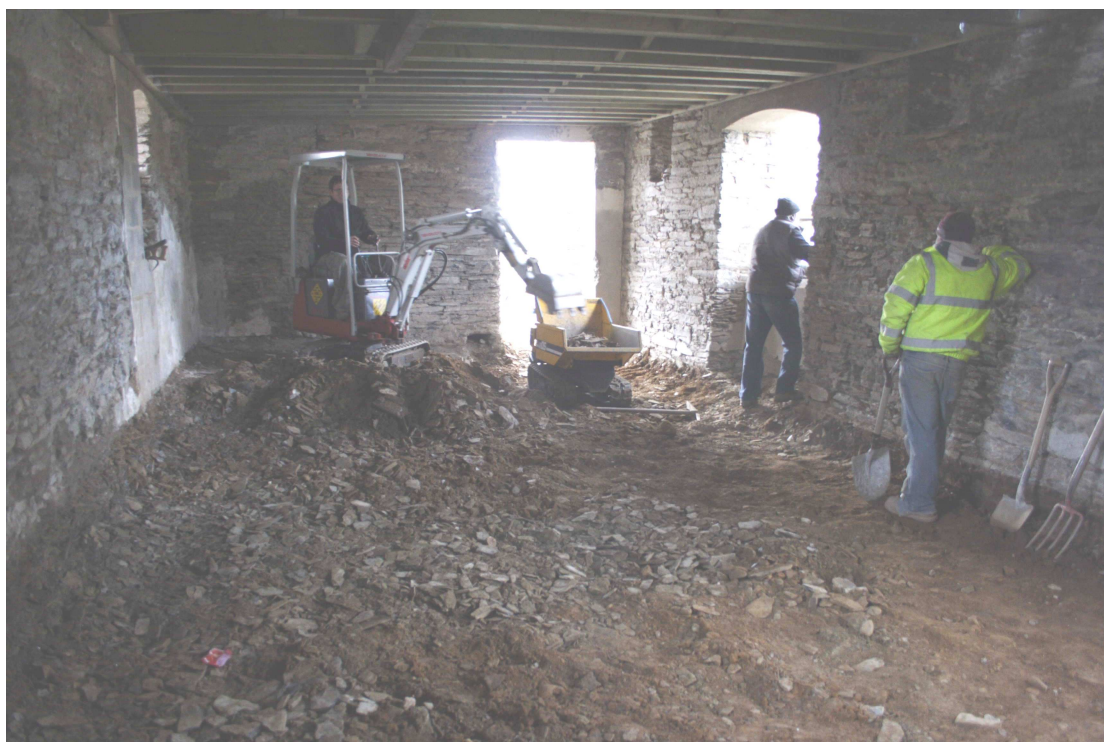
**Photo 3:** General working shot of cattle byre groundworks.

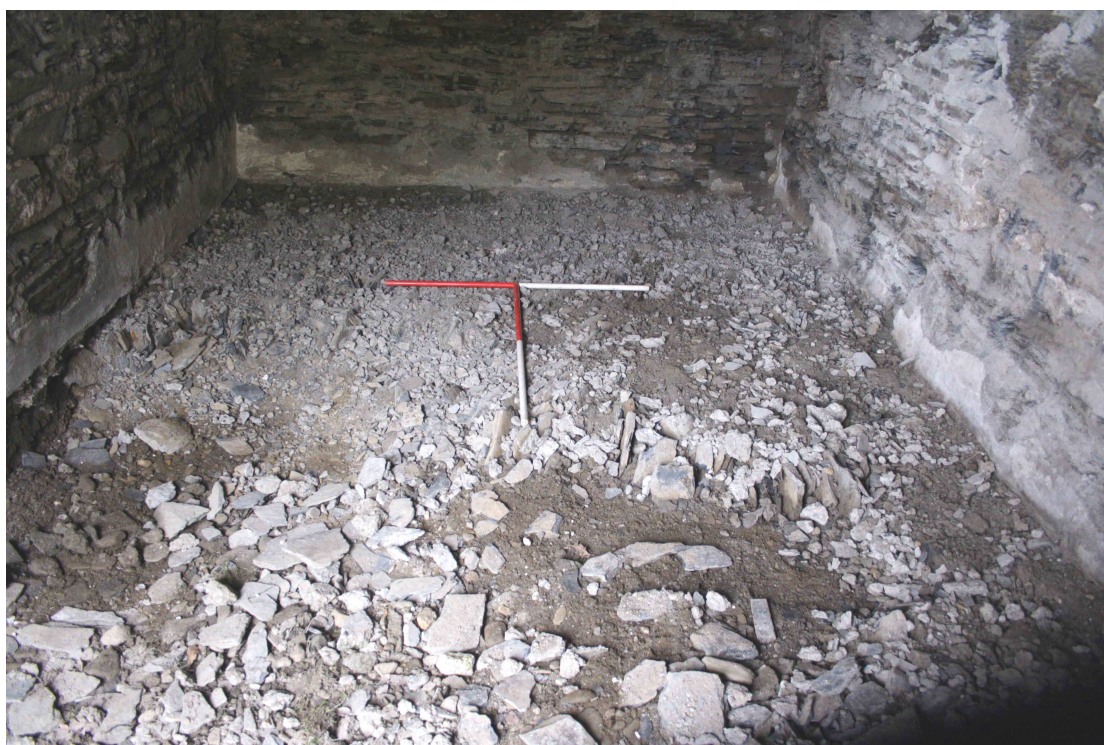
The lowering of the floor level in the storeroom was not archaeologically monitored as the shattered shale bedrock was visible throughout the room.

**Photo 4:** Storeroom facing northwest showing exposed bedrock.

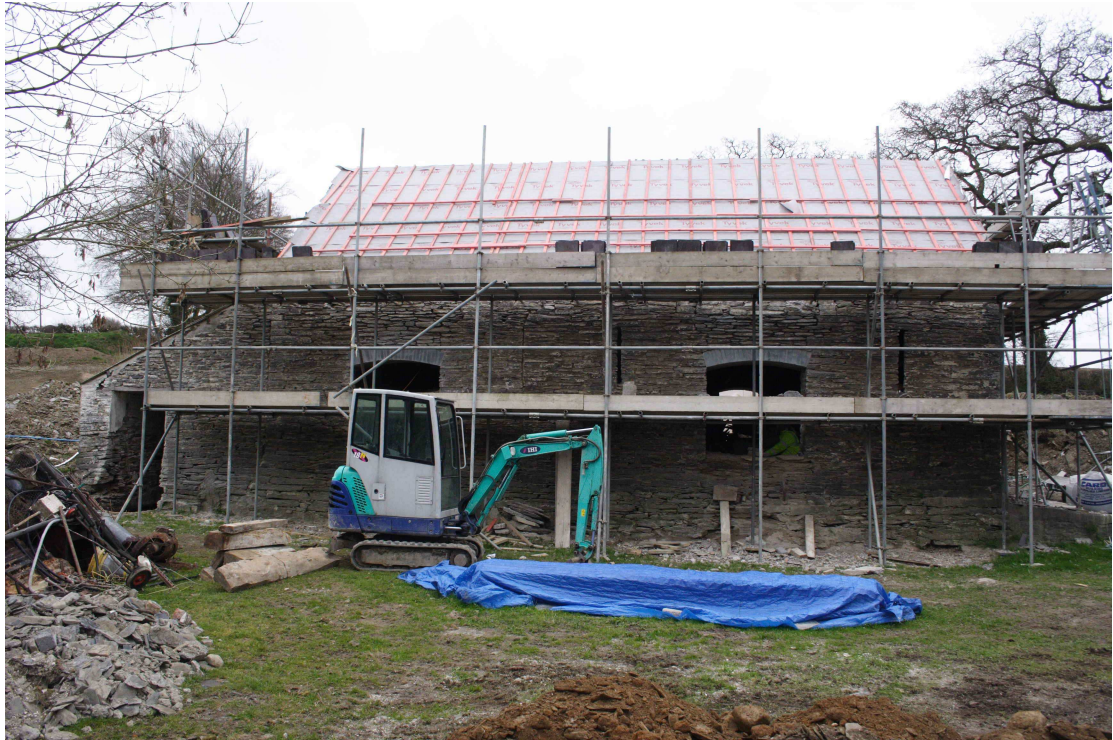
**Photo 5:** Cattle byre and store room undergoing conversion.

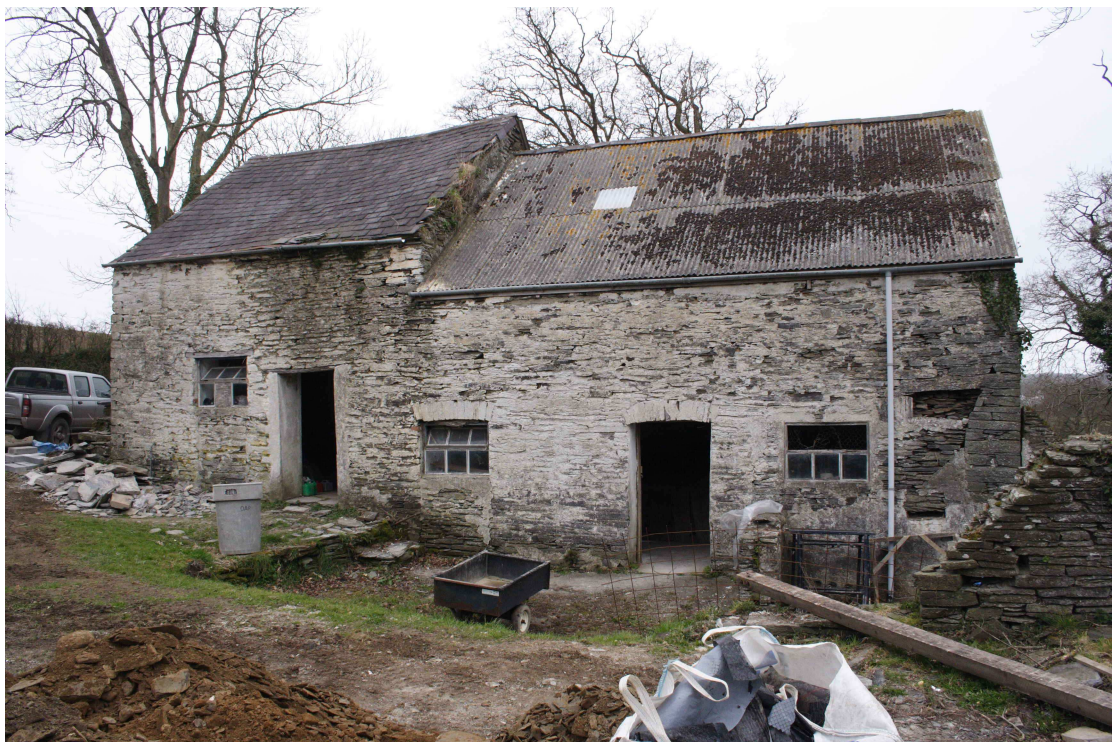
**Photo 6:** Northwest outbuilding prior to conversion.
