AN APPLE STORE AT TYPICCA FARM, DRYSLWYN

STANDING BUILDING SURVEY APRIL 2009

Report No. 2009/52

RHIF YR ADRODDIAD / REPORT NO. 2009/52
RHIF Y PROSIECT / PROJECT RECORD NO. 95176

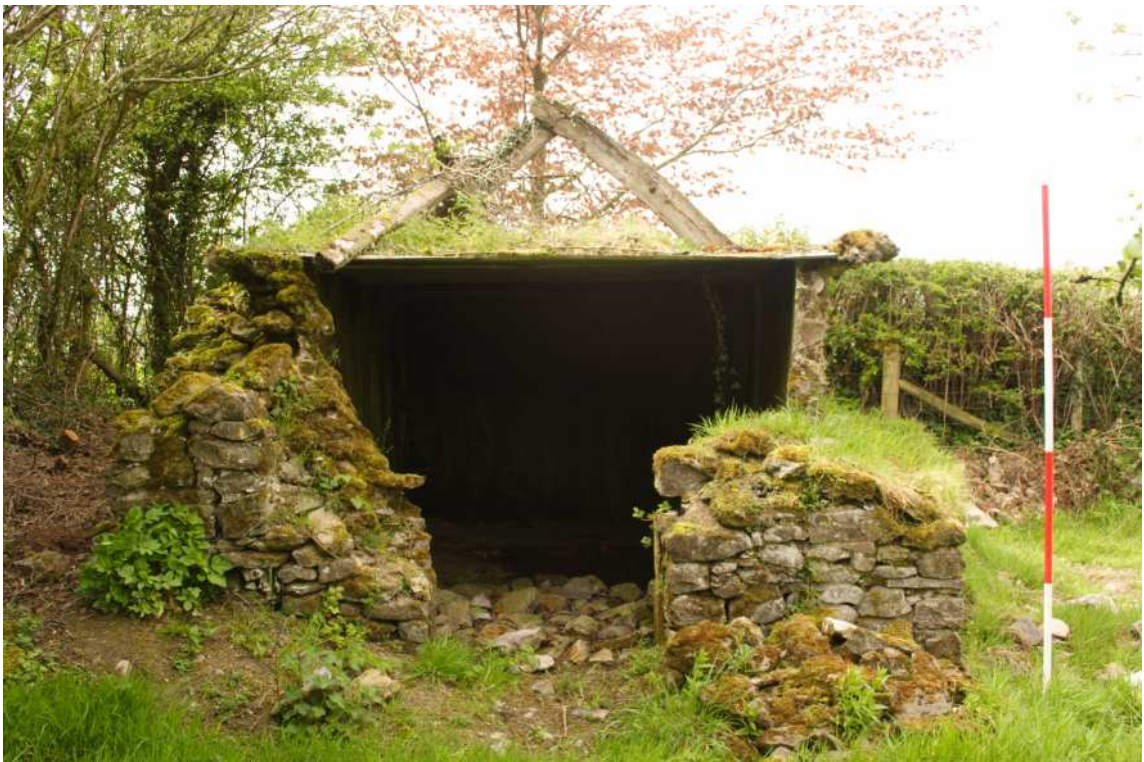
The front elevation is entirely of stone rubble construction, bonded with a lime mortar. The ruinous walls today stand to a reduced height. Possible straight joints suggest that the opening once spanned the full width of the interior before it was narrowed to form a standard width doorway. The interior is concrete rendered internally. An imprint of a former doorjamb is evident in the edge of the concrete wall render.

Photo 2: Front external east-facing elevation

- The removal of any fabric should be overseen by an archaeological watching brief to record additional historic or archaeological features or information relating to its construction.
- Excavating a small area around the modified east side of the building should be considered in order to better establish the extent of the modifications (eg. whether this elevation had rounded corners like those found to the rear).

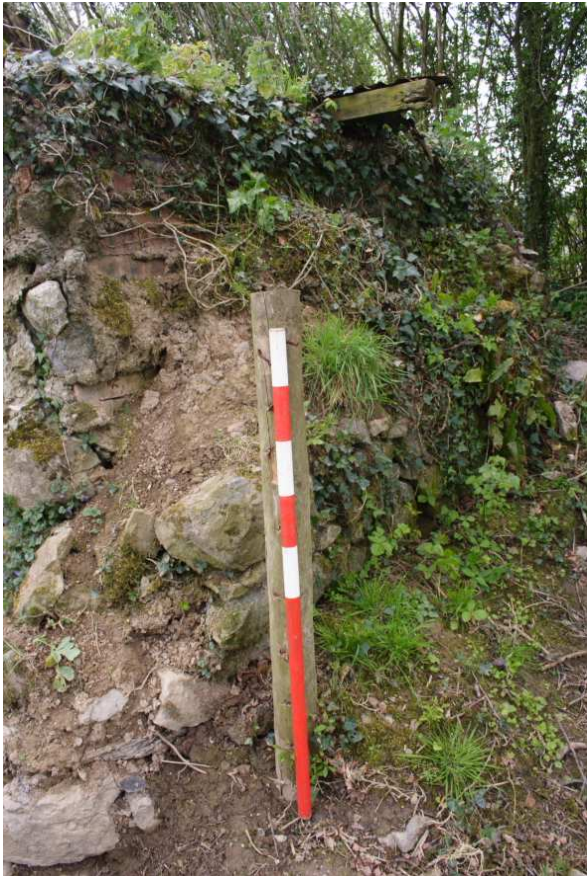
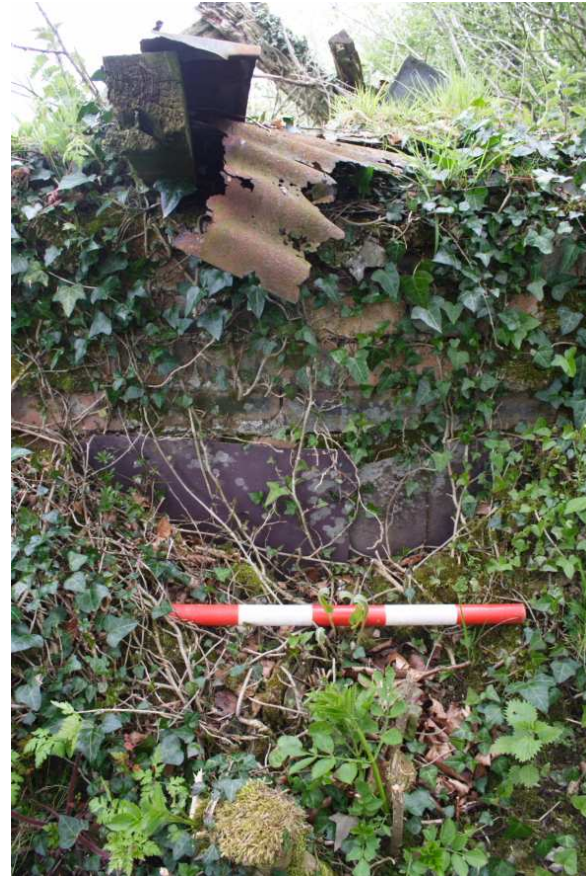
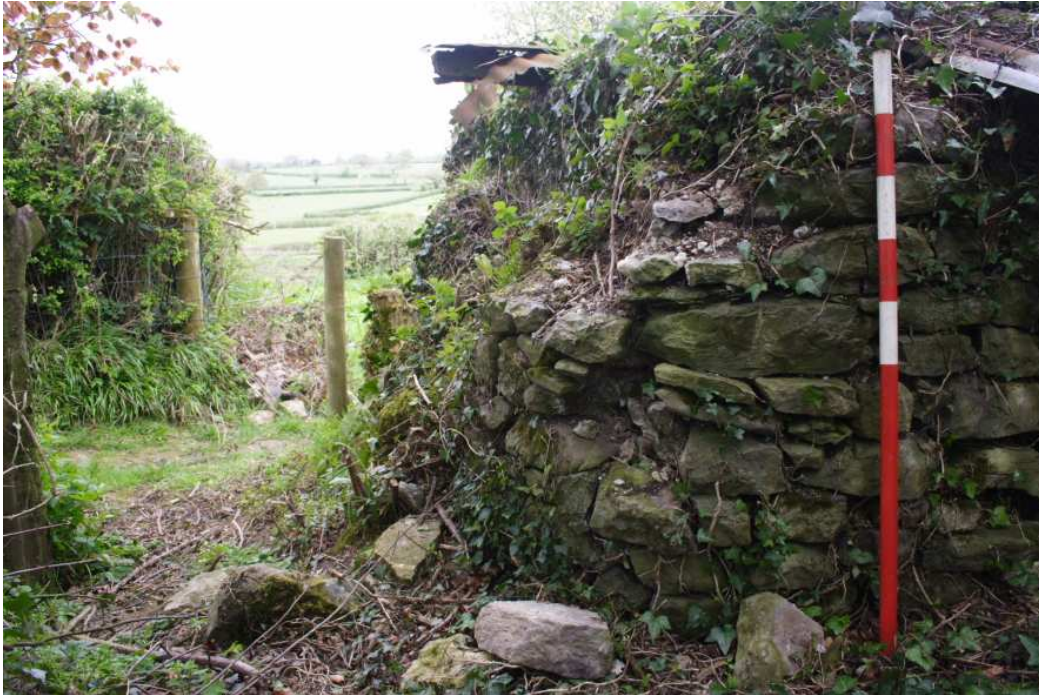
The rear elevation is of stone construction to a height of approximately 0.9m with a clom superstructure. As in other areas this wall height is now diminished since the action of water has led to slumping of the earth walling.

A red brick, single skin wall has been built on the inside of the stone and clom wall which has a few Caernarfon slates on edge between the brick and earth, possibly remnants of former slate hanging. The brick wall is rendered internally.

The arrangement changes towards the south end of the elevation where stone replaces clom in the upper wall courses. The stone walling survives to eaves height.

Photo 3: Rear external west-facing elevation. Facing south-east

Photo 4: Detail of rear external west-facing elevation

Photo 5: Rear external west-facing elevation (looking north)

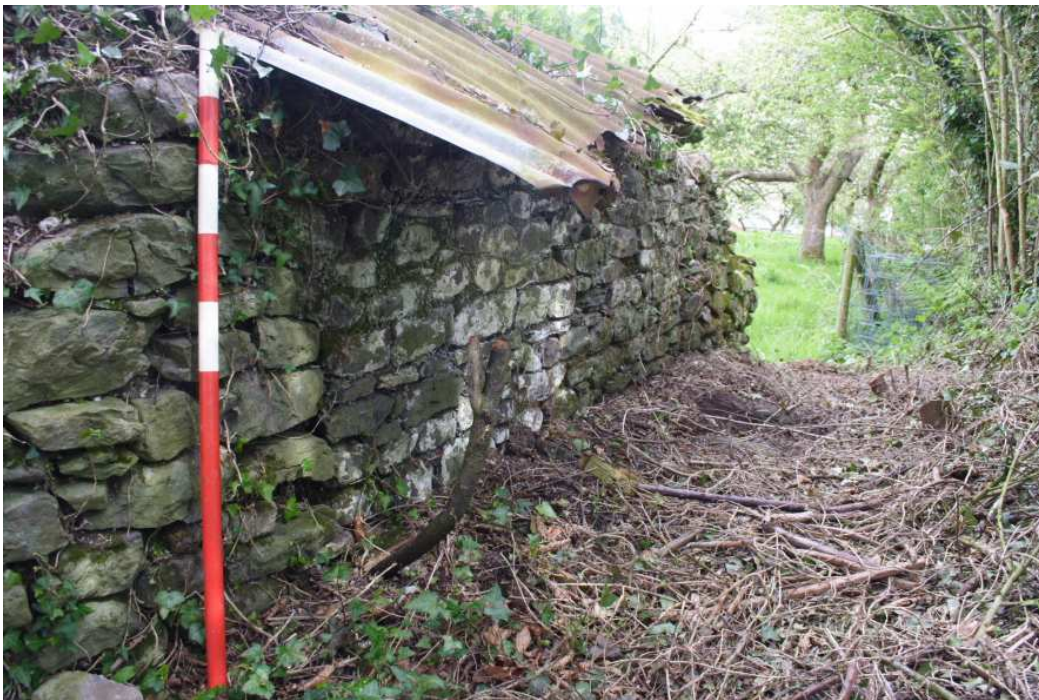
This elevation still stands to eaves height. It is entirely of stone construction and shows evidence of having been substantially rebuilt. Ragged joints visible externally identify the extent of the rebuilding which encompasses the middle section of the wall. The rubble stone coursing which characterises other parts of the building is here replaced by stone brought to rough courses. Occasional bricks within the wall structure suggest a later 19th/ early 20th century date for this repair. Limewash traces on the masonry suggest reuse. A concrete wall render obscures the internal elevation of the wall.

Photo 6: External south facing elevation (looking east)

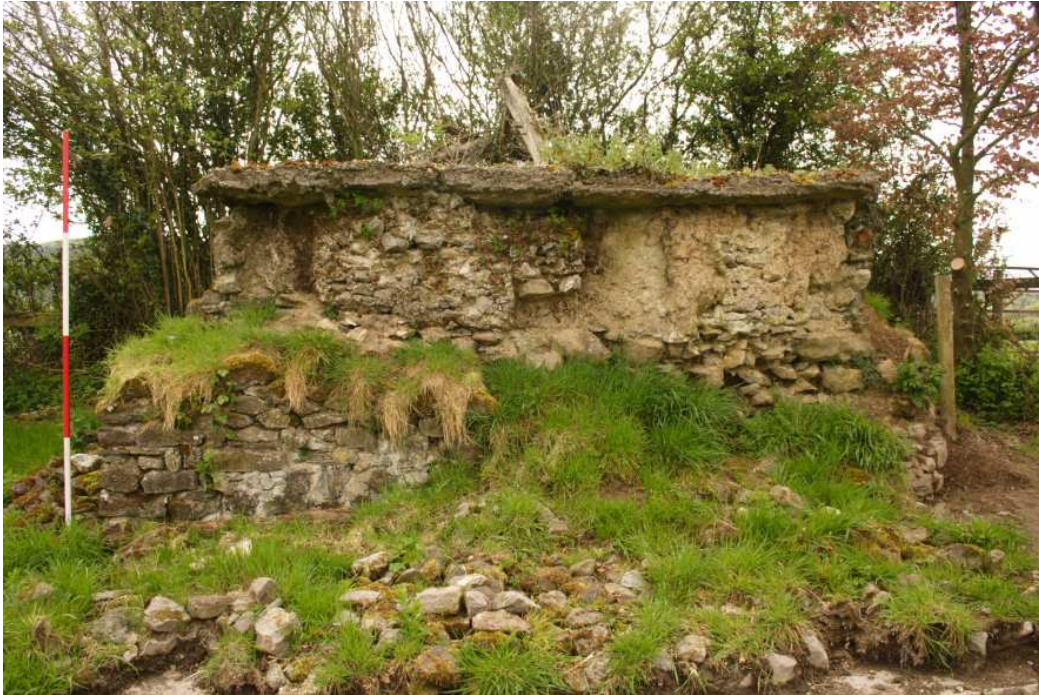
The north side wall is the most complicated elevation, showing evidence of several phases of alteration and rebuilding. This wall still stands predominantly to eaves height, although the external wall face has since weathered away leaving only the wall core visible. The wall has a rubble stone base, originally with a clom superstructure which appears to have been latterly repaired with lime mortar and stone. The central portion of the elevation had a square window which was later blocked with stone and lime mortar. The wooden lintel partially survives, otherwise visible in relief against the internal concrete render. There are no other clearly discernible openings visible.

Photo 7: External north facing elevation

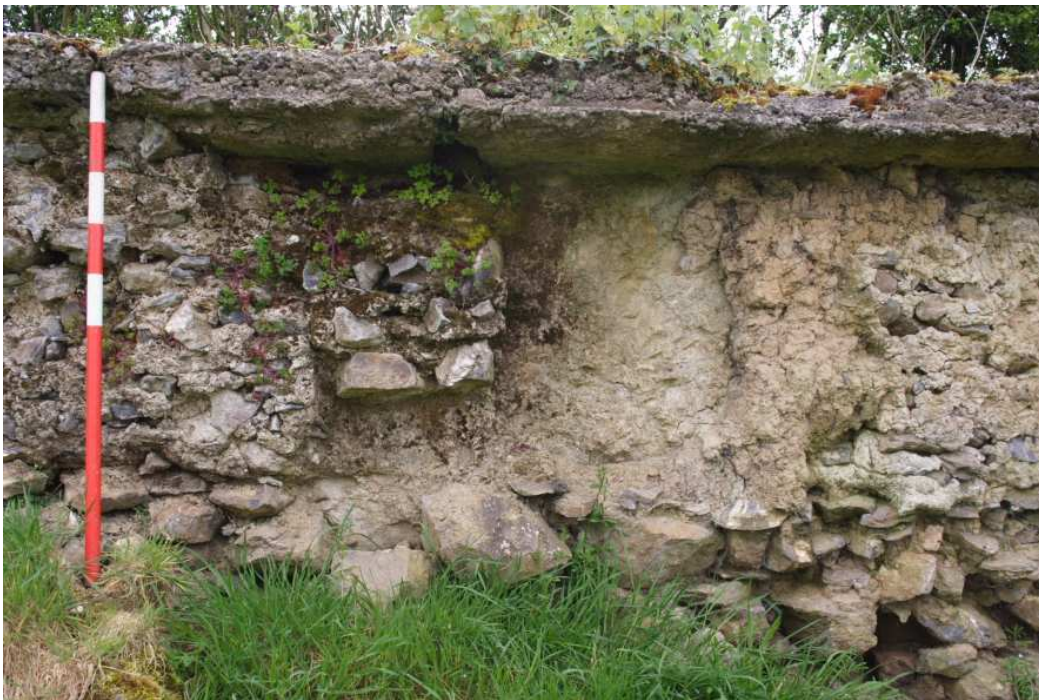
So what of the example at Ty Picca? It is clear that at least two of the walls would have been clom construction although later repairs have since removed or obscured the original material in other areas making further interpretation problematical. The building once had a window in the north wall although this has since been blocked and it would appear that the east facing front wall has been altered over the years.

Photo 8: Detail showing blocked window (external north facing elevation).

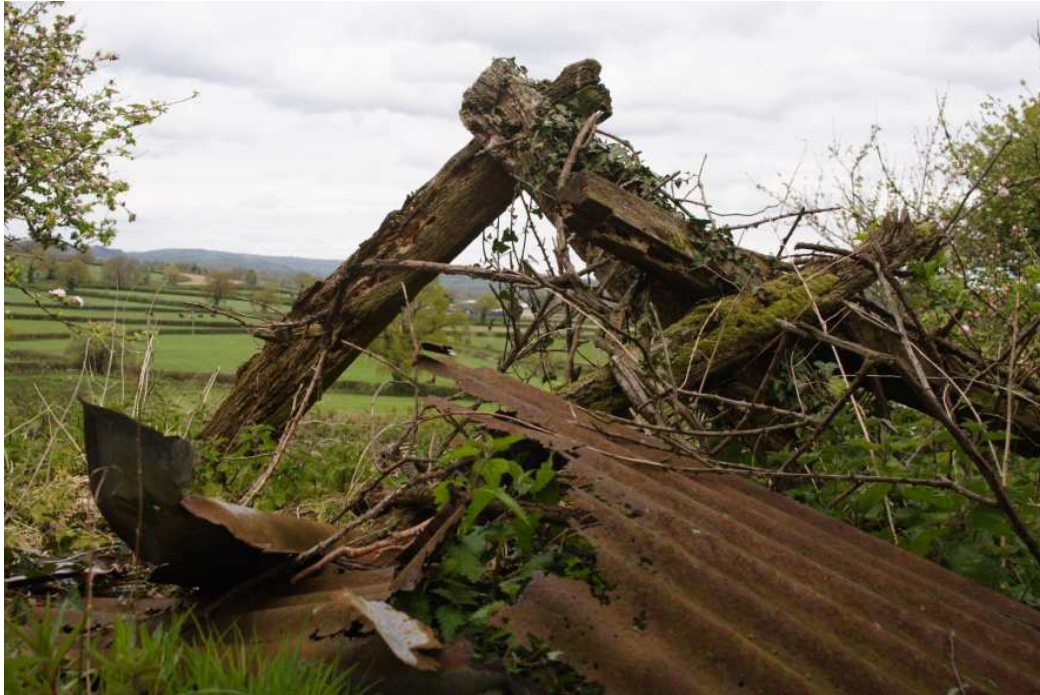
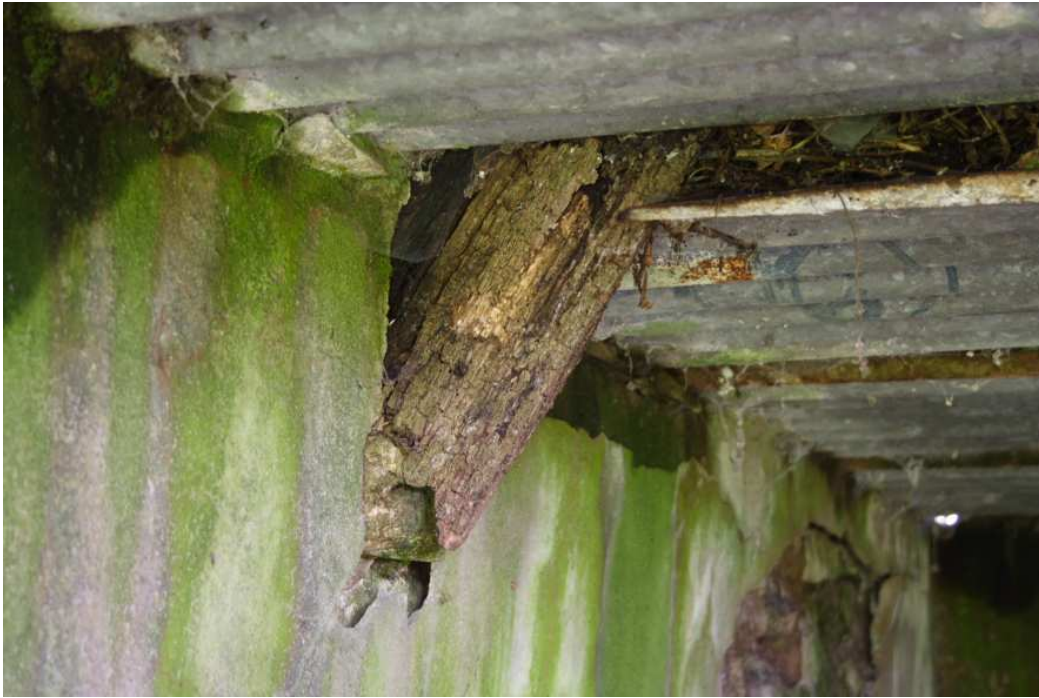
The original roof structure is today evidenced only by a hardwood A-frame truss, wooden pegged and positioned roughly centrally within the building. The bottom of the roof trusses were set into the wall tops some distance back from the outer wall edge. A tin roof covered the building latterly.

The roof has also been much altered: the central A-frame truss had been removed and reinstated, probably by the end of the 19th century following structural repairs whilst the other roof material present today (corrugated tin, machine sawn purlins) is modern. Excavations around the north and west walls uncovered no evidence of the other roofing materials (eg. slate or tile stone) which might commonly be expected to survive had they been used.

Some clue may lie in the position of the A-frame which is bedded into the wall tops some distance back from the wall edges; this would allow for the depth of material found in a thatched roof whilst inhibiting the standard construction of a slate or tile stone roofs. Thatch of wheat, rye, oats, rushes or water reeds with an under thatch of fern or gorse would once have been widespread in the region;

Photo 9: Detail of roof truss. Facing north-east.

Photo 11: Detail of roof truss. Facing west.

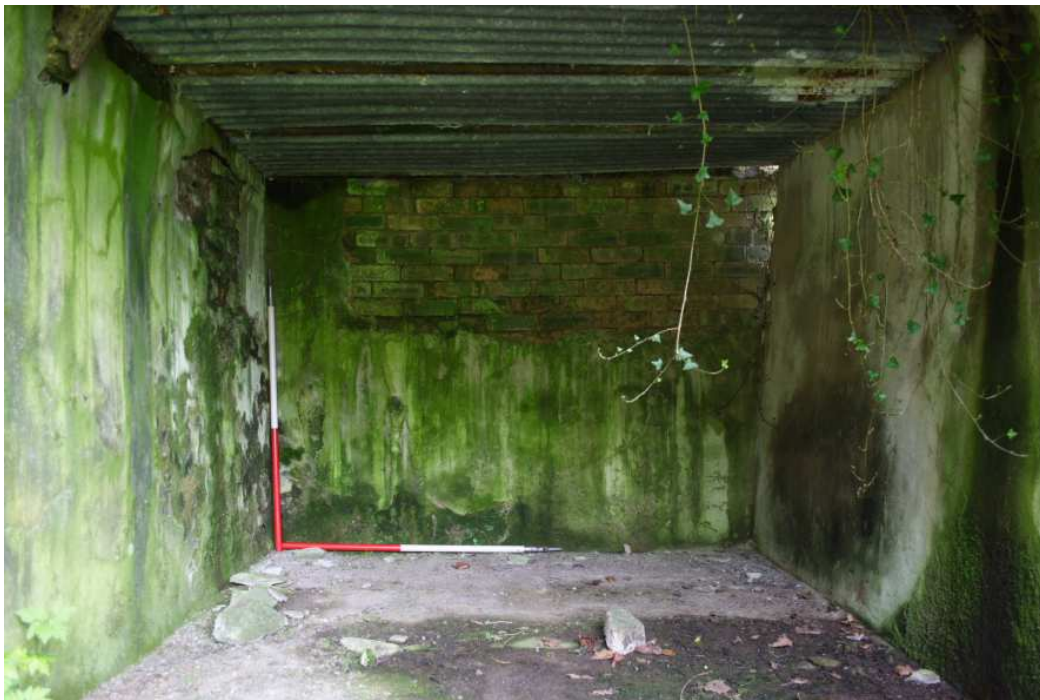
Modern repairs have influenced the present appearance, when a red brick single skin wall was built up against the rear (west-facing) wall, a cement render was applied internally and a concrete floor added. Cemented into the wall tops is a flat corrugated iron ceiling. Above this was a corrugated tin roof with narrow deal boards nailed onto the purlins below.

All interior elevations of the building are today obscured by a cement render which masks the original wall fabric and features.

Photo 10: Building Interior. Facing west.

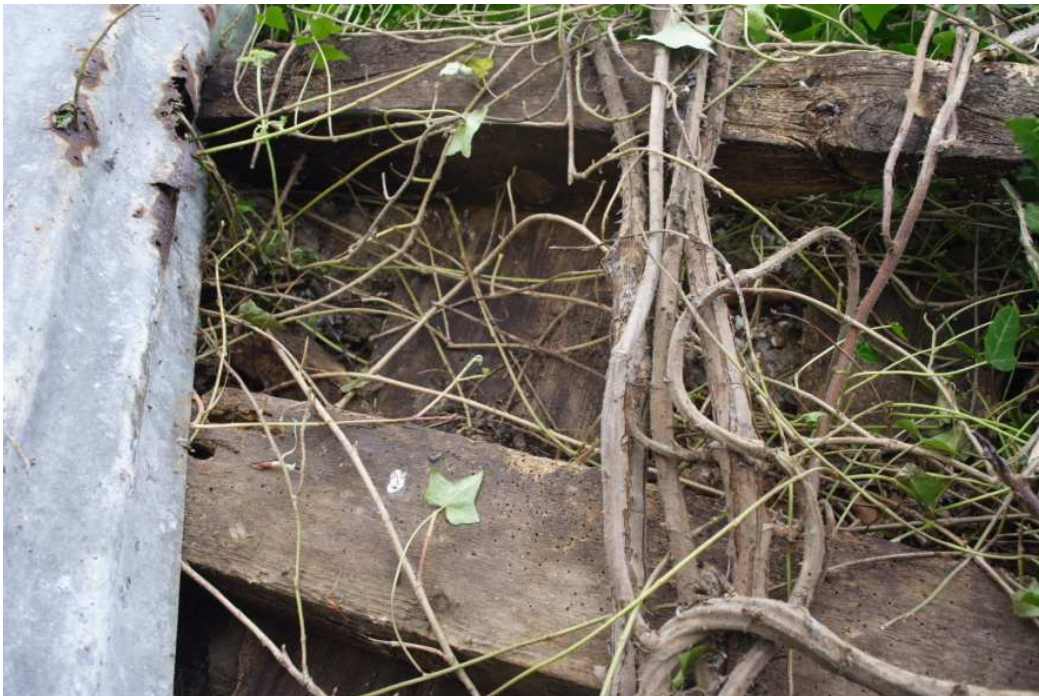
Photo 12: Detail of roof structure
