# **PLOT 1, THE OLD GRAMMAR SCHOOL, THE ESPLANADE, CARMARTHEN ARCHAEOLOGICAL WATCHING BRIEF**

**SEPTEMBER 2009**

RHIF YR ADRODDIAD / REPORT NO. 2009/68  
RHIF Y PROSIECT / PROJECT RECORD NO. 97373

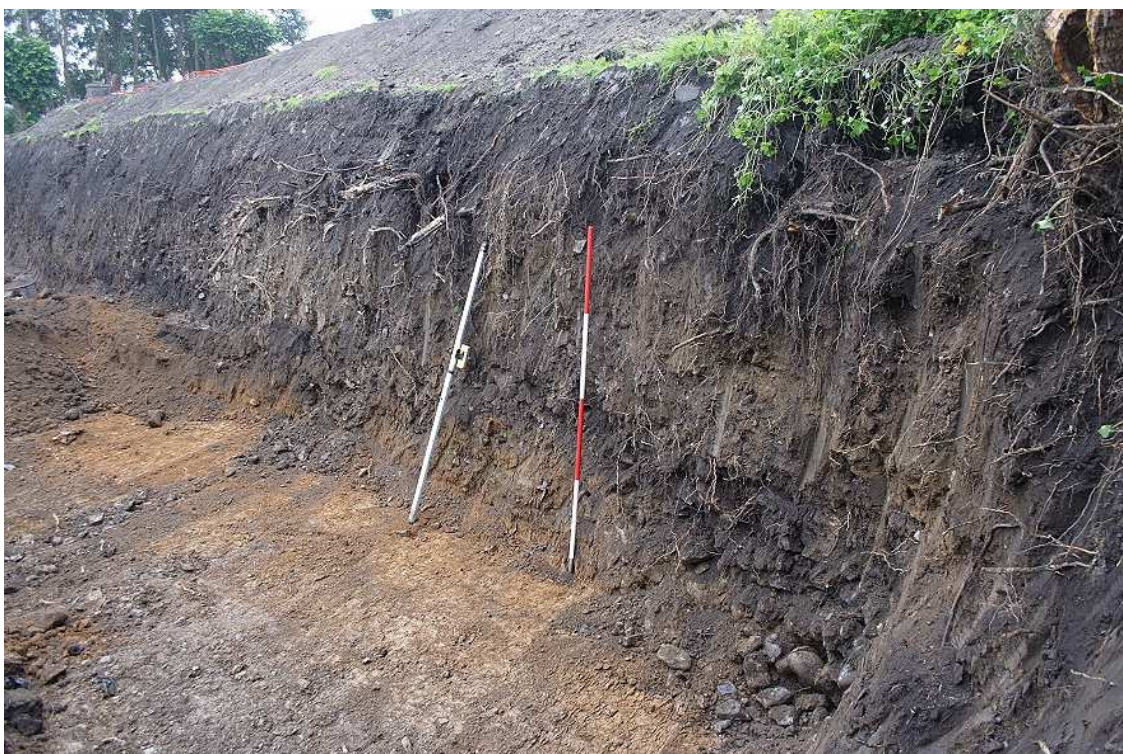
Photo 1: Looking SSE at the deep western section, showing the build-up of layers overlying the orange fluvio-glacial deposits. A fragment of Wall 10 is visible at the base of the section. 2m scale.

This deep deposit consisted of a dark grey-brown friable clayey-silt loam up to 1.1m thick in places. Individual layers were visible within this deposit towards the southern end of the site but they are all described together as a modern topsoil deposit. Modern pottery, glass and metal objects were visible within this layer. This deposit was at its thickest to the west, but spread across the entire development area following the pre-development contours and was still visible along the eastern end of the site after the levels had been reduced (photos 1 & 2).

Underlying Layers 03 and 04 was a series of naturally deposited fluvio-glacial deposits, consisting of a mix of sandy-clays and gravels. These deposits were revealed at a depth of between 2m to 2.6m below the current ground surface in the deep western section of the site, but were only partially revealed across the cleared ground surface of the site, indicating the natural ground level fell quite sharply to the east (photos 1 & 2).

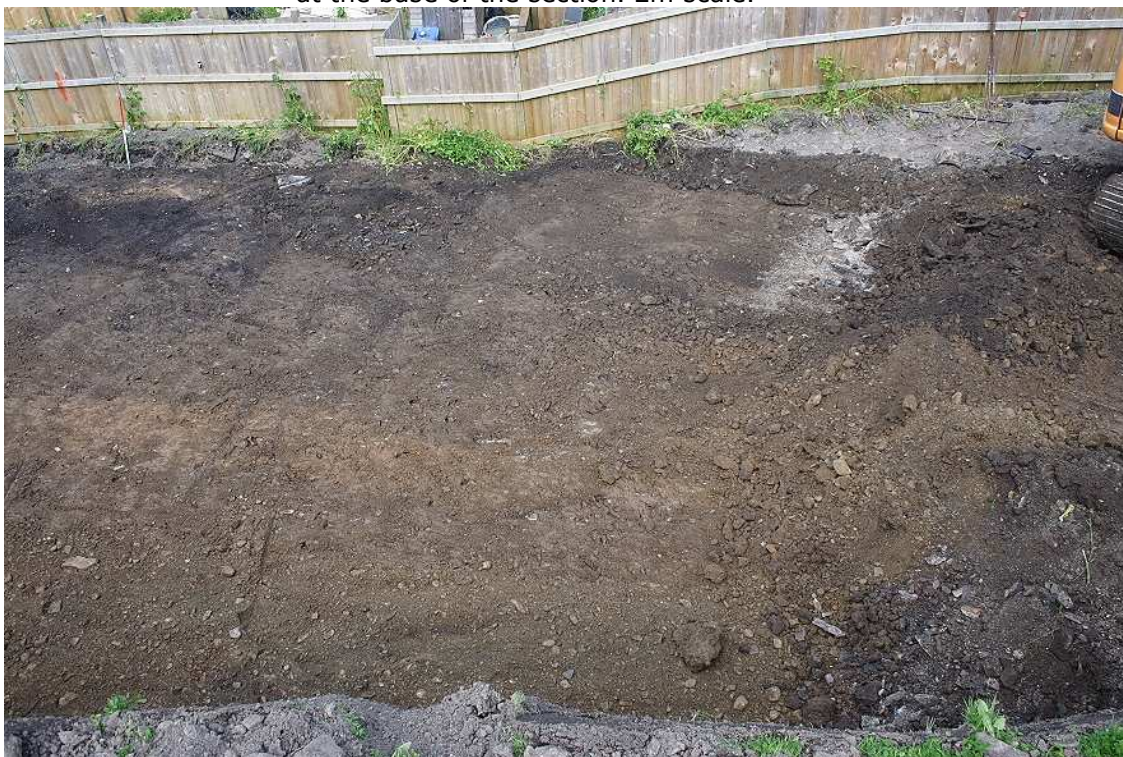
Photo 2. Plan view, looking NE, of the building plot as the levels were being reduced. Natural fluvio-glacial deposits are visible at the bottom of the photo with the succession of layers above showing the naturally falling ground levels.

This deposit would appear to be a large dump or leveling layer of relatively recent (20<sup>th</sup> century) origin, possibly from construction works in the vicinity (photos 1 & 2).

although possibly also a dump or leveling deposit, dates from the later post medieval period and may therefore have come from the construction of the adjacent mid 19<sup>th</sup> century Grammar School or nearby mid to late 19<sup>th</sup> century buildings of Priory Row and The Esplanade (photos 1 & 2).

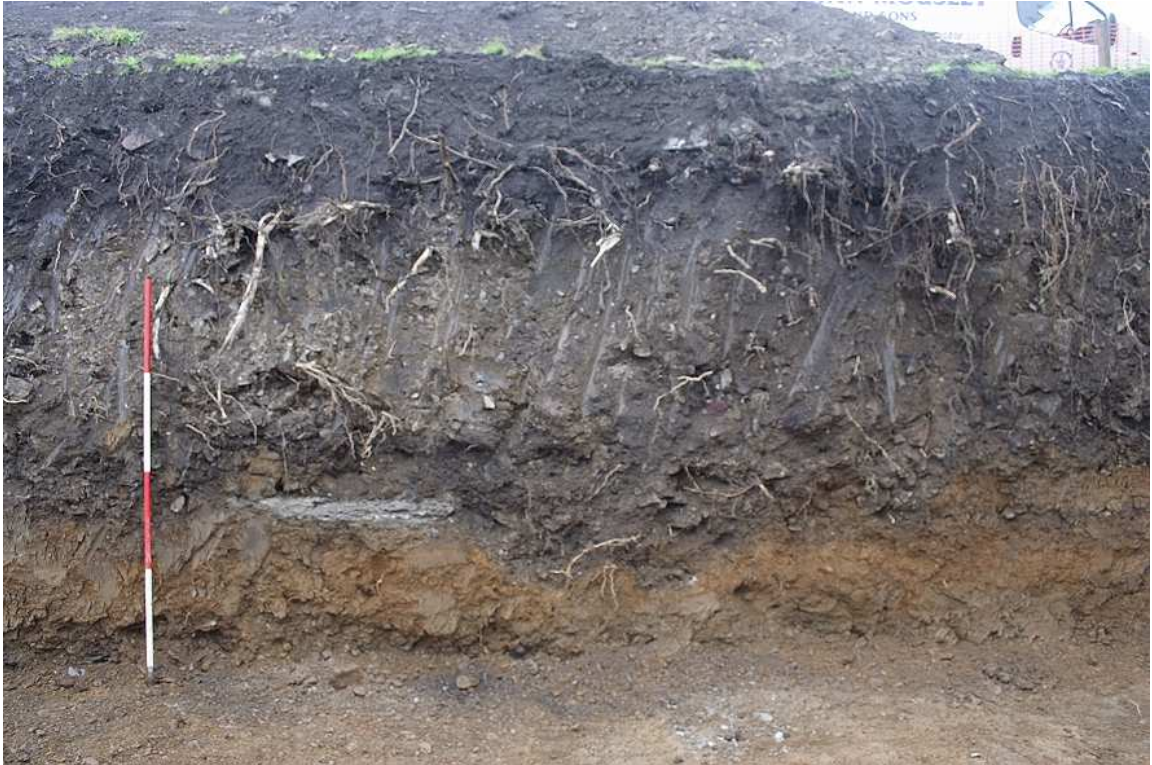
Photo 3. Pits 09 visible in the section, with the pale grey cement deposit clearly visible on the left. 2m scale.

Located 31m northwards from the southern end of the building plot, and also only visible in the western section was a series of three adjoining U-shaped pits or trenches containing a single fill (Fill 08). The northernmost pit/trench measured 0.4m wide and 0.3m deep, adjoining a central pit/trench 0.6m wide and 0.65m deep in turn adjoining the southernmost pit/trench measuring 0.8m wide and 0.55m deep. It appeared the cut of this feature may also have continued as a flat bottomed and straight sided cut extending 1.2m further south, picked out in the section by a 0.08m thick deposit of friable fine cement lying on the base of the cut. All these features were filled with the same deposit (Fill 08) of dark grey-brown sandy-silt with frequent small-medium sub-angular stone inclusions, indicating all the pits/trenches were backfilled at the same time. These features were identifiable during the ground clearance works so their extent east-west was not ascertained. This feature was covered by Layer02 but cut into Layer03. No finds were recovered from this deposit but the occurrence of the cement would suggest a fairly recent date (photo 3).

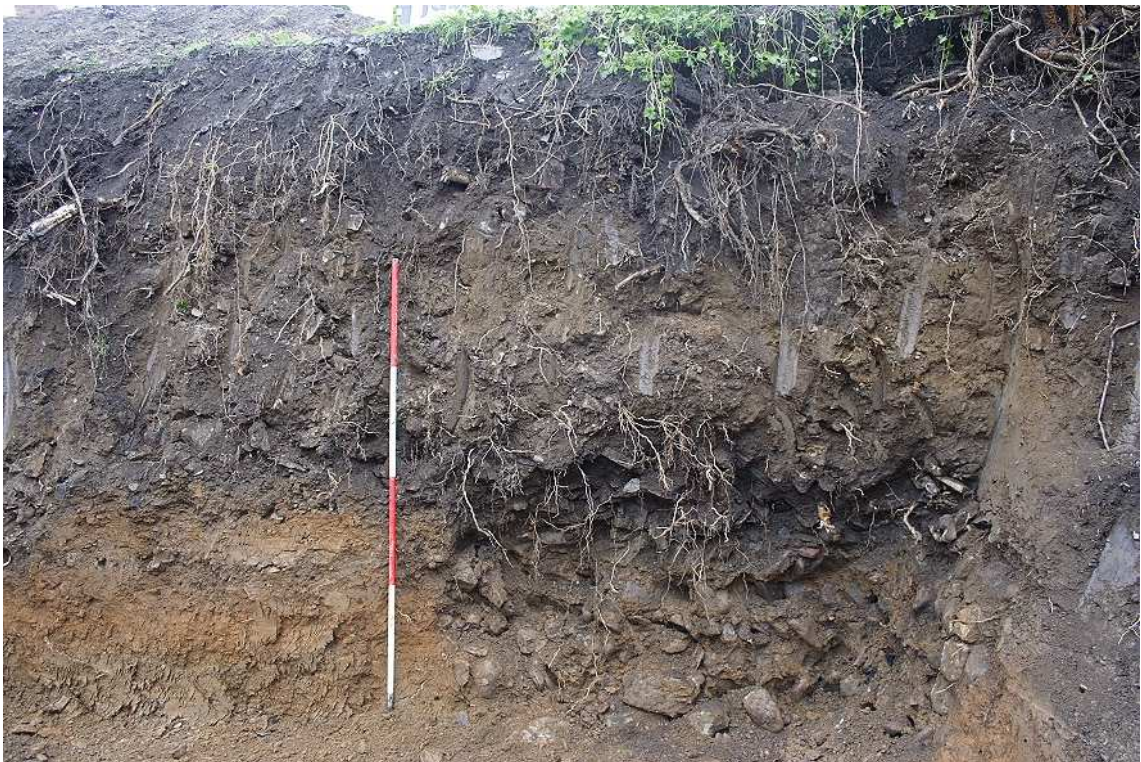
Photo 4. SW facing shot of Wall 10 with layers 01-04 above it. 2m scale.

At the northwestern corner of the site was a layer of dark grey-brown, loose, clayey-silt with c.30% large to very-large sub-angular stone inclusions. This layer was at most 0.45m thick, and extended for c.5m southwards into the plot, underlying Layer03, but overlaying Wall 10. The deposit thinned as it spread to the south. The high content of stone within this deposit would suggest it is demolition layer, presumably from the wall above which it lies. The deposit did contain some ceramic building material (cbm), but due to health and safety constraints this deposit was not examined closely and the date of this cbm could not be ascertained (photos 1 & 4).

Located in the very northwestern corner of the plot and beneath Layer04 were the possible remains of a simply-constructed wall. Set within a straight sided cut (Cut 11), of which a 0.8m depth was revealed but not bottomed, was a series of large to very-large rounded boulders, roughly coursed and surrounded by compacted clay. A segment 2.15m long was visible in the western section, with 0.8m visible in the northern section suggesting, if the wall continued in a straight line, a NNW-SSE orientation. Stratigraphically this appeared to be an early feature, the construction trench was cut directly into natural deposits but no finds were visible in the wall structure and no dating evidence discernable. The wall construction and alignment was markedly different from other wall remnants discovered within the building plot (Wall 12 & Wall 14) suggesting it was not part of the same period of construction. No further evidence of this feature could be discerned extending further north into the area of allotments but the lower courses may still survive below the current ground level in that area (photos 4 & 5).

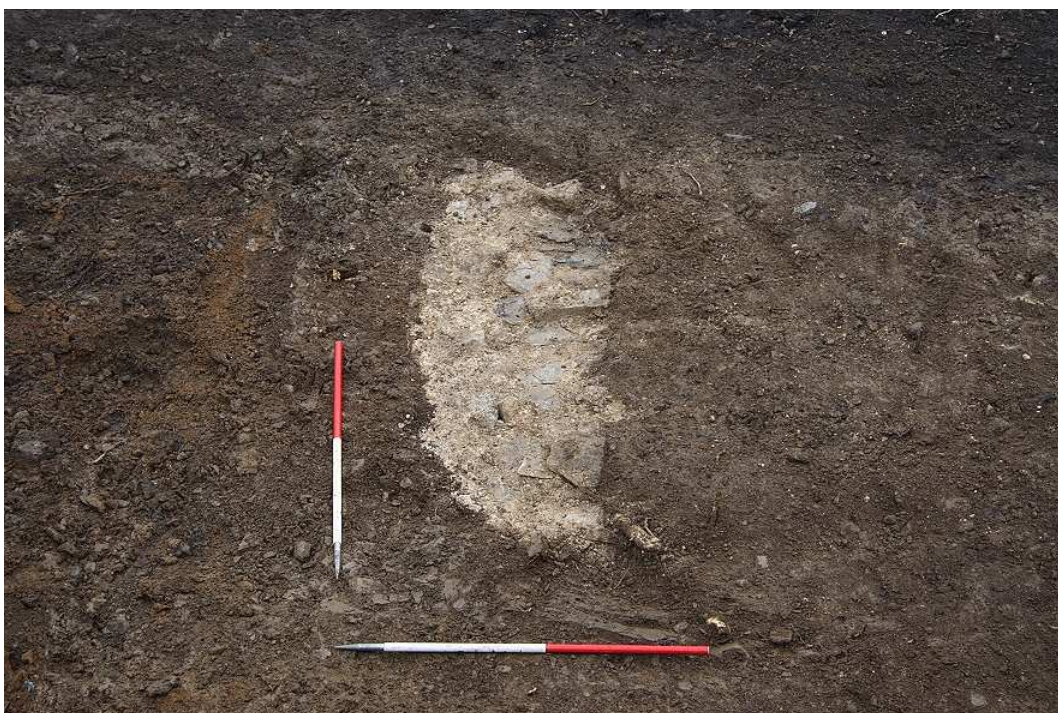
Photo 6. NE facing shot of Wall 12, with the fragmentary remains of Surface 13 visible at the bottom end of the wall. 2 x 1m scales.

Located c.31.5m northwards from the southern end of the building plot was a fragment of mortared stone wall (Wall 12) with an associated slate surface (Surface 13). The wall measured 2.1m long, 0.7m wide and was constructed of local sub-angular rubble stone with slate leveling courses visible, set within a pale creamy-yellow fine mortar. The wall was orientated NE-SW (50°) and was revealed below Layer03 but the groundworks did not extend deep enough to reveal any further construction details or which deposits it may have been cut into. The southeastern edge presented a flat face whilst the northwestern edge was uneven and slightly curved in places. This uneven edge may be accounted for by root action.

An adjoining slate surface was partially uncovered around the southwestern end of the wall, suggesting the visible southwesterly extent of the wall was in fact the terminus of this segment of walling. The surface consisted of some intact, but mainly broken and disintegrating slates covering an area of at least 0.6m wide (NE-SW) and 1.5m long (SE-NW). The full extent of the surface was not revealed, as it extended underneath Layer03.

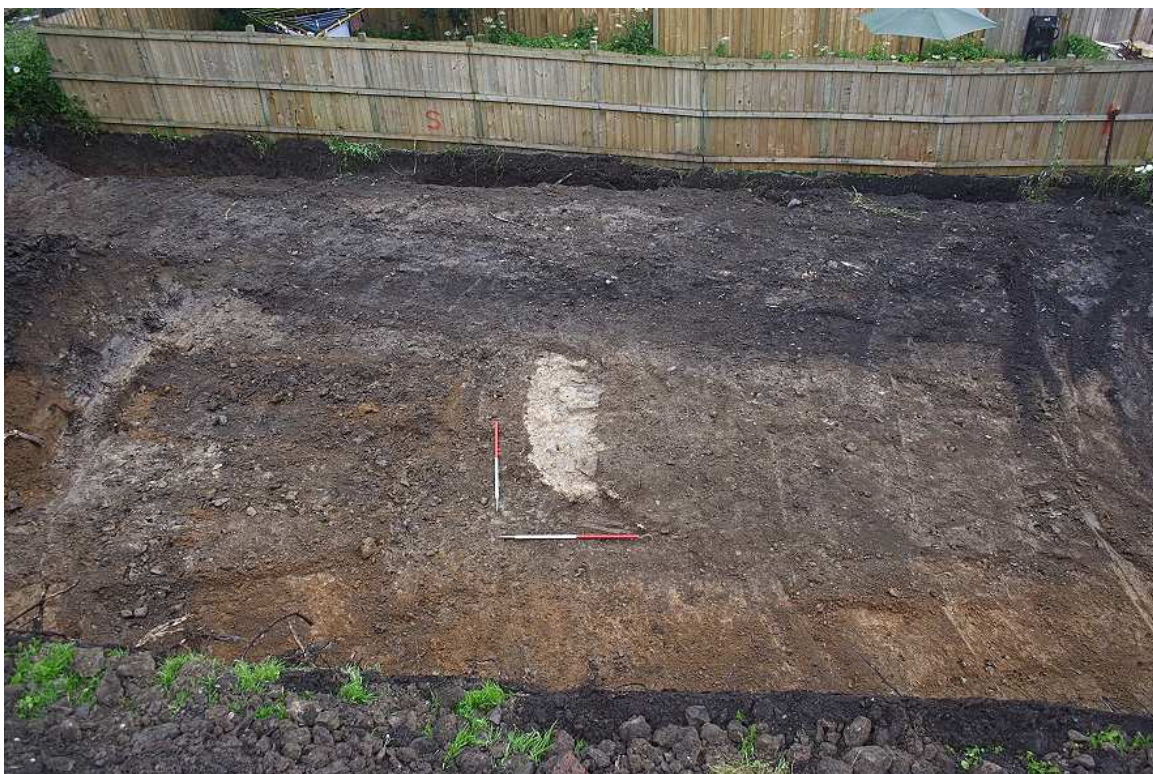
Photo 7. NE facing shot of Wall 12 after the levels had been reduced. The undisturbed fluvio-glacial deposits are visible at the bottom, whilst topsoil 01 deposits still remain at the top. 2x1m scale.

The build, composition and orientation of the wall, and the adjacent slate surface, is very similar to that of Wall 14 and Surface 15 to the southeast (see below), suggesting the two are likely to be contemporary (photos 6 & 7).

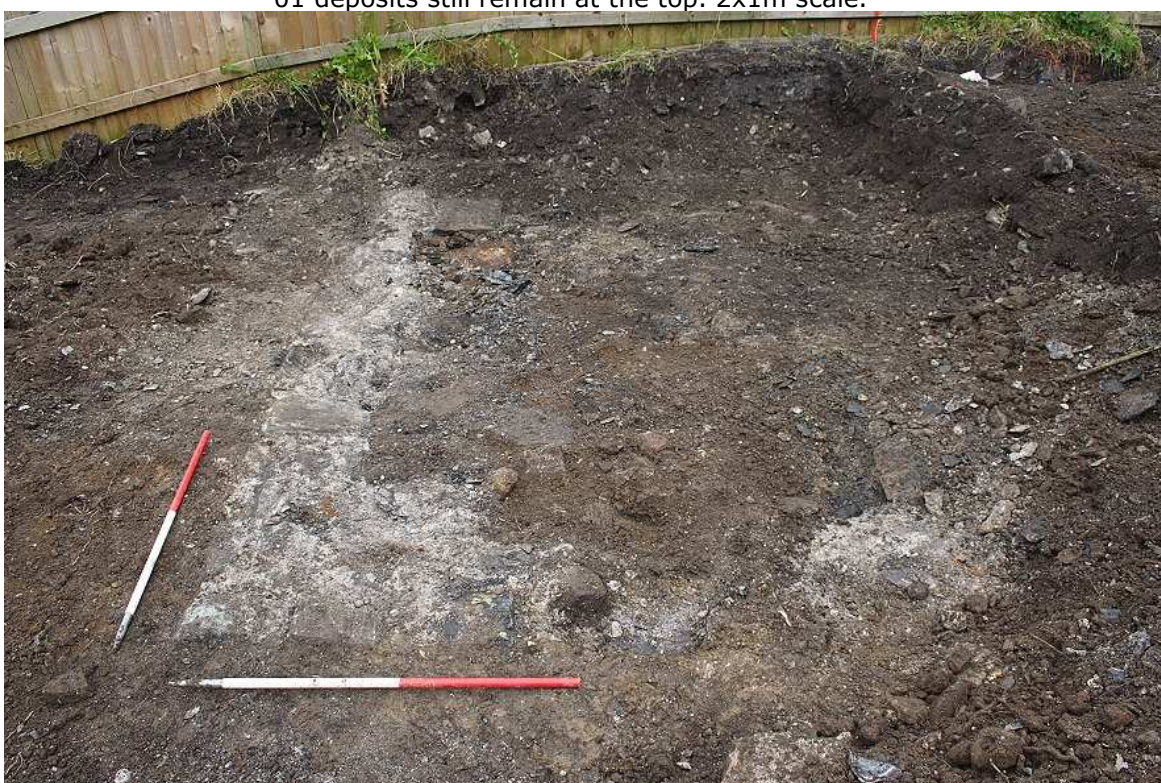
Photo 8. NE facing shot of Wall 14 after levels had been reduced. The return in the wall is clearly visible. 2 x 1m scale.

Located 12.5m northwards from the southern end of the building plot was another fragment of mortared stone wall (Wall 14), enclosing an associated slate surface (Surface 15). The wall measured 5.1m long, 0.55m wide and ran in a NE-SW (55°) direction from the current eastern boundary of the building plot, before returning SE for at least another 3m, extending beyond the area revealed by the level reduction within the building plot. The wall was of one continuous build, constructed of local sub-angular rubble stone with slate leveling courses visible, set within a pale creamy-yellow fine mortar. This wall was revealed below Layer03 but excavation did not go down far enough to reveal any further construction details or which deposits it may have been cut into.

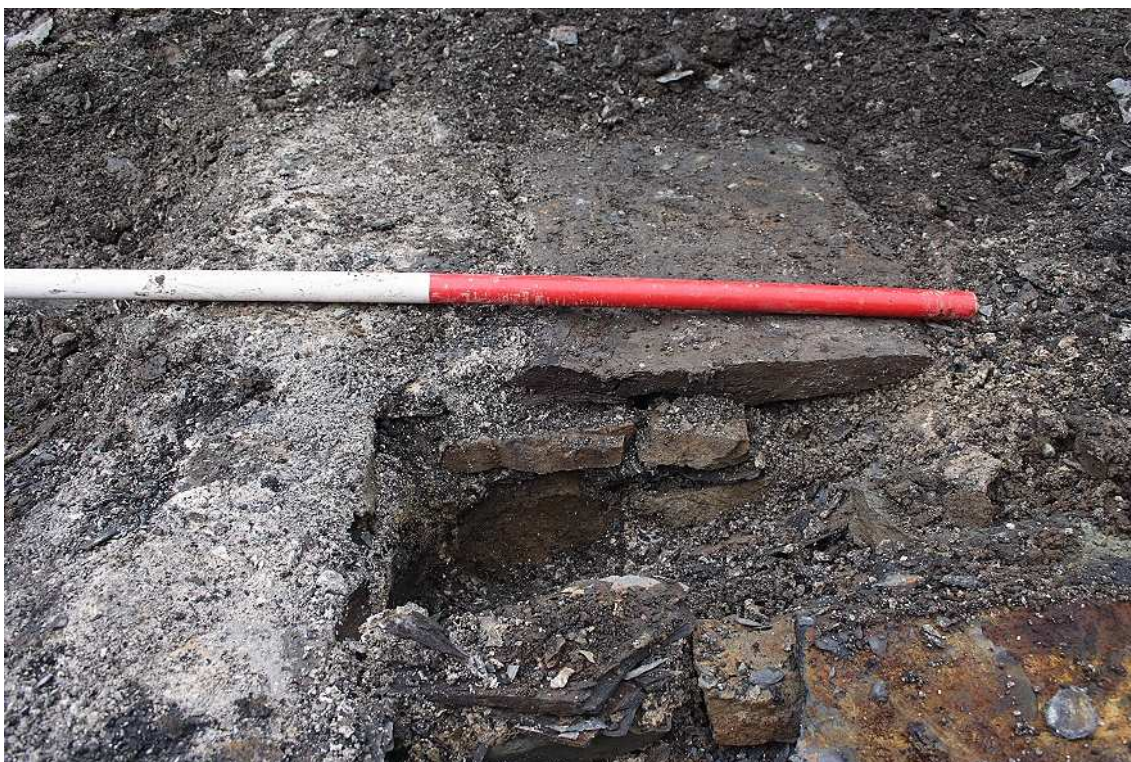
Photo 9. Close-up of the remains of Surface 15 showing the rubble fill (fill 16) below which was a mixture of roughly coursed rubble, shown here, and more random loose rubble. This also shows the surface mortared onto the remains of Wall 14 on the left. Scale in 0.5m segments.

Adjoining this wall to the southeast, and in places mortared onto the wall, were remnants of a slate surface. This consisted of very large slate slabs, measuring up to 0.6m by 0.5m and 0.05m thick, set on top of a very rough surface (Fill 16) of partly loose and partly roughly coursed mortared stone rubble. In places the slate was disintegrating and was not fully revealed, but would appear to represent an internal original ground surface within a building.

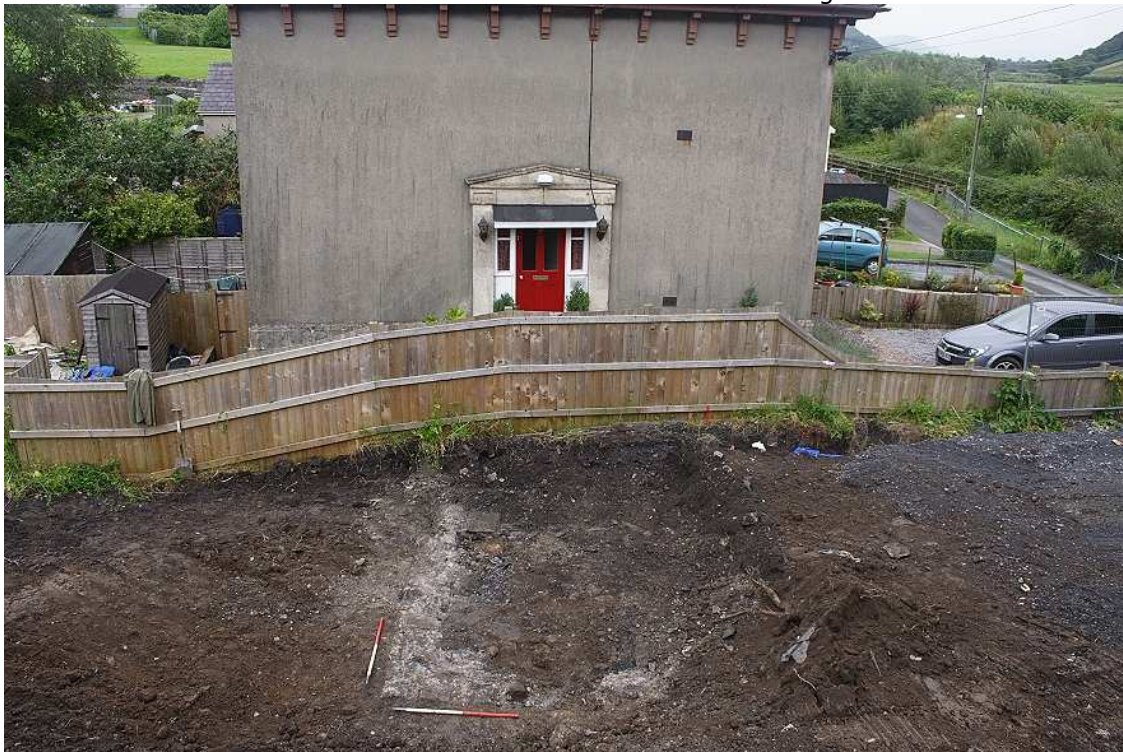
Photo 10. NE facing shot Wall 14 in relation to the Old Grammar School. 2 x 1m scale.

The wall itself was on a slightly different alignment to, and appeared to continue under, the adjacent Old Grammar School building (built in 1846), suggesting an earlier structure. No building is marked in this location on either the tithe map of 1842, Wood's map of 1834 or Lewis's map of 1786 which would suggest the building may predate 1786 at least, and was already demolished a long time before the construction of the Grammar School.
