**ST. INA'S CHURCH, LLANINA,  
CEREDIGION  
(SN 4049 5982)  
ARCHAEOLOGICAL EVALUATION**

RHIF YR ADRODDIAD / REPORT NO. 2009/92  
RHIF Y PROSIECT / PROJECT RECORD NO.98573

# ST. INA'S CHURCH, LLANINA, CERIDIGION (SN 40494 59826) ARCHAEOLOGICAL EVALUATION

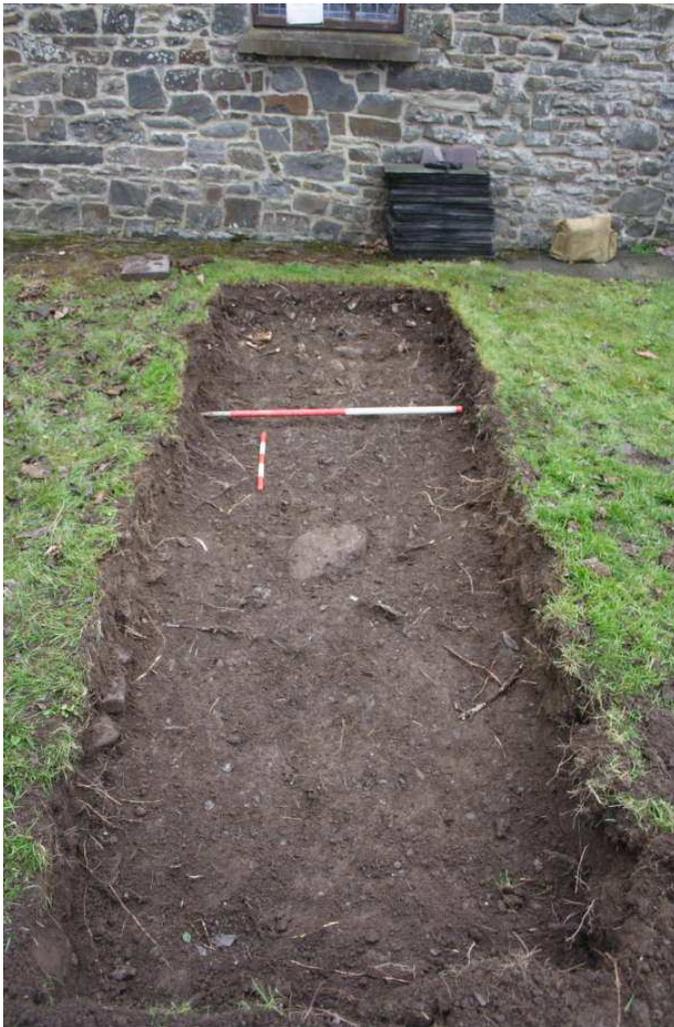
**Photo. 1:** South facing view of trench after removal of topsoil.

Underlying the topsoil was a layer of building debris (113), probably derived from the construction of the church in 1810. Below layer (113) was a possible a buried soil (114). Several cut features were identified beneath this layer, cutting through the natural clay subsoils. These were partially excavated to confirm the assumption that they were burials. A total of five intercutting east-west aligned burials were revealed within the trench. Grave [108] appeared to be cut through layer (113), suggesting it was later than 1810. Graves [110], [112] [116] and [106] appear to have been cut through layer (114) and were sealed by layer (113), suggesting that these graves were cut before 1810.

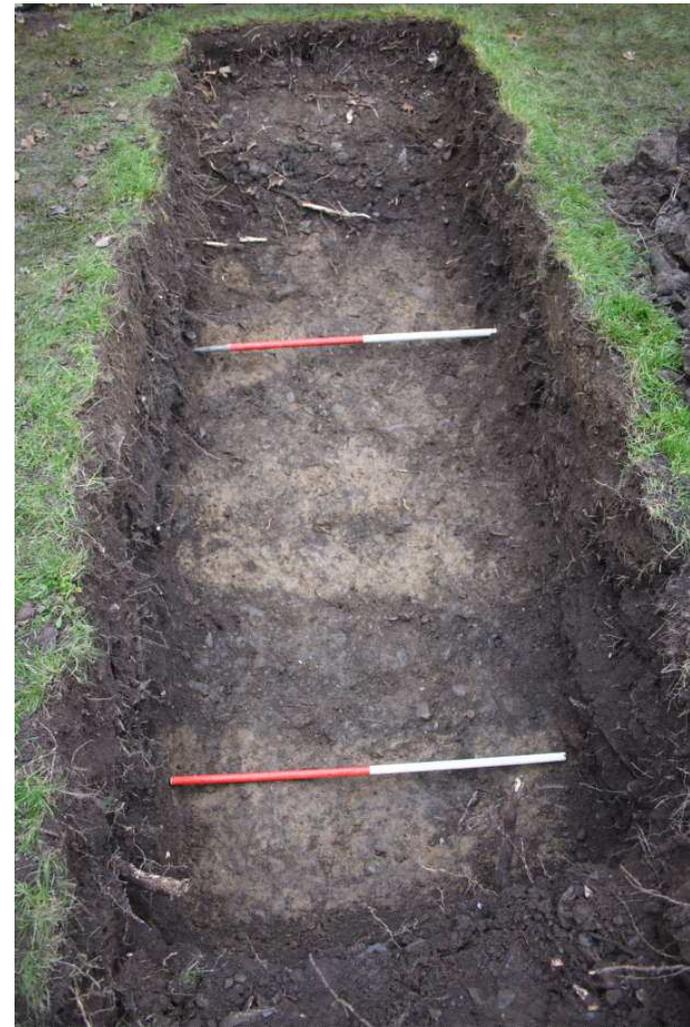
**Photo. 2:** South facing view showing grave cuts

Grave [112] cuts grave [110], demonstrating that grave [110] is the earlier burial of the two, but no finds or dating evidence (such as pottery fragments,) or other finds such as coffin nails or shroud pins (which might help to date the burials) was found within the partially excavated fills of the grave cuts.

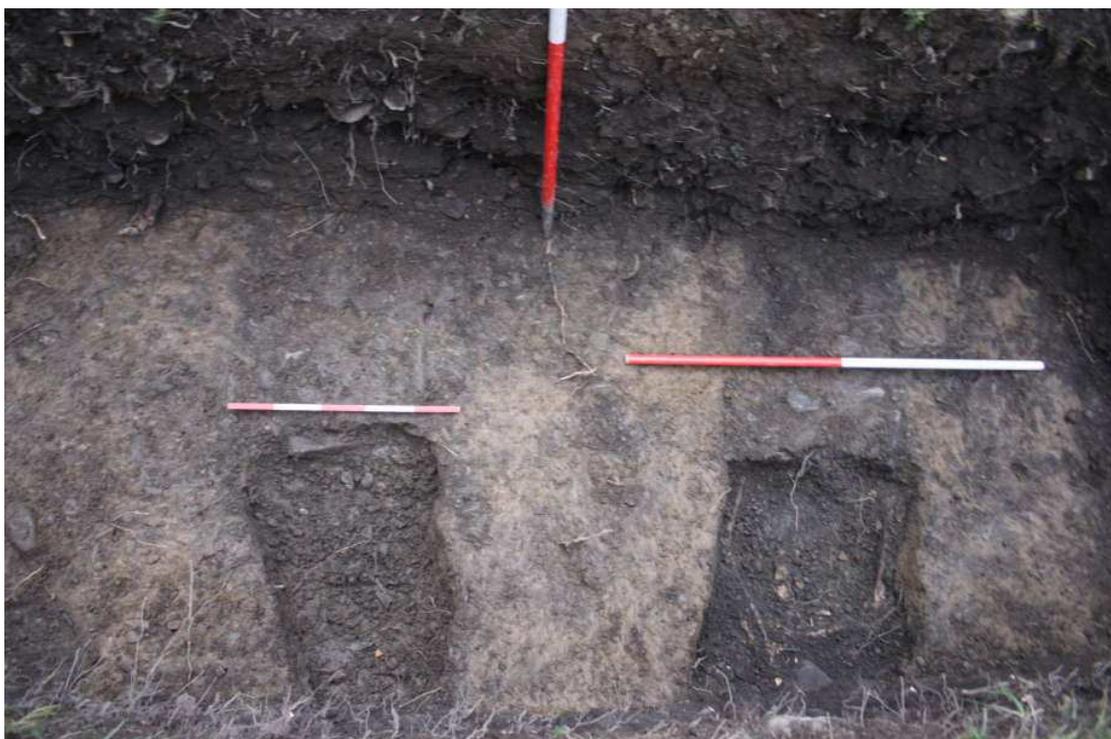
**Photo. 3:** West facing view of graves [108] and [112].

Cut [108]	Grave cut containing fill (107). The cut was 0.45m wide. The grave was aligned east-west.	Grave cut visible 0.22m below ground level.
Fill (109)	Fill of Grave [110]. Mid brown friable silty clay with 30% small sub angular and sub rounded stones.	Unexcavated.
Cut [110]	Grave cut containing fill (109). This grave was cut by later grave [112]. The grave cut was 0.19m wide and protruded 0.58m from the western section.	Unexcavated.
Fill (111)	Fill of grave cut [112]. Friable dark brown silty clay. 10% small sub-angular stones.	Burial at 0.66m below ground level.
Cut [112]	Grave cut containing fill (111). The grave extended from the east section to the west section of the trench and at maximum was 0.45m wide. This grave truncates earlier grave [110].	Grave cut visible 0.44m below ground level.
Fill (114)	Possible buried soil This fill was a friable dark greyish-brown silty clay. Particle size 0.02mm-0.06mm with 10% small sub-angular stones.	0.18m thick.

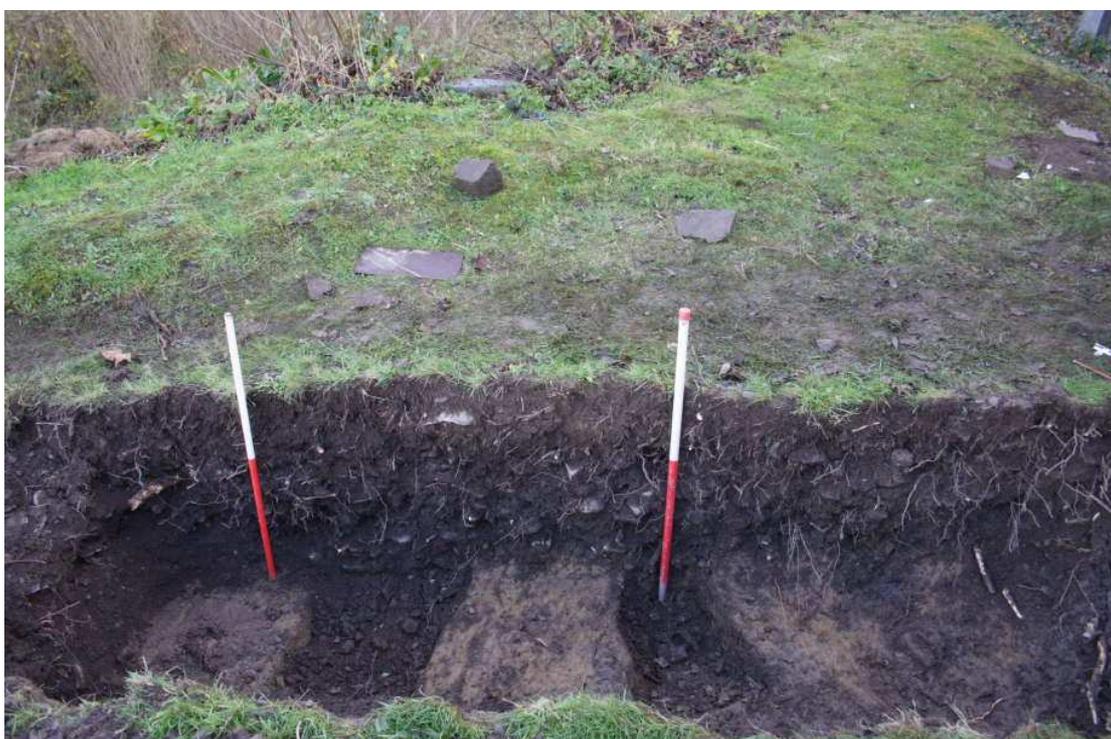
**Photo 4:** East facing view of graves [108] and [112].

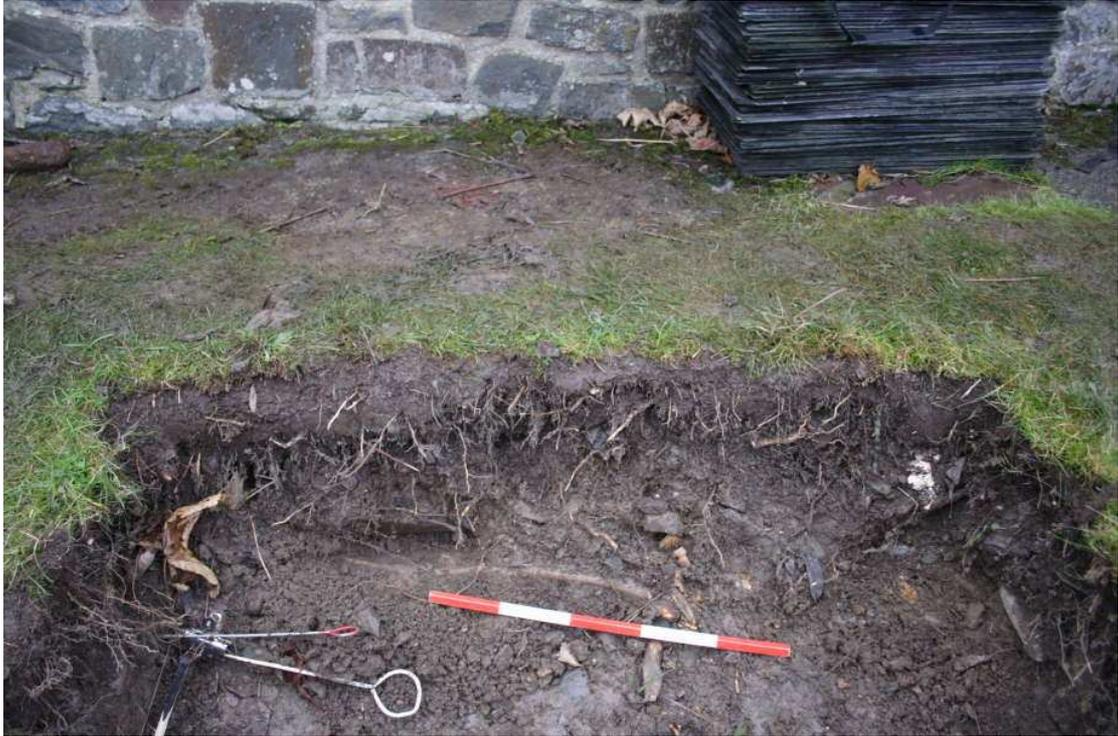
**Photo 5:** South facing view showing grave [116].

Four of the burials are at least 0.46m below the ground surface, Burial [116] on the southern edge of the trench, is situated at 0.31m below the ground surface. The shallow depth of the burials would suggest they are of relatively early date, but this remains speculative. The slight variation in east-west alignment demonstrated by some of the graves may also suggest a significant time depth to the burials.

Fill (105)	Fill of grave [106]. Mid brown silty clay. 20% small sub-angular stones. Grave unexcavated	Excavated to 0.22m.
Cut [106]	Grave cut containing fill (105). Protrudes slightly from east section.	Grave cut visible 0.36m below ground level.
Fill (115)	Fill of grave [116]. Light greyish-brown silty clay with 20% small sub angular stones	
Cut [116]	Grave cut containing burial at the southern extremity of the trench.	0.31m below ground level.
Natural subsoil (117)	Yellowish brown silty clay.	0.67m below ground level.
Fill (118)	Yellowish brown silty clay. This fill is possibly spoil from grave [108].	0.20m thick.
