# **SOUTH HAVEN GAS PIPELINE, MILFORD HAVEN, PEMBROKESHIRE: ARCHAEOLOGICAL EVALUATION.**

Prepared by Dyfed Archaeological Trust  
For: RWE Npower Plc

RHIF YR ADRODDIAD / REPORT NO. 2010/03  
RHIF Y PROSIECT / PROJECT RECORD NO. 98576

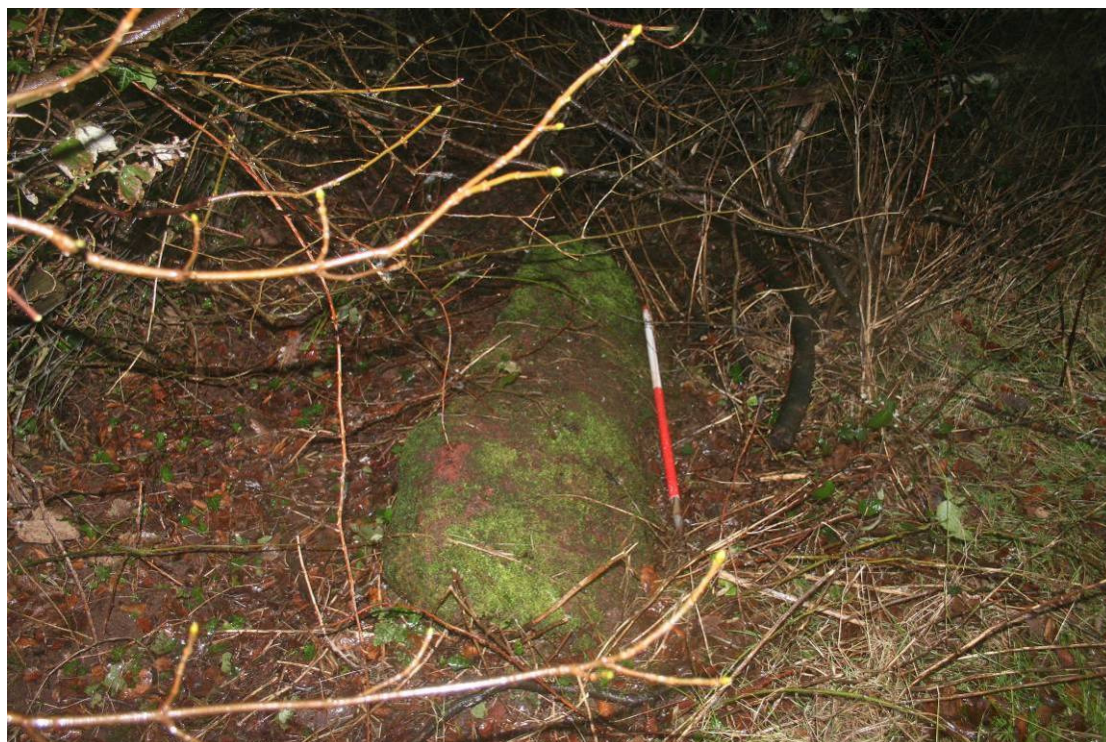
**Photo 1:** Former standing stone removed from western most field during 1950s.

A conversation with the present occupant of Castle Hall Farm revealed that during the 1950s a standing stone was removed from the western most field of the pipeline route. It was stated that the stone was removed from the northwestern area of the field and dumped in the hedge-line. A search of the hedge-line in this area revealed a substantial recumbent red sandstone block (see photo 1) which may potentially be the former standing stone.

*During the works it was made known to the archaeologists on site that a standing stone formerly stood in the northwestern end of field 4 at the most westerly field of the pipeline route, which was removed in the 1950s and deposited in a hedgeline,. This may suggest that the potential for archaeological features and deposits in this area remains. Given that the gas pipeline route ran to the south of this area, it is considered that the route would have no impact on the site of the standing stone or any features associated with it that may lie in the immediate area.*

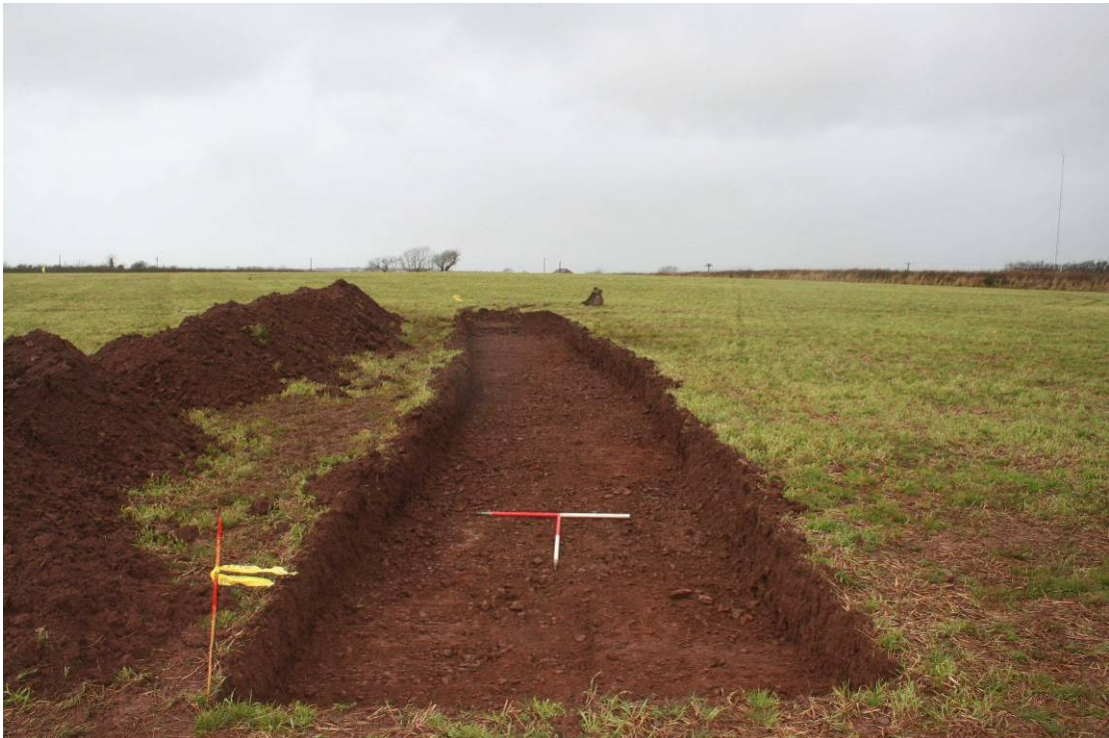
**Photo 2:** West facing view of trench 1.

Number	Description	Depth
Layer 100	Topsoil Mid red brown silty clay of moderate compaction containing occasional small angular stone. Modern ceramic recovered from surface but not retained.	0.27m
Layer 101	Subsoil Light red brown silty clay of moderate compaction containing occasional small angular stone.	0.14m
Layer 102	Shattered old red sandstone bedrock rising towards the west

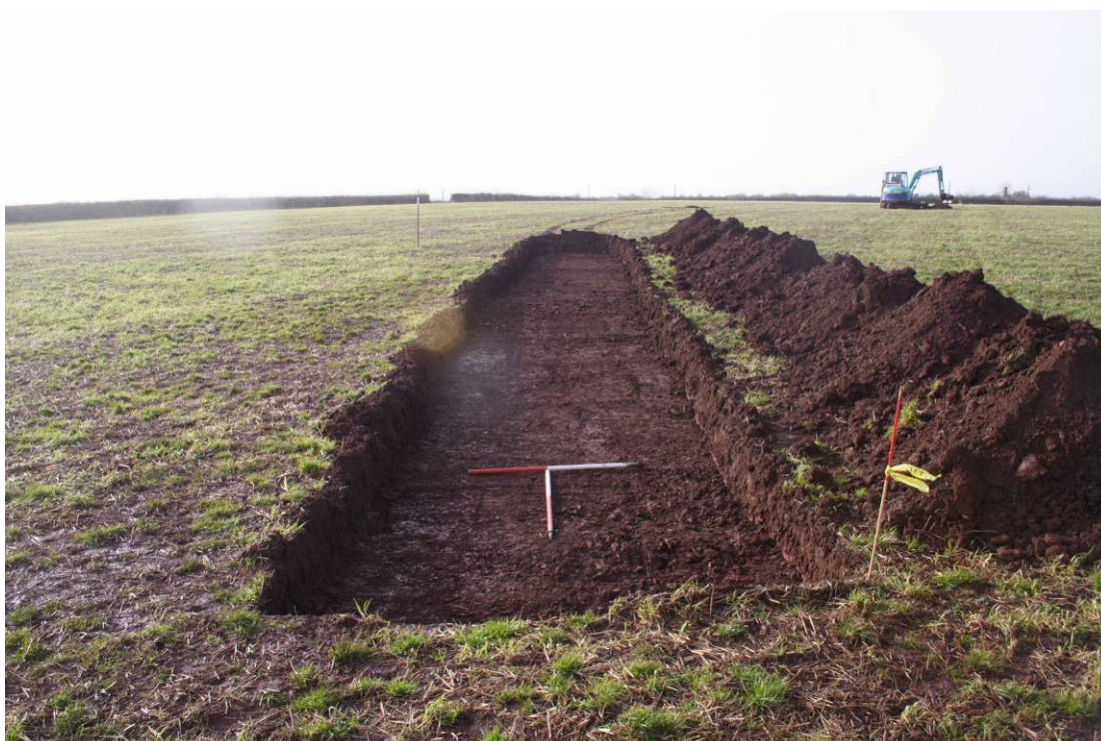
**Photo 3:** Southwest facing view of trench 2.

Number	Description	Depth
Layer 200	Topsoil Mid red brown silty clay of moderate compaction containing occasional small angular stone.	0.17m
Layer 201	Subsoil Light red brown silty clay of moderate compaction containing occasional small angular stone.	0.13m
Layer 202	Shattered old red sandstone bedrock rising towards the west

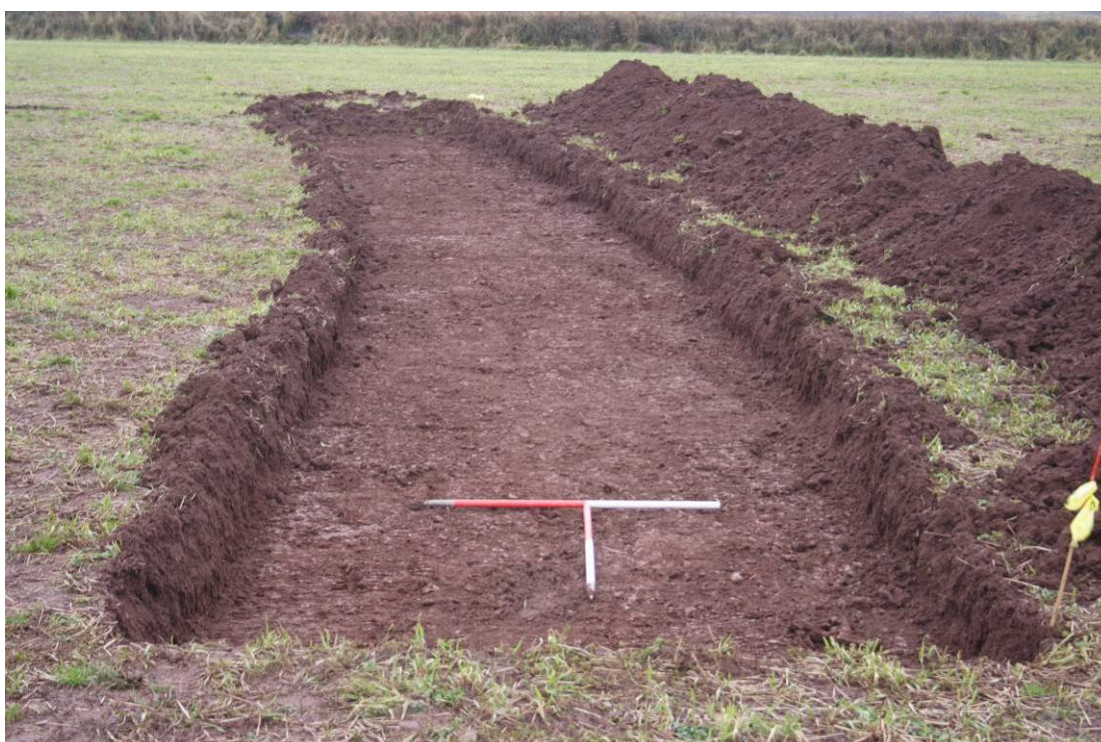
**Photo 4:** Southeast facing view trench 3.

Number	Description	Depth
Layer 300	Topsoil Mid red brown silty clay of moderate compaction containing occasional small angular stone.	0.25m
Layer 301	Subsoil Light red brown silty clay of moderate compaction containing occasional small angular stone.	0.10m
Layer 302	Natural Shattered old red sandstone bedrock

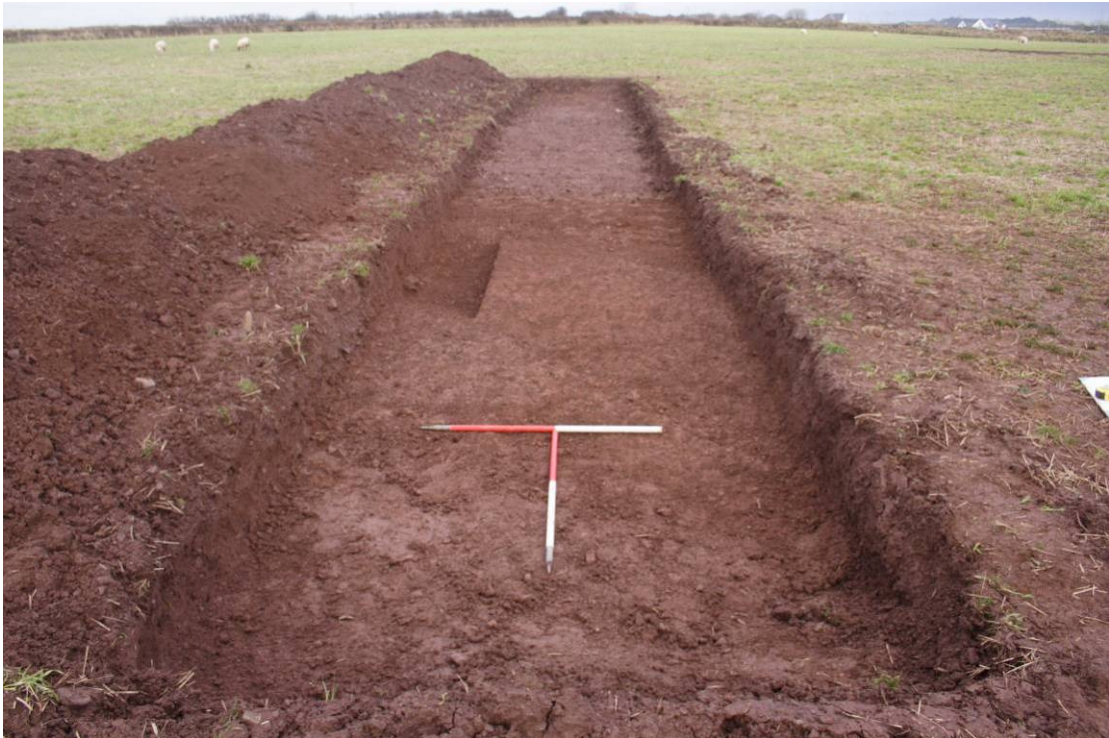
**Photo 5:** Northeast facing view of trench 4.

Number	Description	Depth
Layer 400	Topsoil Mid red brown silty clay of moderate compaction containing occasional small angular stone.	0.36m
Layer 401	Natural Shattered old red sandstone bedrock rising towards the west	
Layer 402	Fill of [403] Moderately compacted med reddish brown silty clay containing occasional small to medium angular stone.	
Cut [403]	Linear North – south aligned with moderately sloping sides tapering to shallow concave u shaped base.	0.16m

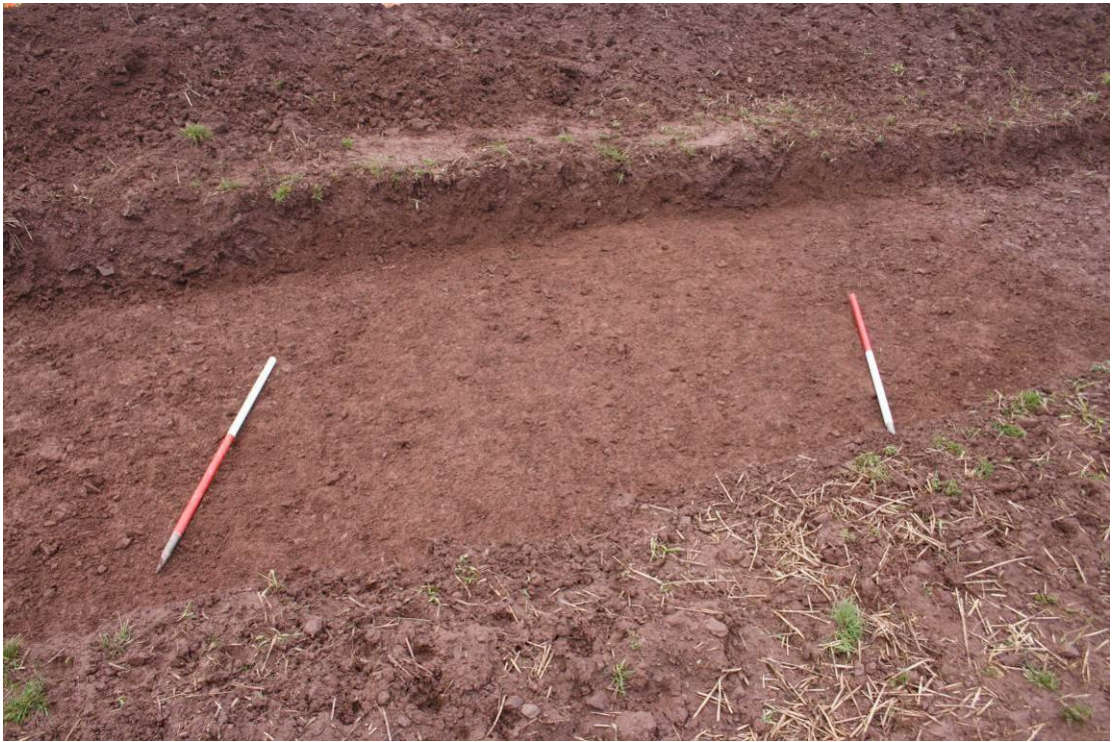
**Photo 6:** Northeast facing pre-excitation view of linear feature [403].

A single linear north – south aligned linear feature [403] was revealed in the trench that corresponded to the anomaly identified in the geophysical survey. However, no evidence of a central bank or second ditch was revealed.

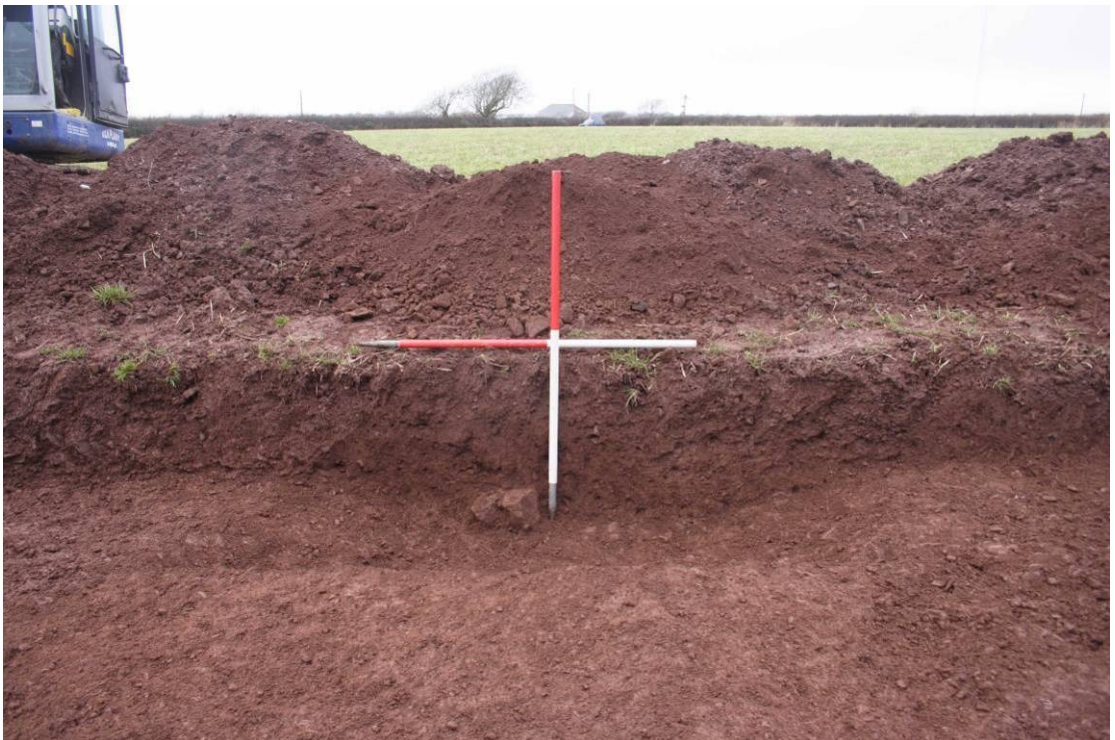
**Photo 7:** Southeast facing section of [403].

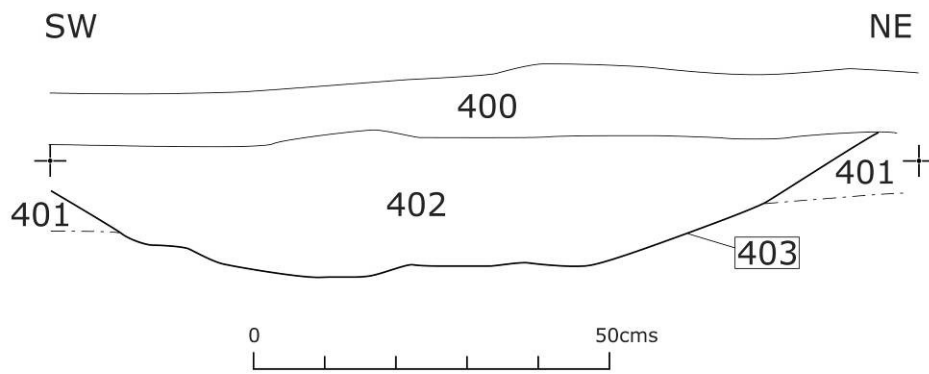
**Figure 6:** Southeast facing section of [403].

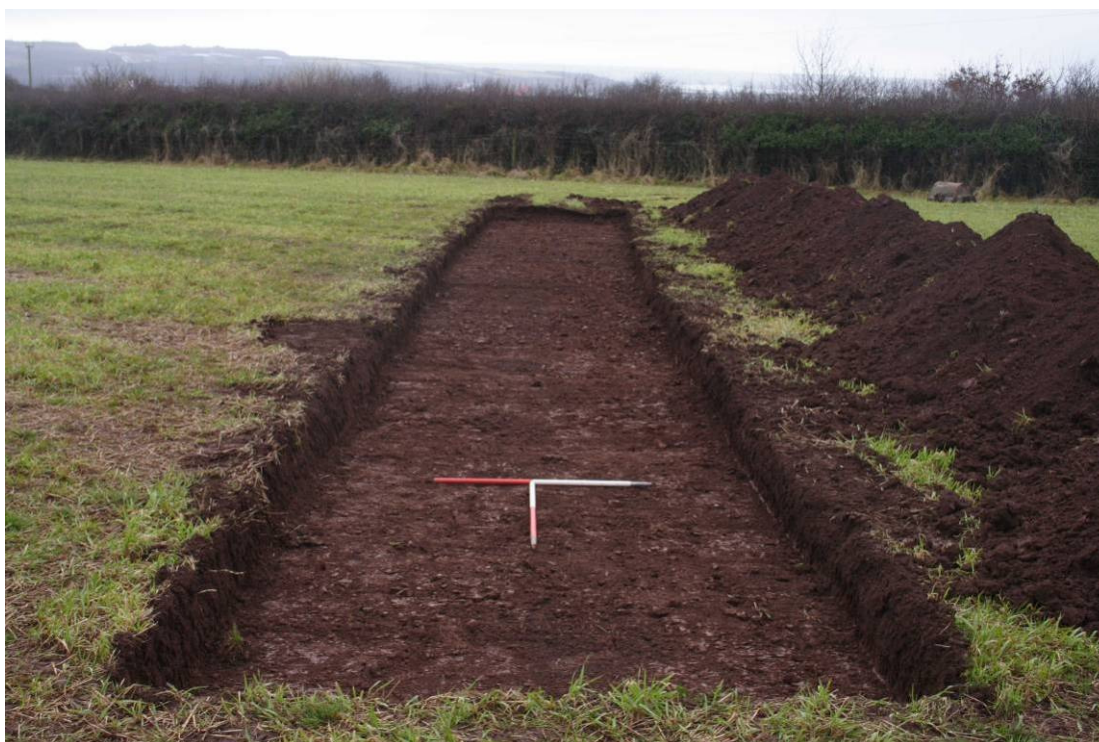
**Photo 8:** Southwest facing view of trench 5.

Trench 5 was aligned northeast – southwest, measured 21.65m x 2.4m and was excavated to an average depth of 0.3m. The trench was positioned to target two substantial linear anomalies that were considered to either form underlying banks or natural undulations in the underlying subsoil or geology. Excavation of the trench confirmed that no underlying banks were present at this location and it is considered that geological undulations caused the geophysical anomalies.

Number	Description	Depth
Layer 500	Topsoil Mid red brown silty clay of moderate compaction containing occasional small angular stone.	0.30m
Layer 501	Natural Shattered old red sandstone bedrock.

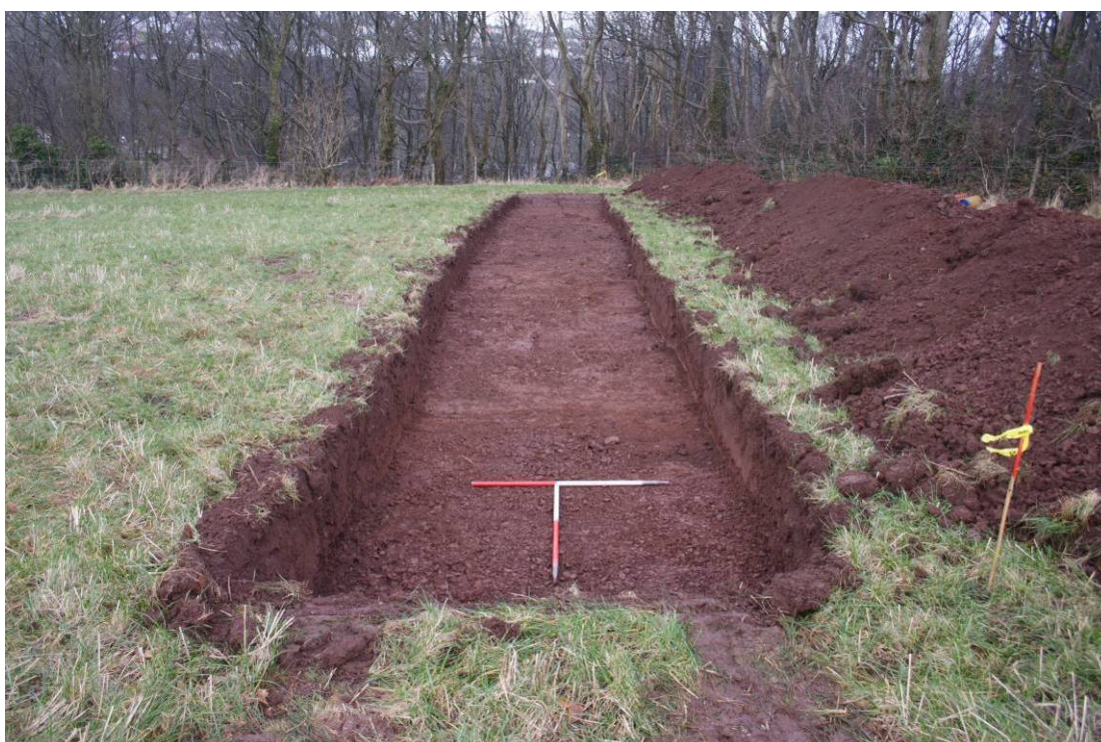
**Photo 9:** Southeast facing view, trench 6.

Number	Description	Depth
Layer 600	Topsoil Mid red brown silty clay of moderate compaction containing occasional small angular stone.	0.33m
Layer 601	Subsoil Mid red brown silty clay of moderate compaction containing rare small angular stone.	0.14m
Layer 602	Natural Shattered old red sandstone bedrock.

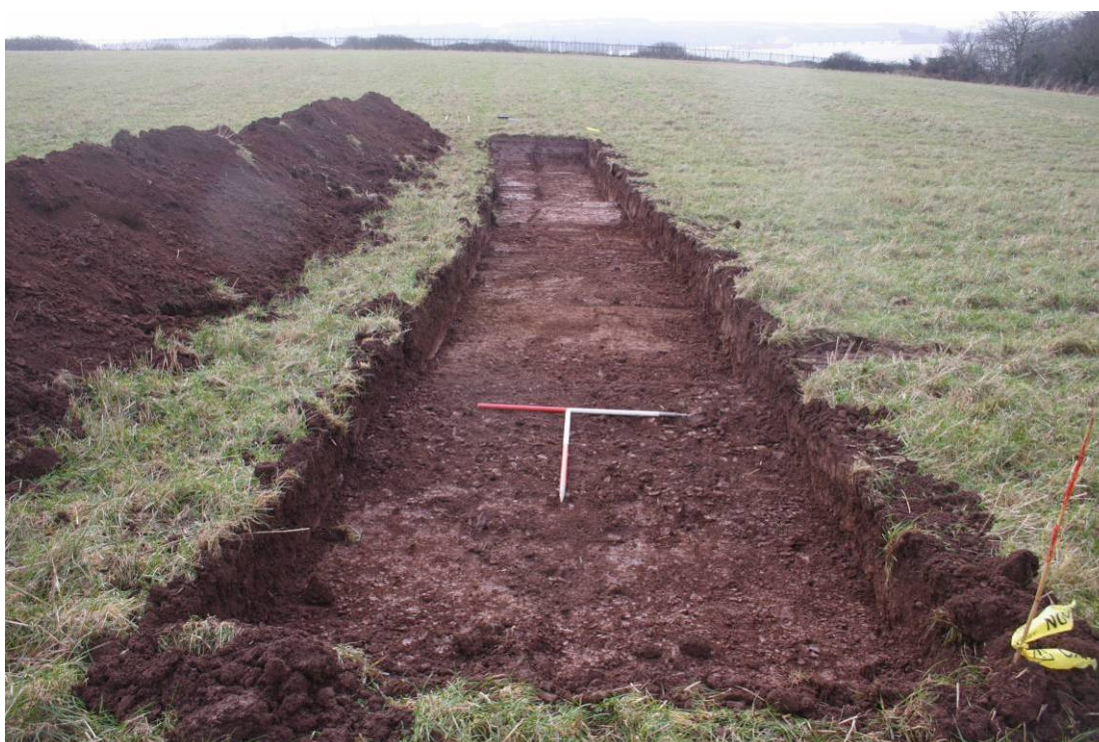
**Photo 10:** South facing view of trench 7.

Number	Description	Depth
Layer 700	Topsoil Mid red brown silty clay of moderate compaction containing occasional small angular stone.	0.30m
Layer 701	Subsoil Mid orange brown silty clay of moderate compaction containing rare small angular stone.	0.26m
Layer 702	Natural Shattered old red sandstone bedrock.

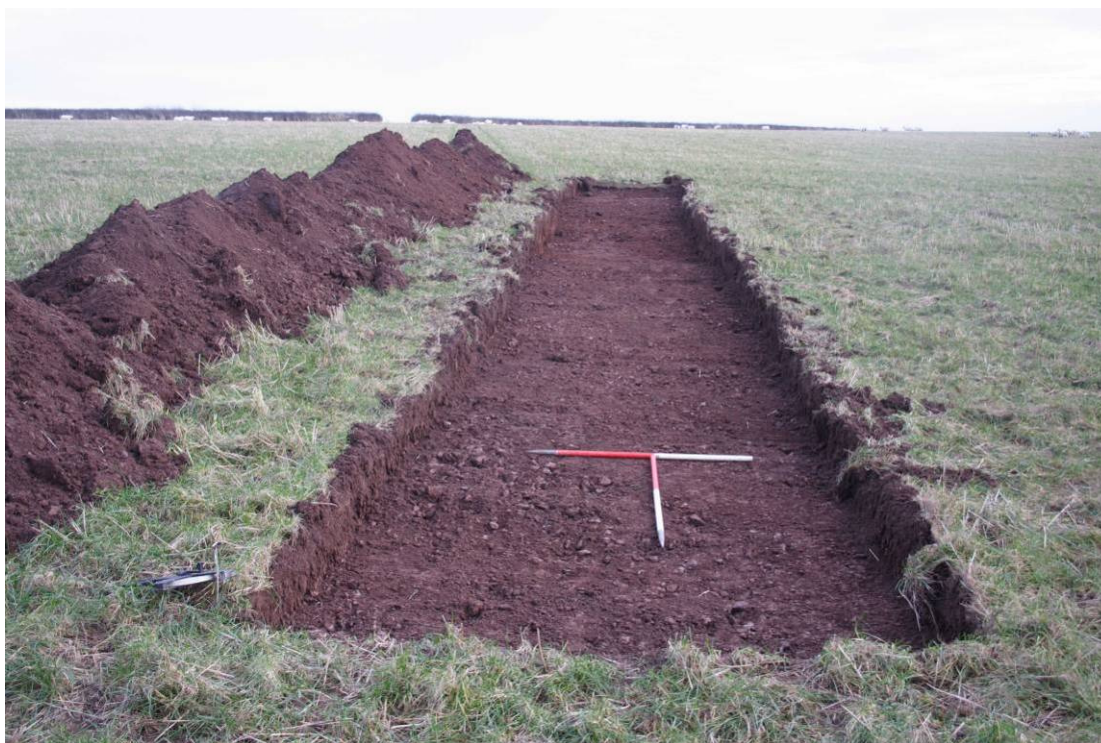
**Photo 11:** Northwest facing view of trench 8.

It is considered that the linear feature and its associated indentations represent the base of a wheel track. Given the presence of oblique linear indentations it is considered that the wheel track was produced by a steam ploughing engine which often utilised the pattern on the rear wheels to aid grip. When operating on wet ground, lugs known as 'spuds' would be fitted to the wheels to further enhance grip. It is considered that feature (803) was caused by the wheels and 'spuds' of a ploughing engine whilst working on wet ground.

In addition to the field and trackway boundaries identified, a wheel track probably caused by a steam ploughing engine, was revealed in trench 8 (803) and is considered to date between the late 19<sup>th</sup> to early 20<sup>th</sup> centuries. The presence of evidence for steam ploughing suggests a desire by the landowner to increase the agricultural efficiency and profitability of the land.

Number	Description	Depth
Layer 800	Topsoil Mid red brown silty clay of moderate compaction containing occasional small angular stone.	0.33m
Layer 801	Subsoil Mid red brown silty clay of moderate compaction containing rare small angular stone.	0.14m
Layer 802	Natural Shattered old red sandstone bedrock.	
Layer 803	Wheel track 0.4m wide linear with oblique linear impressions

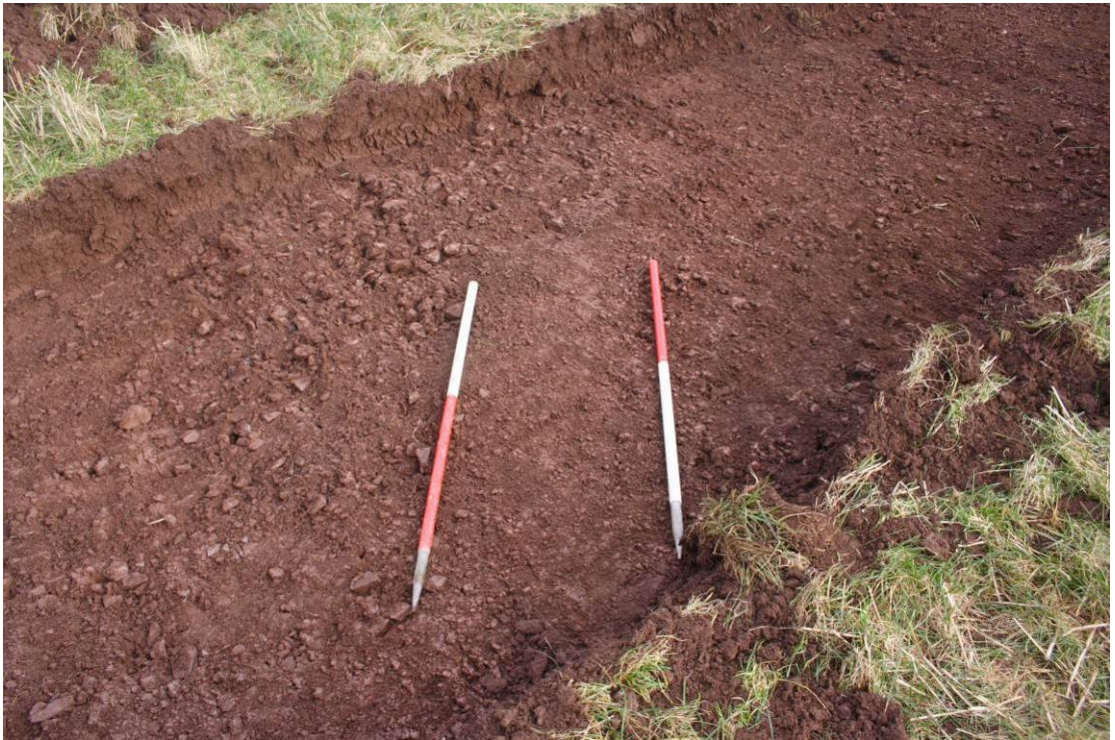
**Photo 12:** Northeast facing view of wheel track (804).

A northeast – southwest aligned linear feature with northwest – southeast linear indentations along its length (803) was revealed at the northwest end of the trench.

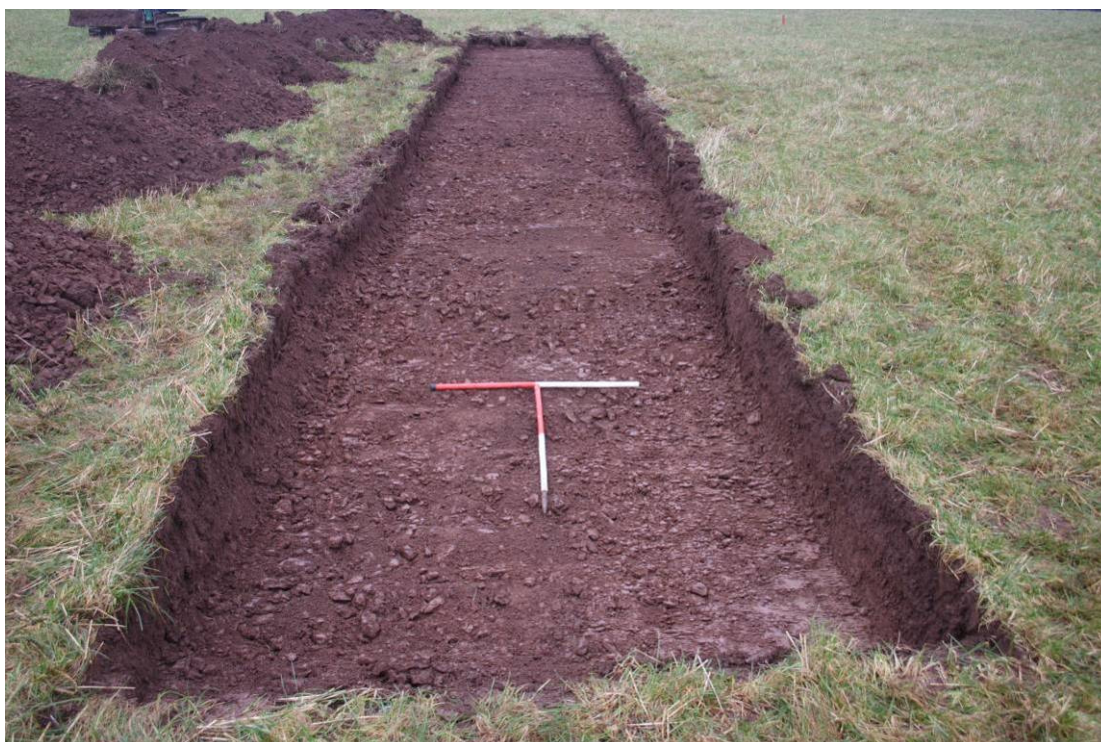
**Photo 13:** Southwest facing view, trench 9.

Number	Description	Depth
Layer 900	Topsoil Mid red brown silty clay of moderate compaction containing occasional small angular stone.	0.23m
Layer 901	Natural Shattered old red sandstone bedrock.	0.14m

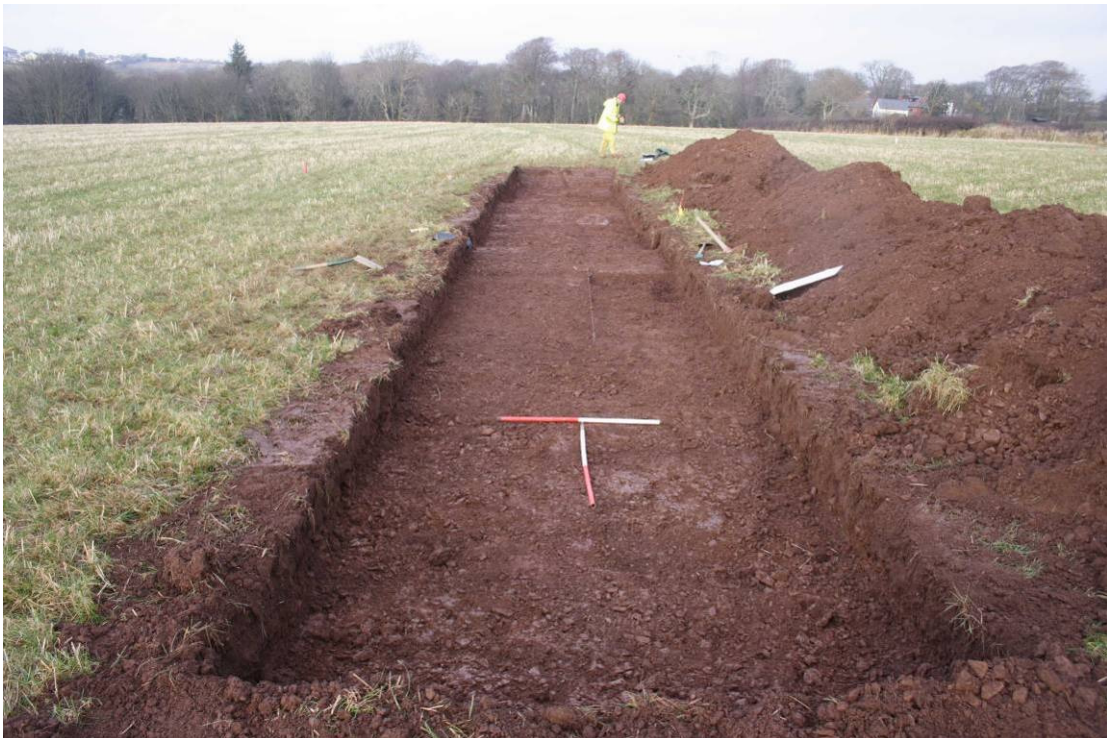
**Photo 14:** North facing view of trench 10.

Number	Description	Depth
Layer 1000	Topsoil Mid red brown silty clay of moderate compaction containing occasional small angular stone.	0.30m
Layer 1001	Subsoil Mid reddish brown silty clay of moderate compaction containing rare small angular stone.	0.12m
Layer 1002	Natural Shattered old red sandstone bedrock.	
Cut [1003]	Field Boundary East – west aligned boundary ditch with moderately sloping sides and concave U shaped base	0.18m
Layer 1004	Fill of [1003] Friable mid brown silty clay containing occasional small angular stone. Modern ceramic recovered but not retained.	
Cut [1005]	Geological feature Northwest- southeast aligned geological fissure	0.18m
Layer 1006	Fill of [1005] Friable light grey yellow sandy silty clay with no inclusions.

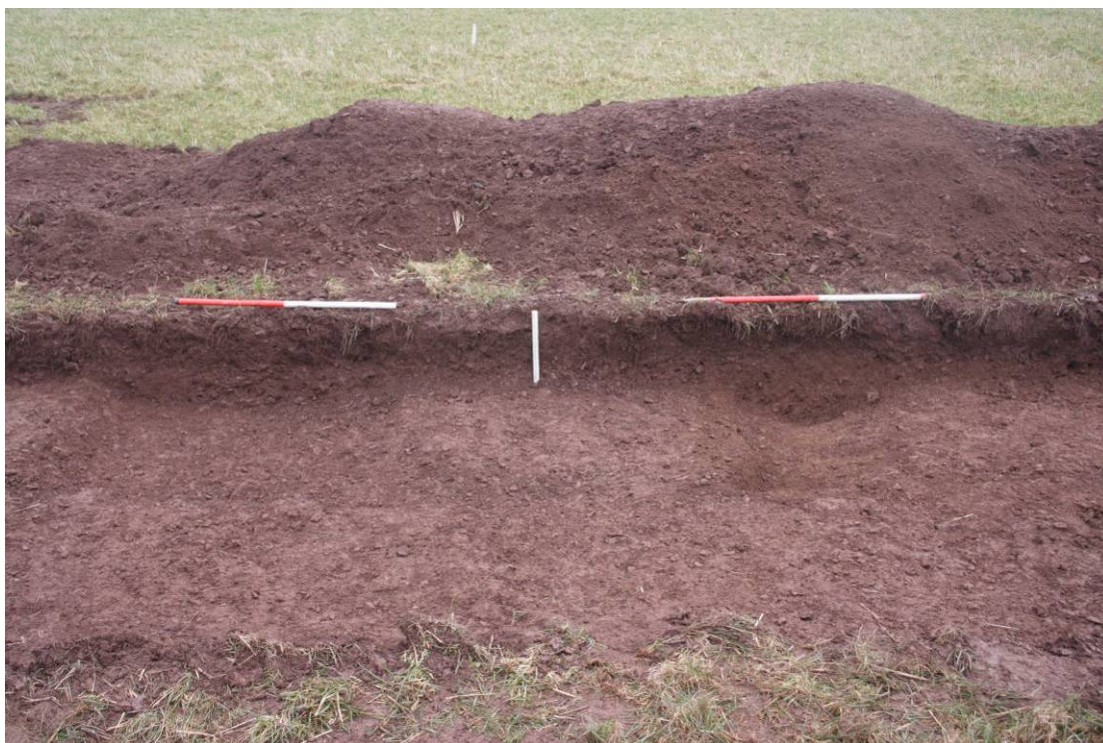
**Photo 15:** West facing section of linear features [1003] and [1005].

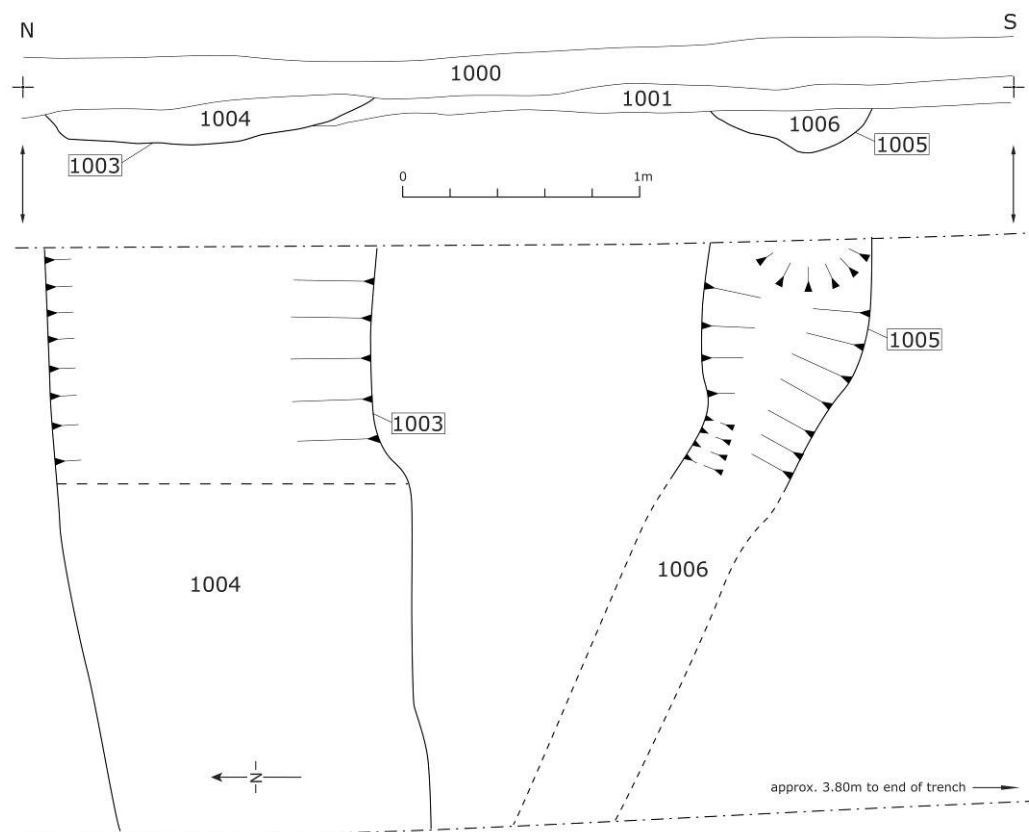
**Figure 7:** Plan and section of linear features [1003] and [1006].

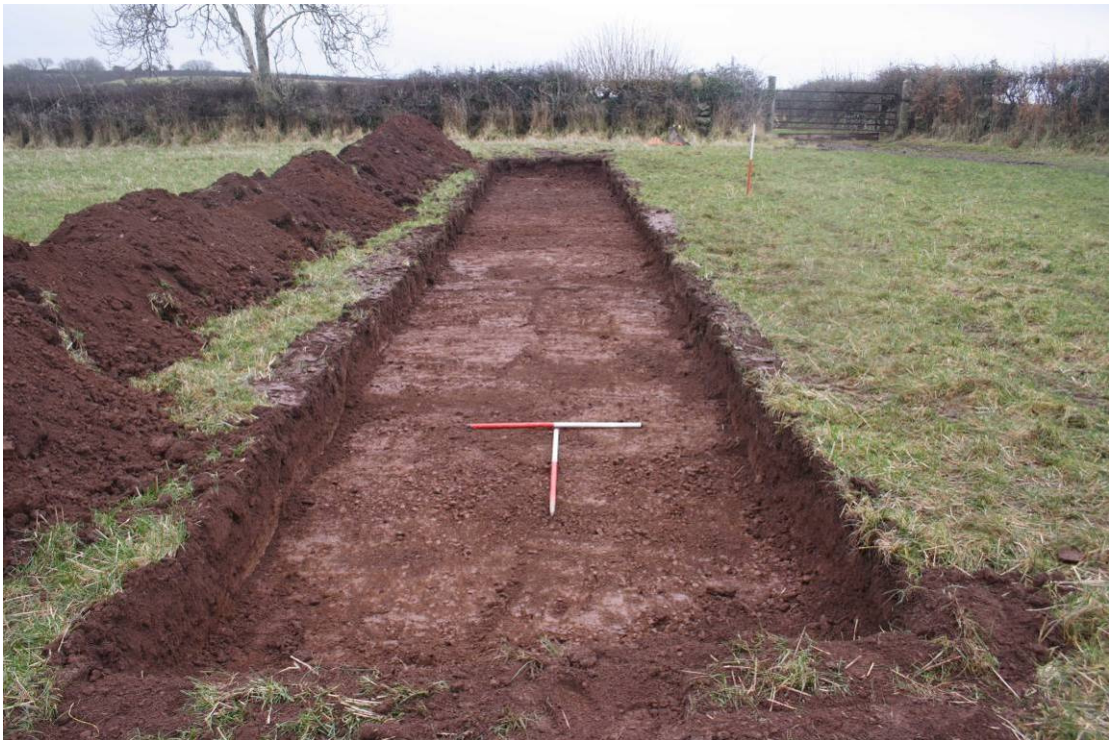
**Photo 16:** East facing view of trench 11.

Number	Description	Depth
Layer 1100	Topsoil Mid red brown silty clay of moderate compaction containing occasional small angular stone.	0.58m
Layer 1101	Natural Shattered old red sandstone bedrock	
Cut [1102]	Trackway boundary ditch 1.58m wide linear aligned northwest – southeast. Moderately sloping sides with shallow concave u-shaped base.	0.22m
Layer 1103	Fill of [1102] Dark red brown silty clay of moderate compaction containing frequent small to medium angular stone. Glass and coal recovered but not retained.

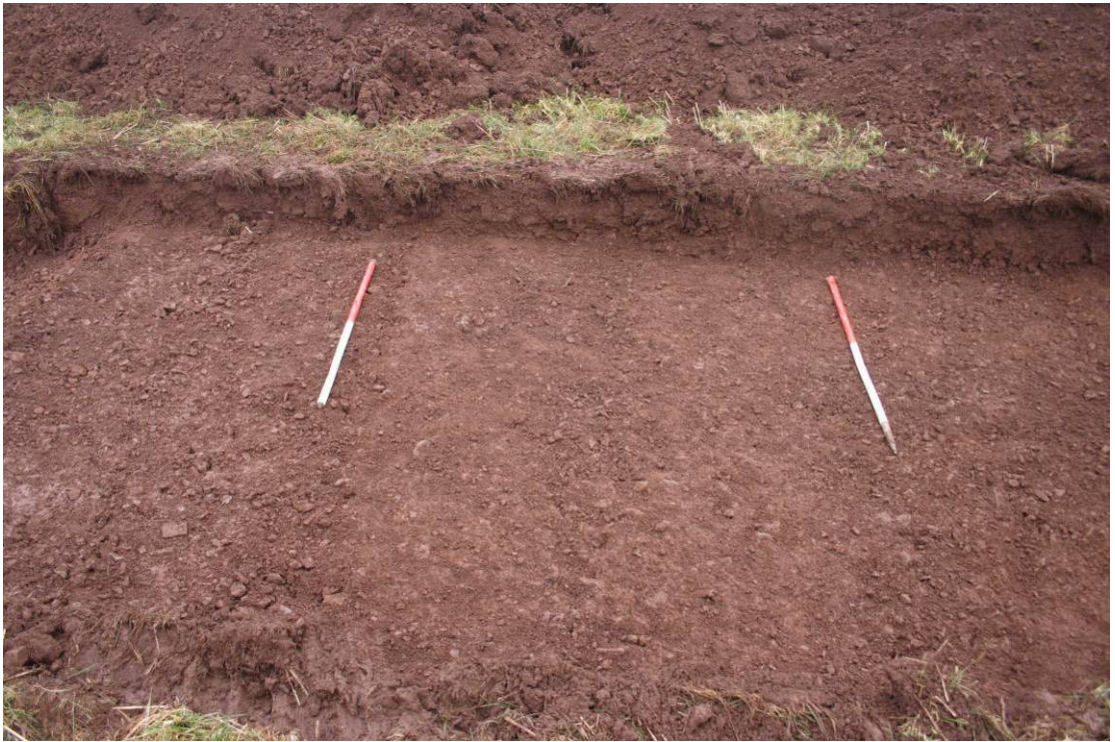
**Photo 17:** North facing pre-excitation shot of boundary ditch [1102].

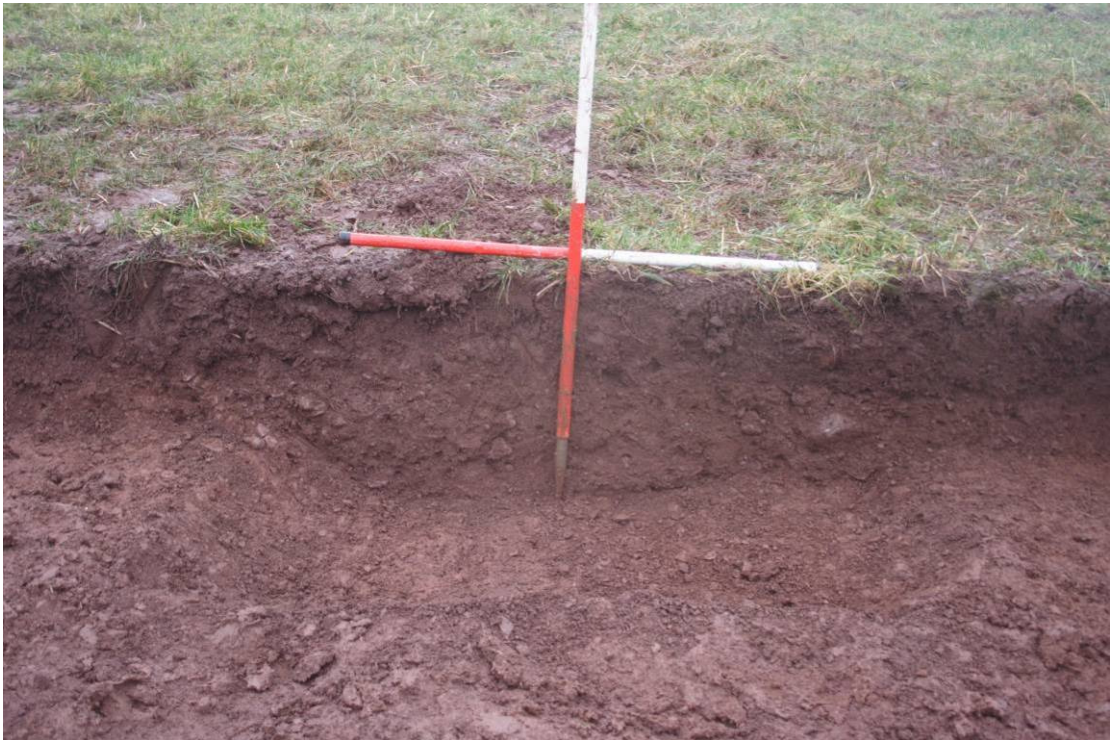
**Photo 18:** South facing section of boundary ditch [1102].

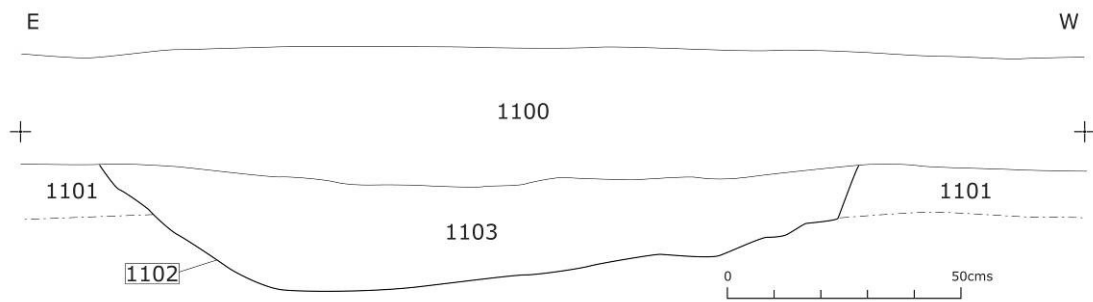
**Figure 7:** South facing section of boundary ditch [1102].

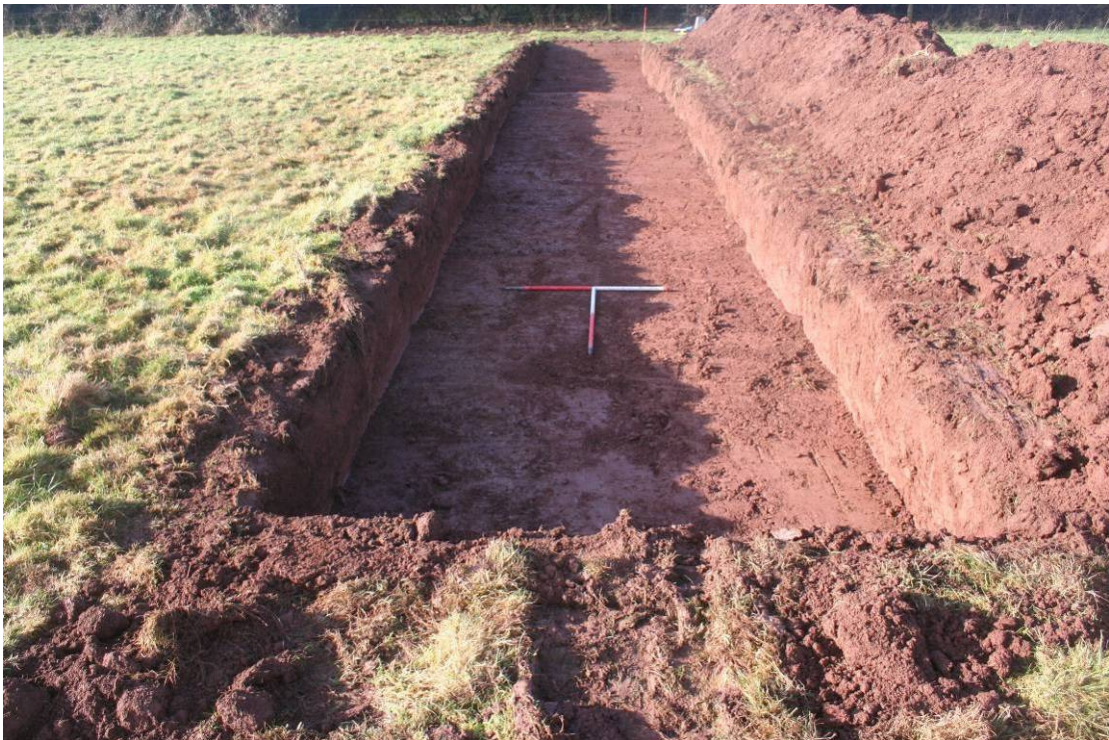
**Photo 19:** East facing view of trench 12.

Number	Description	Depth
Layer 1200	Topsoil Dark red brown silty clay of moderate compaction containing occasional small angular stone.	0.4m
Layer 1201	Natural Mid reddish brown silty clay of moderate compaction containing abundant small angular stone.	0.14m

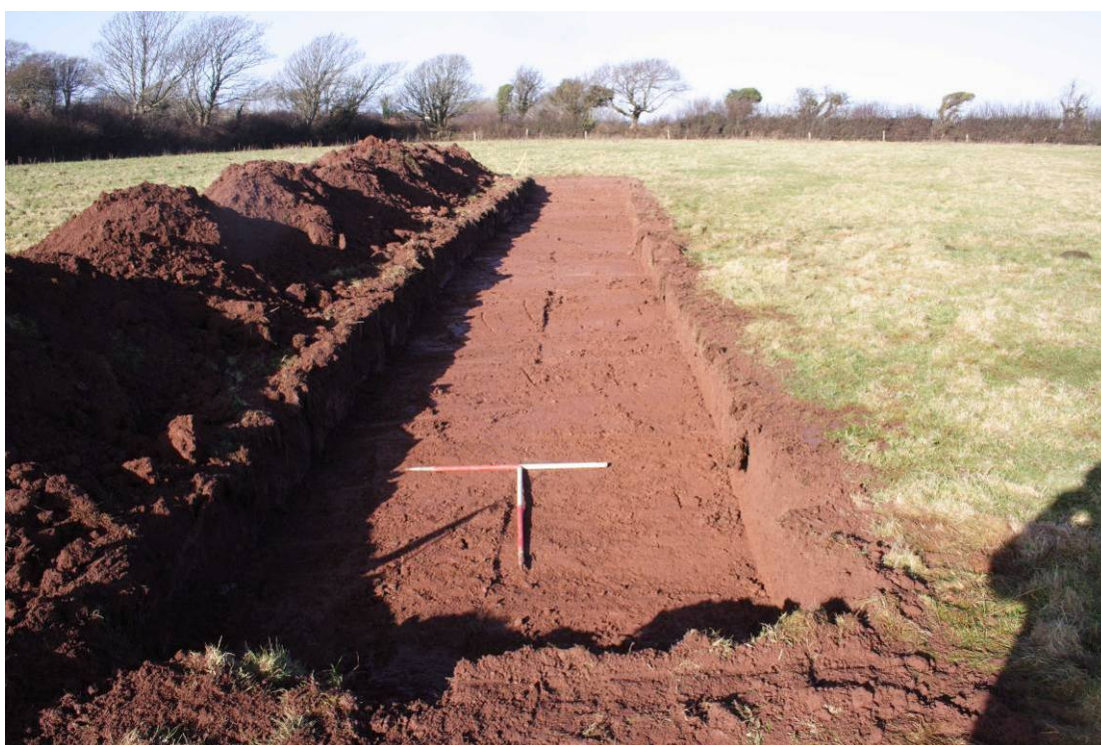
**Photo 20:** Northwest facing view of trench 13.

Number	Description	Depth
Layer 1300	Topsoil Dark red brown silty clay of moderate compaction containing occasional small angular stone.	0.5m
Layer 1301	Subsoil Mid reddish brown silty clay of moderate compaction containing occasional small angular stone.	0.08m
Layer 1302	Natural Shattered old red sandstone bedrock.

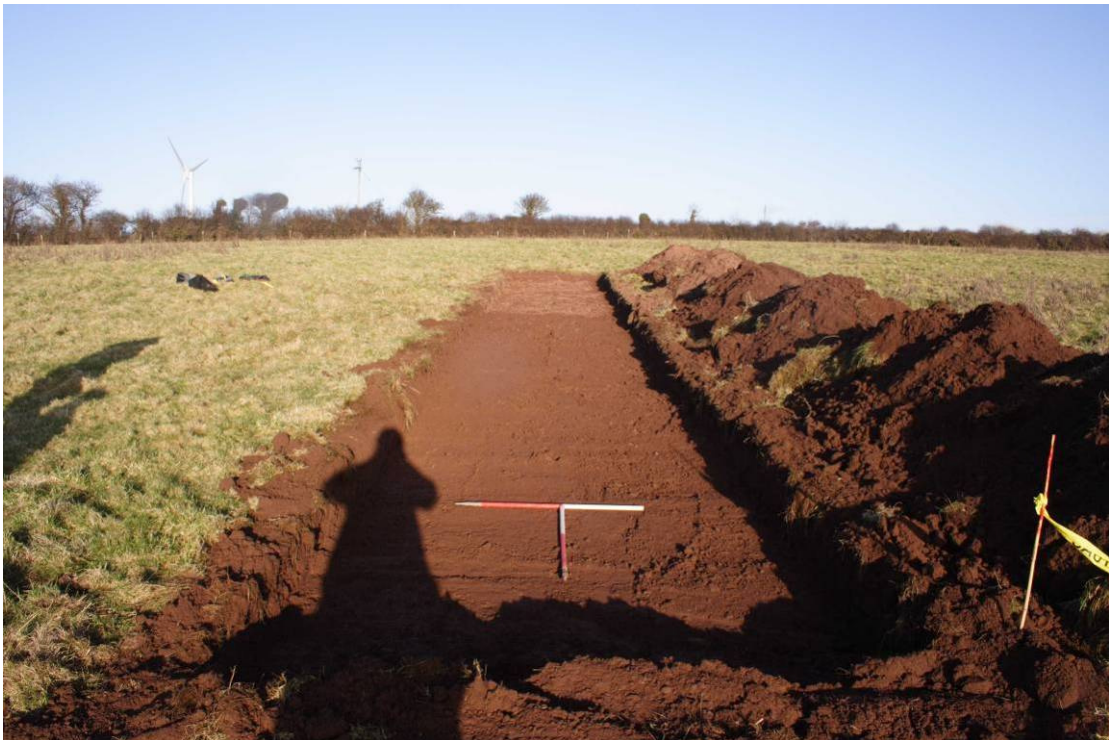
**Photo 21:** Northeast facing view of trench 14.

Number	Description	Depth
Layer 1400	Topsoil Mid red brown silty clay of moderate compaction containing occasional small angular stone. Modern ceramic recovered from surface but not retained.	0.24m
Layer 1401	Natural Shattered old red sandstone bedrock.

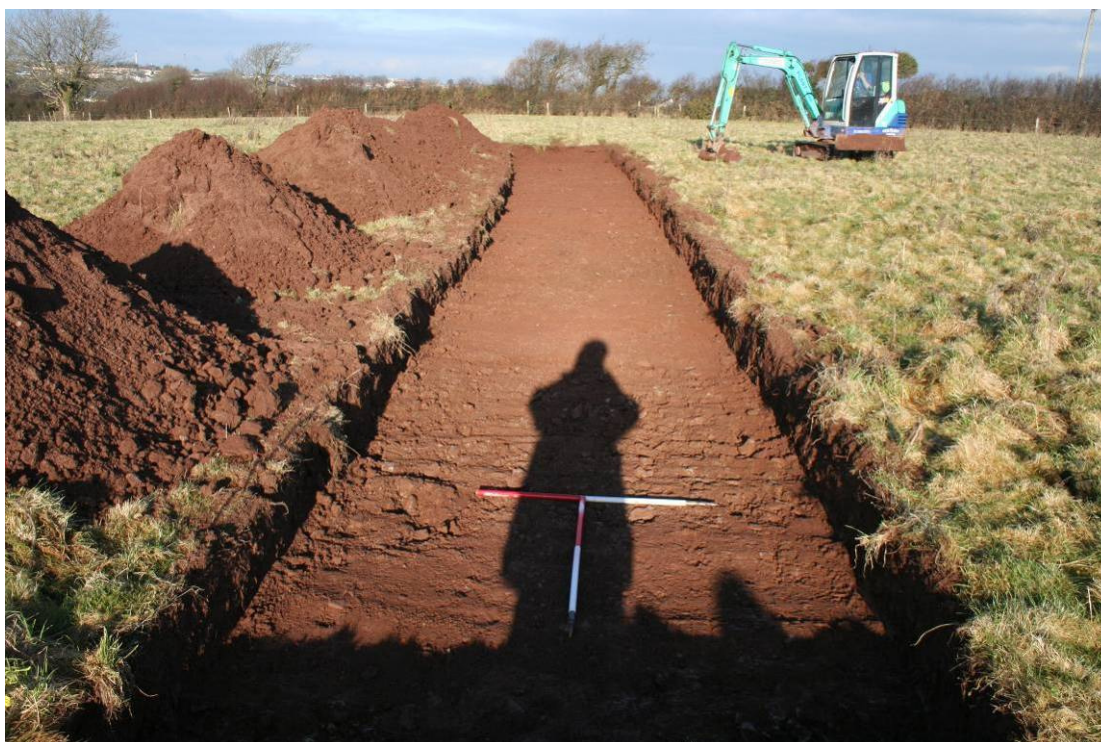
**Photo 22:** Northeast facing view of trench 15.

Number	Description	Depth
Layer 1500	Topsoil Mid red brown silty clay of moderate compaction containing occasional small angular stone.	0.24m
Layer 1501	Natural Shattered old red sandstone bedrock.

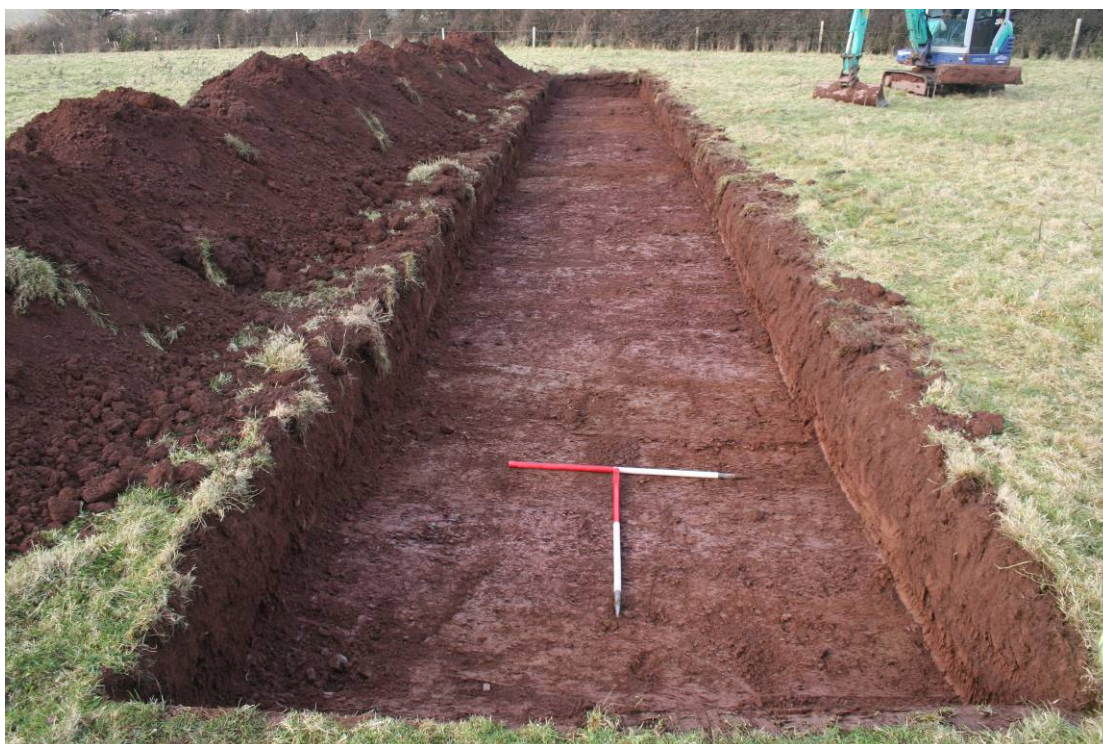
**Photo 23:** Northeast facing view of trench 16.

Number	Description	Depth
Layer 1600	Topsoil Mid red brown silty clay of moderate compaction containing occasional small angular stone.	0.29m
Layer 1601	Natural Shattered old red sandstone bedrock.
