# **SOUTH HAVEN GAS PIPELINE, MILFORD HAVEN, PEMBROKESHIRE: ARCHAEOLOGICAL EVALUATION.**

Prepared by Dyfed Archaeological Trust  
For: RWE Npower Plc

RHIF YR ADRODDIAD / REPORT NO. 2010/03  
RHIF Y PROSIECT / PROJECT RECORD NO. 98576

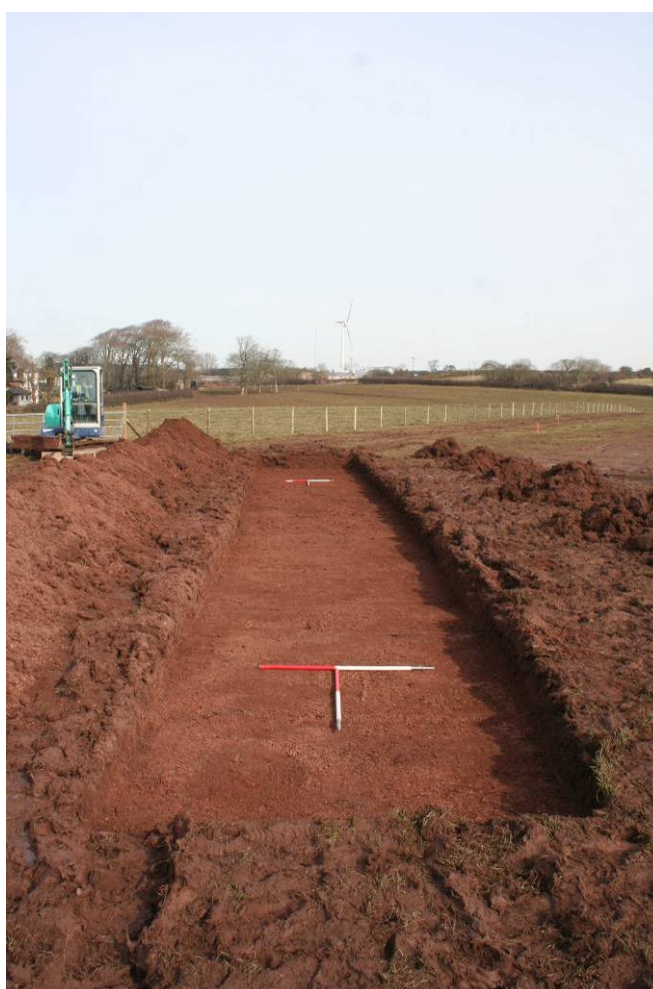
**Photo 24:** Northeast facing view of trench 17.

Number	Description	Depth
Layer 1700	Topsoil Mid red brown silty clay of moderate compaction containing frequent small angular stone. Coal fragments recovered but not retained.	0.25m
Layer 1701	Subsoil Moderately compacted mid reddish brown silty clay containing abundant small angular stone	0.1m

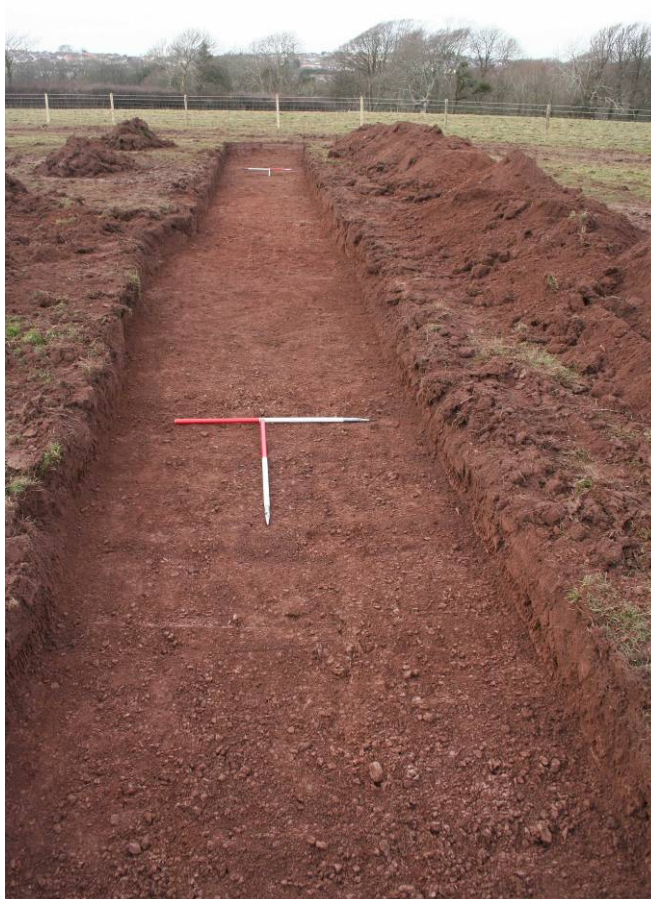
**Photo 25:** Southeast facing view of trench 18.

Number	Description	Depth
Layer 1800	Topsoil Mid red brown silty clay of moderate compaction containing frequent small angular stone. Coal fragments recovered but not retained.	0.20m
Layer 1801	Subsoil Moderately compacted mid reddish brown silty clay containing abundant small angular stone	0.17m

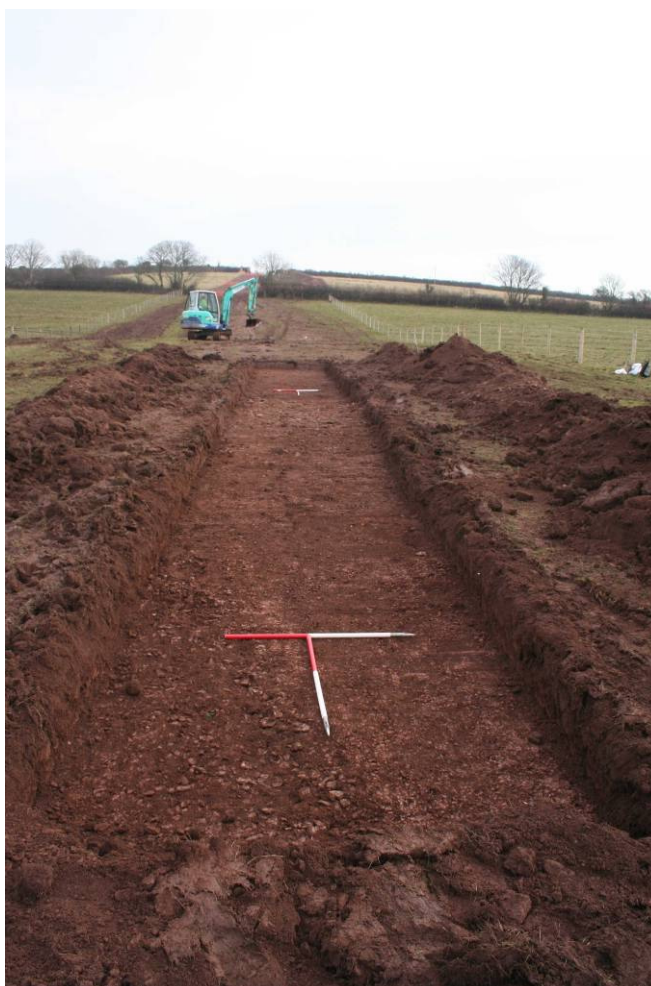
**Photo 26:** East facing view of trench 19.

Number	Description	Depth
Layer 1900	Topsoil Mid red brown silty clay of moderate compaction containing frequent small angular stone. Coal fragments and post medieval pottery recovered but not retained.	0.32m
Layer 1901	Subsoil Moderately compacted mid reddish brown silty clay containing abundant small angular stone	0.1m
Layer 1902	Natural Shattered old red sandstone bedrock.

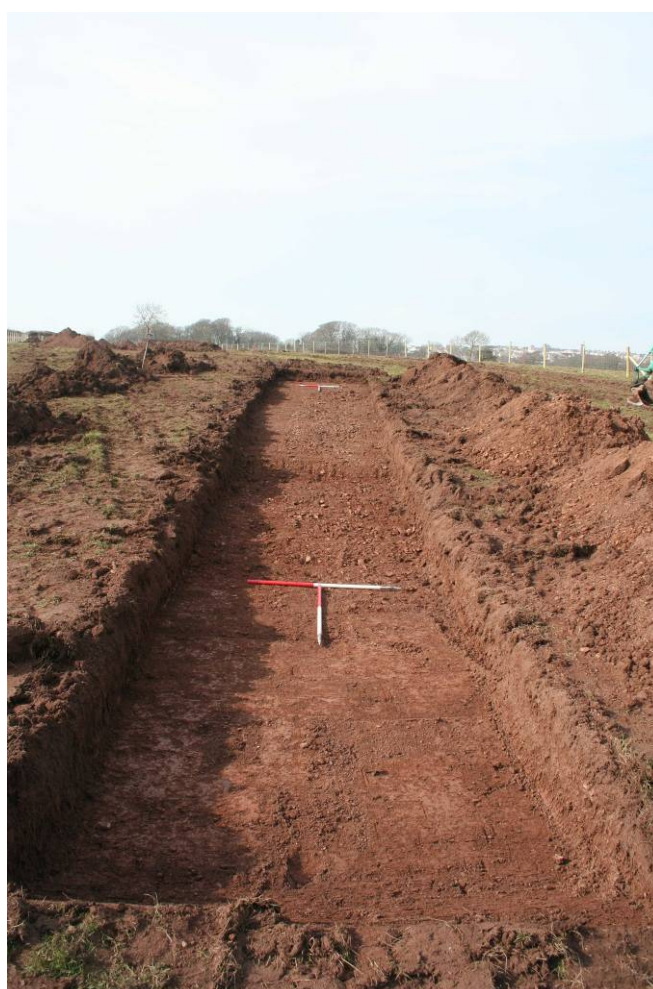
**Photo 27:** West facing view of trench 20.

Number	Description	Depth
Layer 2000	Topsoil Mid red brown silty clay of moderate compaction containing frequent small angular stone. Coal fragments and modern pottery recovered but not retained.	0.18m
Layer 2001	Subsoil Moderately compacted mid reddish brown silty clay containing abundant small angular stone	0.15m

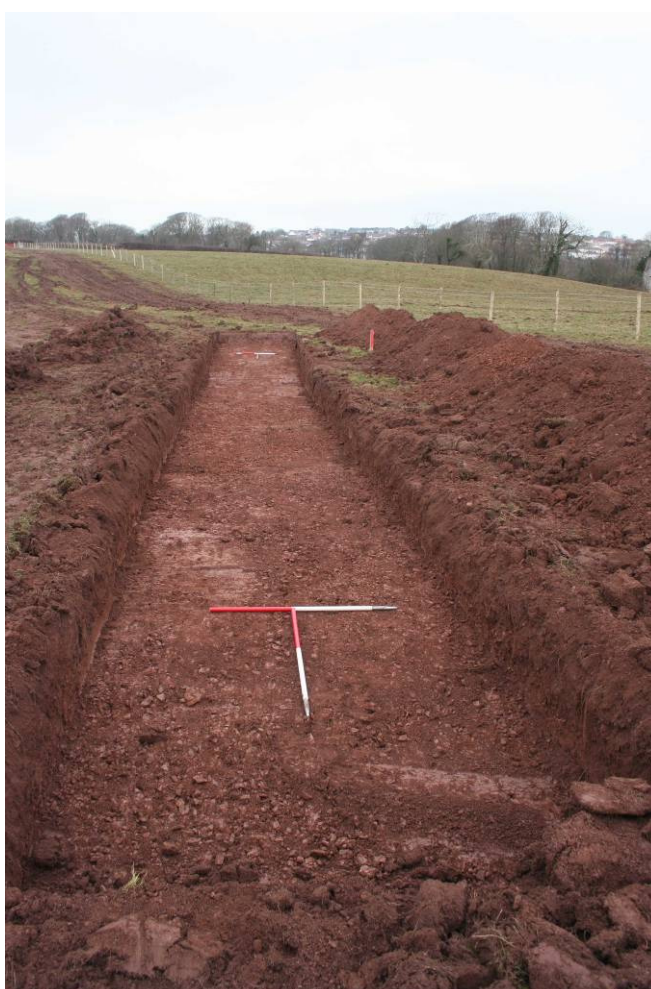
**Photo 28:** Northwest facing view of trench 21.

Number	Description	Depth
Layer 2100	Topsoil Mid red brown silty clay of moderate compaction containing frequent small angular stone. Coal fragments and modern pottery recovered but not retained.	0.45m
Layer 2101	Subsoil Moderately compacted mid reddish brown silty clay containing frequent small angular stone	0.11m
